# NATIONAL TRANSPORTATION SAFETY BOARD

## MATERIALS LABORATORY FACTUAL REPORT

Report No. 19-031

Place : Bettles, Alaska  
Date : 7/29/2018  
Vehicle : Robinson R44 II N744AK  
NTSB No. : ANC18LA058  
Investigator : Brice Banning

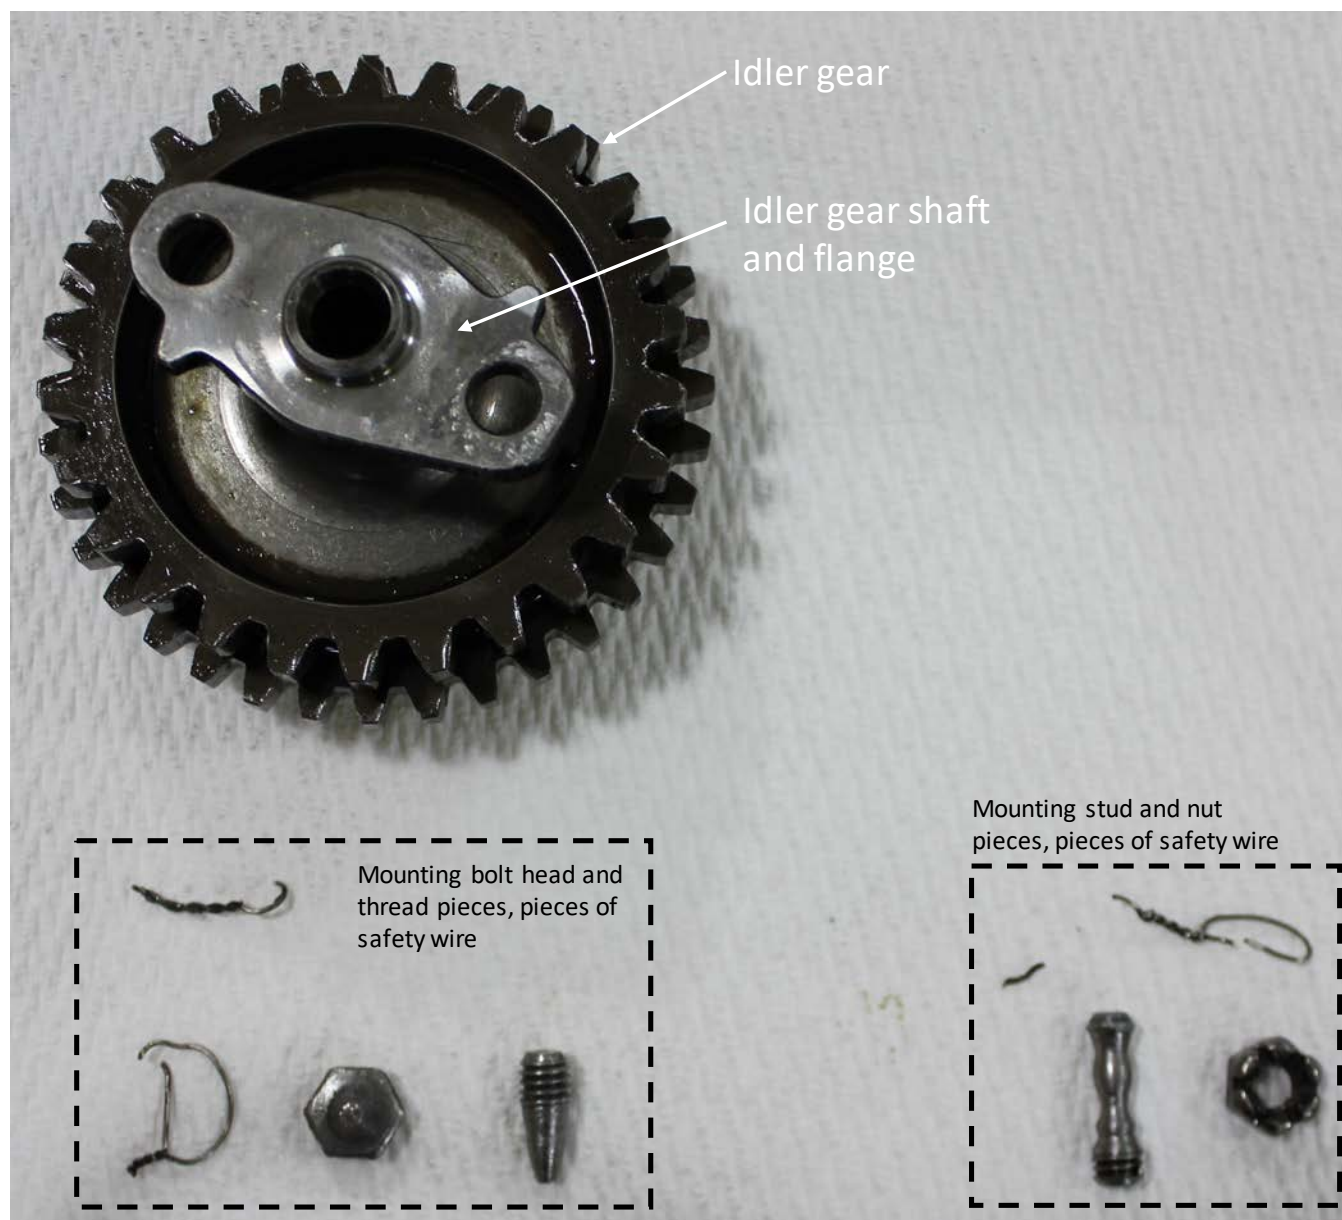
Figure 1 Image of an idler gear, idler gear shaft and flange, mounting bolt pieces, and mounting stud pieces with nut.

Figure 1 shows the idler gear shaft and flange installed on the idler gear. The mounting holes exhibit good circularity with some batter around the right-most mounting hole on the side that faces the crankcase.

Pieces of a mounting bolt and safety wire fragments are shown in Figure 1 (lower left). The bolt head is separated from the shank due to wear-loss of the bolt's cross-sectional area accompanied by final fracture.

A mounting stud, nut, and safety wire fragments are also shown in Figure 1 (lower right). The stud threads have been worn off over 80% of the stud length to an extent that the remaining diameter is free of threads and is smaller than the thread root diameter.

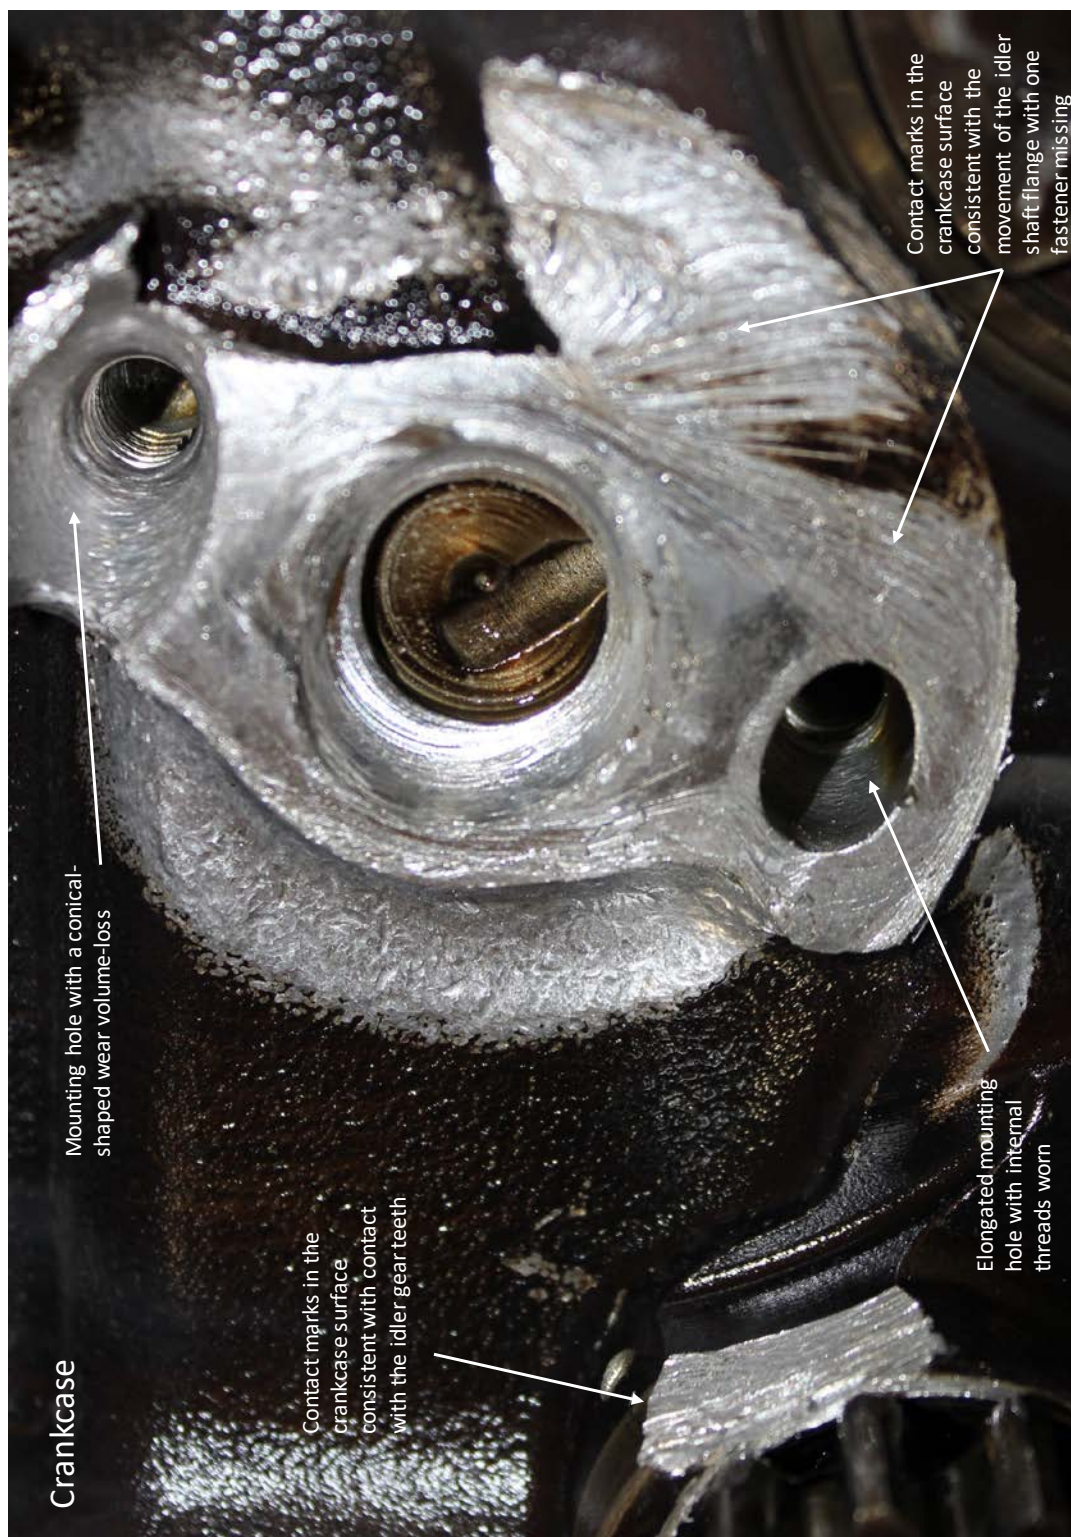
Figure 2 Image of engine crankcase in the region of the idler gear shaft and flange threaded mounting holes.

Figure 2 shows damage to the crankcase in the region of the idler gear shaft flange mounting holes. Specific damage to the threaded mounting holes and the shaft flange mounting face is identified in the image. The damage is consistent with the partial or complete loss of bolt and stud clamping force of the shaft flange to the crankcase.
