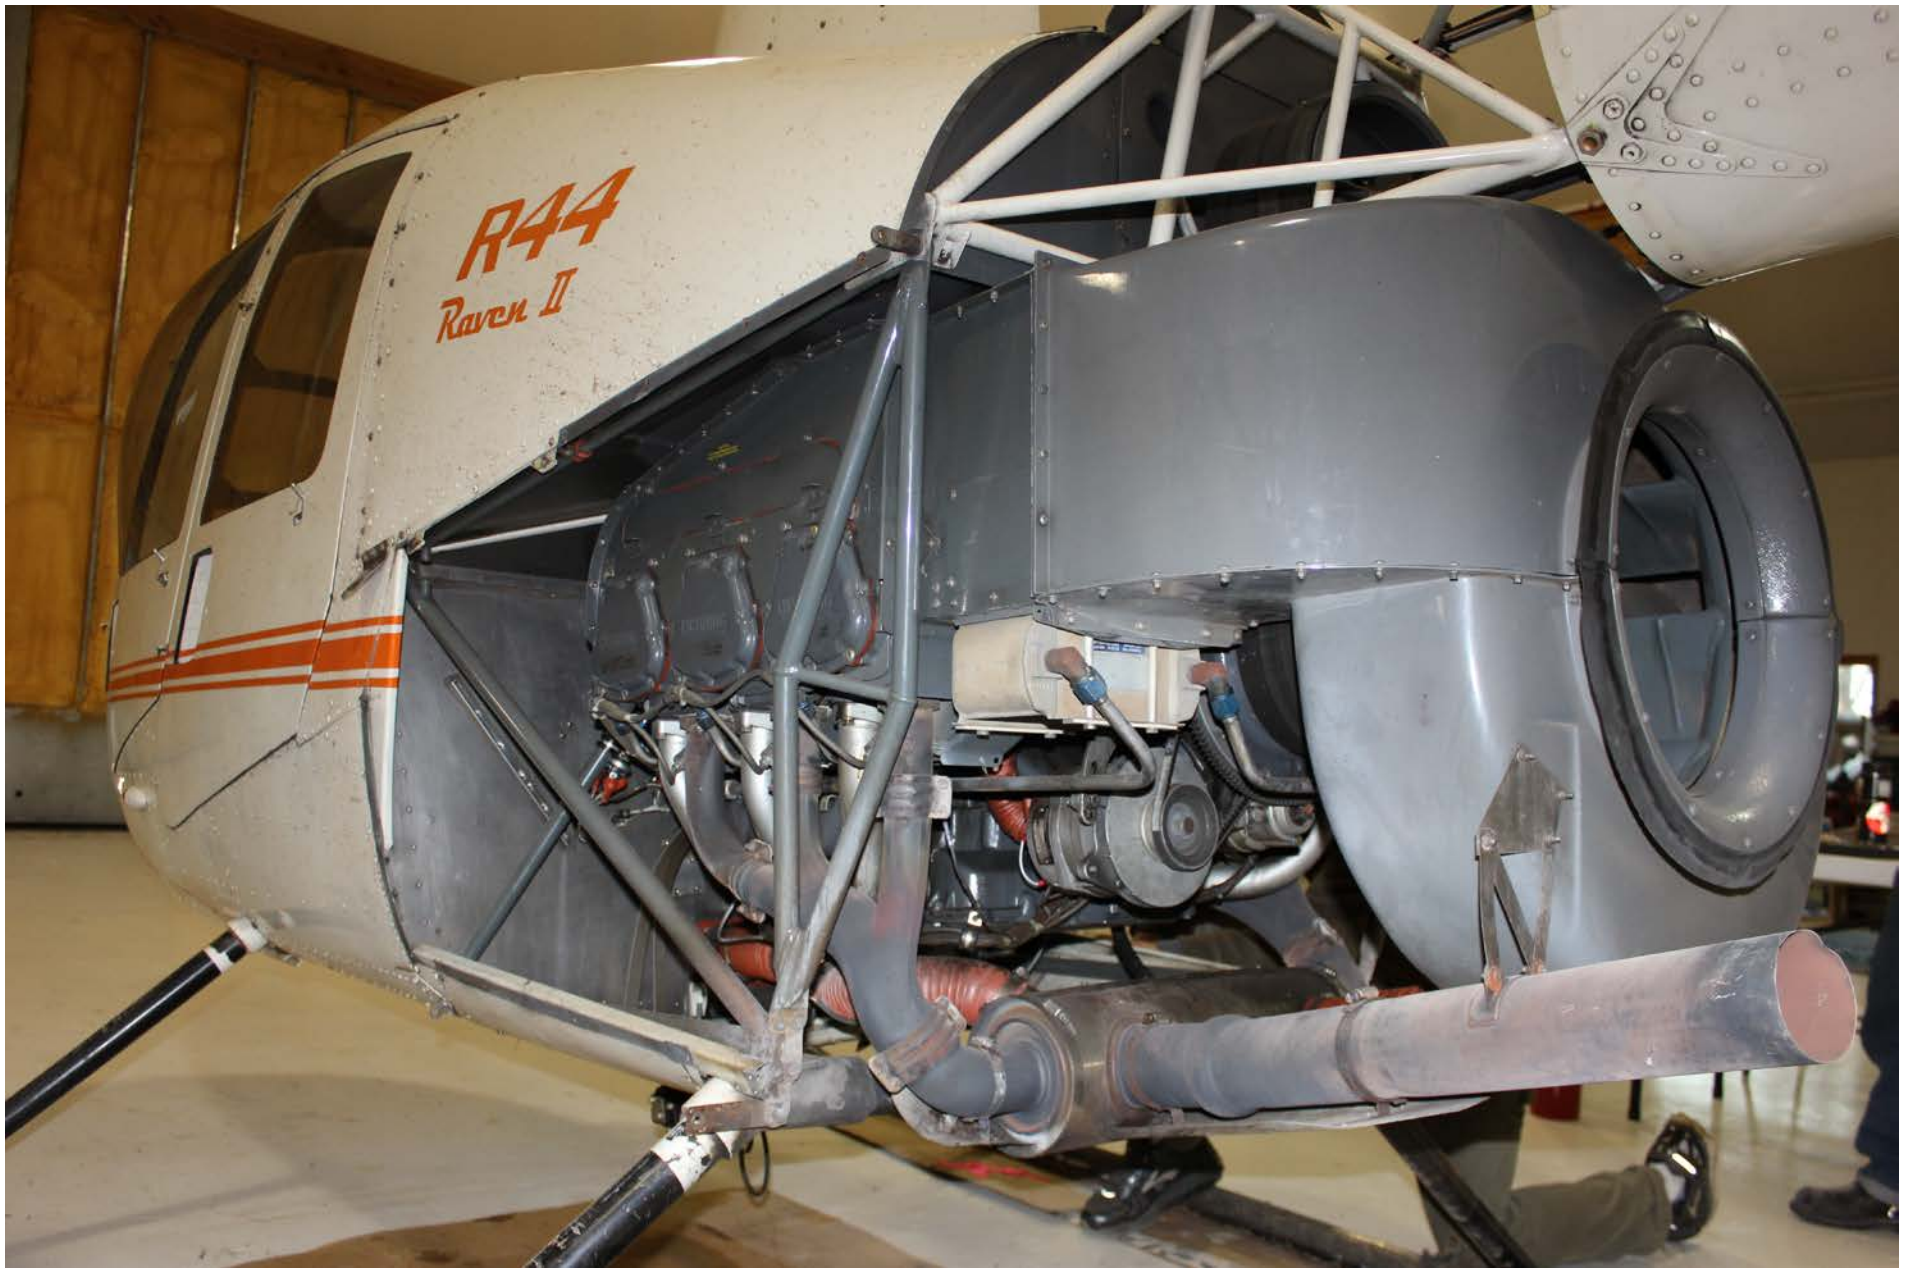
**Photo 1 – Accident helicopter after recovery with the engine installed.**

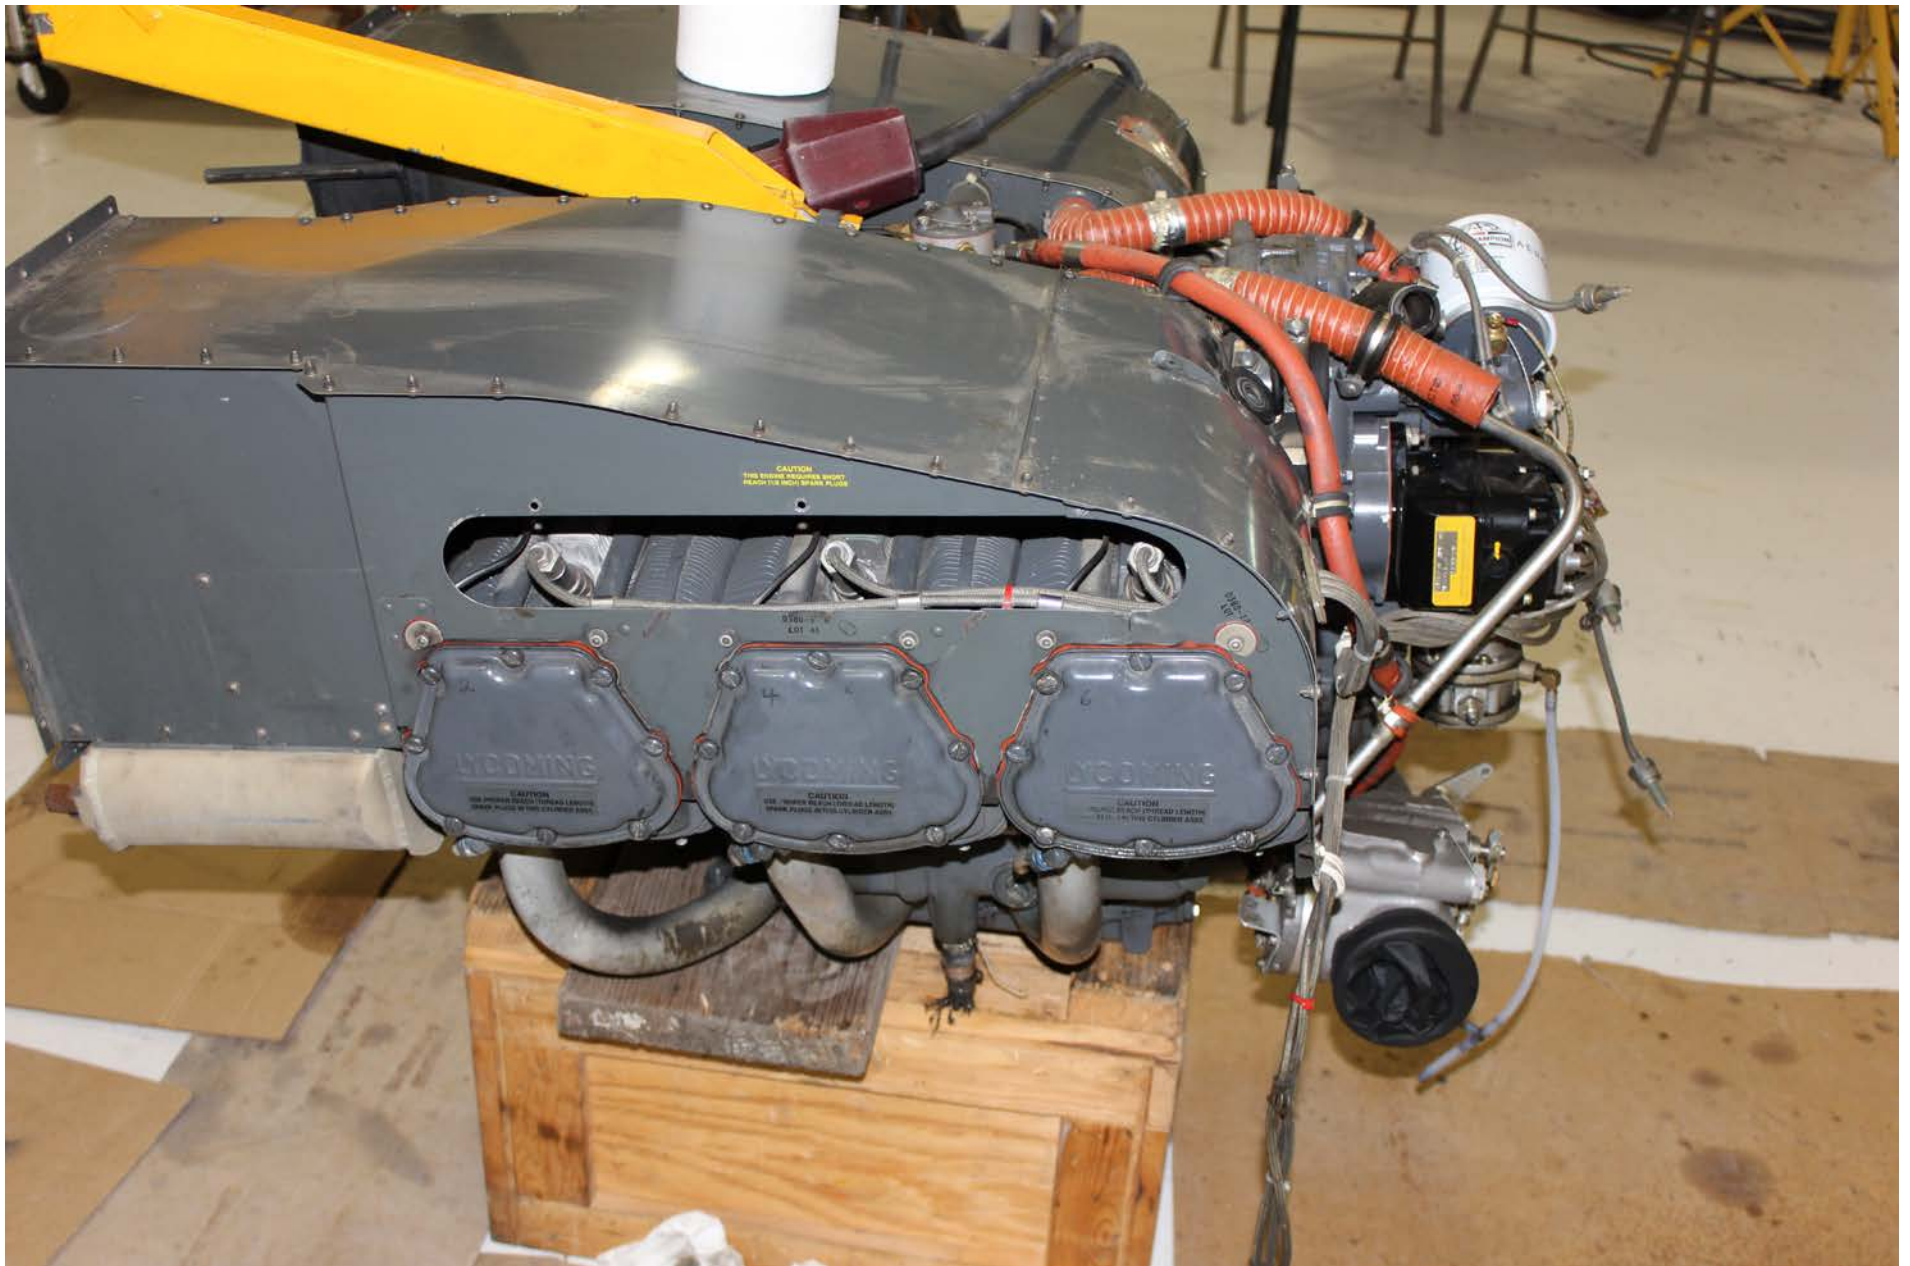
**Photo 2 – Accident helicopter's engine after removal from the helicopter.**

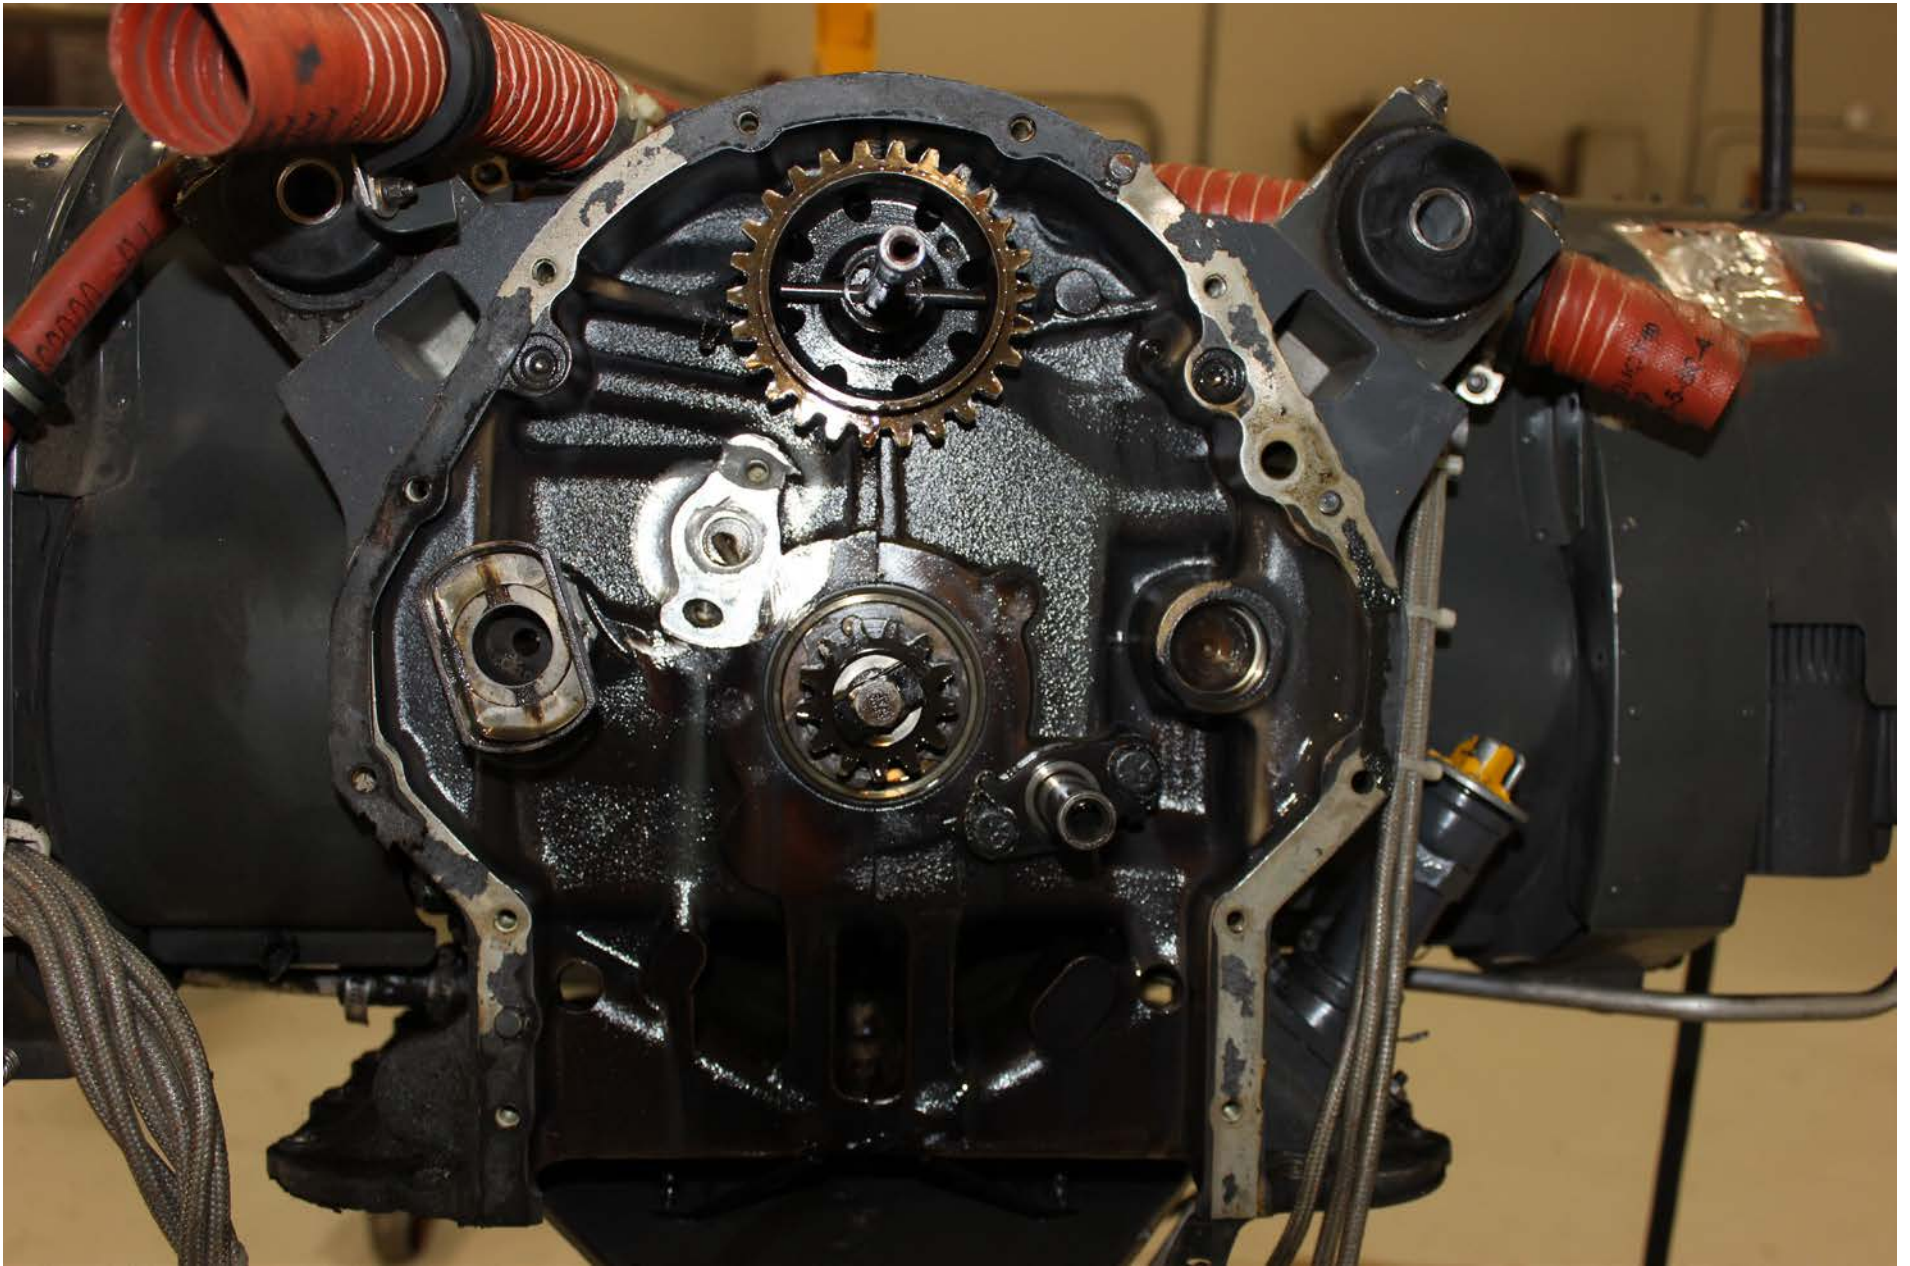
**Photo 3 – Rear view of the helicopter's engine after removal of the rear accessory housing.**

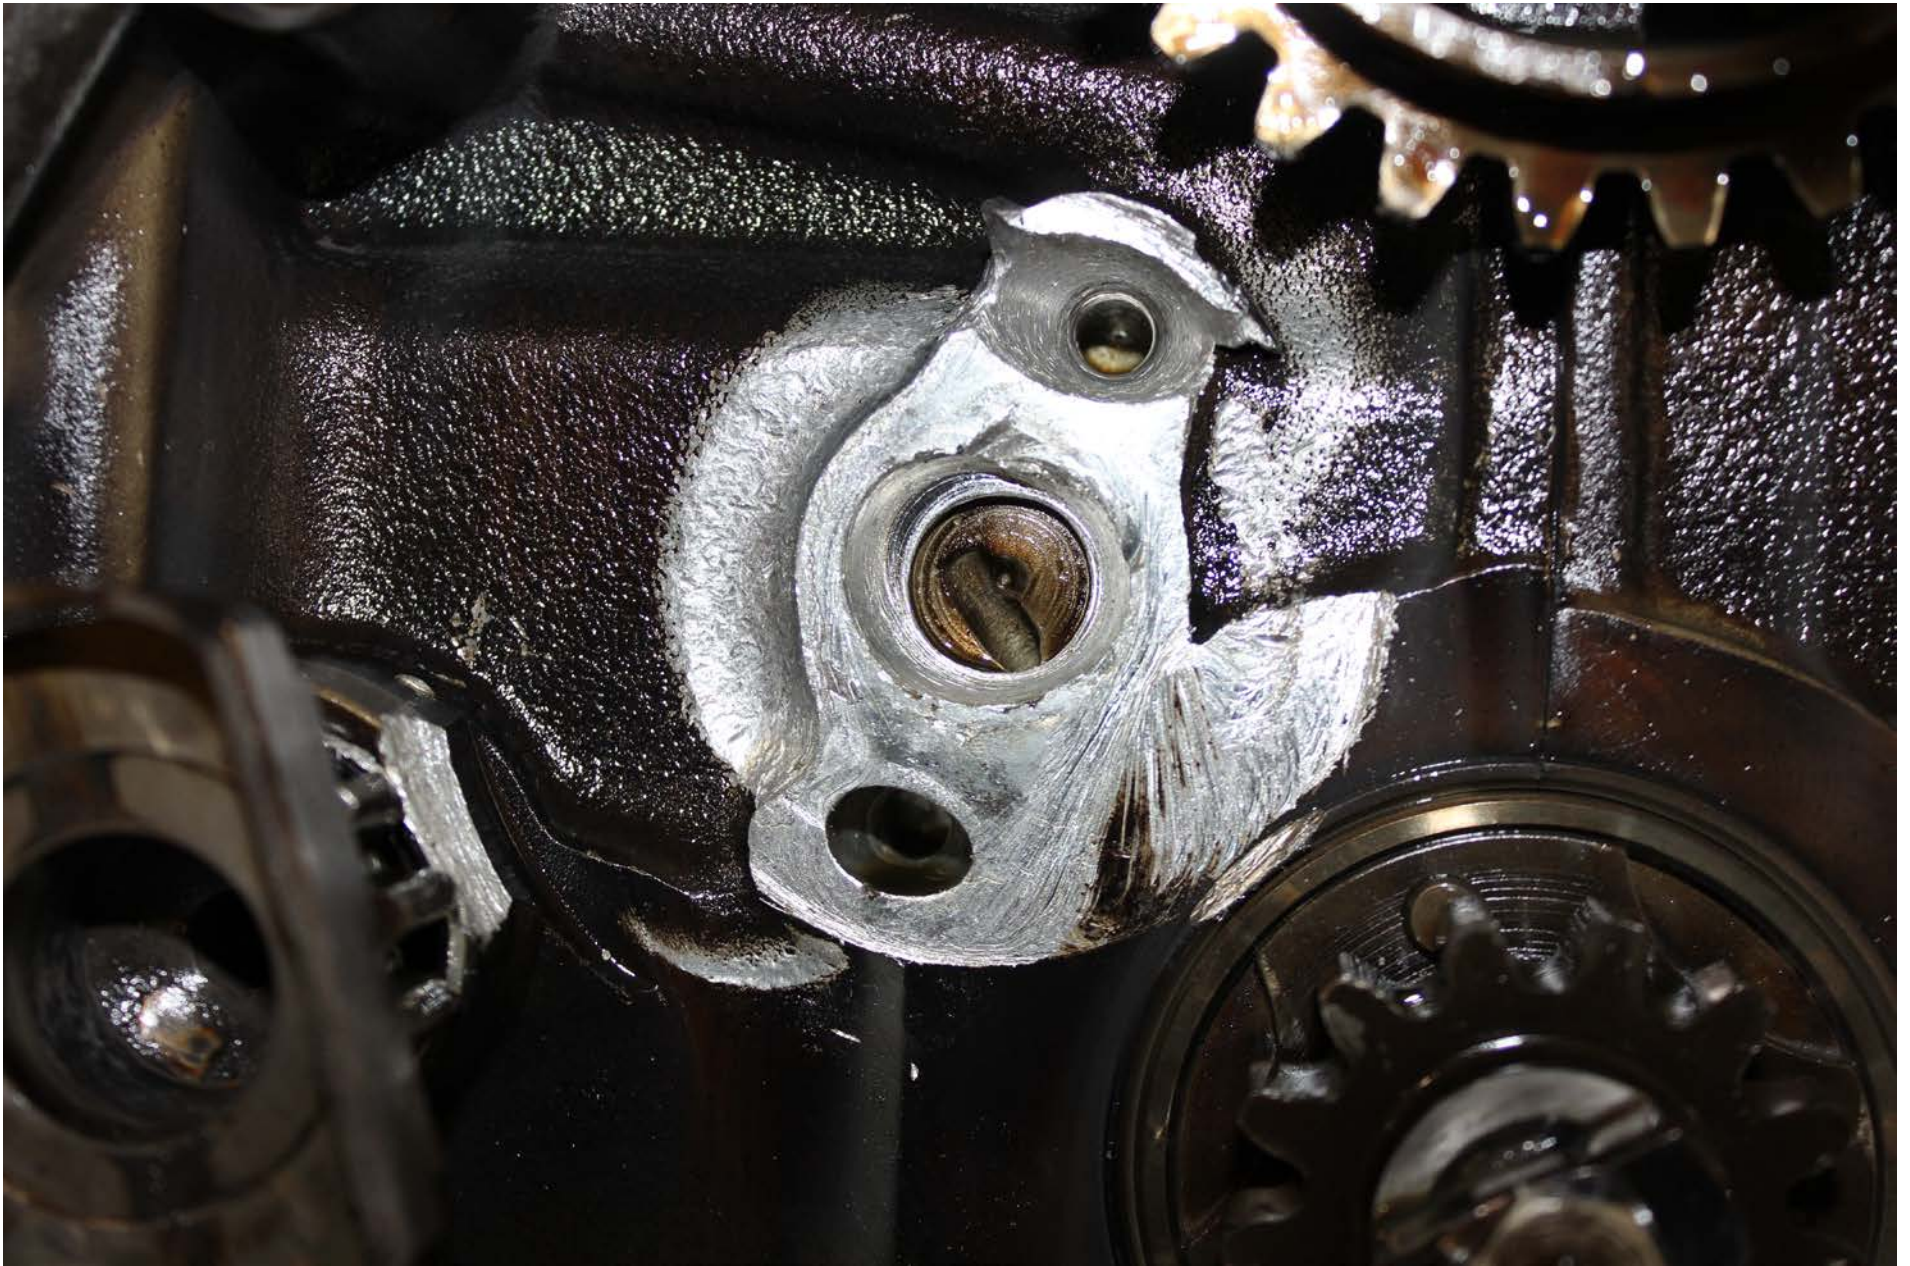
**Photo 4 – Crankcase shaft flange mounting face and mounting holes.**

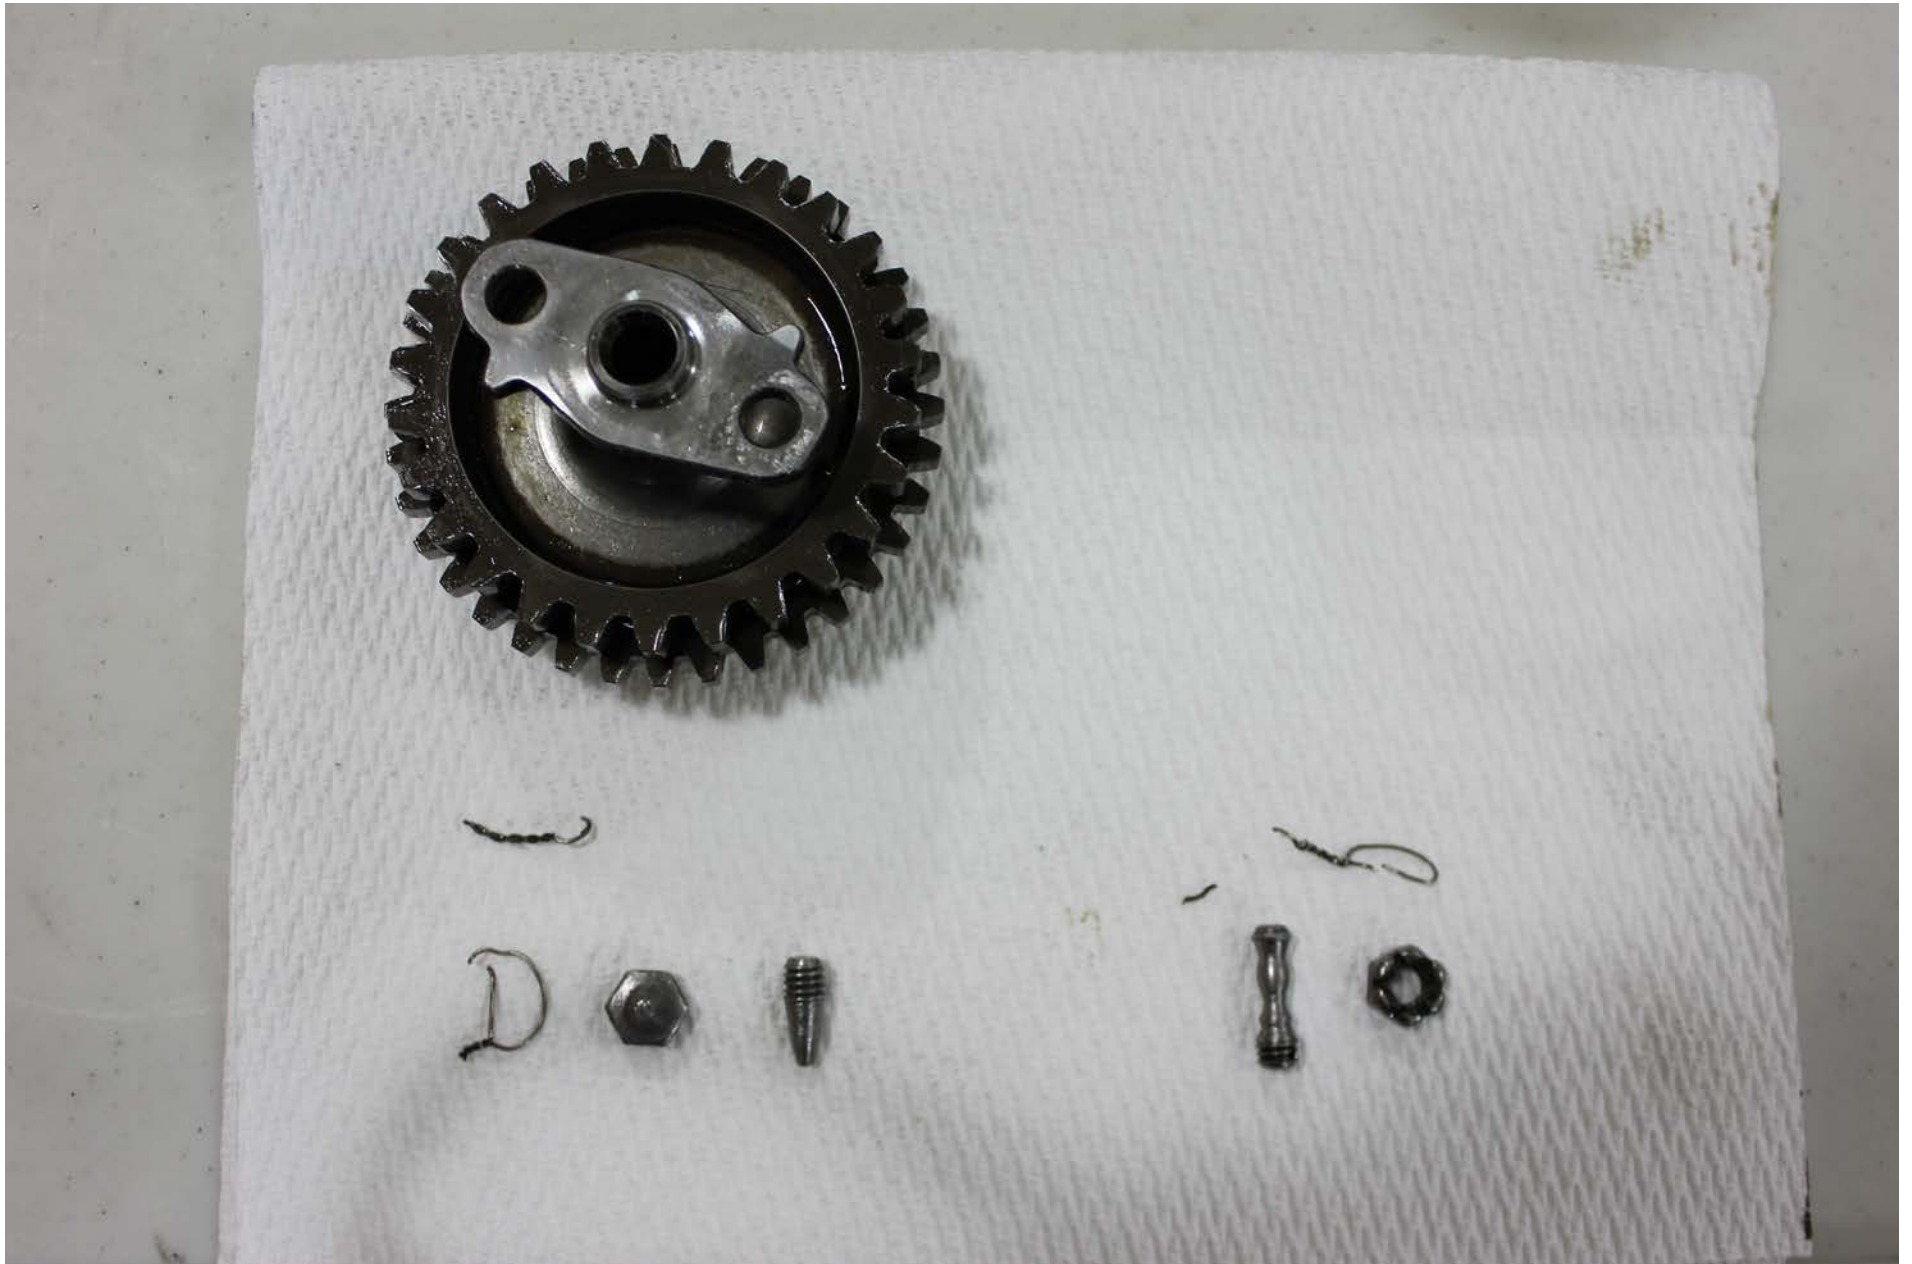
**Photo 5 – Image of idler gear, idler gear shaft and flange, mounting bolt pieces, and mounting stud pieces with nut.**

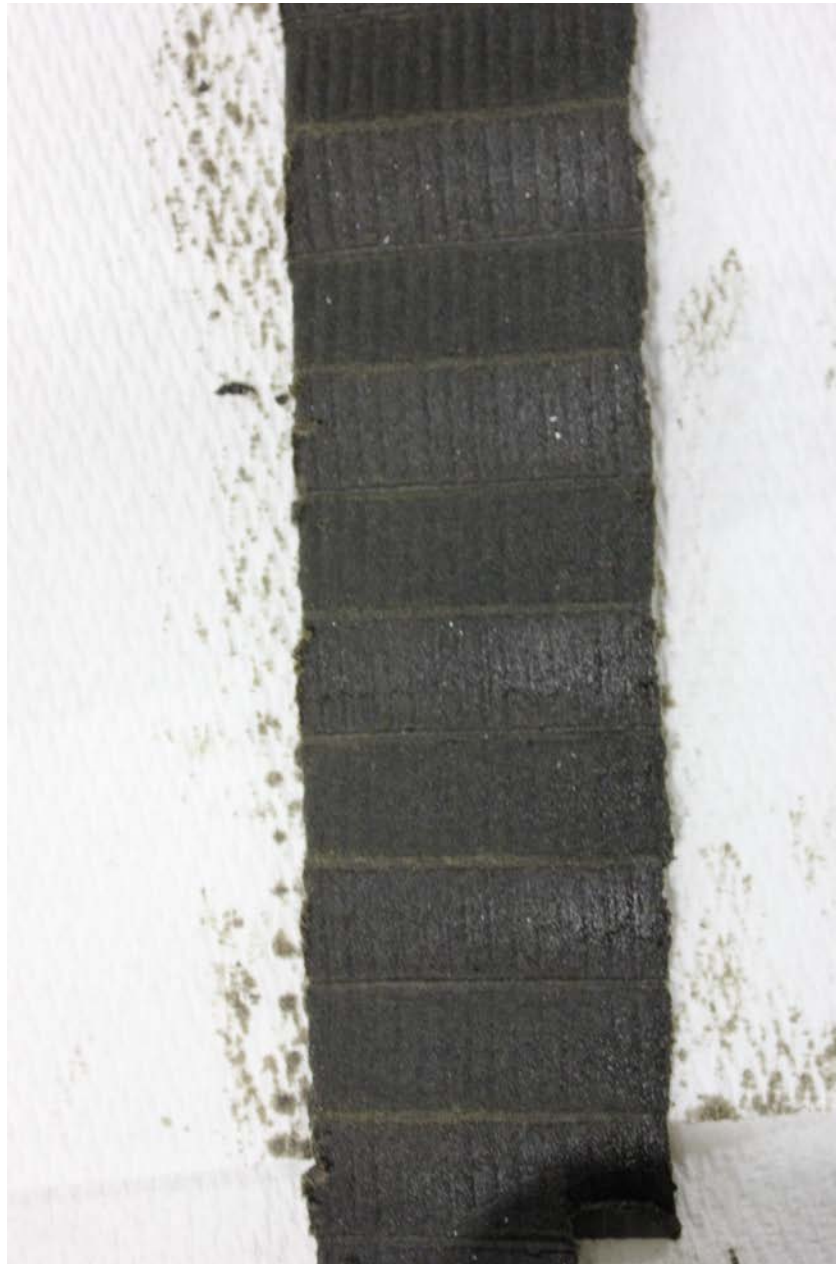
**Photo 6 – Oil filter element with shiny flake like metal material from previous 100 hour, 18.1 hours prior to the accident.**

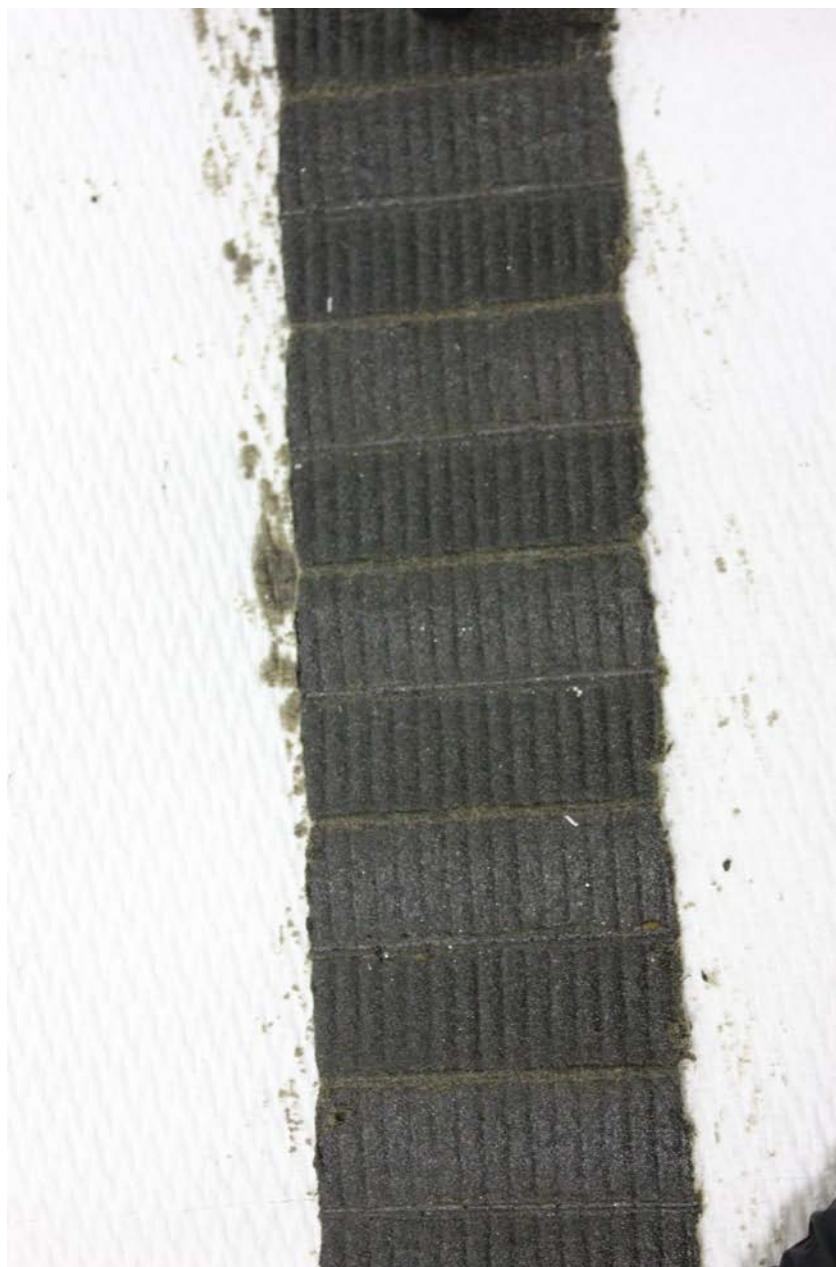
**Photo 7 - Oil filter element with shiny flake like metal material from previous 100-hour inspection, with some flakes estimated to be greater than 1/16 of an inch.**
