**Photo 1 –N185KB Cessna 185 inverted at the accident site. (Source: owner)**

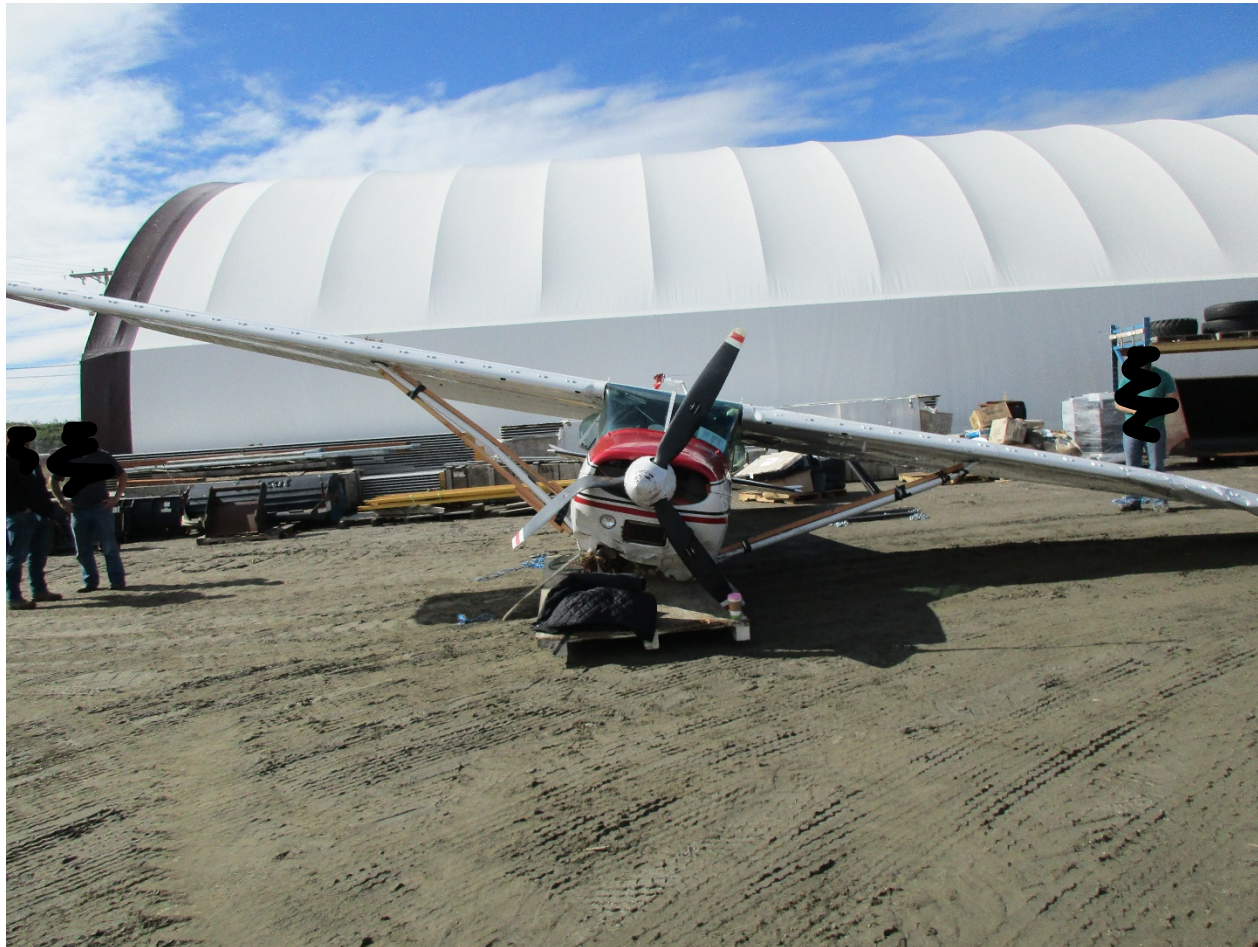
**Photo 2 - Airplane after recovery before examination. (Source: FAA)**

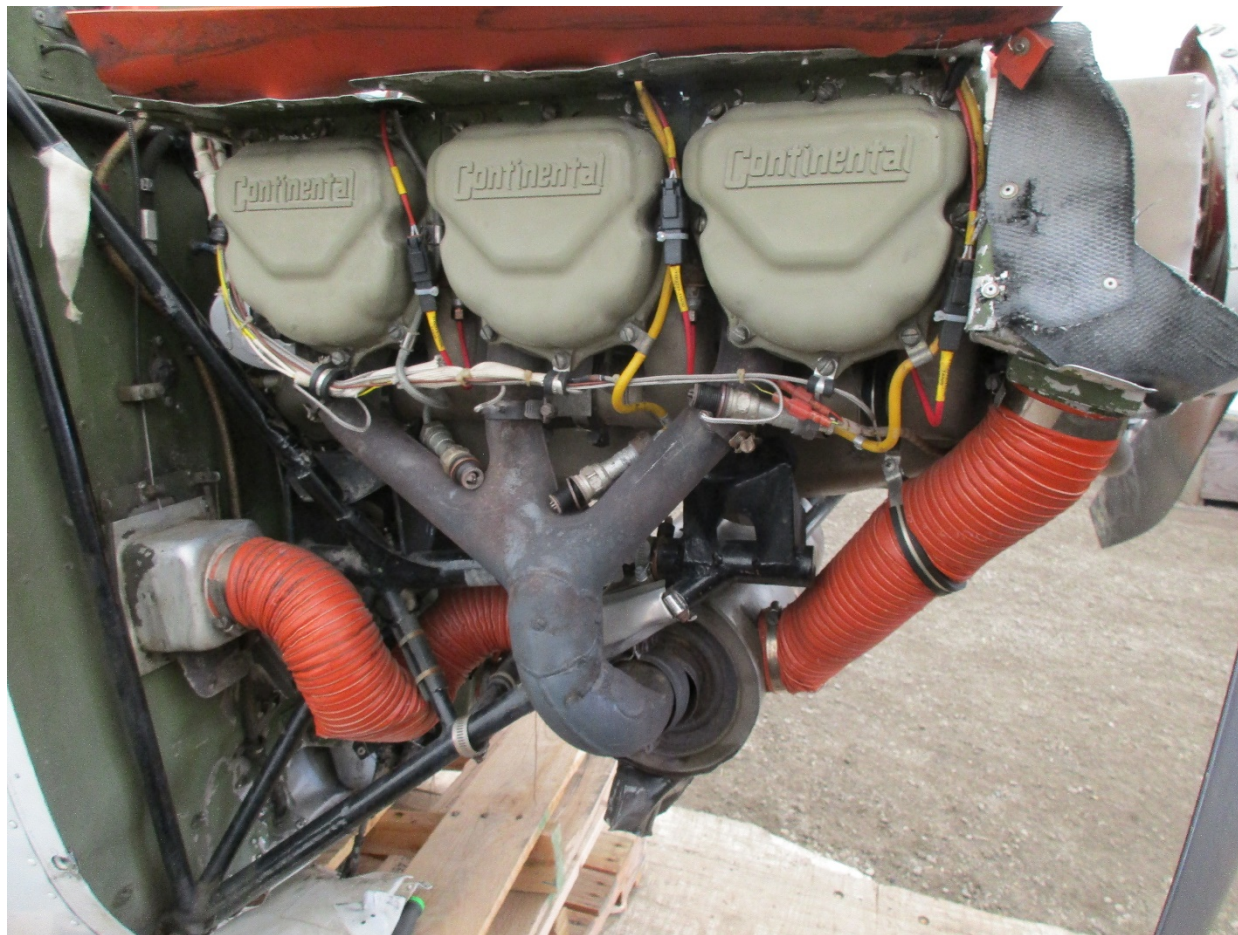
**Photo 3 - Continental IO-520 before the engine examination. (Source: FAA)**

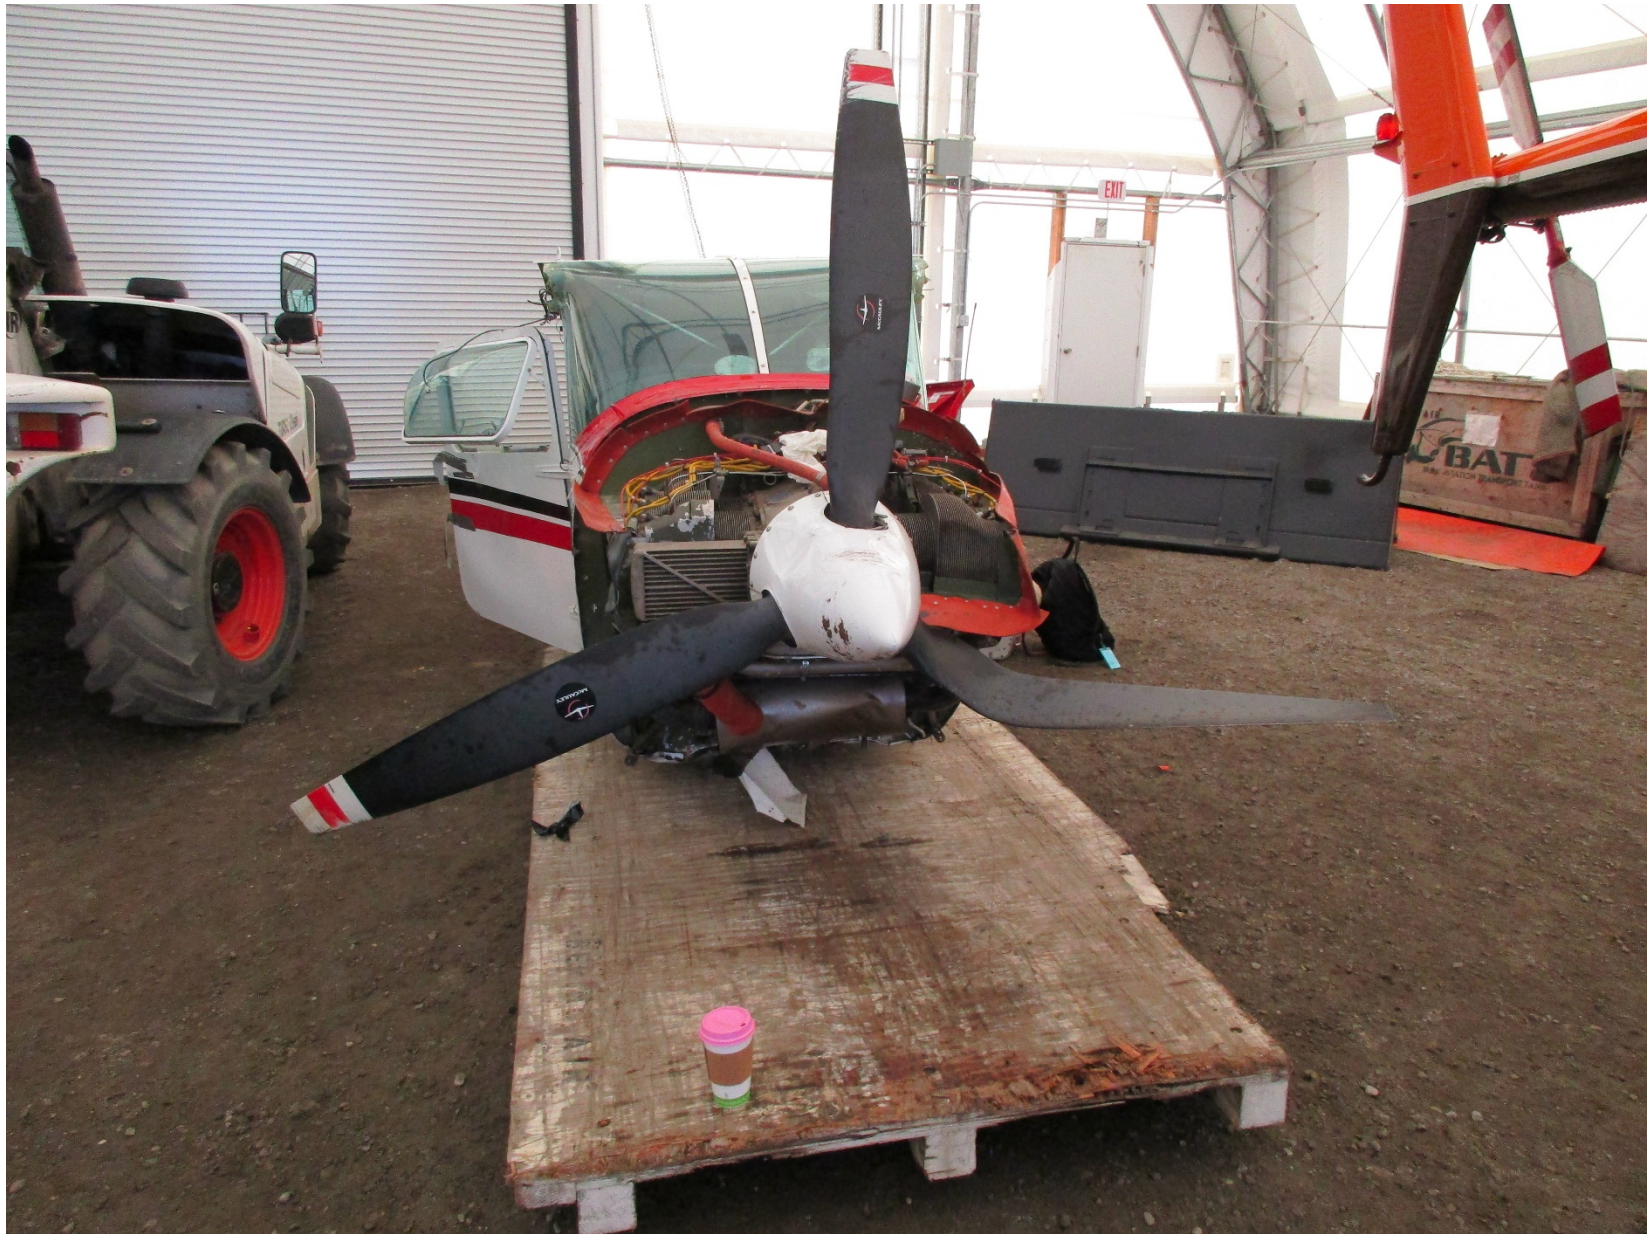
**Photo 4. - Front view after wings removed. (Source: FAA)**

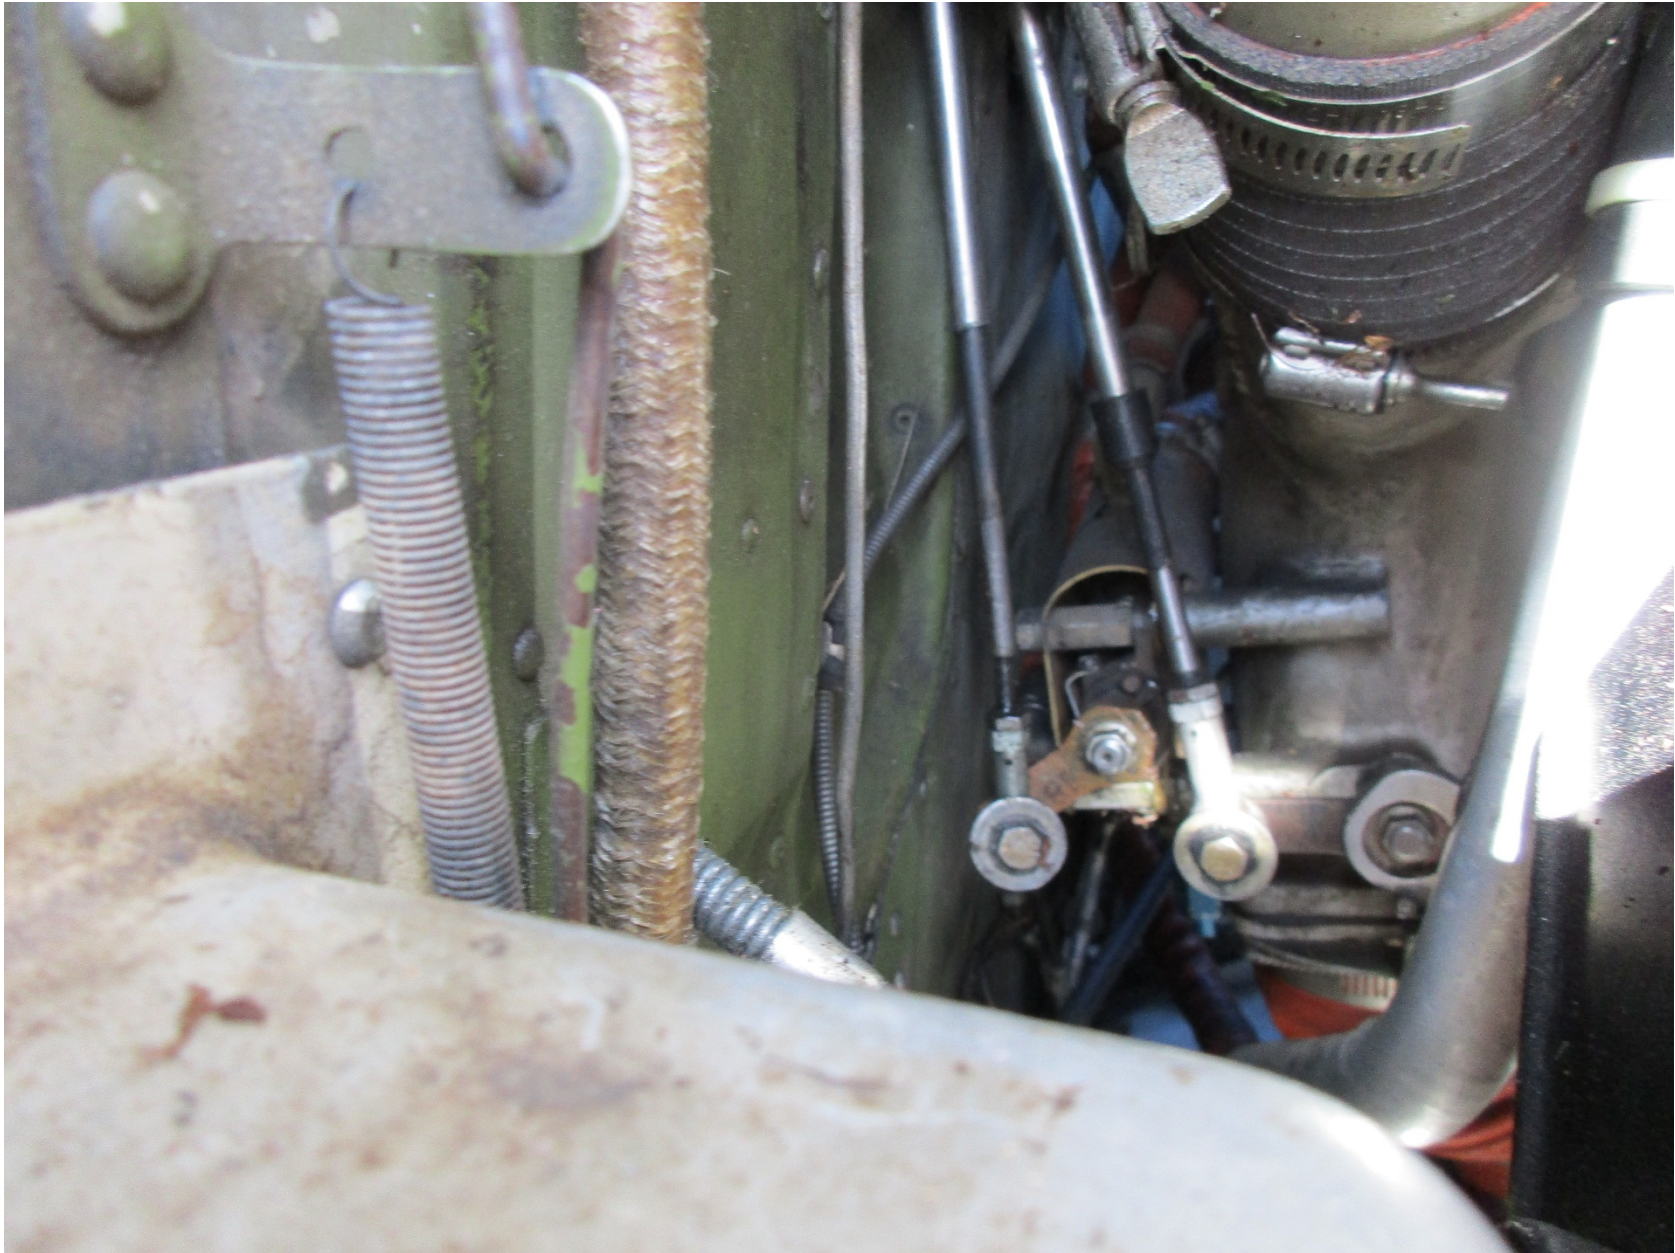
**Photo 5 - Engine control linkages. (Source: FAA)**

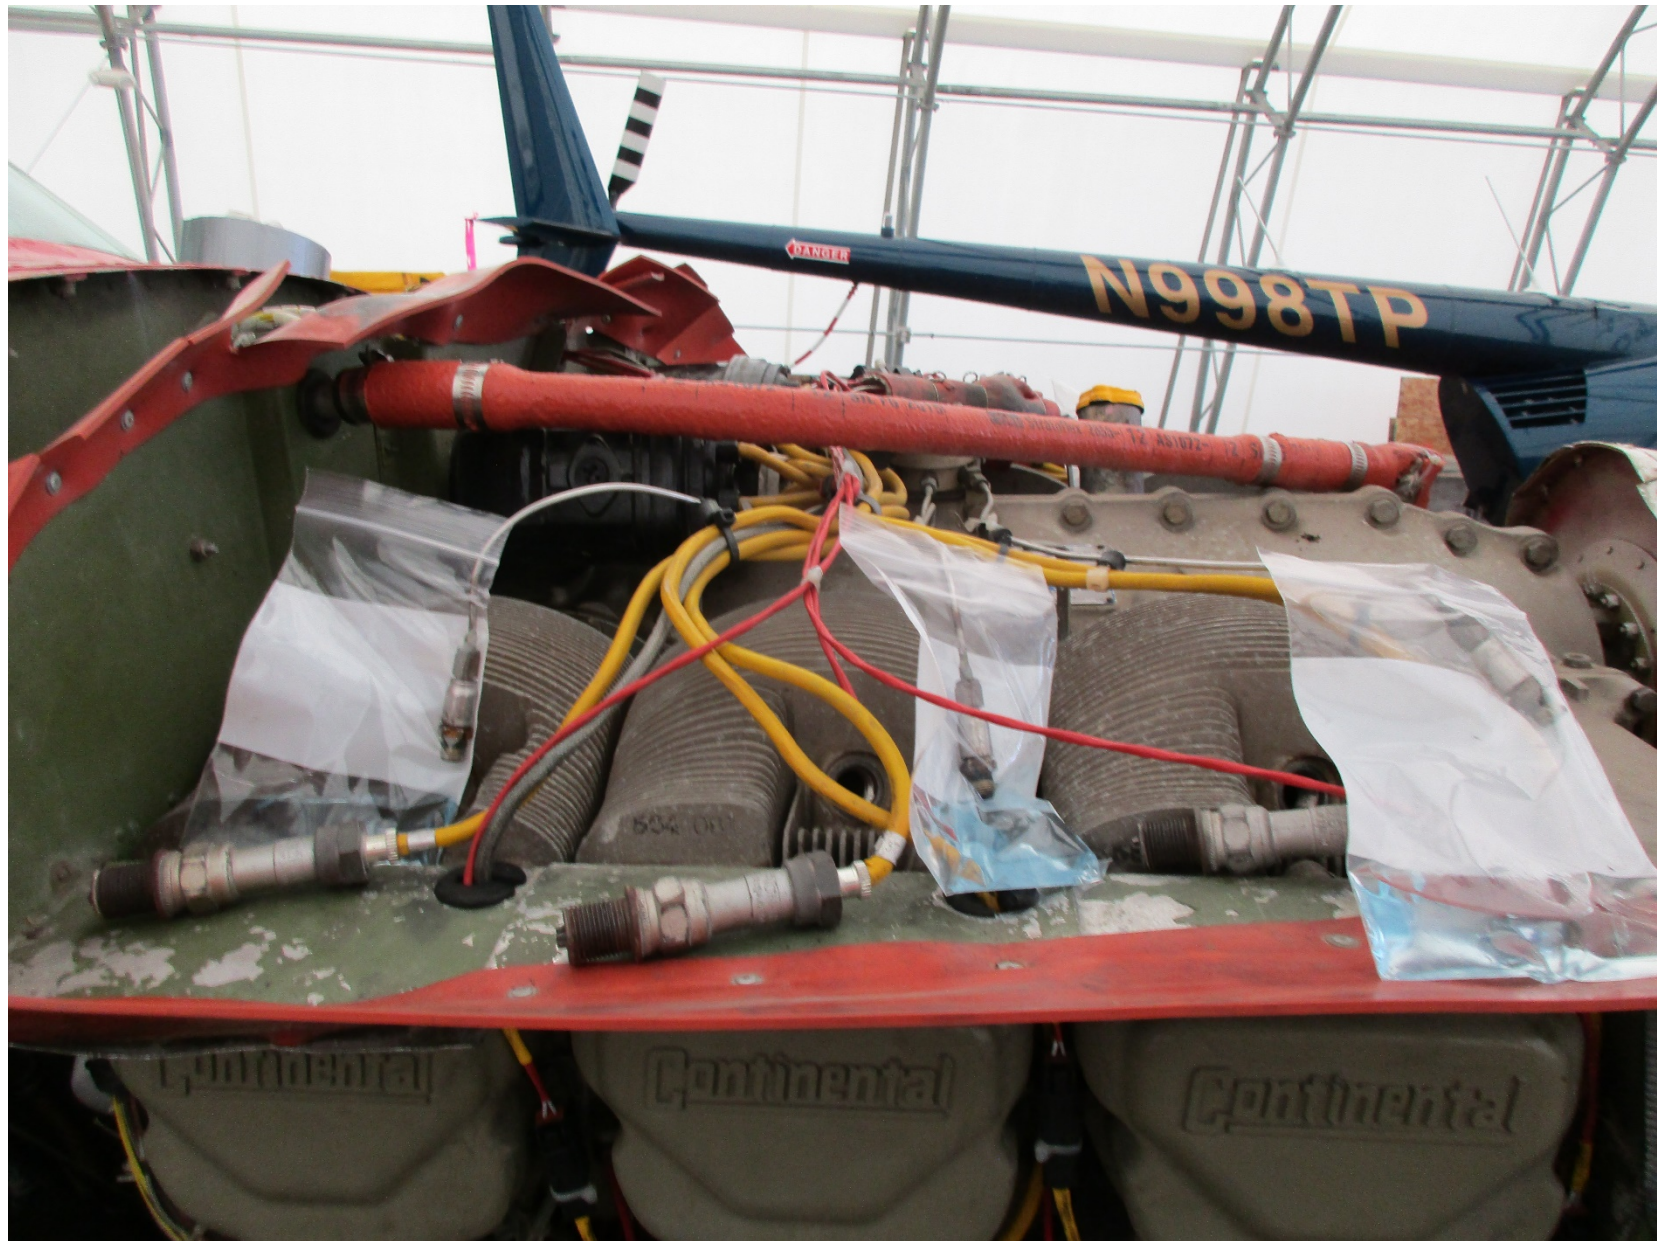
**Photo 6 - Sparkplugs and fuel injectors with fuel from fuel lines captured in bags. (Source: FAA)**
