# Continental Motors

## ENGINE EXAMINATION REPORT

| ENGINE MODEL | IO-520-F13B |
| FILE NUMBER | 18-089 |

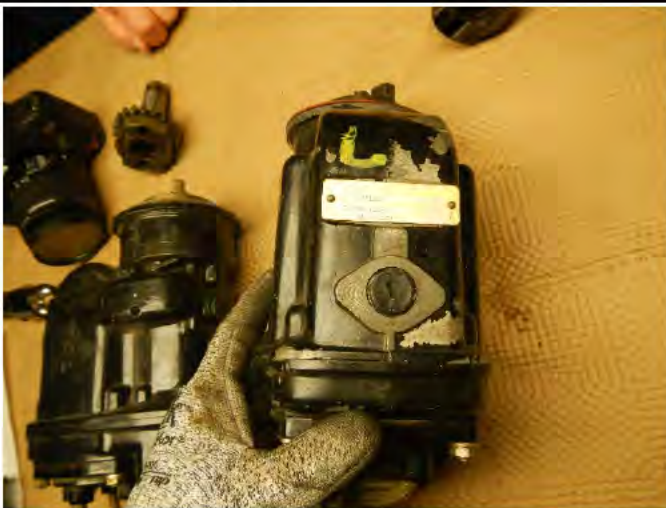
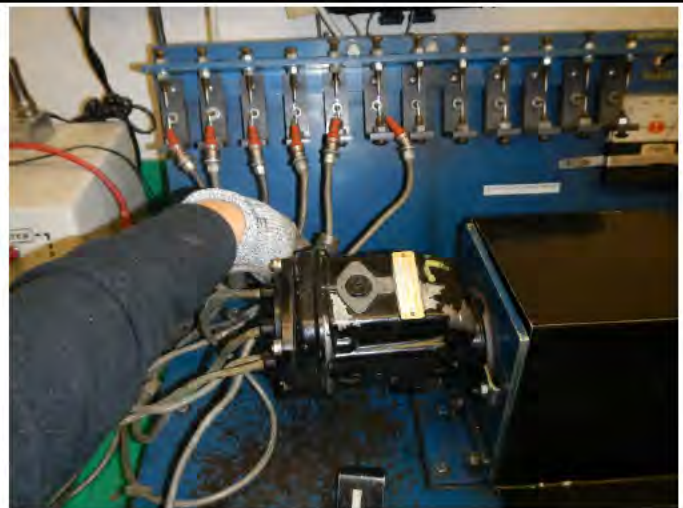
##### LEFT MAGNETO

The magneto-to-engine timing was checked with the left magneto timed to 23° BTDC and the right magneto being timed to 25° BTDC. The magnetos were placed on a test bench and both produced a spark from each of their leads in firing order with no pre-accident anomalies noted.

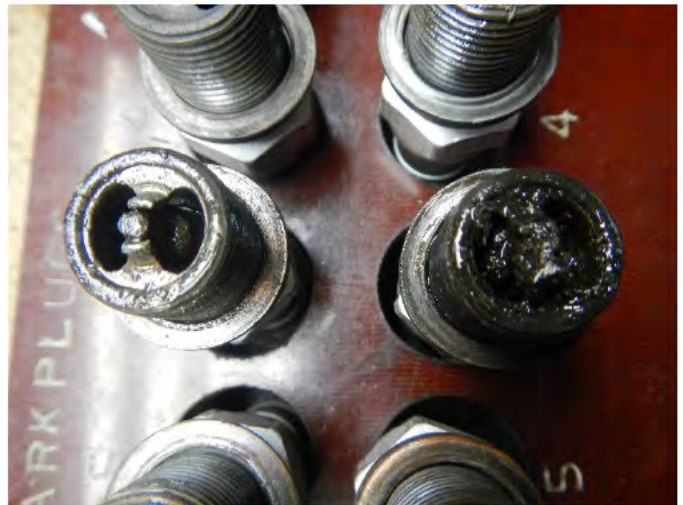
2 T&B

The engine was disassembled. The #2 piston was eroded and burned through consistent with a pre-ignition/detonation event. The #2 top and bottom sparkplugs were eroded and mechanically damaged with deformed electrodes. The bottom sparkplug insulator was fractured. The bottom sparkplug Heli-Coil showed evidence of re-solidified molten metal concentrated at the tang notch.

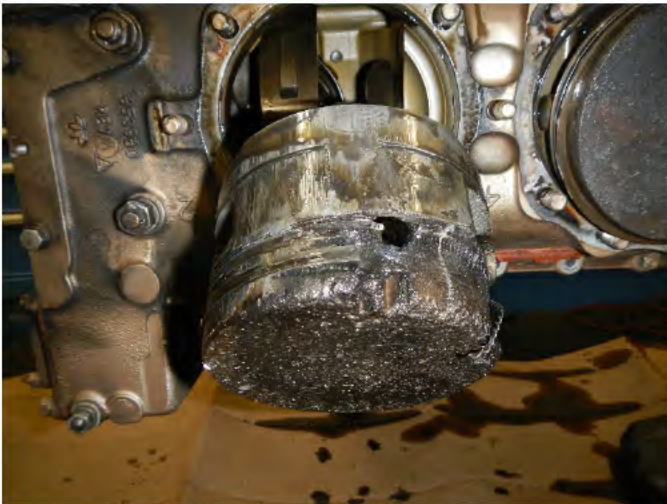
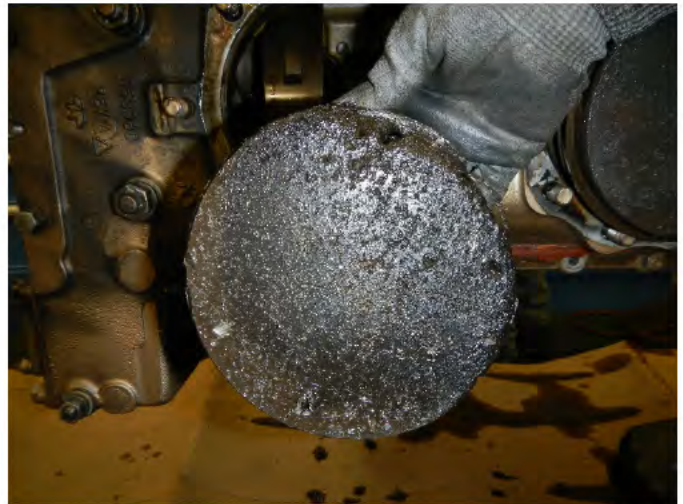
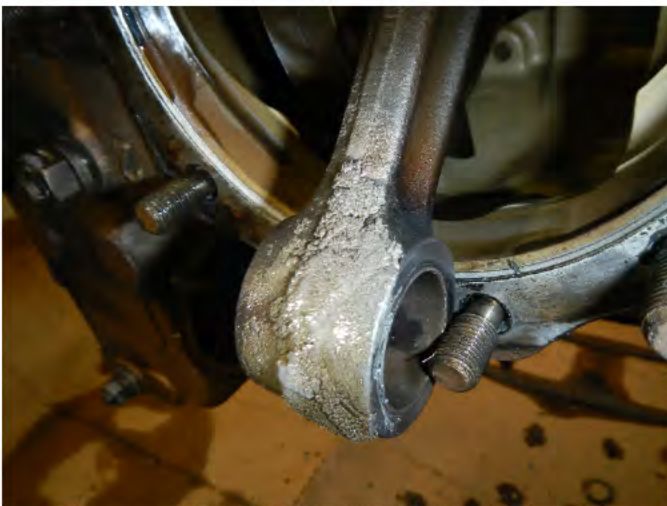
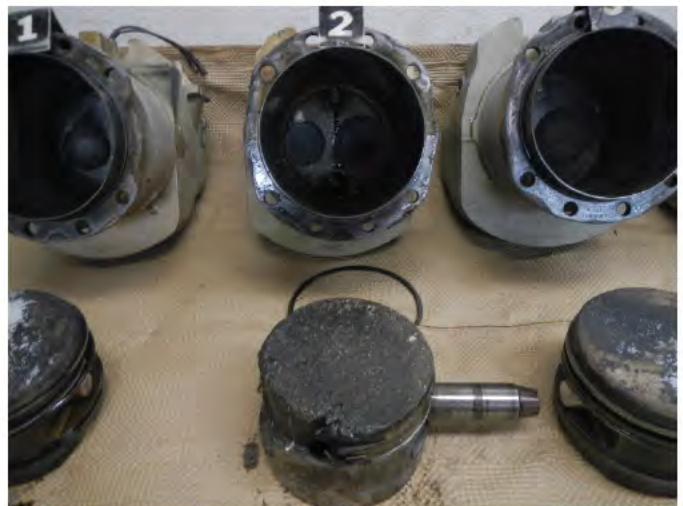
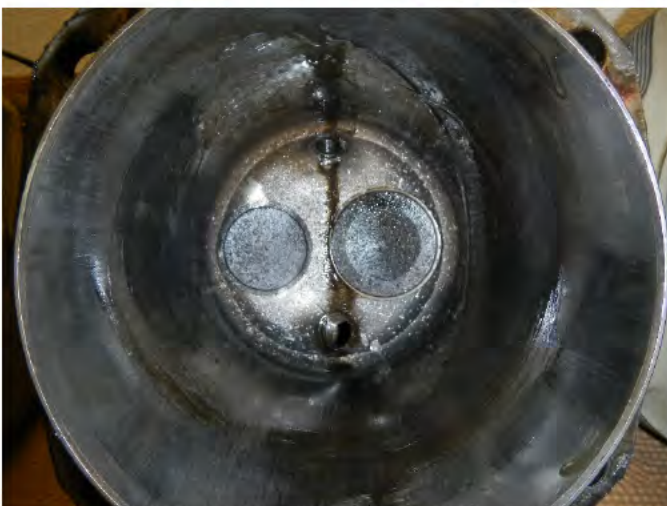
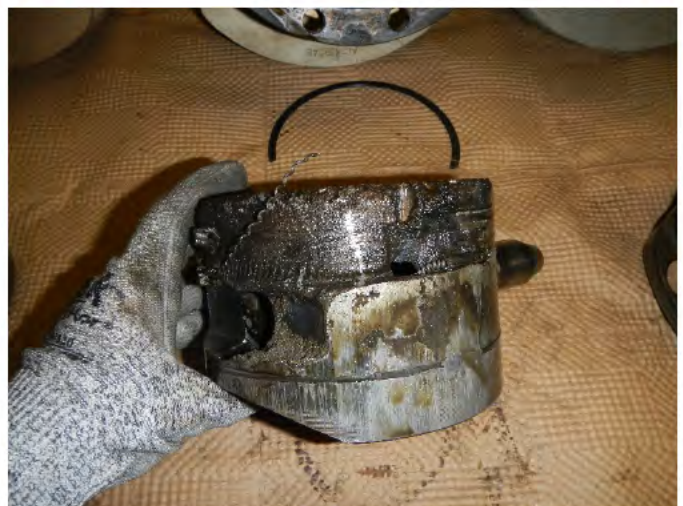
### CYLINDER #2

The #2 piston was eroded on the bottom side and a hole was burned through, consistent with a pre-ignition/detonation event. The piston and cylinder head were also mechanically damaged by loose piston ring debris. The top and bottom sparkplug electrodes were eroded and mechanically damaged and deformed. The #2 bottom, #4 top and #6 bottom sparkplug insulators were cracked and mechanical damage was noted around those sparkplug bays. Closer examination of the #2 cylinder head revealed re-solidified molten metal around the bottom Heli-Coil tang notch. No other pre-accident anomalies were noted with the engine that would have precluded its normal operation.
