## **NATIONAL TRANSPORTATION SAFETY BOARD**

# **AIRFRAME AND ENGINE EXAMINATION**

**ANC18LA064**

Location: Iliamna, AK  
Date: 08/07/2018  
Aircraft: Cessna 207, Registration Number: N7379U, Serial #: 20700427  
NTSB IIC: Clint Johnson

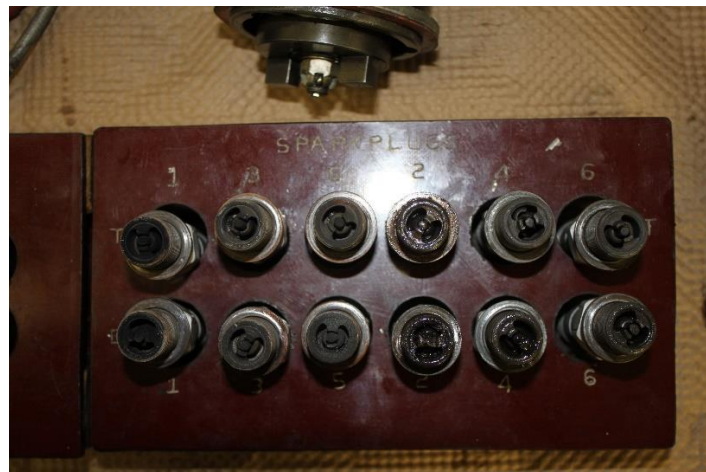
- Engine rotates from propeller flange to rear accessory gear
- Engine compression (thumb) on all cylinders
- Plug:
  - #1
    - Top: carbon fouled (worst)
    - Bottom: carbon fouled (worst)
  - #2
    - Top: lead (not fouled but between insulator and housing)
    - Bottom: carbon
  - #3
    - Top: lead (between insulator and housing)
    - Bottom: carbon
  - #4
    - Top: insulator is fractured
    - Bottom: good
  - #5
    - Top: good
    - Bottom: good
  - #6
    - Top: wore out
    - Bottom: insulator is fractured

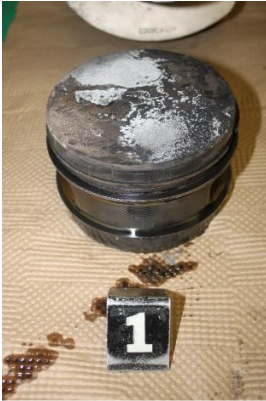
#1 : Signs of erosion

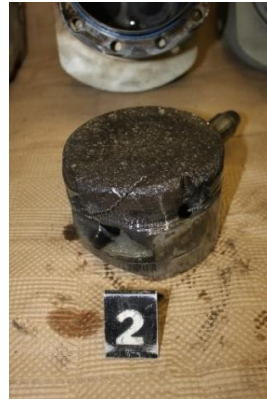
#2 : Damaged/failed – detonation / pre ignition

Pre ignition/detonation from #2 cylinder, possible hot spot/wore out spark plug/Heli-coil damage. Piston failed near bottom plug consistent with damaged Heli-coil and detonation. Further engine notes and report will be provided by Continental Motors.

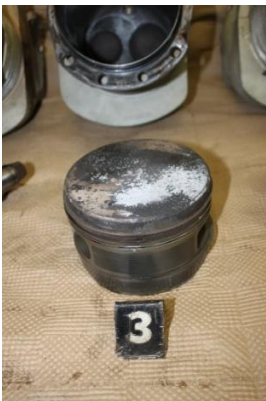
#3 : Signs of erosion

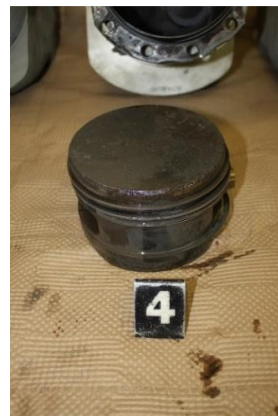
#4 : Mechanical damage, likely #2 cylinder parts that traveled through induction

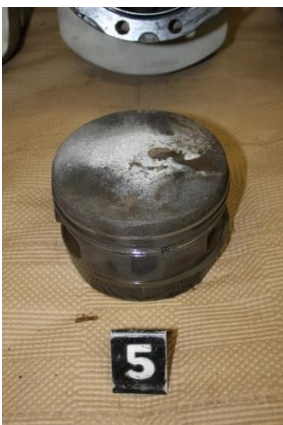
#5 : Signs of erosion

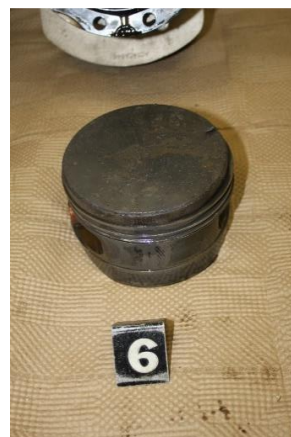
#6 : Mechanical damage, debris on piston, likely pieces from #2 cylinder

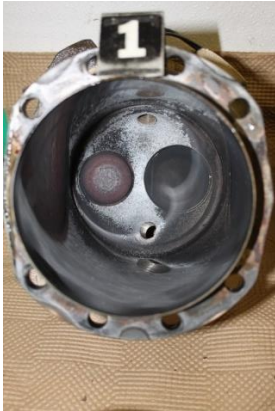
#1 : Signs of erosion

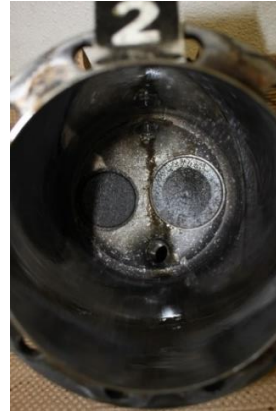
#2 : Mechanical damage from failed piston, Heli-coil damaged/molten down

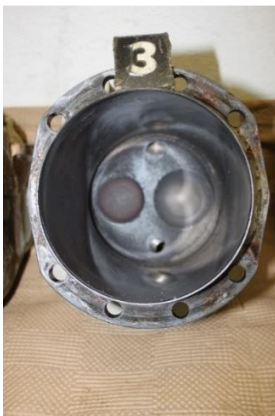
#3 : Signs of erosion

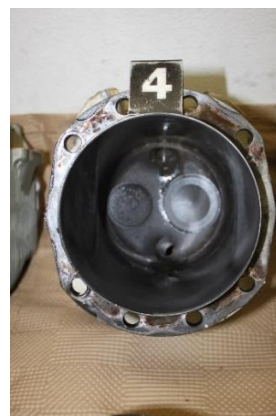
#4 : Mechanical damage around top spark plug bay

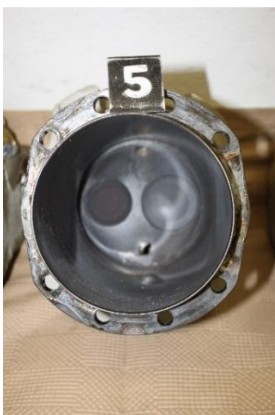
#5 : Signs of erosion

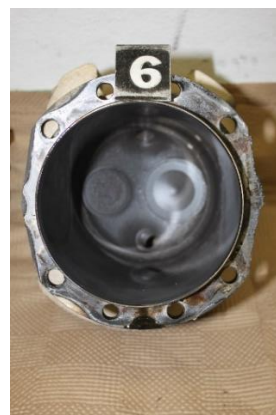
#6 : Light mechanical damage

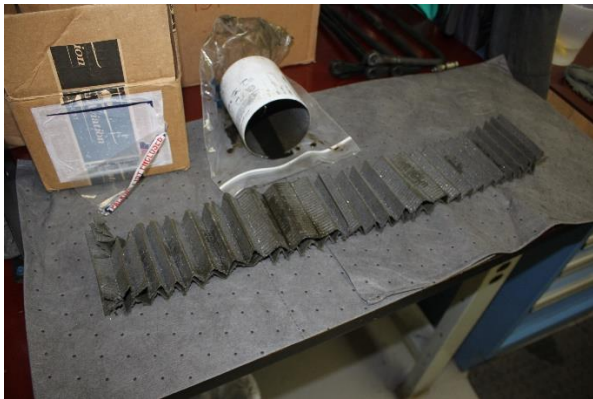
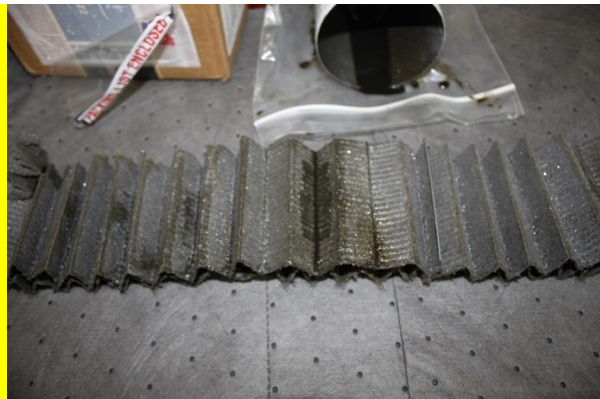
- Ignition Leads
  - All in working order
- Oil screen and filter
  - Metallic debris found
