## **NATIONAL TRANSPORTATION SAFETY BOARD**

#### **Engine Examination Summary**

NTSB Number: ANC18LA066

Aircraft: Cessna 185, N8041R, S/N 18502098

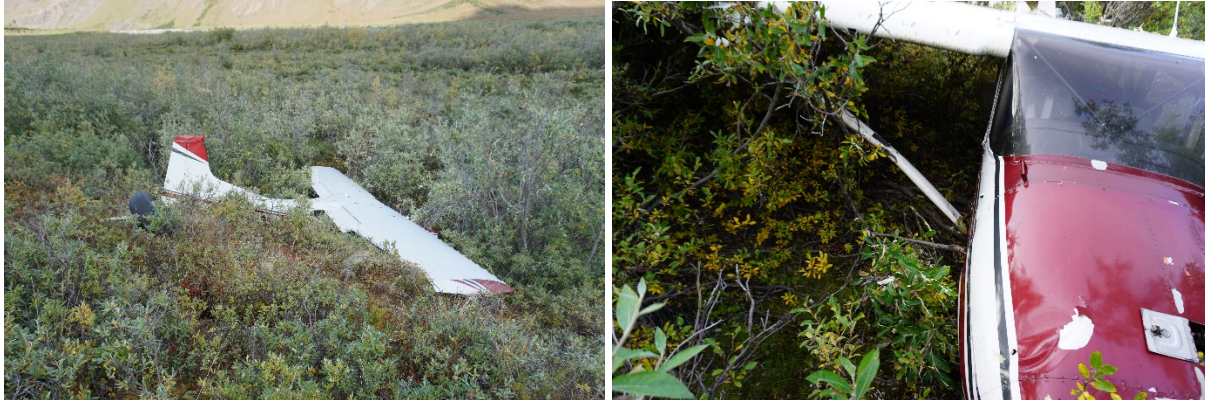
activated the auxiliary fuel pump and engine power was restored; however, the airplane was too low to recover, and it impacted the brush covered terrain. The main landing gear sheared off and the airplane slid off the riverbank, resulting in substantial damage to the fuselage, left elevator and right lift strut. See figure 1.

*Figure 1. N8041R at the accident scene.*

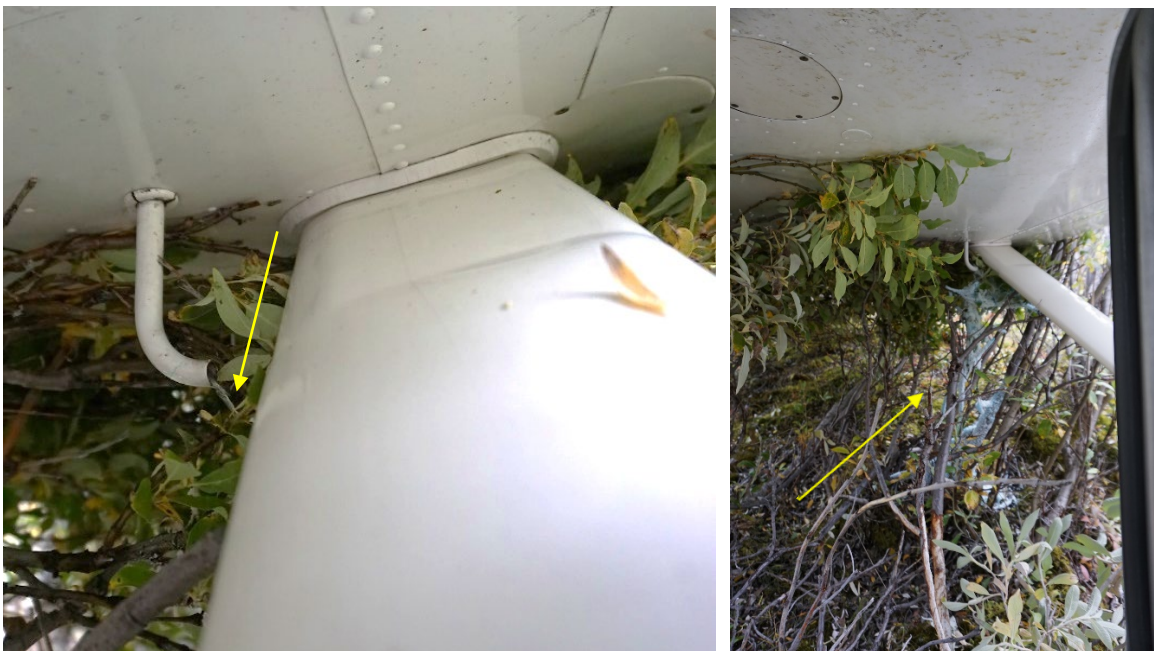
The pilot provided photographs of fuel leaking out of the left wing fuel tank vent after the accident and frozen fuel puddling the following day. The airplane was recovered about a week later and neither the NTSB nor FAA traveled to the scene. According to the wreckage recovery crew, there was no fuel in one of the tanks, and the other side was low, with no obvious signs of leakage. No specific quantity or wing tank was recorded, however the recovery crew stated that fuel exhaustion was likely. The remaining fuel was drained for transport. The quantity of fuel that leaked and/or was drained could not be established. See figure 2.

*Figure 2. Postaccident left wing fuel leak from vent (source: pilot)*

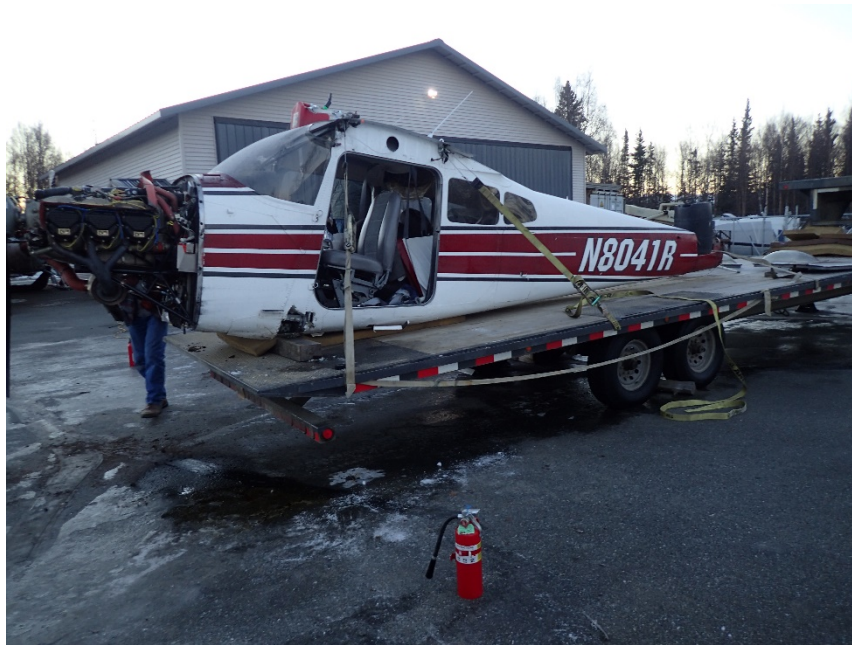
*Figure 3. The airplane post-recovery with the wings, doors, cowling and empennage removed.*

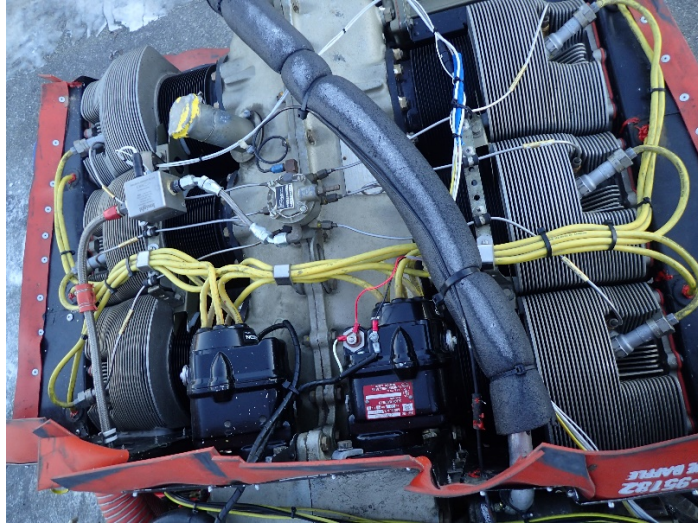
The engine was attached at the airframe mounts and all fuel, hoses, electric lines, and accessories were attached and secure. The propeller blades were damaged in the impact, but the hub was intact and attached to the engine. The ignition harness, ignitors and spark plugs were in place. The intake and exhaust system were intact with minor impact dents to the crossover tube and exhaust shroud. The engine case was intact. The engine crank shaft rotated when the propeller was moved by hand. An airworthy propeller assembly was installed on the airplane to facilitate a test run. A five gallon can of avgas was fed to the right wing root fuel line. The fuel selector valve was rotated through the detents and positive gravity fed fuel flow was observed with the right fuel position was selected. Engine control continuity and functionality was established from the cockpit engine controls to the fuel control. Engine oil was between full and minimum marks on the dip stick. See figure 3.

*Figure 4. Continental IO-520 before the test run.*
