# **NATIONAL TRANSPORTATION SAFETY BOARD**

## **MATERIALS LABORATORY FACTUAL REPORT**

Report No. 18-080

Place : Pedro Bay, AK  
Date : 8/18/2018  
Vehicle : Cessna 206  
NTSB No. : ANC18LA067  
Investigator : Brice Banning

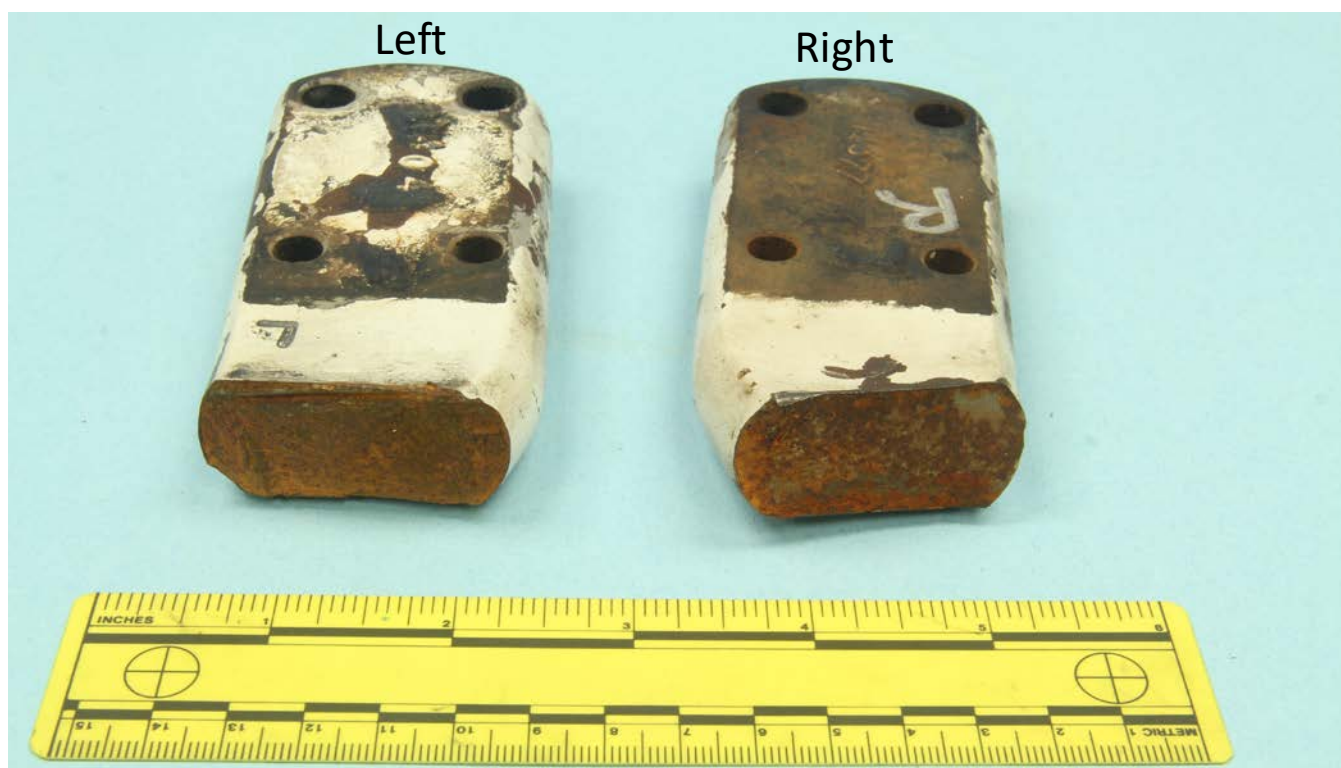
Portions of the left and right lower main landing gear legs (figure 1)

Figure 1: As received, left and right portions of the main landing gear.

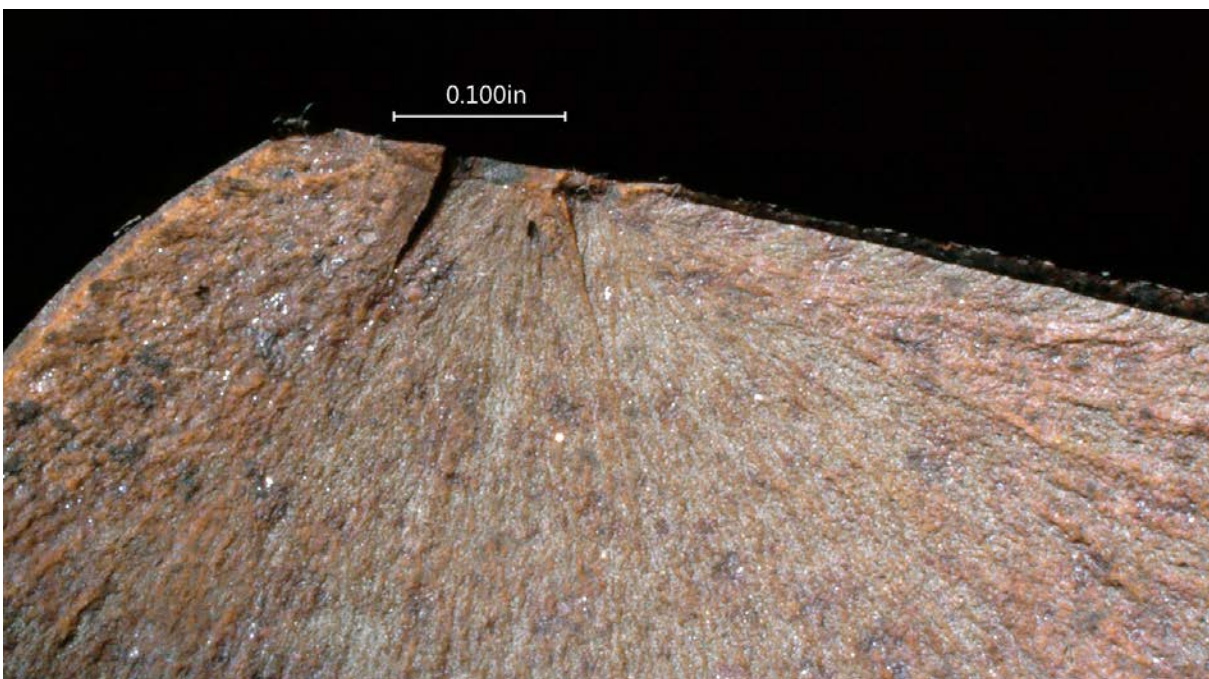
The fracture surface on the portion of the left main landing gear (figure 2) exhibited chevron marks leading to a small thumbnail region. The thumbnail region included two distinct ratchet marks. These fracture features are consistent with a fatigue crack.

Figure 2: Portion of left main landing gear exhibiting fracture features consistent with a fatigue crack.

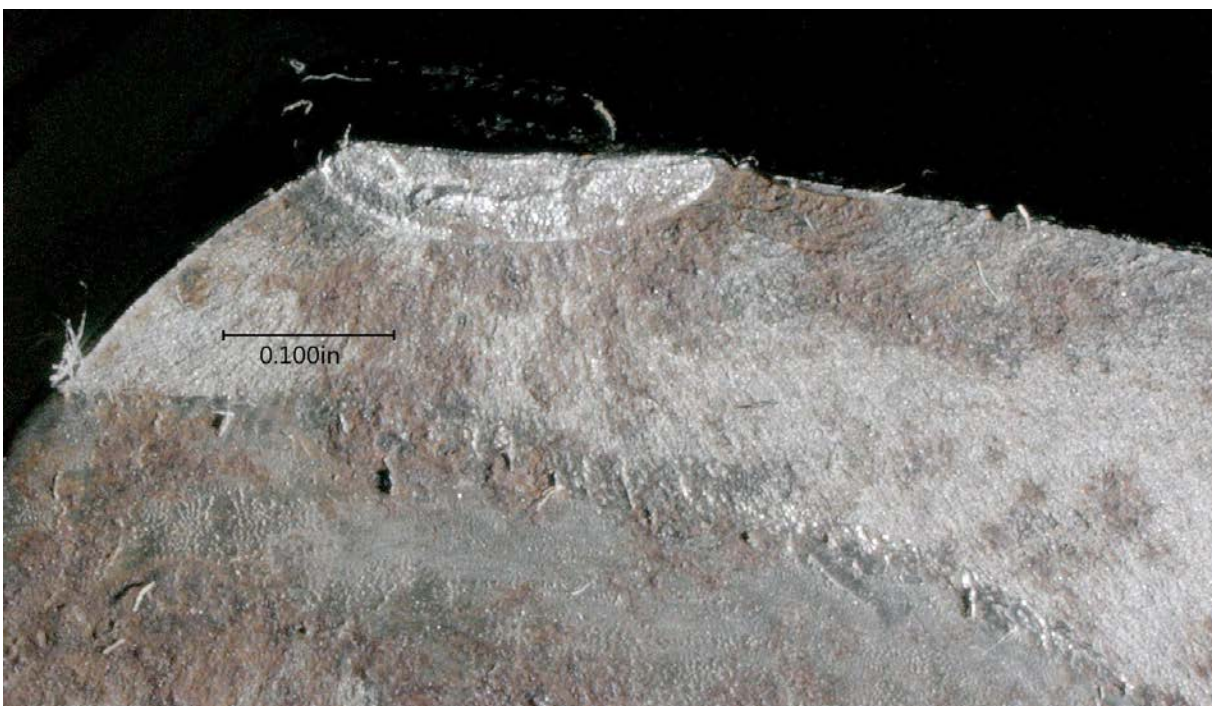
The fracture surface on the portion of the right main landing gear (figure 3) also exhibited chevron marks leading to a small thumbnail region consistent with a fatigue crack.

Figure 3: Portion of right main landing gear exhibiting fracture features consistent with a fatigue crack.
