## **Wreckage Examination Summary**

NTSB ACCIDENT NUMBER: ANC18LA069

AIRCRAFT REGISTRATION/AIRCRAFT TYPE: N3957X, Piper PA-32

ACCIDENT LOCATION: Wrangell, Alaska

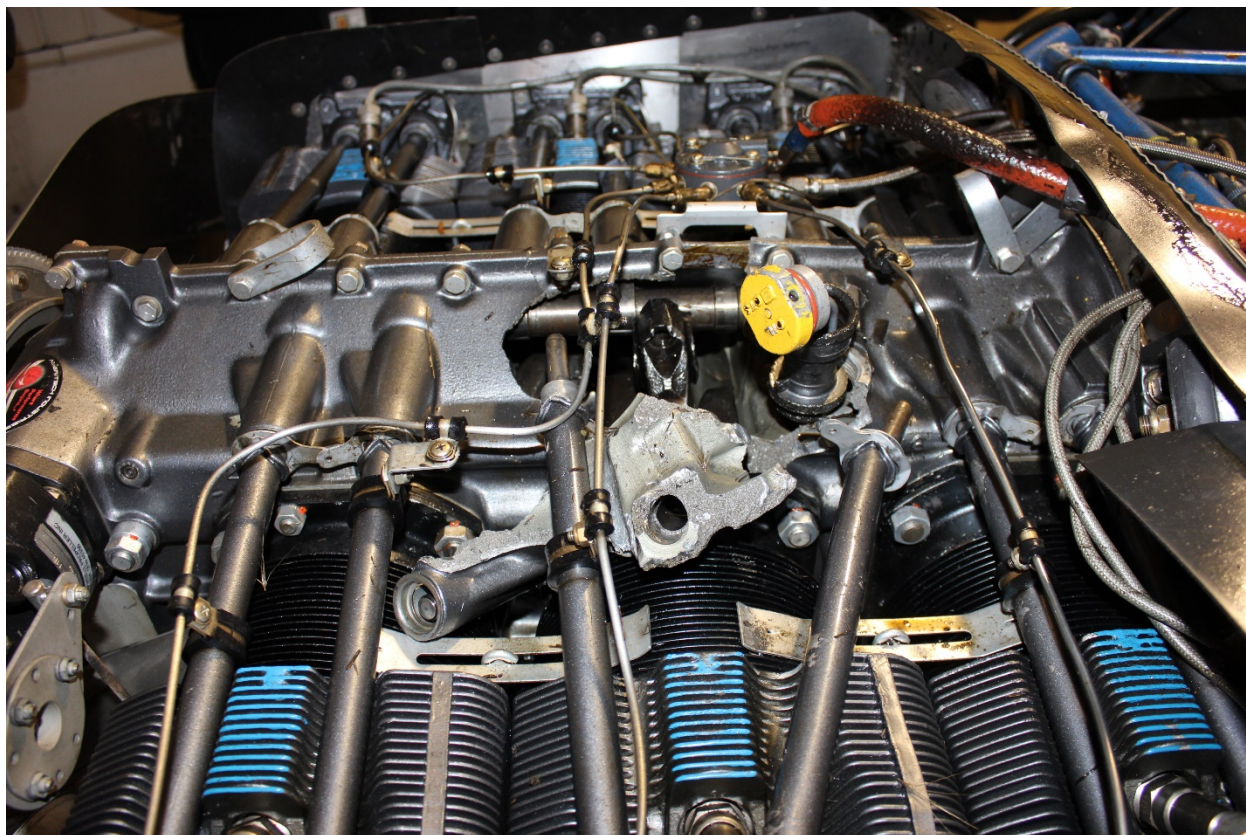
**Engine – Exam 10/17/2018**

- Airframe Total Time: 8228.6
- Model: Lycoming IO-540-K1G5
- Serial Number: RL-16942-48A
- 300HP @ 2,700 RPM
- Engine Time Since Overhaul: 219.6

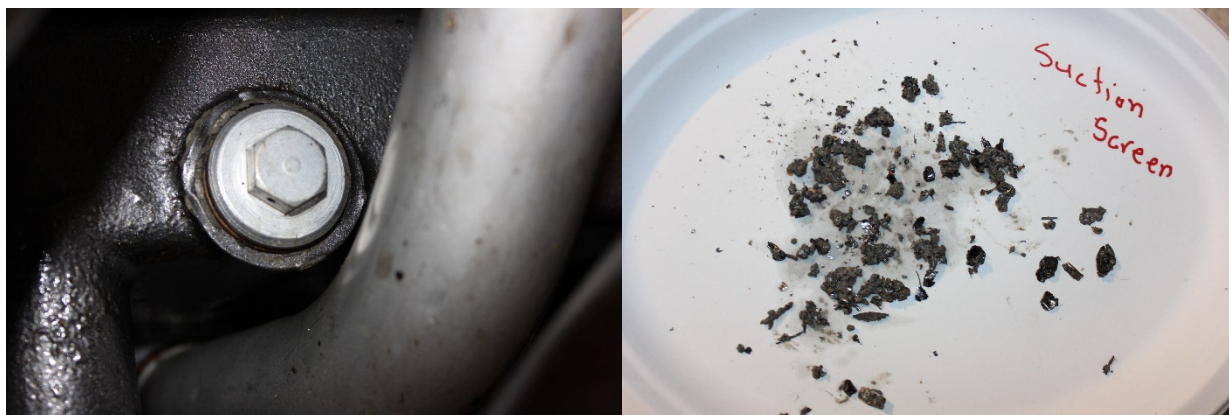
### Oil Suction Screen

The oil suction screen was secure at its respective mounting; however, the nut was not secured with safety wire. A large amount of metal contamination was observed at the oil suction screen.

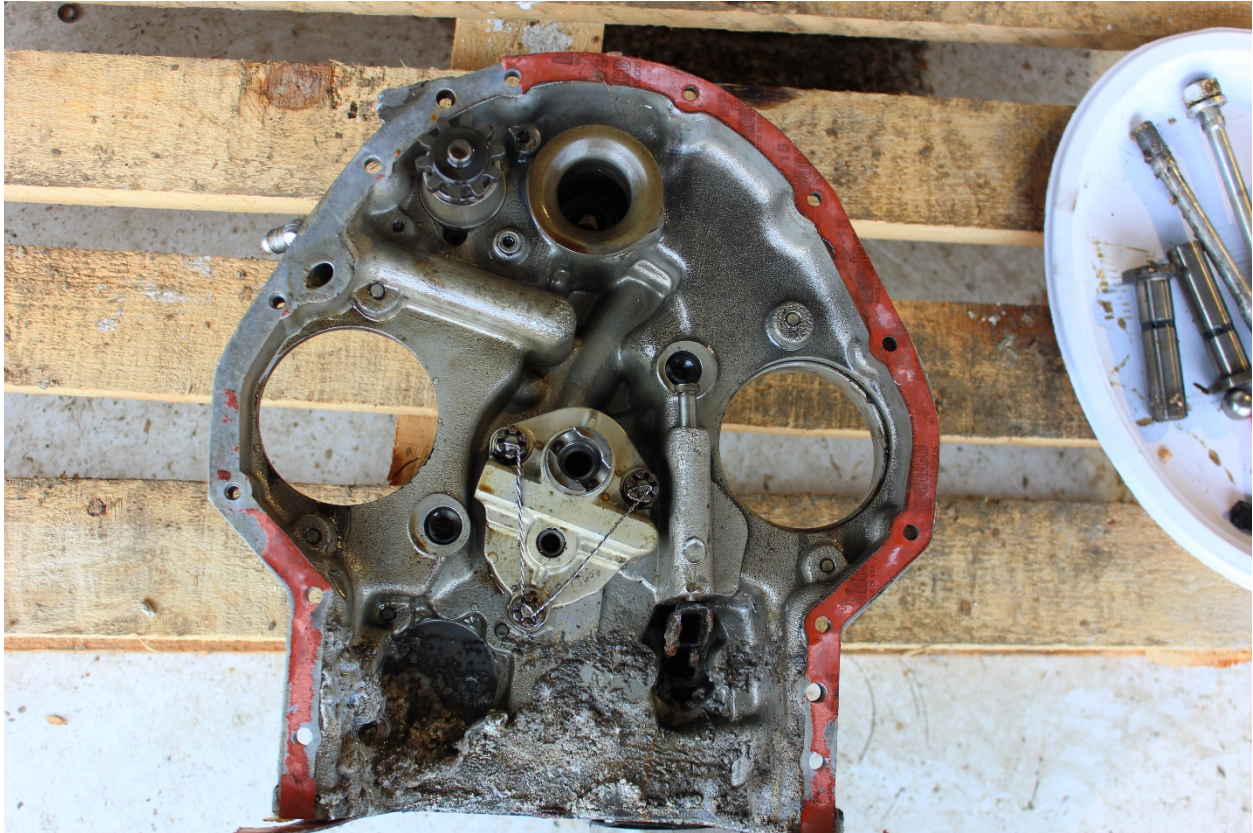
### Oil Pump

- Exhibited no thermal damage.

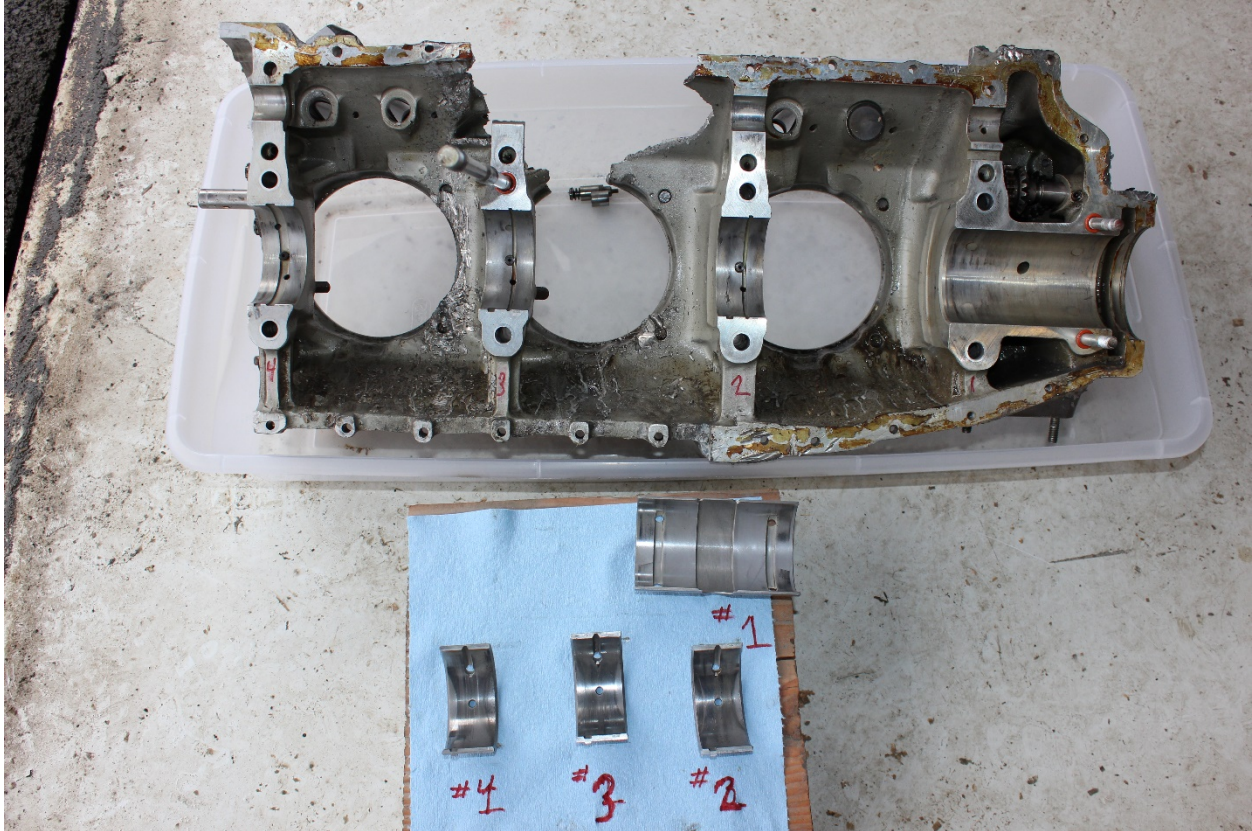
Left side crankcase and main bearings.

- Front main bearing – was unremarkable.
- #2 Main bearing – exhibited a small amount of normal wear.

- #3 Main bearing – exhibited a small amount of normal wear
- #4 Main bearing – exhibited a small amount of normal wear
- Crankcase was fractured above #4-cylinder pad.
- Crankcase fractured above the #6-cylinder pad.

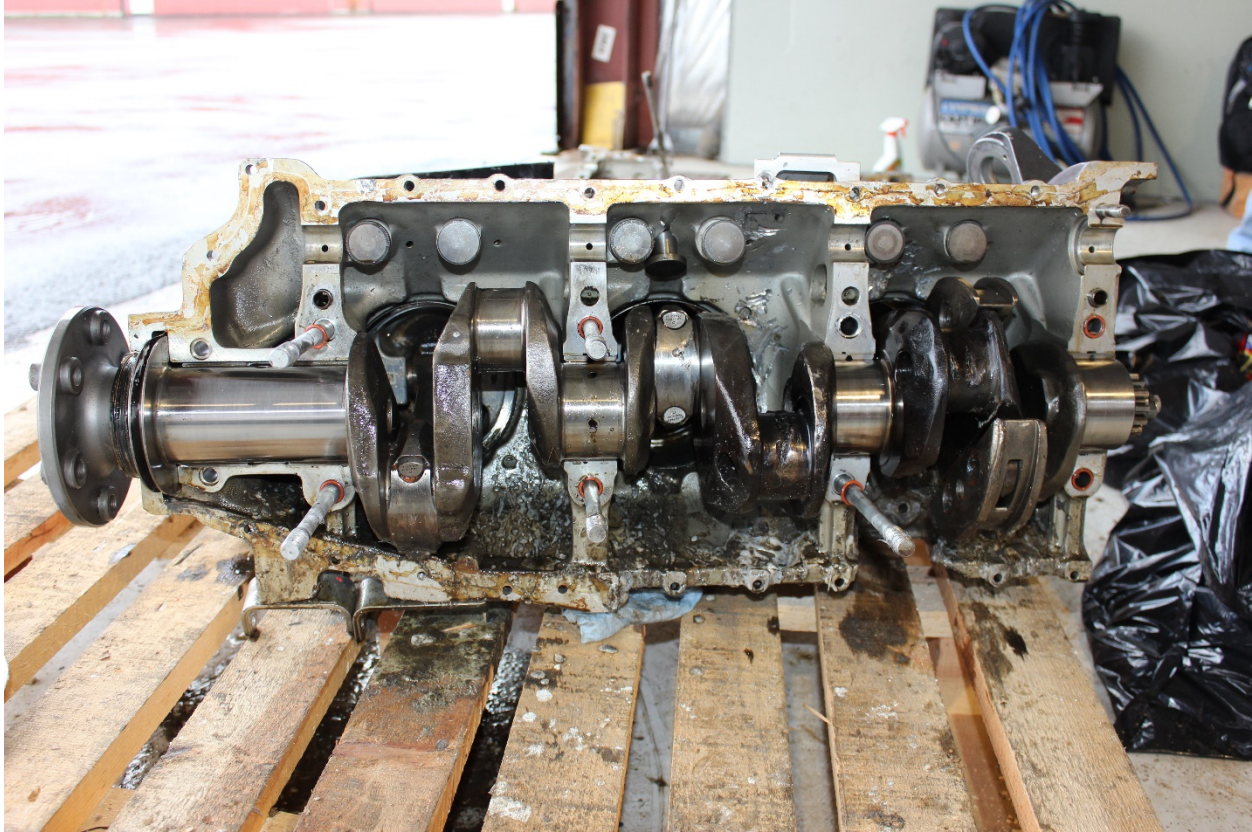
Right side crankcase and main bearings.

- Front main bearing – was unremarkable.
- #2 Main bearing – exhibited a small amount of normal wear.
- #3 Main bearing – exhibited a small amount of normal wear.
- #4 Main bearing – exhibited a small amount of normal wear.
- Crankcase fractured below the #6-cylinder pad

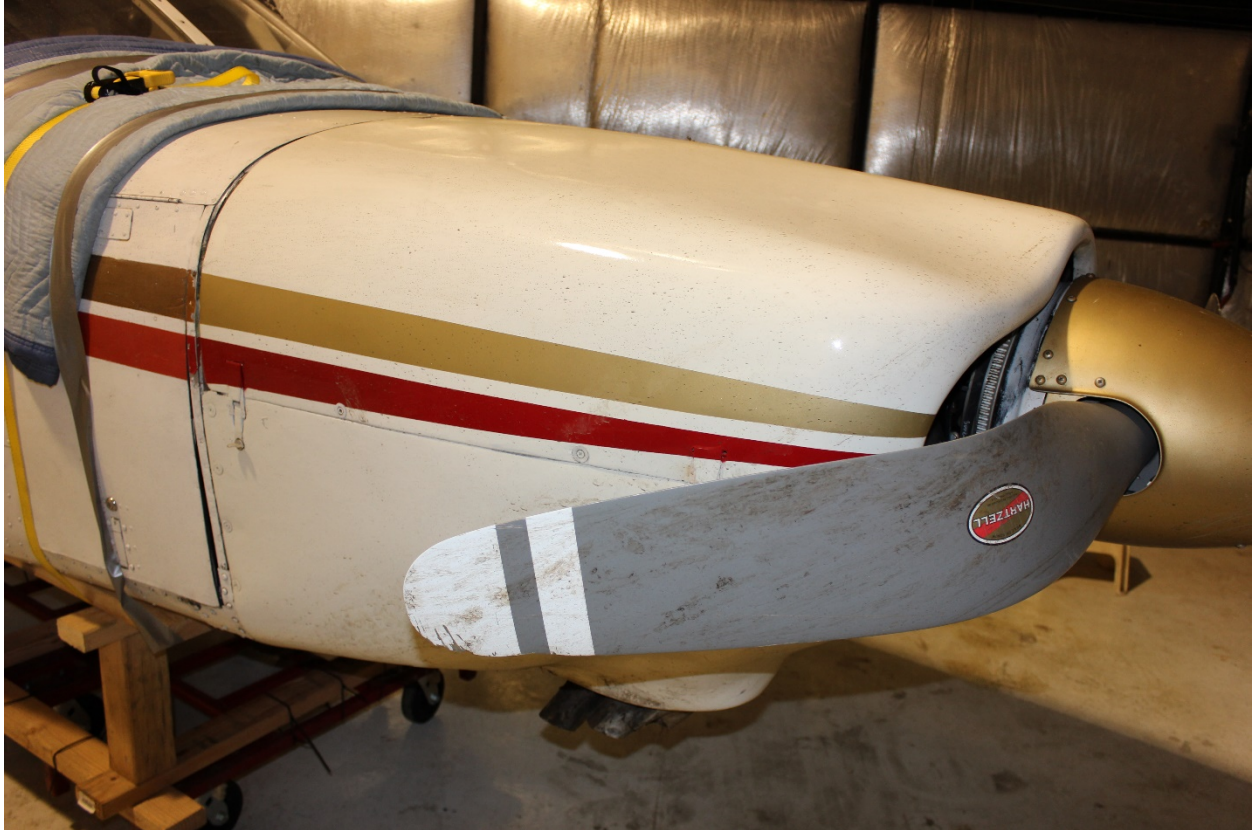
**Propeller Remarks:**

The two-blade constant speed propeller remained attached at the engine crankshaft flange. One of the propeller blades was bent aft about 45 degrees. The other propeller blades were relatively undamaged. The damage signatures were consistent with a propeller that was not rotating.
