## **Examination Summary**

NTSB ACCIDENT NUMBER: ANC19FA035

AIRCRAFT REGISTRATION/AIRCRAFT TYPE: N68083, de Havilland DHC-2

ACCIDENT LOCATION: Seldovia, AK

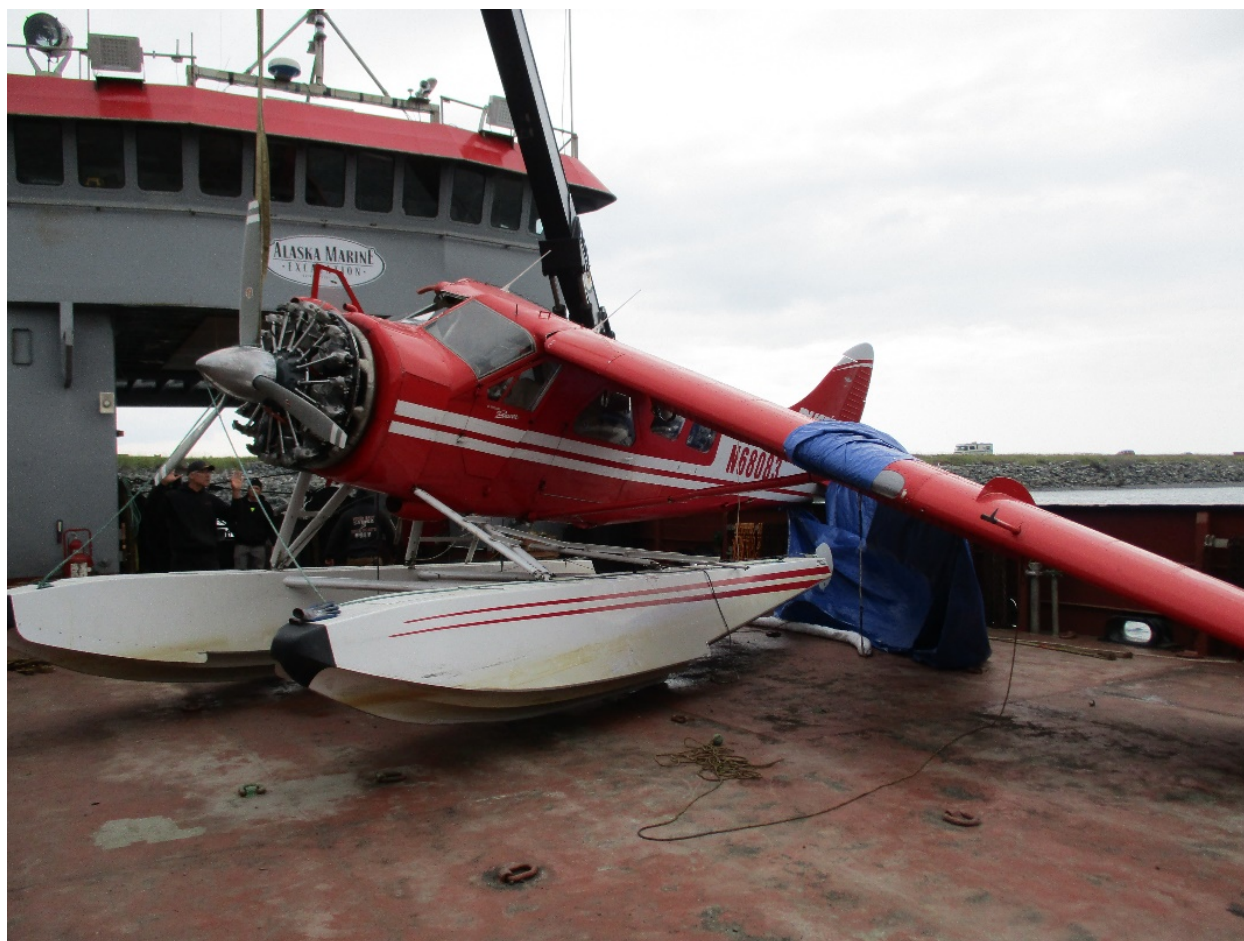
*Figure 1- Accident airplane after removal from the ocean waters.*

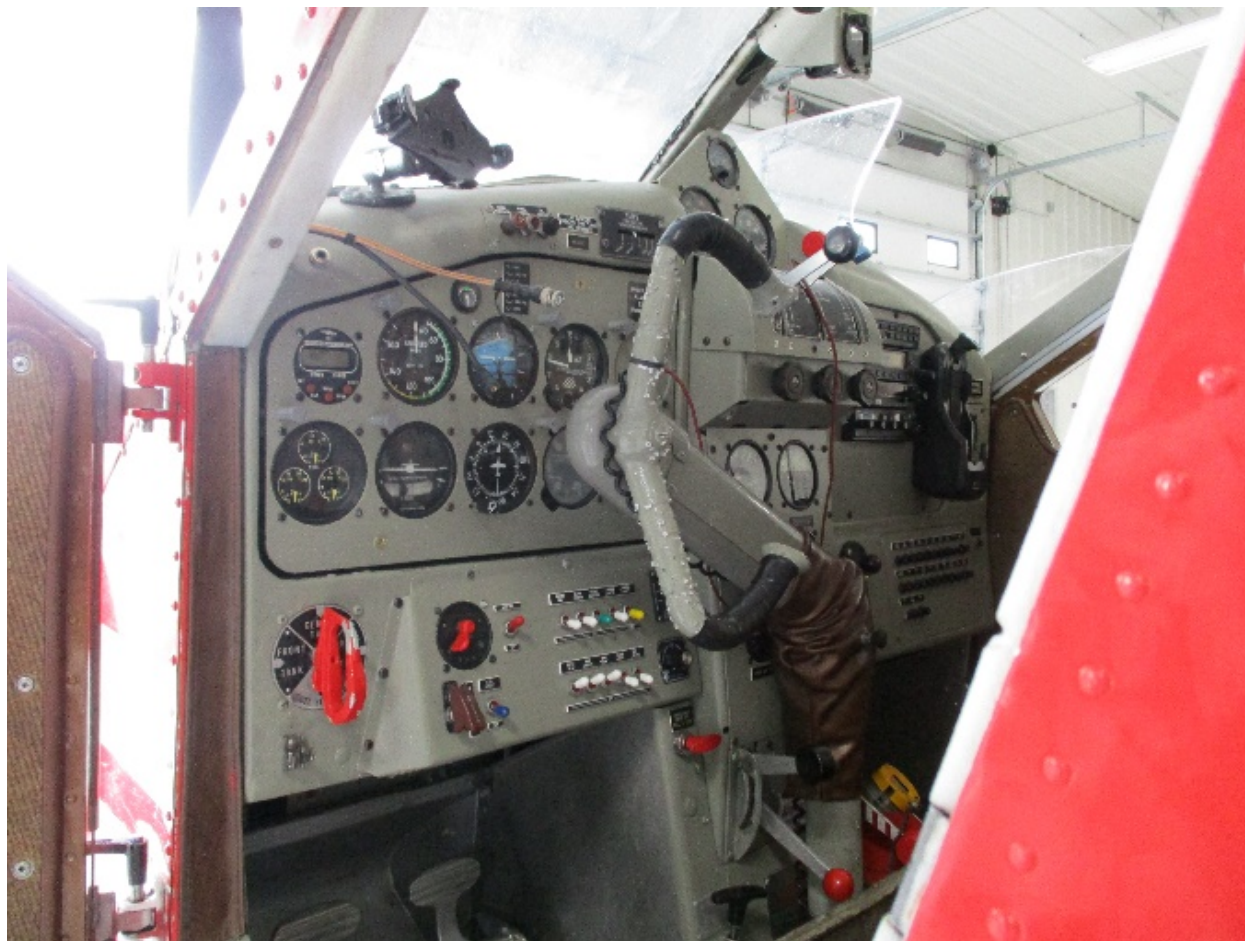
- Tach – 917.6
- Hobbs – 2765.5
- Fuel – Center Tank
- Ignition (Magnetos) – Both
- Starter - Off
- Master – On
- Fuel Boost – Off
- Engine Inst – Off
- Turn Coord – Off
- Radio Master – Off
- Strobe Lights – Off
- Landing Lights – Off
- Pitot Heat – On
- Nav Lights – On
- Map Light – On
- Cabin Light – Off
- Inst Lights – Off
- Panel Dimming – Off
- Artex ELT – Arm
- Emergency Carb Air – In
- Flap Indicator – Takeoff Position

*Figure 2 - Cockpit of accident airplane.*

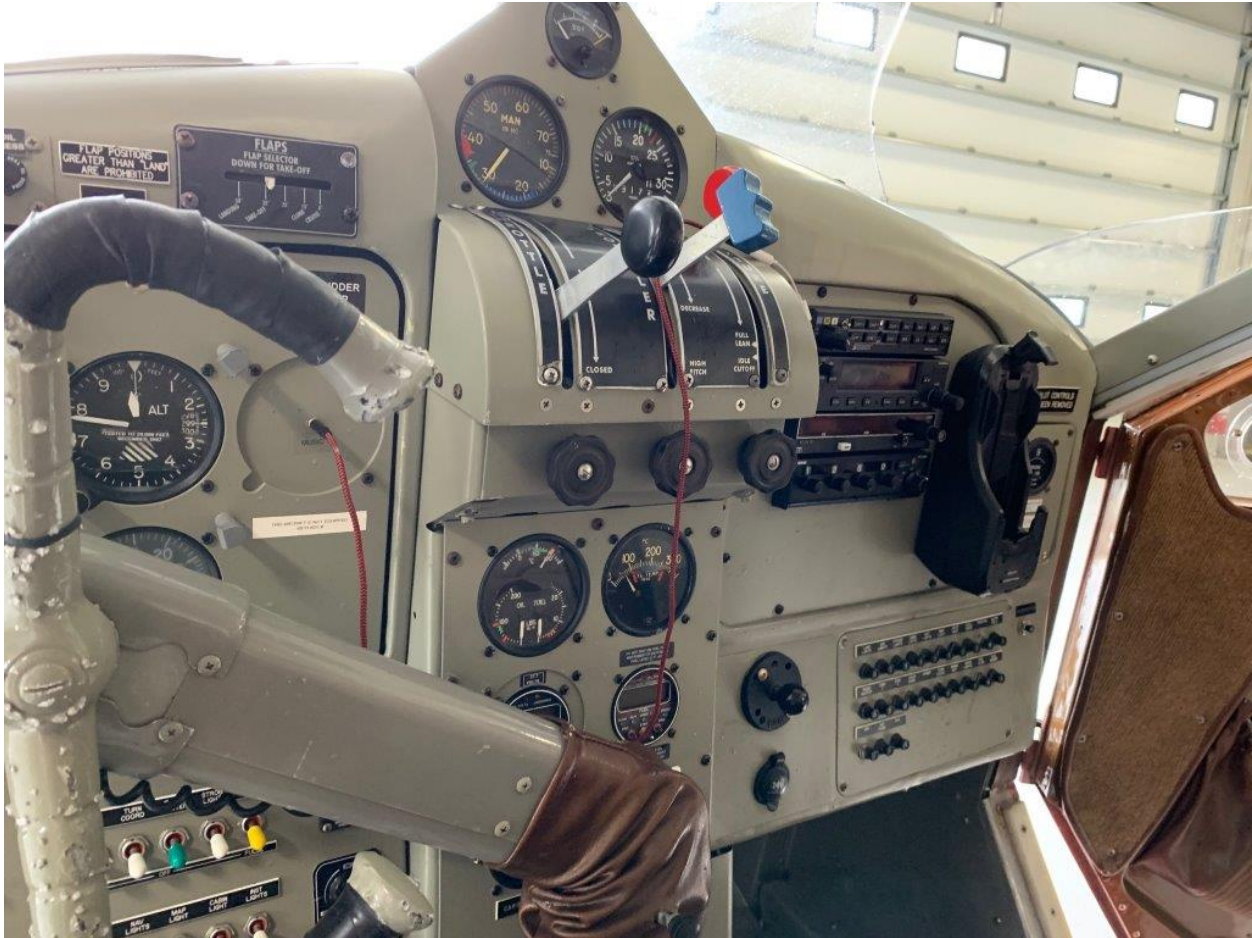
*Figure 3 - Throttle quadrant and wing flap indicator of accident airplane.*

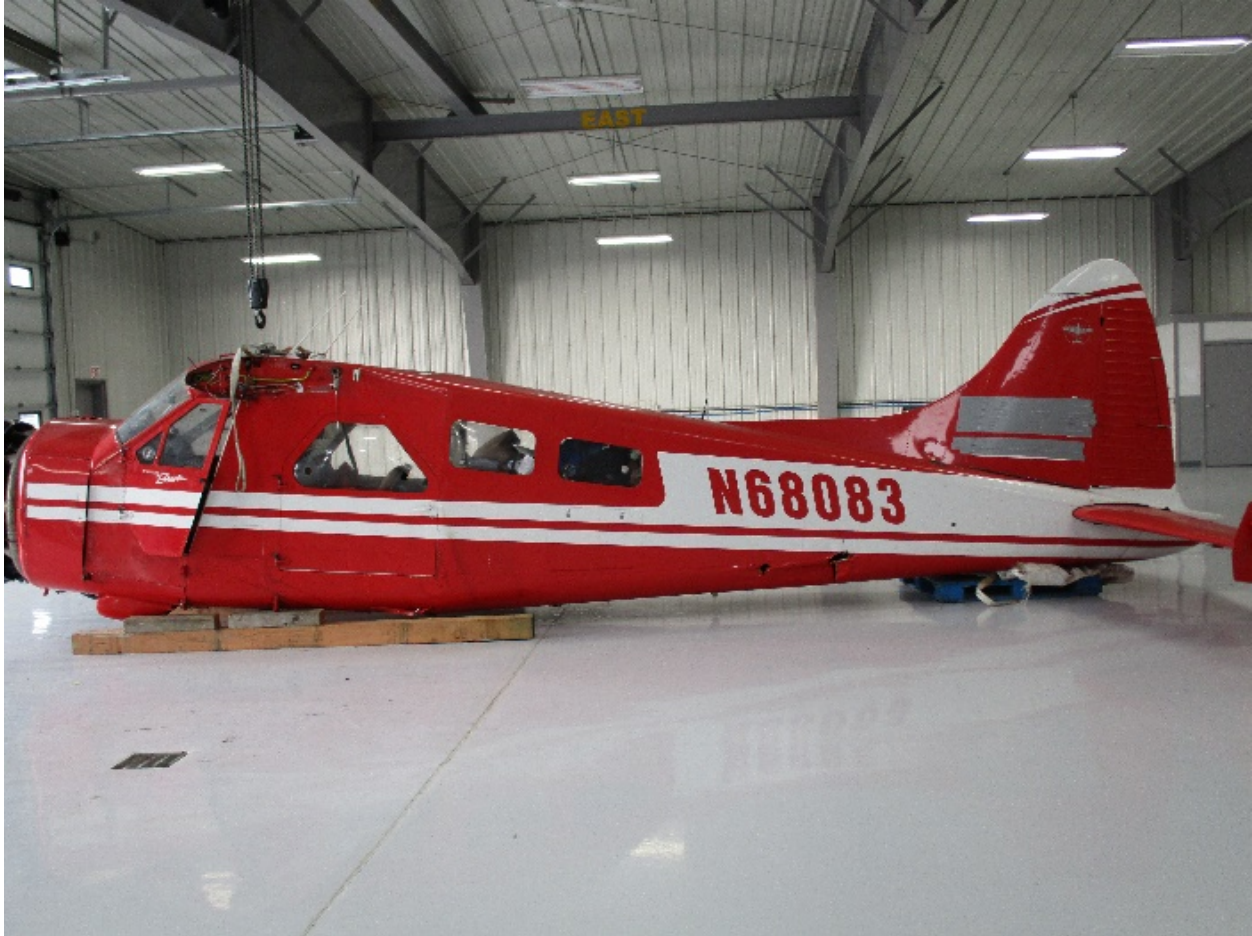
*Figure 4 - Left side view of accident airplane's fuselage.*

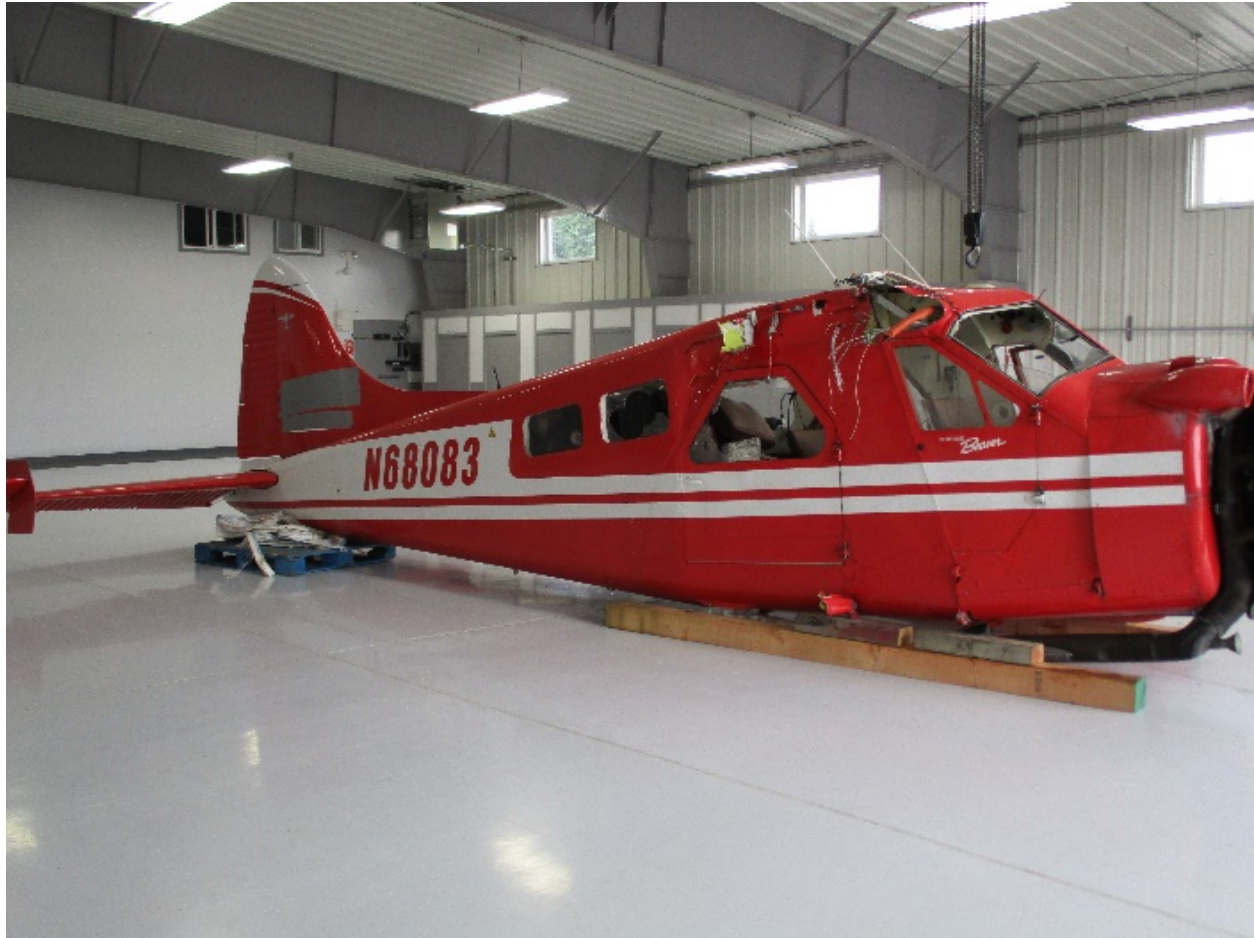
*Figure 5 - Right side view of accident airplane's fuselage.*

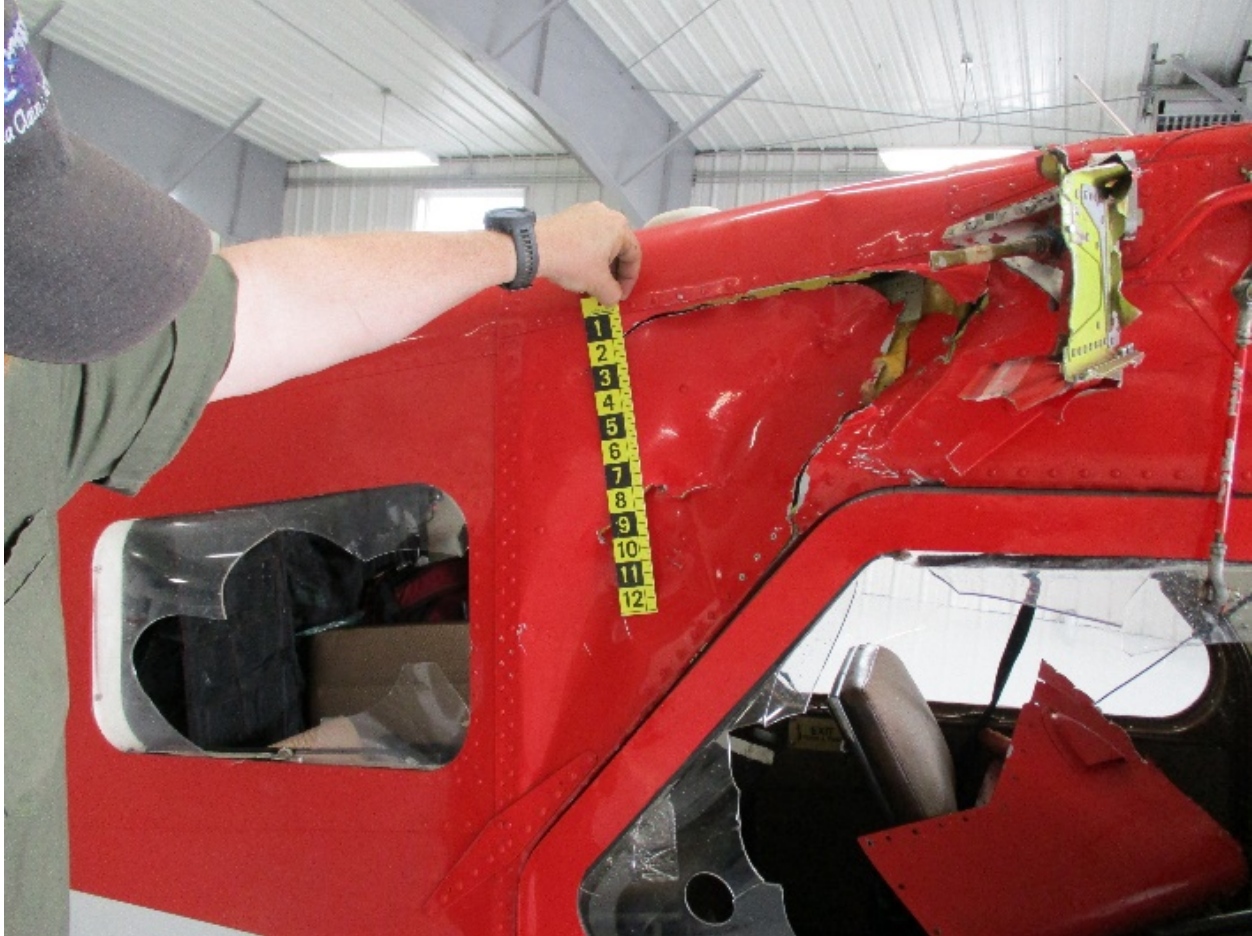
- The fuselage was largely intact but sustained damage over the right fuselage door, consistent with the right wing root and wing flap impacting the fuselage during the accident sequence.
- The cockpit seats remained attached and secure.
- Seat belts and shoulder harnesses were available in the cockpit.
- Lap belts were available in the passenger cabin.

*Figure 6 - Right side fuselage damage consistent with the flap and wing root impacting the fuselage during the accident sequence.*

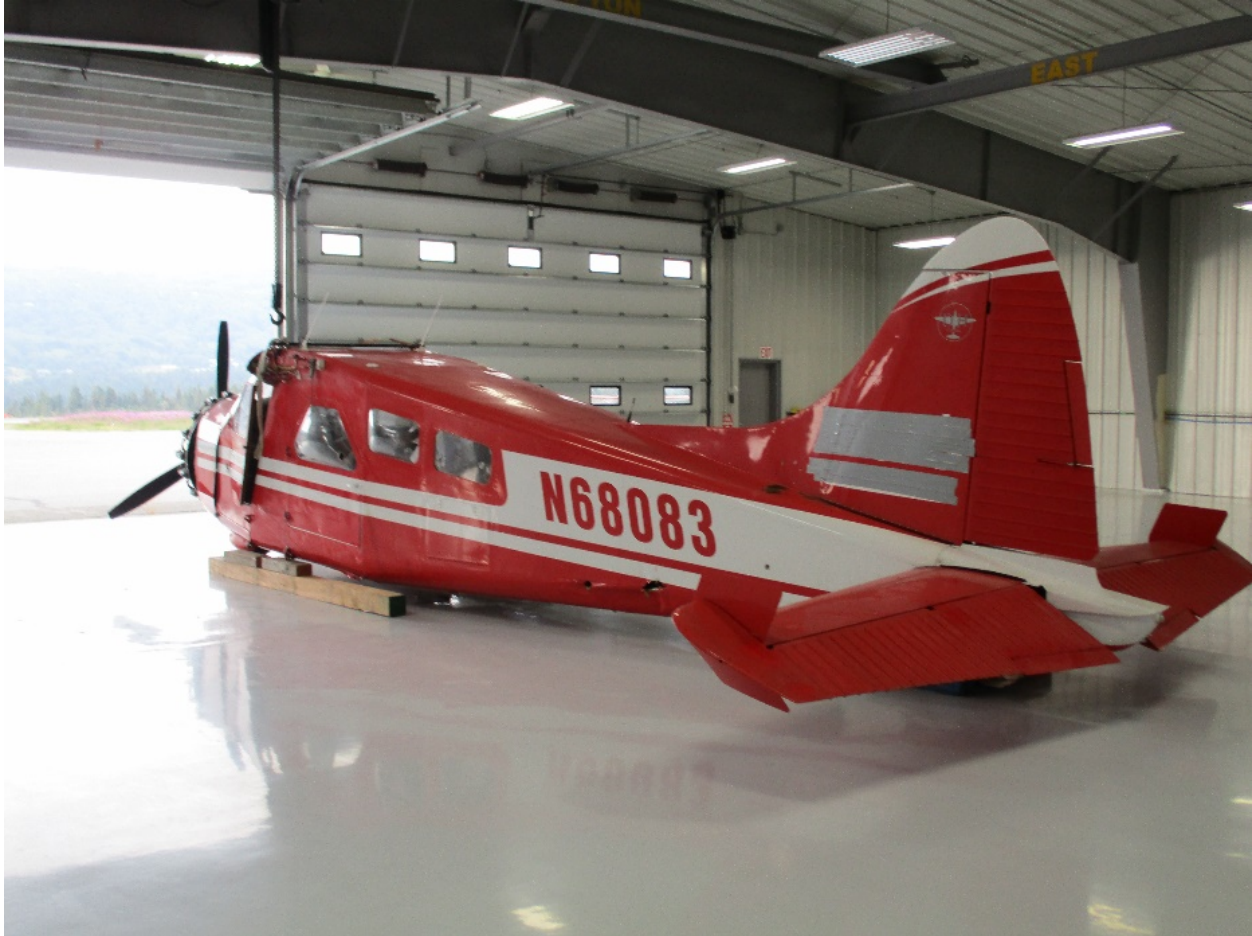
- The left and right horizontal stabilizer, elevators, vertical stabilizer and rudder, along with both left and right elevator and rudder trim tabs remained attached to their respective attach points and were relatively undamaged.
- Control continuity was established from the elevator to the control yoke.
- Control continuity was established from the rudder to the rudder pedals.

*Figure 7 - Empennage of accident airplane.*

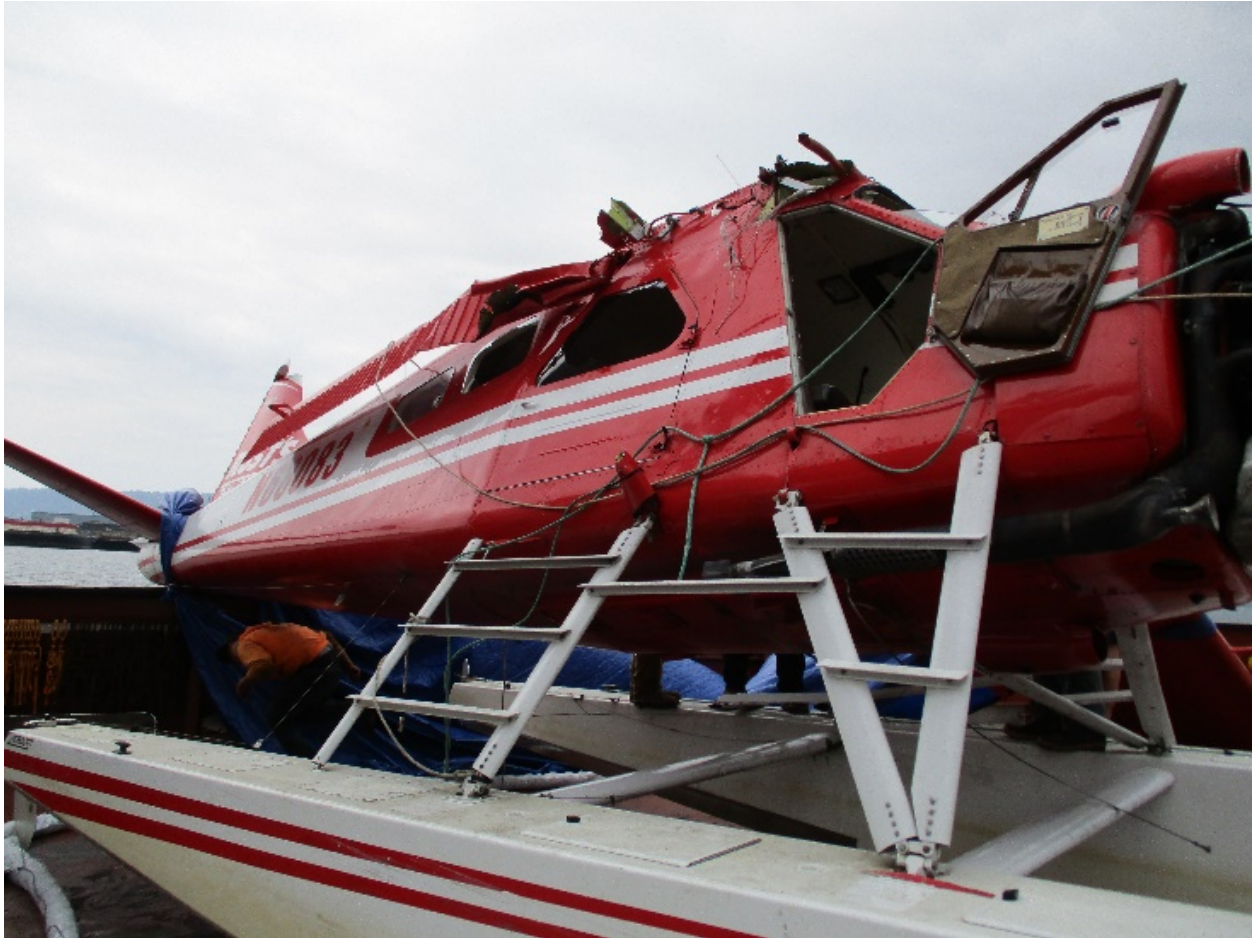
- The right wing, right aileron, and right lift strut separated from the airframe and were not recovered.
- Aileron control cable continuity was confirmed from the control yoke to the fuselage bell crank push pull tube.
- The right flap separated from the right wing but remained attached to the fuselage.

*Figure 8 - Accident airplane's right flap.*

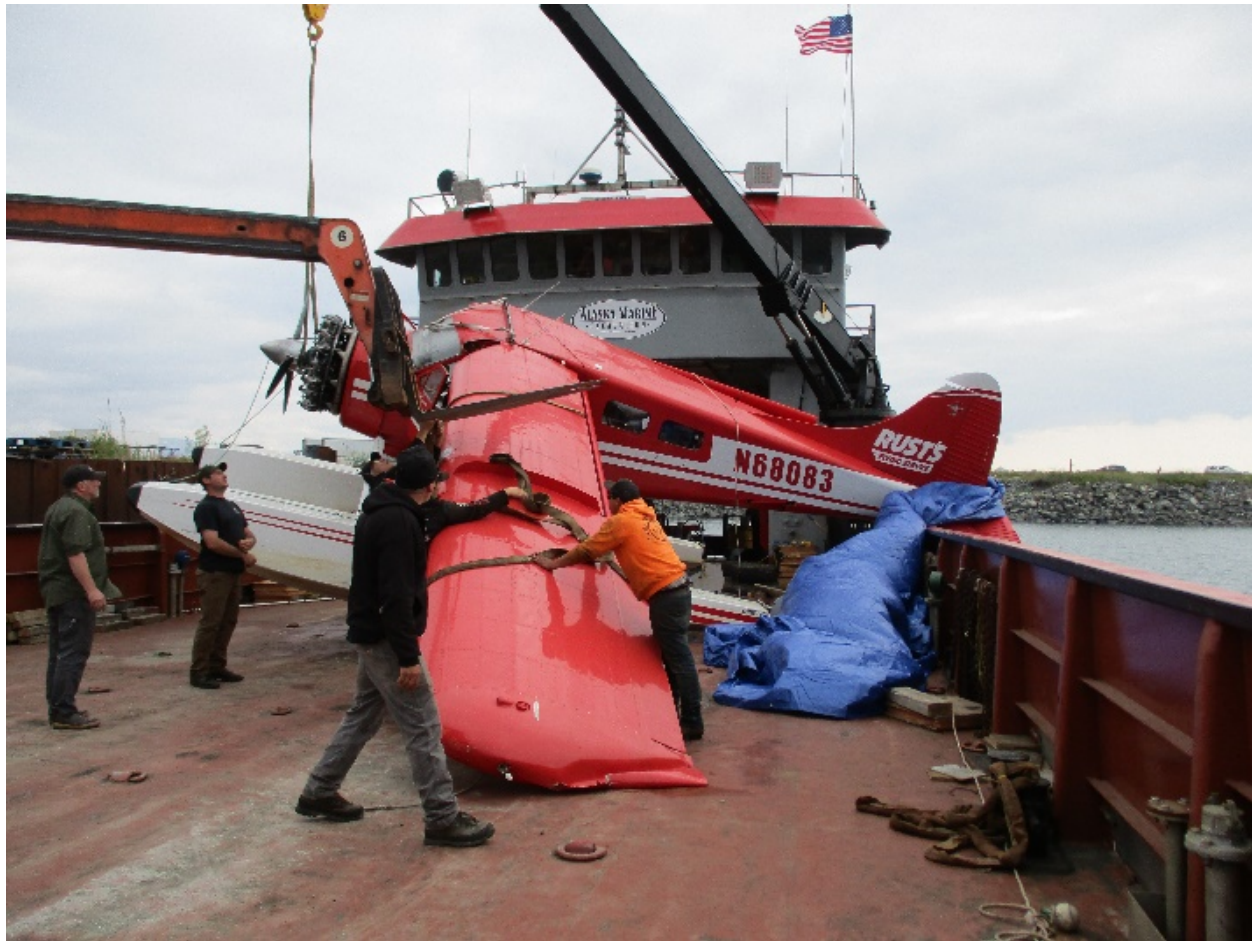
- The left wing remained attached to its respective attach points.
- The left wing sustained leading edge impact damage and tearing of the wing's skin about mid-span.
- The left aileron remained attached to its respective attach points and was relatively undamaged.
- The left flap remained attached to its respective attach points and was relatively undamaged.
- The left lift strut remained attached at its attach points but buckled about midspan.
- Aileron control cable continuity was established from the left aileron to the control yoke.

*Figure 9 - Accident airplane's left wing, flap, and aileron.*

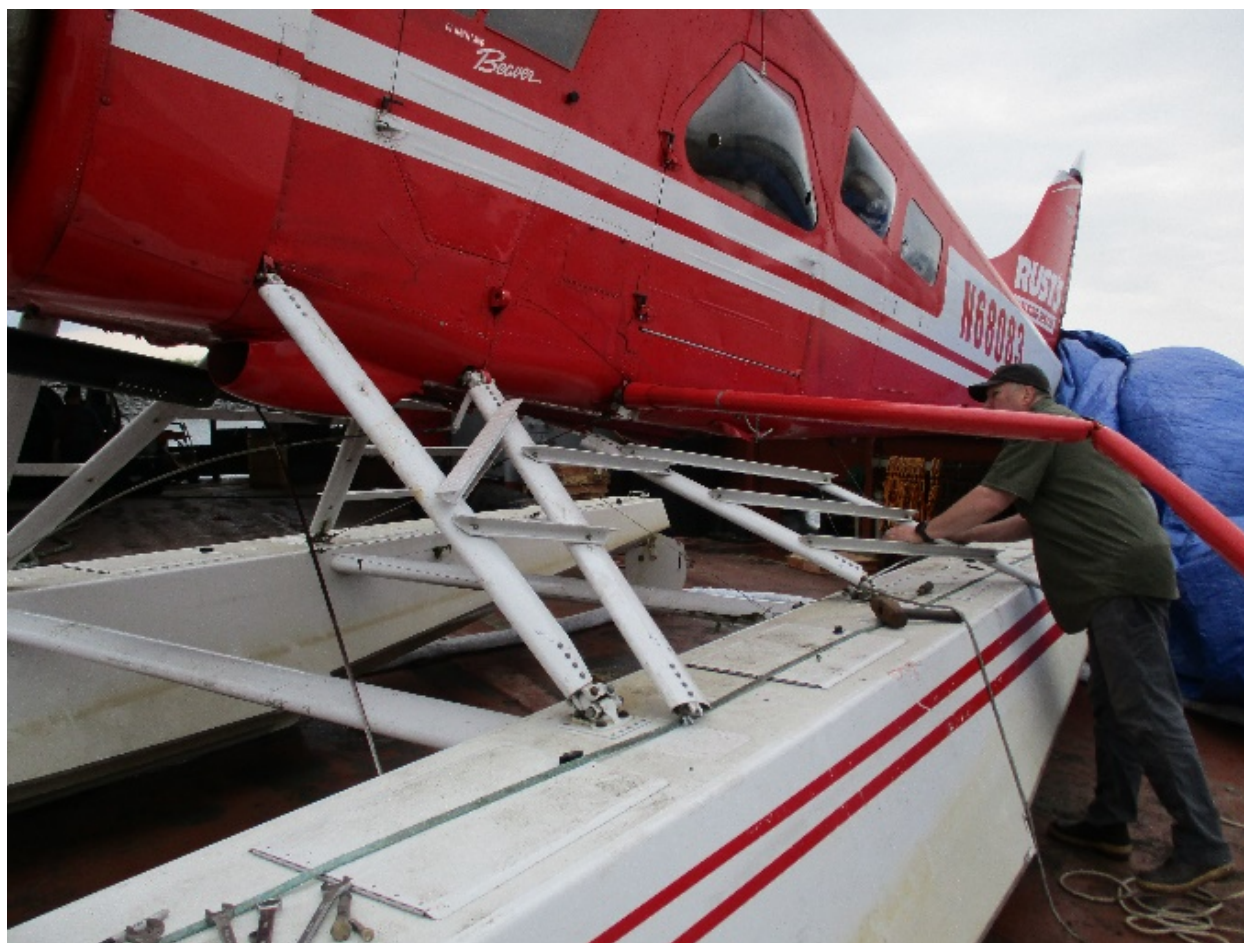
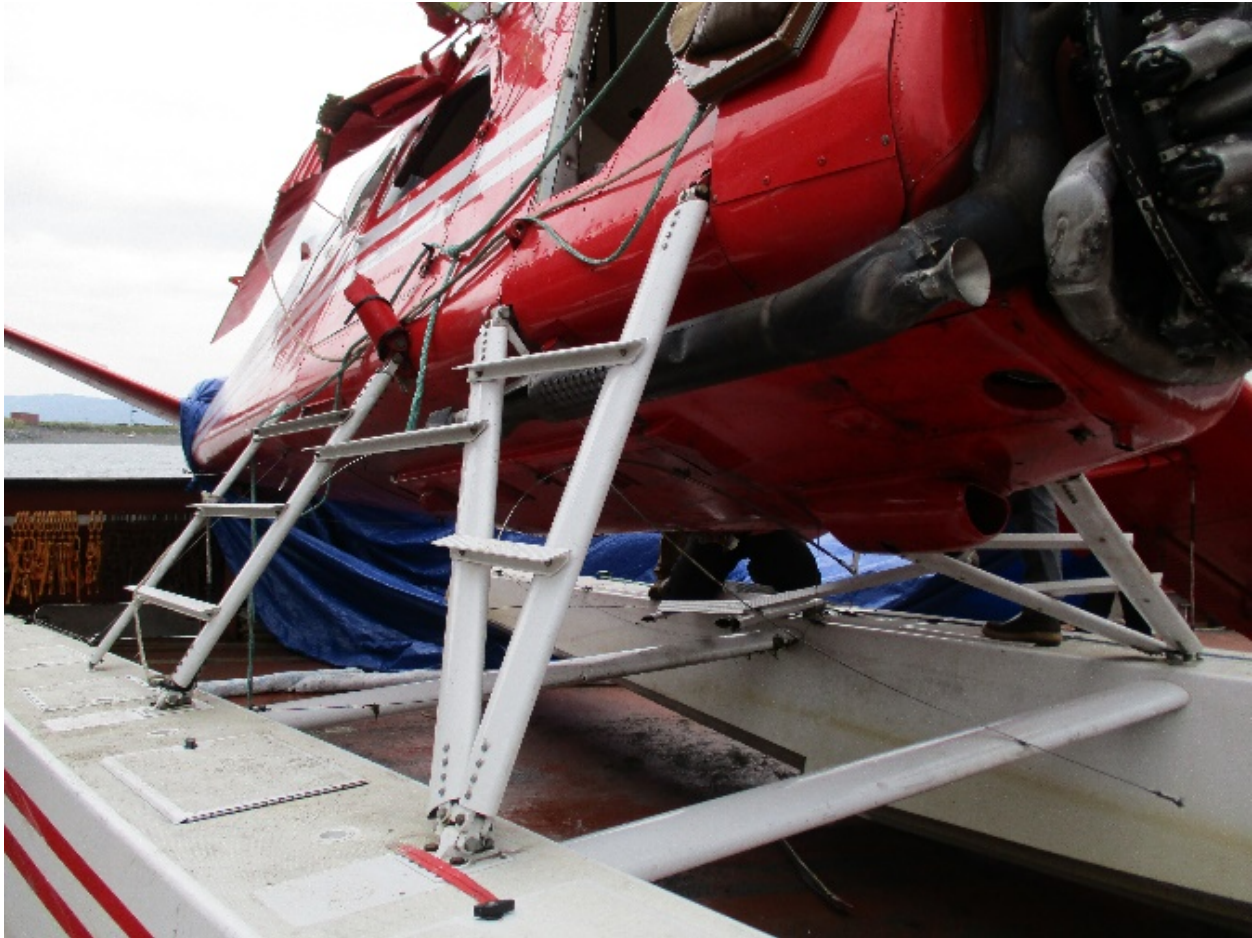
- The left forward float strut remained attached to its attach points.
- The left middle float strut remained attached at its fuselage attach point but separated at its float attach point.
- The left rear float strut separated at its fuselage attach point and partially separated at its float attach point.
- The right forward, middle and rear float struts remained attached to their respective attach points.

*Figure 10 - Accident airplane's left side float struts.*

*Figure 11 - Accident airplane's left side float struts.*

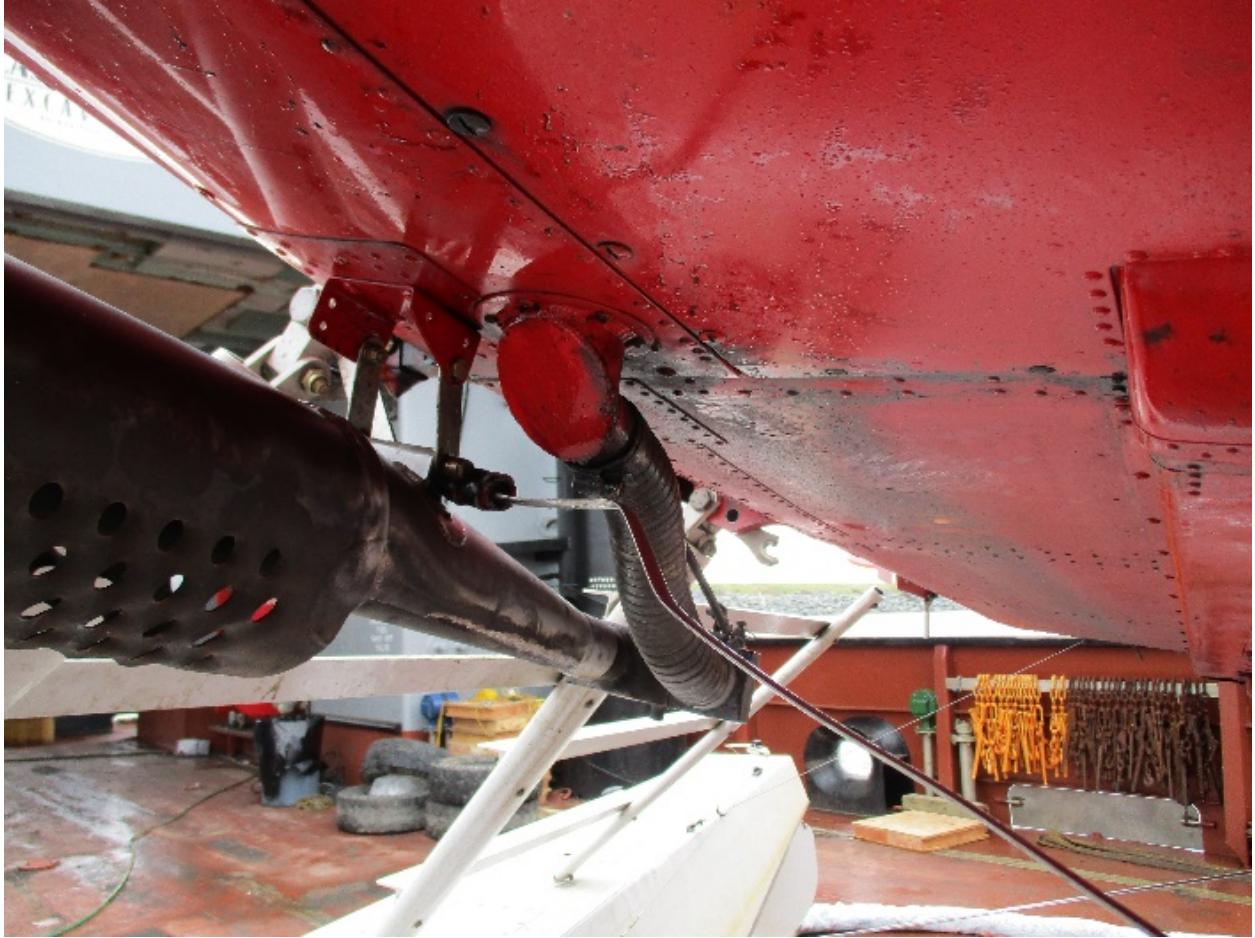
- The forward left lower tie rod attachment fitting separated, and the streamlined tie rod (Crossing Wire) exhibited S shaped buckling signatures near its upper attachment point as shown in the photograph below (see figure 12).
- The rear right upper tie rod attachment fitting separated, and the streamlined tie rod (Crossing Wire) exhibited S shaped buckling signatures near its lower attachment point as shown in the photograph below (see figure 13).

*Figure 12 - Accident airplane's damaged forward streamlined tie rod.*

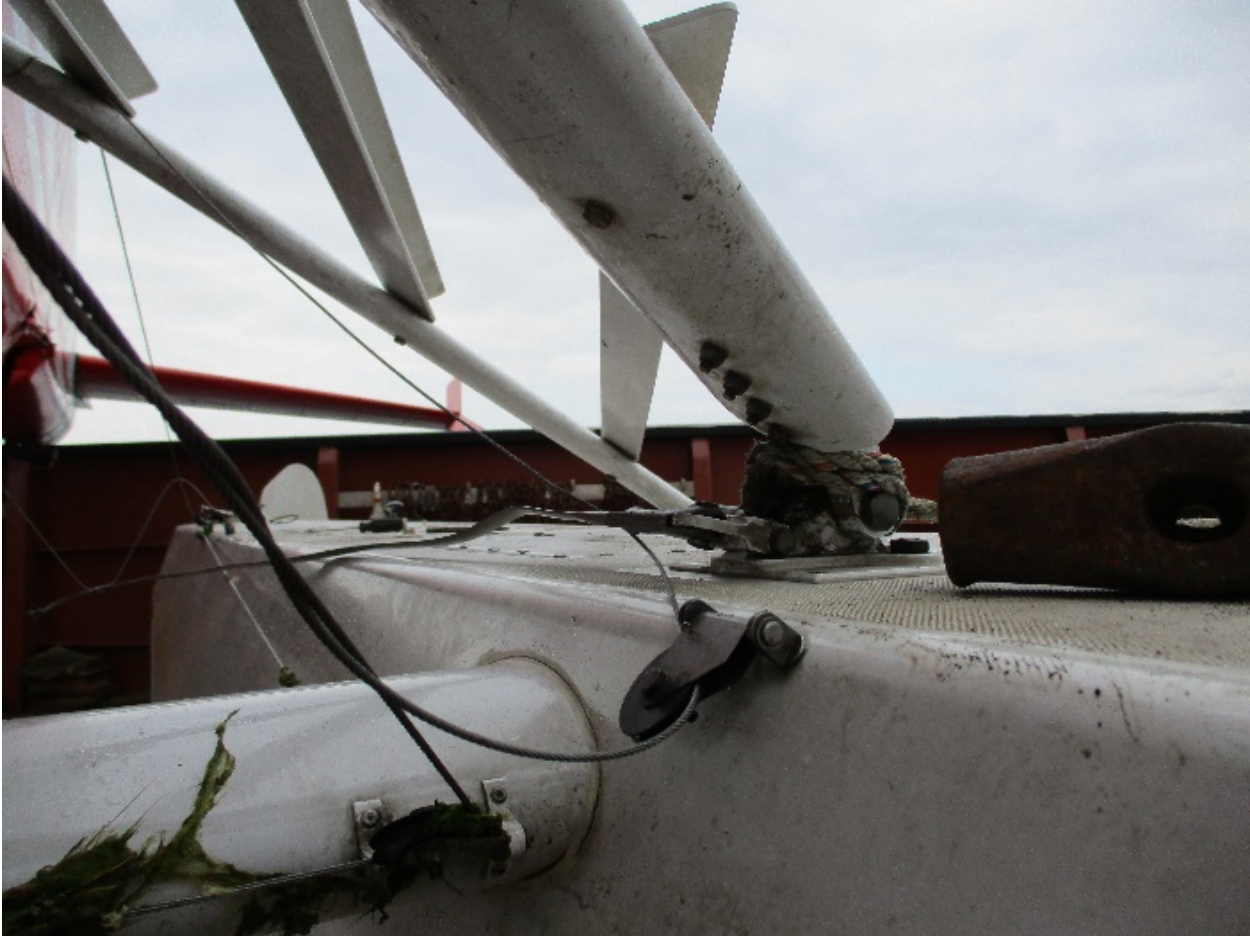
*Figure 13 - Accident airplane's damaged rear streamlined tie rod.*
