# NATIONAL TRANSPORTATION SAFETY BOARD

## MATERIALS LABORATORY FACTUAL REPORT

Report No. 20-025

Place : Seldovia, Alaska  
Date : July 19, 2019  
Vehicle : de Havilland DHC-2 Mk. I, N68083  
NTSB No. : ANC19FA035  
Investigator : Brice Banning, AS-ANC

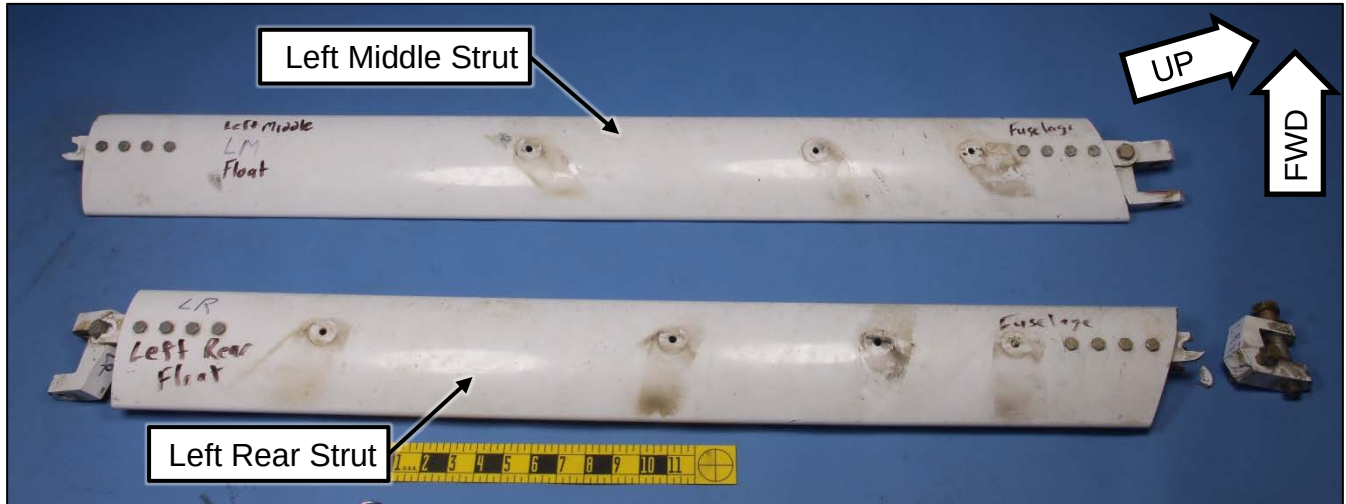
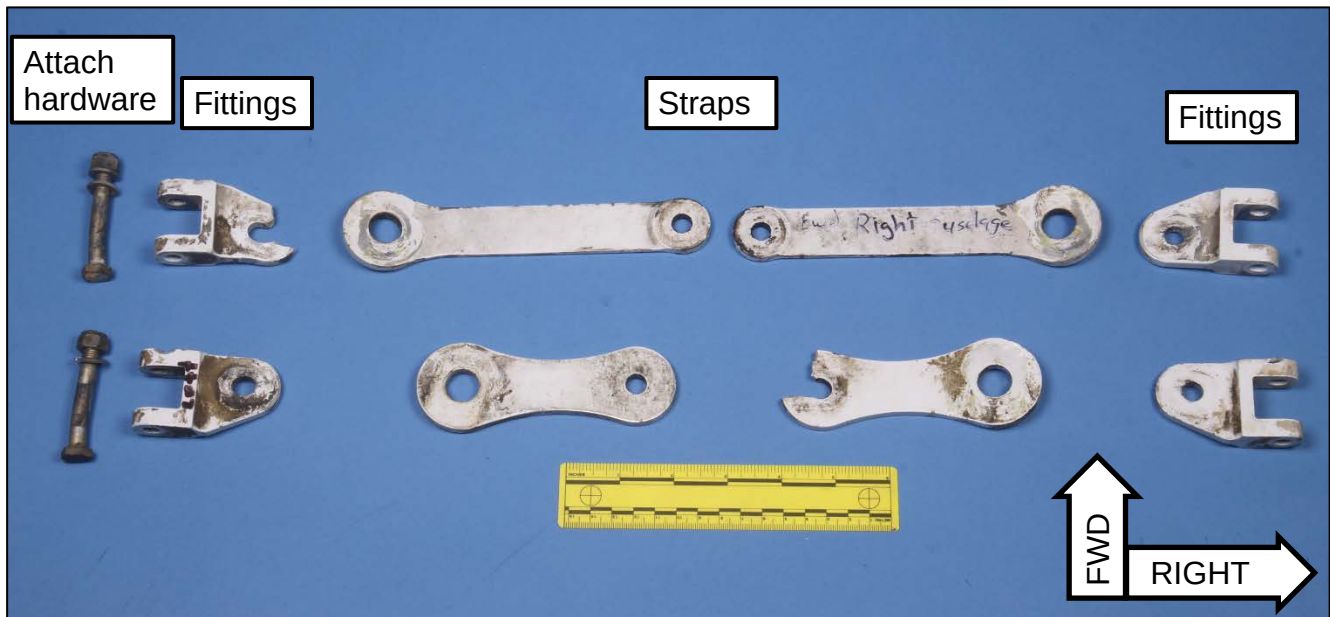
Overall views of the submitted components are shown in figure 1. The components were from an Aerocet Model 5850 float assembly installed on the accident airplane. Two struts from the left side were submitted as shown in the upper photograph in figure 1, and attachment straps and fittings for all four streamline cables (flying wires) were submitted as shown in the lower image in figure 1. Attach hardware for the two left flying wire attachment fittings were also included as shown in figure 1. The left middle strut was fractured at the lower end of the strut, and the left rear strut was fractured at both the upper and lower ends of the strut. The left forward flying wire fitting and the right rear flying wire strap were also fractured.

Figure 1. Overall view of the submitted left middle and left rear struts with attachment fittings and hardware (upper image) and flying wire attachment straps and fittings with attachment hardware for the lower left fittings (lower image).

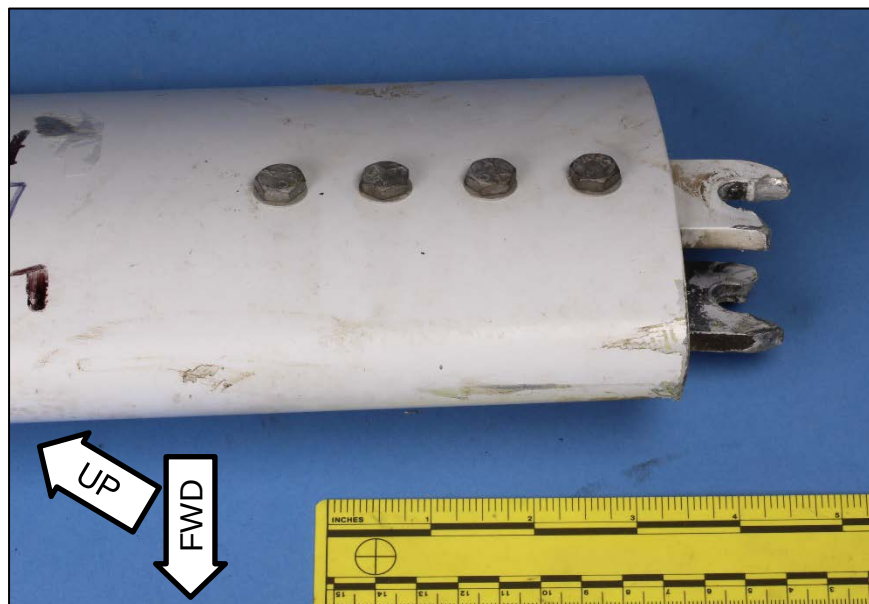
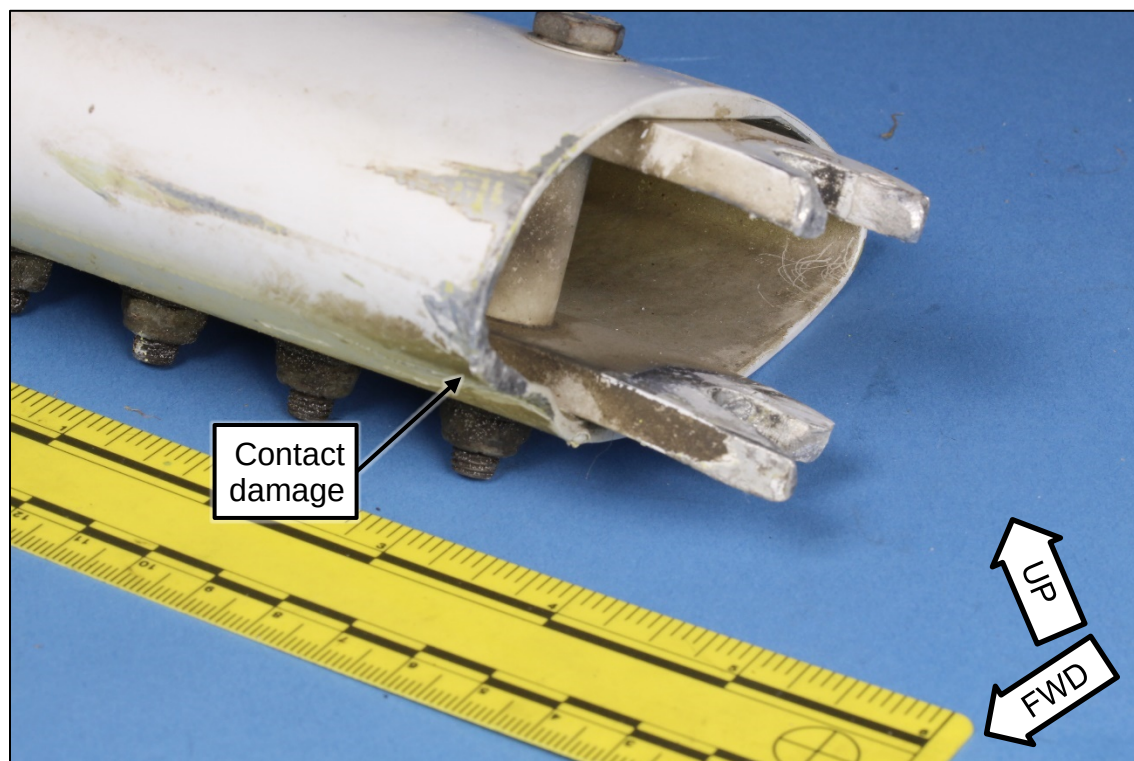
Both straps at the lower end of the left middle strut were fractured as shown in figure 2. The fracture surfaces had rough matte-gray features consistent with ductile overstress fracture. The overall deformation pattern associated with the fracture was consistent with a tension load with some torsion. An area of contact damage was present at the lower forward end face of the aerodynamic tube section as indicated in the lower image in figure 2.

Figure 2. Views of the strap fractures at the lower end of the left middle strut. Contact damage was observed on the forward end face of the strut as indicated.

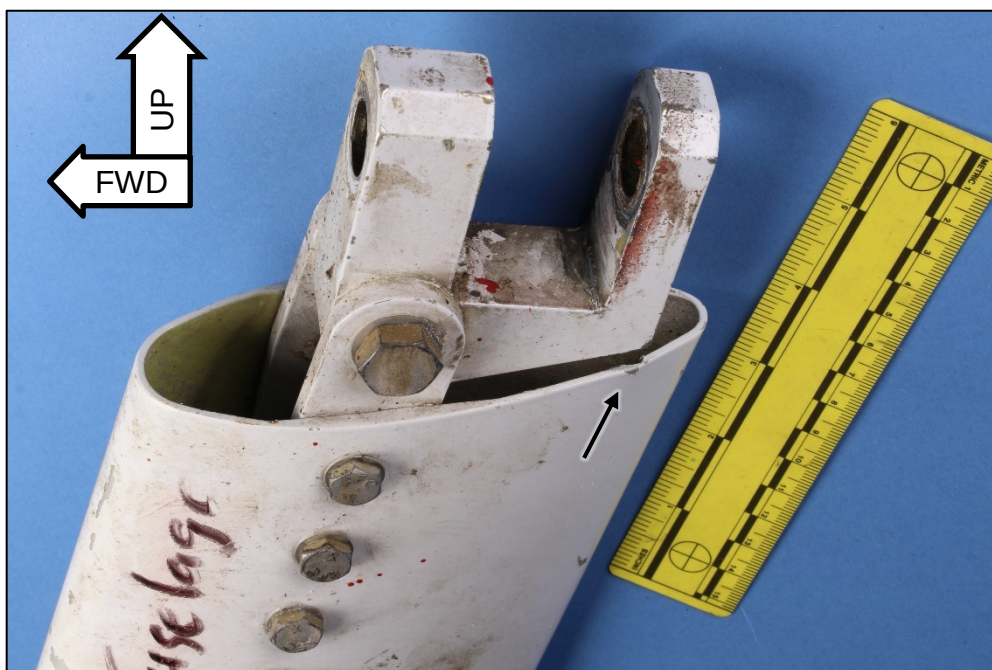
The upper end of the left middle strut was intact and remained attached to the upper clevis fitting as shown in figure 3. The upper end of the aerodynamic tube section was deformed near the aft end of the strut as indicated with an unlabeled arrow in figure 3. The deformation corresponded to contact with the lower aft corner of the clevis fitting consistent with the fitting rotating about the strap attachment bolt axis to contact the upper end face of the strut tube section.

Figure 3. Intact upper end of the left middle strut. An unlabeled arrow indicates damage corresponding to contact between the strut and the aft corner of the clevis fitting.

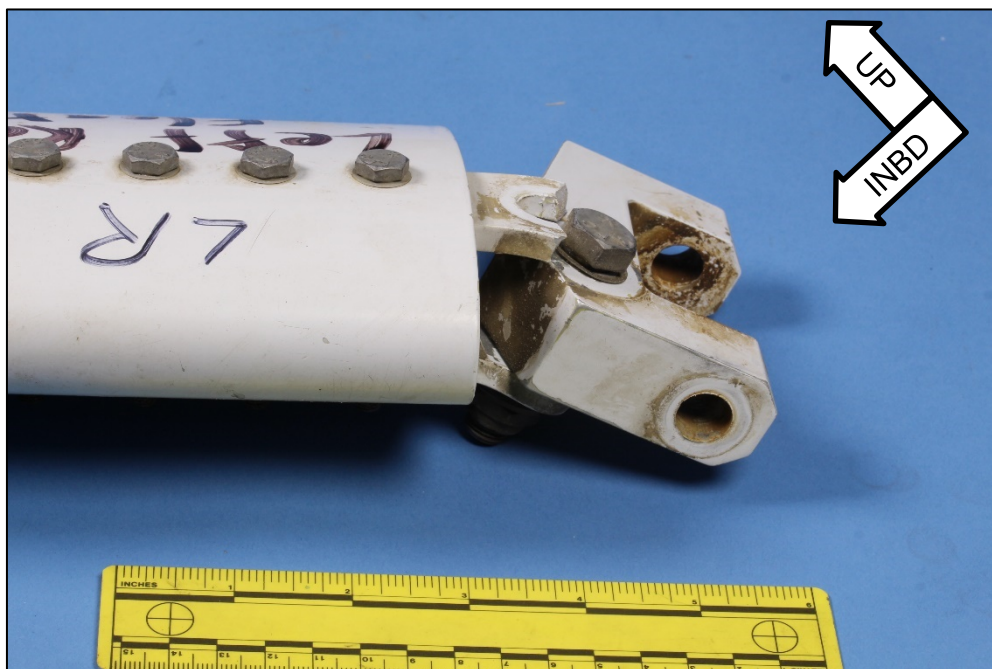
The lower end of the left rear strut is shown in figure 4. The inboard strap was bent inboard and downward, and the lower clevis fitting remained attached to the inboard strap. The outboard strap was fractured and had rough, matte gray features consistent with ductile overstress fracture. The outboard strap adjacent to the fracture was also bent downward and inboard consistent with an overall load causing the strut to bend downward and inboard relative to the clevis fitting.

Figure 4. Lower end of the left rear strut. The inboard strap was bent downward, and the outboard strap was fractured.

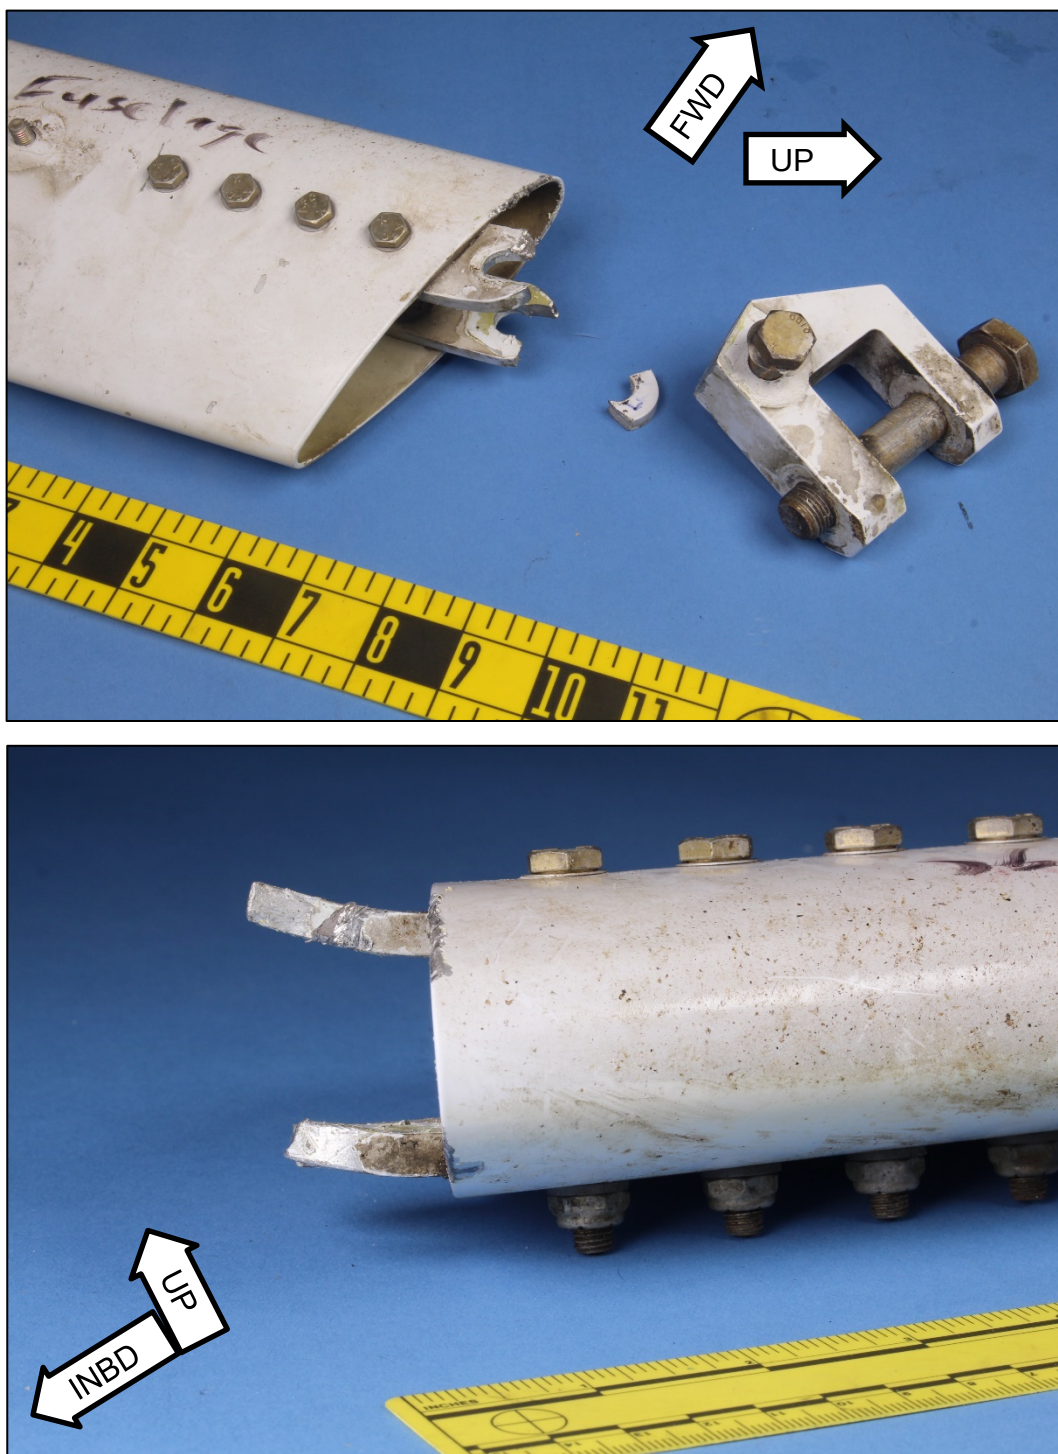
Both straps at the upper end of the left rear strut were fractured as shown in figure 5. The upper clevis fitting for the rear strut was received with attachment hardware as shown in the upper image in figure 5, and a mating piece of the outboard strap is also shown. Fracture features for the straps were rough and matte gray consistent with ductile overstress fracture. Both straps were also bent upward and outboard adjacent to the fracture as shown in the lower image in figure 5. Evidence of contact damage was observed on the end face of the tubular strut section forward of the straps.

Figure 5. Views of the upper end of the left rear strut. The corresponding fitting with mating strap piece is shown in the upper image, and upward bending deformation of the straps is shown in the lower image.

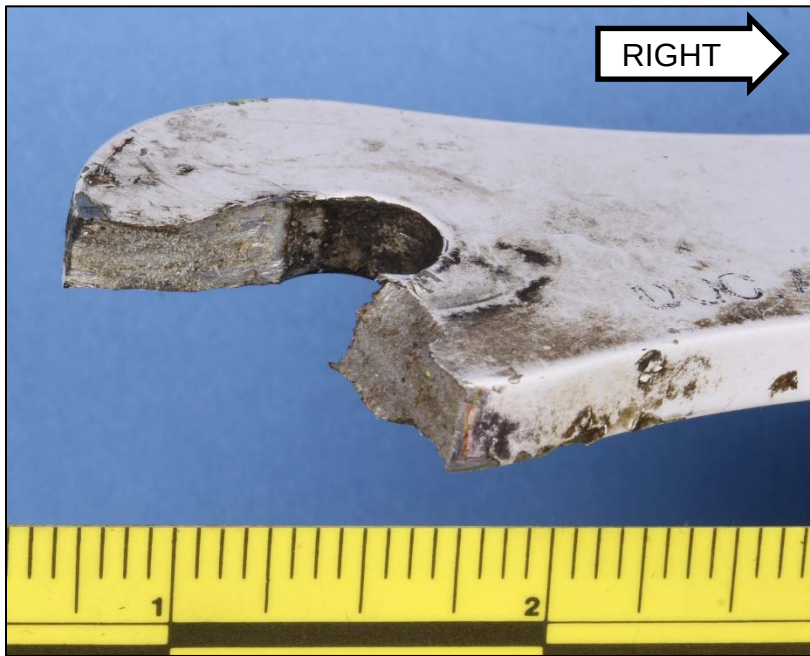
In the flying wire assemblies, fractures occurred in components associated with the two flying wires attached to the left float. In the assembly for the rear flying wire attached to the left float, the fracture occurred in the strap at the right rear fuselage attachment. A close view of the strap fracture features is shown in figure 6. The fracture features had a rough matte gray appearance consistent with ductile overstress fracture.

Figure 6. Fractured end of the right rear flying wire attachment strap.

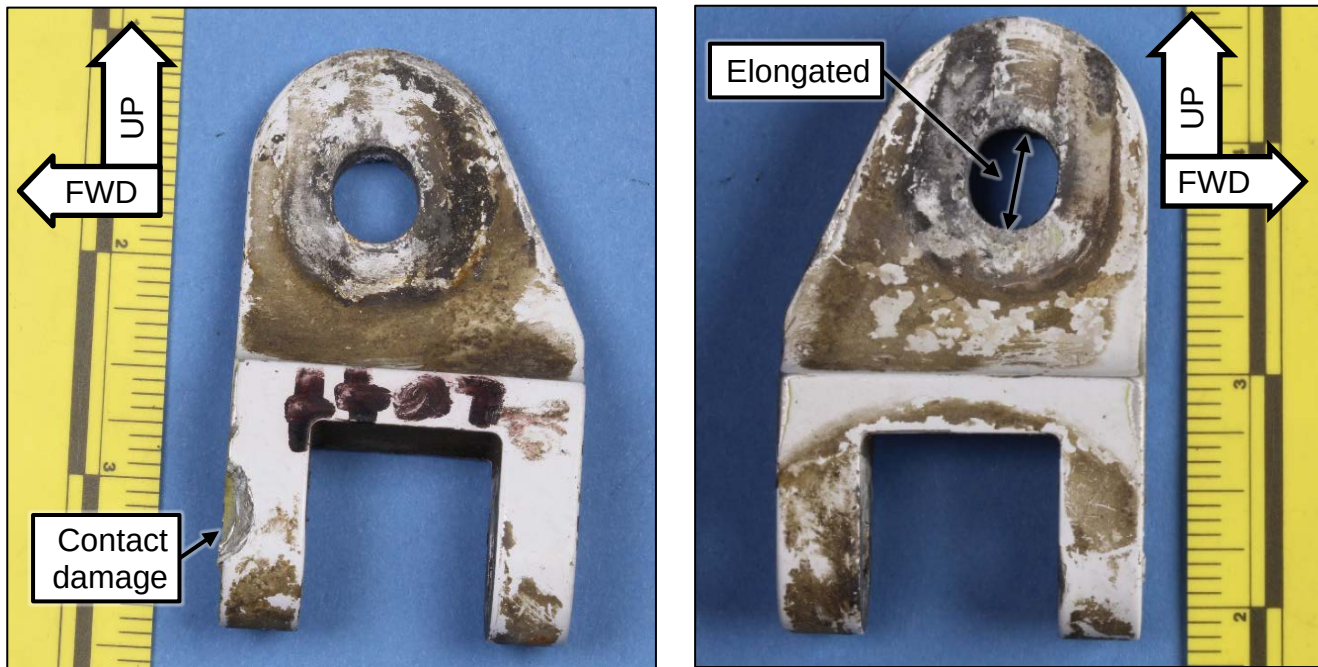
Close views of the fitting at the left rear flying wire float attachment location (float end of the flying wire with the fractured strap) are shown in figure 7. The hole where the flying wire attached to the clevis fitting was elongated as indicated in the right image in figure 7. The flying wire attachment hole diameter measured 0.4315 inch parallel to the flying wire axis and 0.3810 perpendicular to the flying wire axis. According to an engineering drawing for the fittings, the specified diameter was 0.375 inch to 0.377 inch. Tension cracks were observed in the paint around the elongated hole consistent with overstress deformation. The bolt for attaching the clevis end of the fitting to the float (hardware shown in figure 1) had a bent shank. The paint on the fitting was mostly intact, but some relatively small areas of corrosion and missing paint were observed around the flying wire attachment hole.

On the outboard side of the left rear flying wire fitting, a curved area of contact damage was observed on the outboard side of the clevis as indicated in figure 7. The damage was consistent with contact with the attachment hardware at the lower end of the left rear strut as the upper end of the left rear strut rotated downward and inboard onto the flying wire fitting located just inboard of the strut attachment.

Figure 7. Photographs of the left rear flying wire attachment fitting showing the outboard (left image) and inboard (right image) sides of the fitting. The flying wire attachment hole was elongated, and some corrosion was observed around the flying wire attachment hole. Contact damage corresponding to strut attachment hardware was observed on the outboard front corner of the clevis front lug as shown.

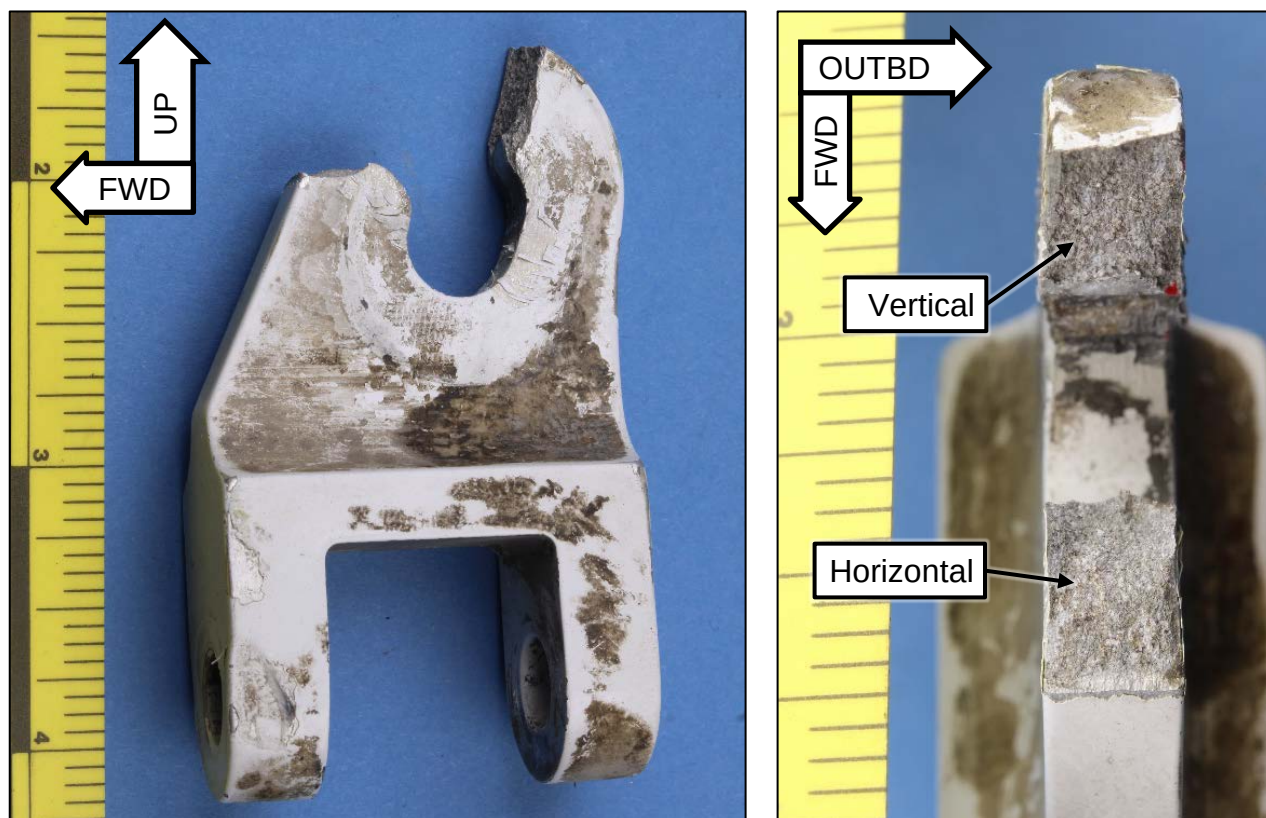
The left front flying wire fitting was fractured at the flying wire attachment lobe as shown in figure 8. The hole for the attachment was elongated, and tension cracks were observed in the paint next to the elongated hole consistent with overload deformation of the hole. The attachment bolt at the clevis end of the fitting was also bent (see figure 1) consistent with overload deformation.

Figure 8. Left forward flying wire attachment fitting. An overall view of the outboard side is shown in the left image, and a view of the fracture surfaces are shown in the right image.

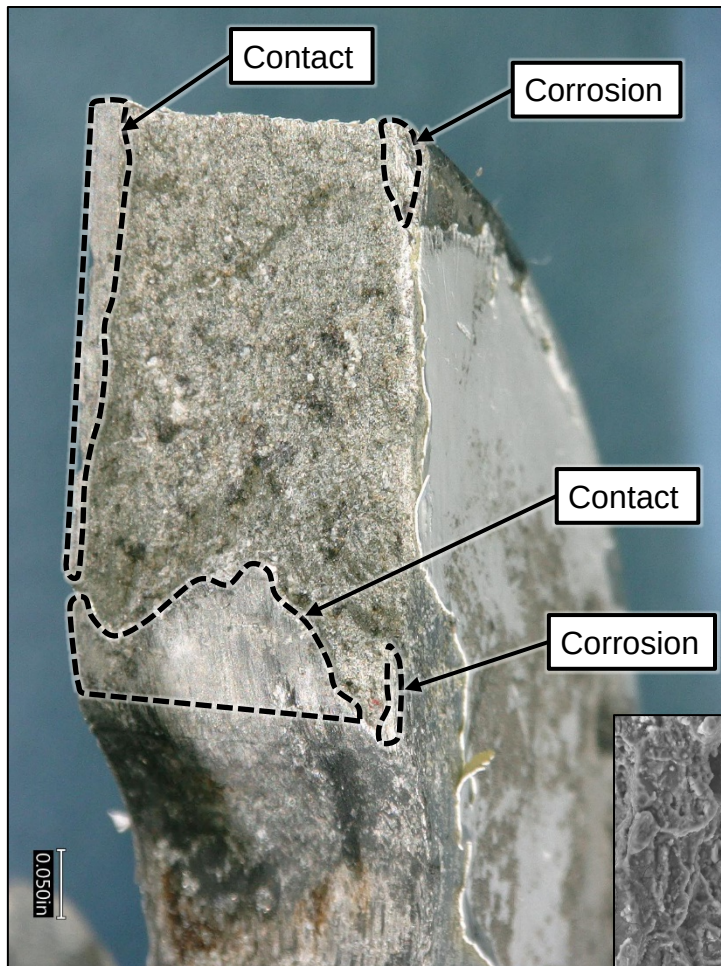
Overall, the fractures had rough, matte gray features consistent with ductile overstress fracture. Sliding contact marks consistent with contact with the flying wire attachment bolt were observed on the vertical portion of the lug fracture as indicated in figure 9. The horizontal portion of the fracture (see figure 8) was free of post-fracture contact with the attachment bolt, but the forward edge of the fracture was smeared consistent with a bending fracture secondary to the vertical fracture. The inboard surface of the lug adjacent to the vertical fracture near the attachment hole had missing and bubbled paint, and the exposed surface was corroded and bulging slightly consistent with exfoliation corrosion.

The vertical fracture surface of the left front flying wire fitting was cleaned by submerging the fitting in acetone while cleaning using an ultrasonic cleaner. The cleaned fitting was then examined using a scanning electron microscope (SEM). Relatively small areas of the fracture surface had intergranular fracture features consistent with exfoliation corrosion. Both areas of corrosion were located at the inboard side of the fracture adjacent to the attachment bolt hole and near the upper edge of the lug as indicated in figure 9. The remainder of the fracture surface had dimple features such as the typical SEM image shown in figure 9 consistent with ductile overstress fracture. No evidence of a progressive crack growth mechanism such as fatigue was observed outside of the areas of corrosion.

Figure 9. Optical image (left) and SEM image (below) of the vertical fracture surface on the left forward flying wire attachment fitting. Dashed lines in the optical image indicate areas of exfoliation corrosion and areas of sliding contact damage in the fracture plane.

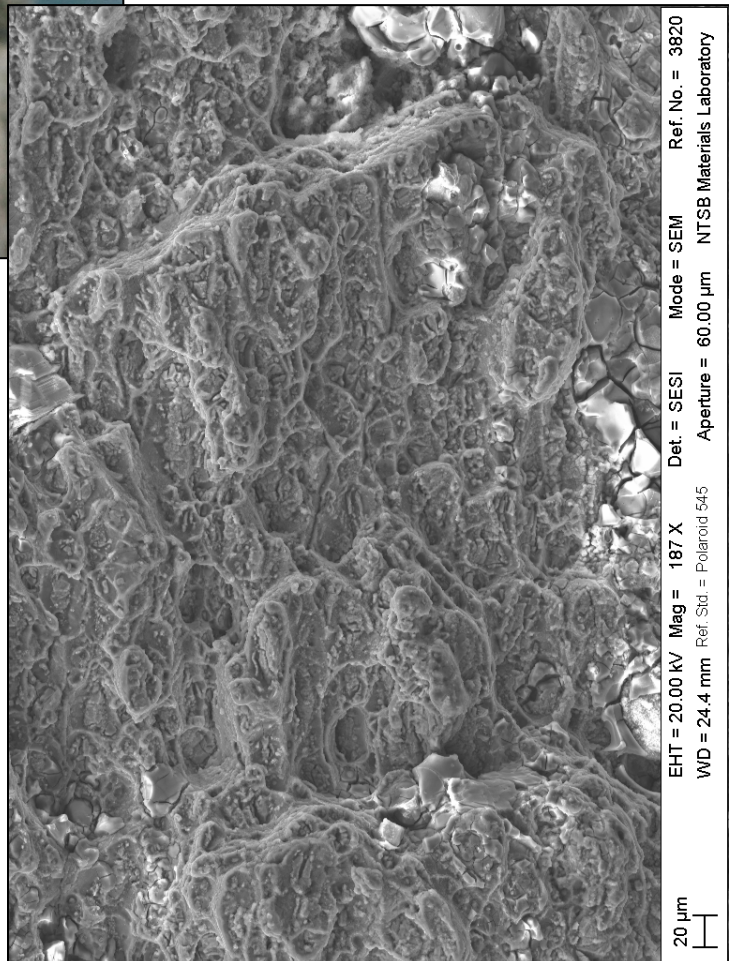
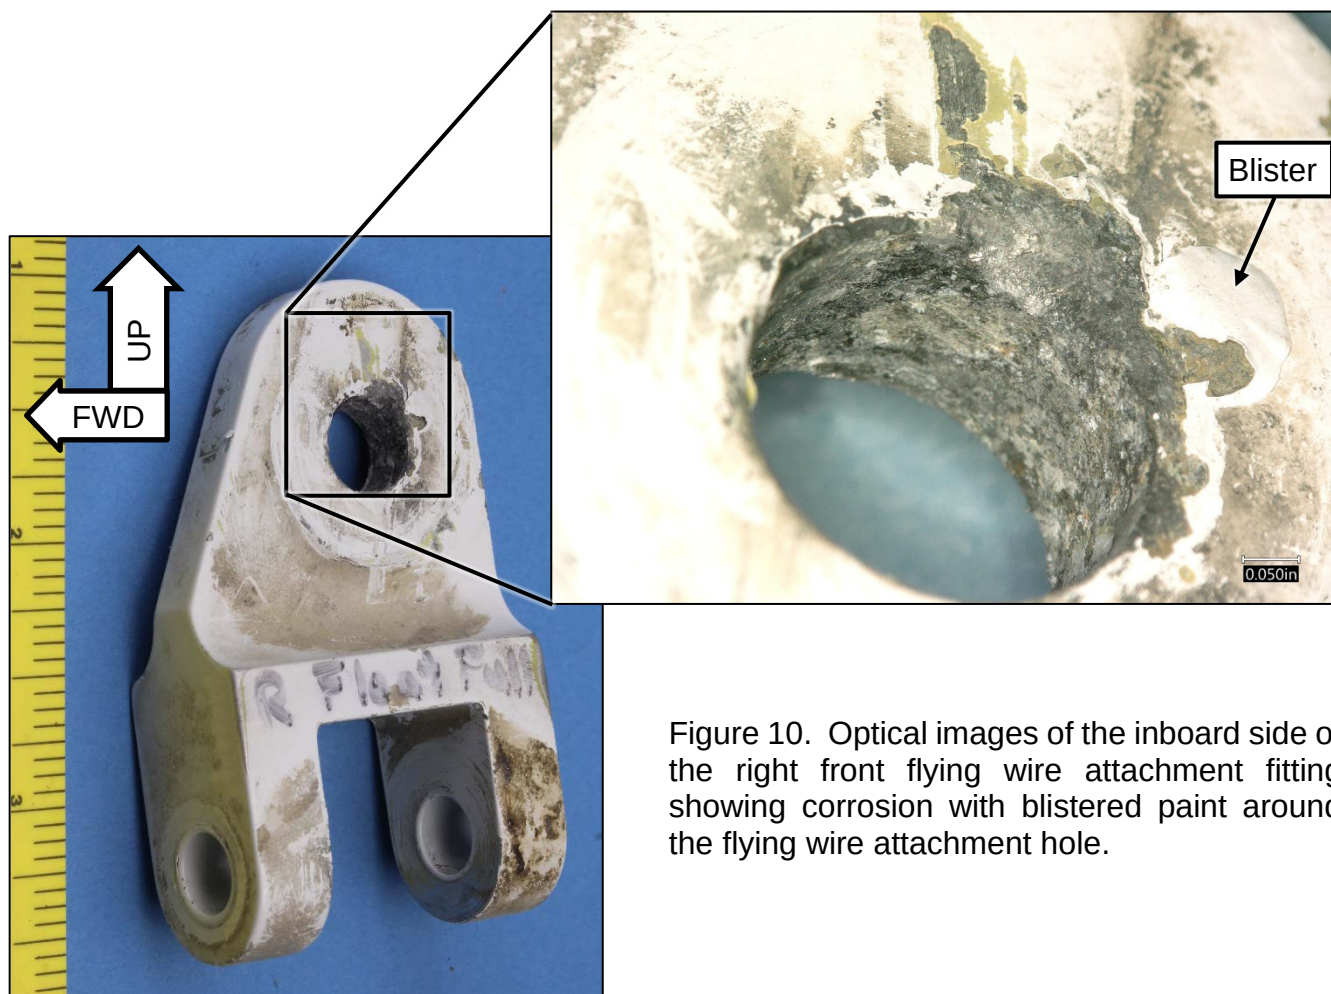
The right forward and right rear flying wire fittings were cleaned using acetone and a soft-bristle brush, and the cleaned fittings are shown in figures 10 and 11. The area in and around the flying wire attachment holes had a corroded appearance, particularly on the inboard sides shown in figures 10 and 11, and paint around the attachment holes was blistered. The flying wire attachment hole diameters were measured in the loading and transverse directions, and the hole in the forward fitting was slightly elongated (0.3795 inch diameter) in the loading direction relative to the transverse direction (0.3765 inch diameter). The flying wire attachment hole in the right rear fitting measured 0.3765 inch in both the loading and transverse directions.

Figure 10. Optical images of the inboard side of the right front flying wire attachment fitting showing corrosion with blistered paint around the flying wire attachment hole.

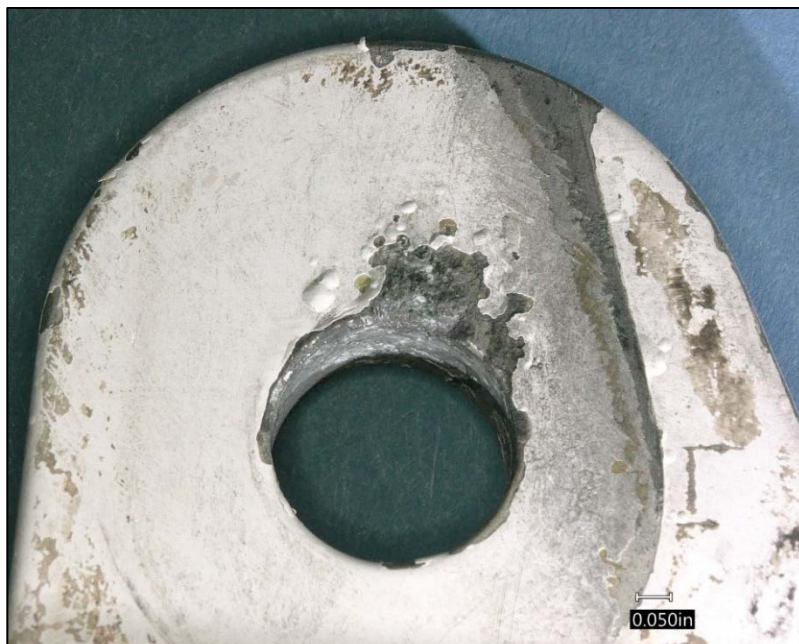
Figure 11. Optical image of the inboard side of the right rear lower flying wire attachment fitting showing corrosion with blistered paint around the flying wire attachment hole.
