## **NATIONAL TRANSPORTATION SAFETY BOARD**

### **Airframe and Engine Examination Summary**

NTSB Number: ANC19LA027

Aircraft: Helio Courier H391B, N10CJ

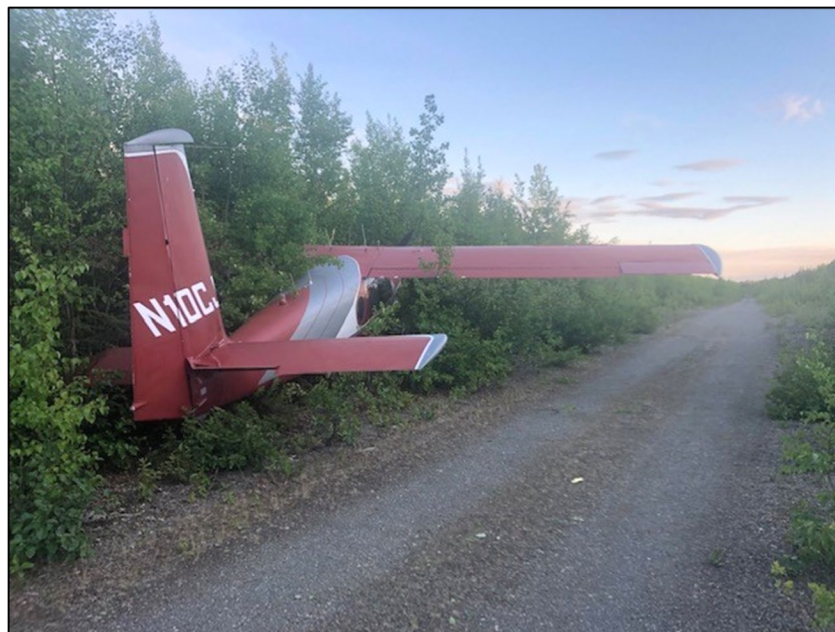
He cycled the throttle lever, increased the mixture lever to full rich, and turned on the electric fuel boost pump, but full power was not restored. The pilot rated passenger pulled the carburetor heat lever out (heat on) with no effect on engine performance. The pilot was able to maintain airplane altitude, but engine power was limited, so he searched for a landing location. He located an abandoned airstrip along the pipeline road and performed an approach to land to the north. The pilot stated that during the landing, the airplane drifted to the right, and touched down further than he intended. During the landing roll out, the right wing tip struck vegetation, the airplane veered rapidly to the right, and the empennage and left wing trailing edge impacted trees. Subsequently the airplane sustained substantial damage to the left aileron and left horizontal stabilizer. See figure 1. The pilot stated that there was a history of propeller rpm surging.

*Figure 1. N10CJ at the accident scene.*

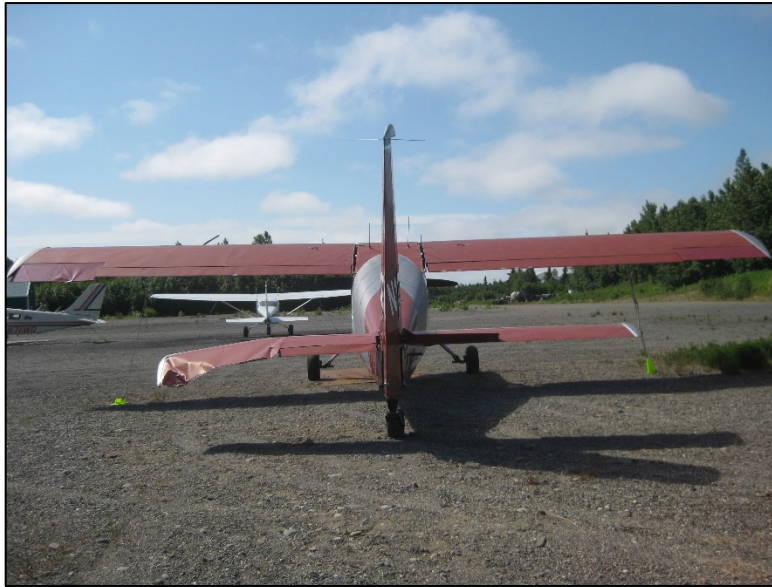
On July 2, 2019, the airplane was examined at the McGahan Industrial Airpark (AK73). The left and right stabilators and the left aileron sustained substantial damage. See figure 2.

*Figure 2. The airplane before the examination exhibiting substantial damage to the stabilator and left aileron.*

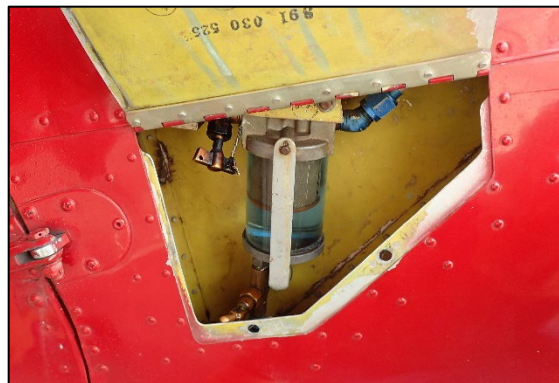
The remainder of the airplane and engine were intact. The fuel system, engine and propeller were examined. There was blue fuel in the gascolator that was clear of debris and smelled like avgas. A sample of drained fuel tested negative for water when tested with Sar-Gel paste. The fuel filter was clear of contamination. See figure 3.

*Figure 3. Gascolator with avgas present.*

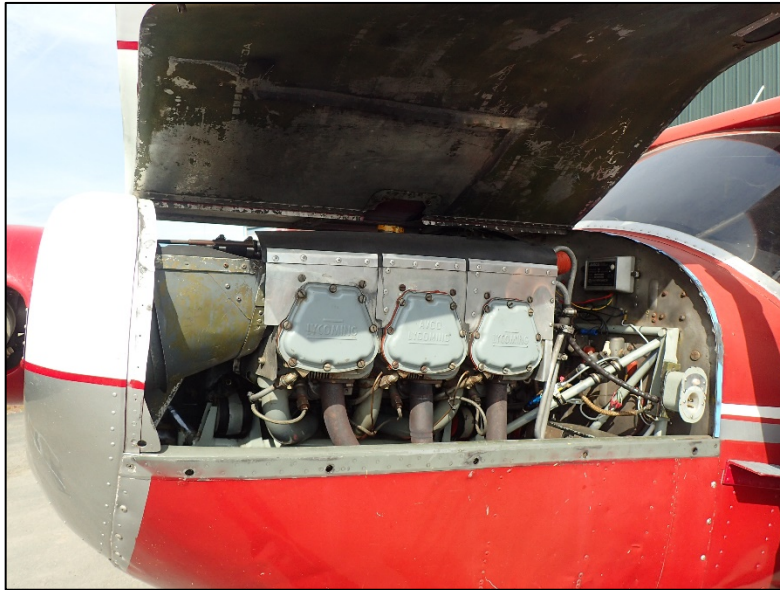
The engine was attached at the mounts and the propeller was intact and attached to the engine. The propeller blades were secure in their mounts and rotated by hand within the hub. The start locks were retracted, which according to a Hartzell investigator, is normal for this model. See figures 4 and 5.

*Figure 4. Lycoming GO-435-C2B2 left side of engine.*

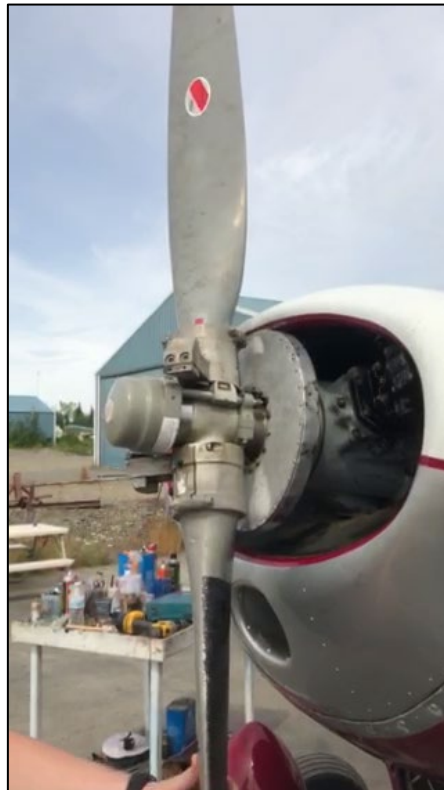
*Figure 5. Propeller.*

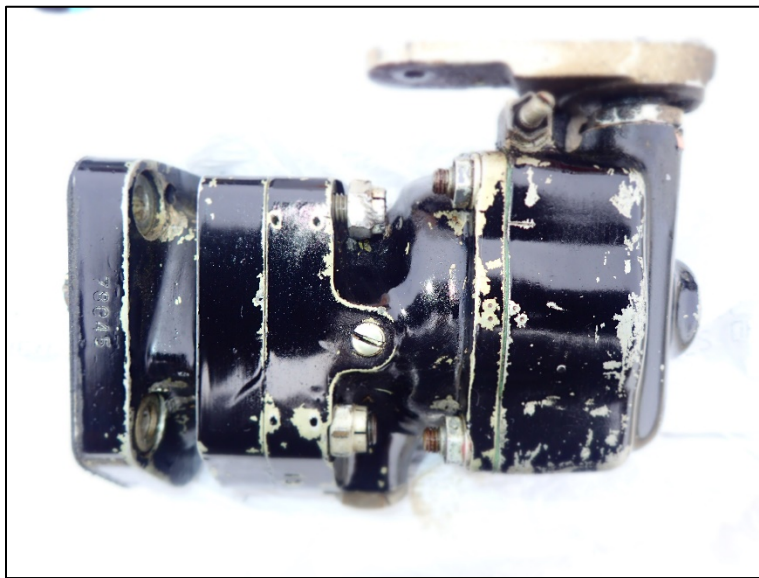
The propeller governor (Hartzell B3) was removed and sent to Hartzell for a functional bench test. See figure 6. An NTSB engineer supervised the test and a summary of the results is below.

The test stand was started with the governor installed and let run until the fluid temperature reached 115°F. The input speed was increased to 2725 rpm and the relief pressure tested within limits at 289 psi. The high rpm set screw was 2820 rpm, which was above the limit of 2725+/- 10 rpm. The input rpm was decreased to 1750 and the output flow capacity was 8.1 quarts/minute, and the internal leakage was 5.2 ounces/minute, which both were within limits. The low rpm set screw was within limits at 1720 rpm.

*Figure 6. Propeller governor after removal.*
