## **NATIONAL TRANSPORTATION SAFETY BOARD**

### **Group Chairman's Factual Report**

# **AIR TRAFFIC CONTROL**

ANC19LA031

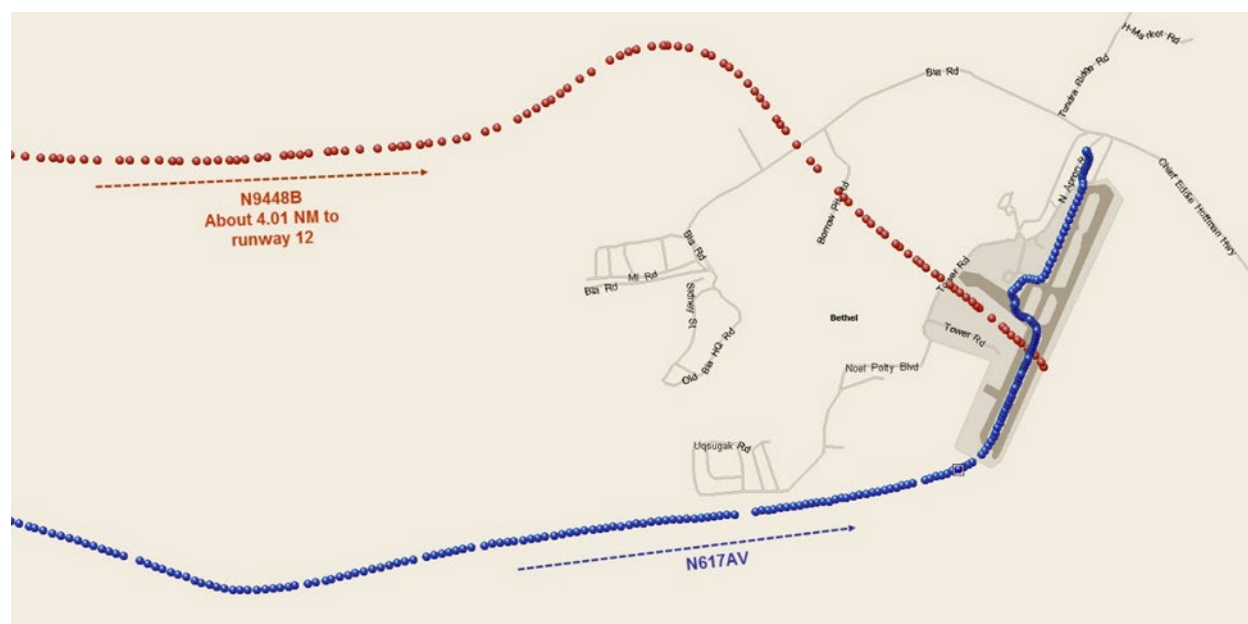
Figure 1 - Illustrating the flight path of N9448B when the aircraft was about 4.01 NM from the runway threshold.

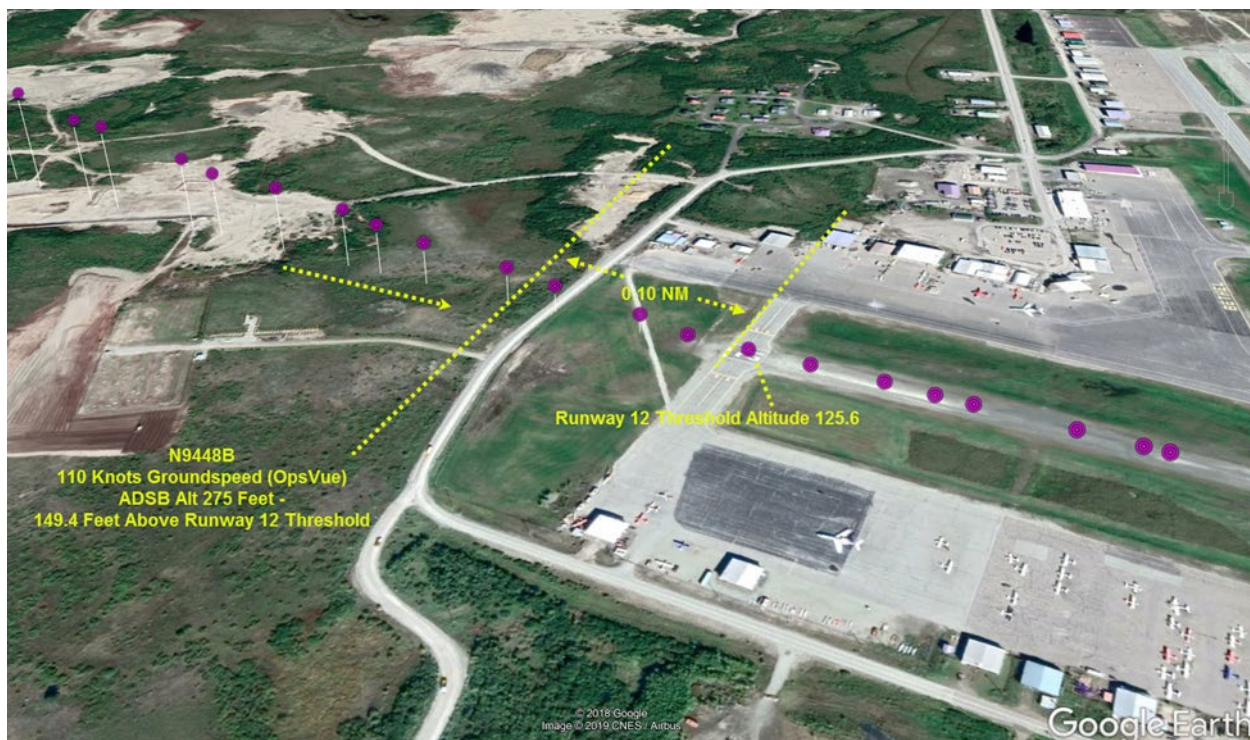
Figure 3 illustrates the groundspeed and altitude of N9448B at 0.10 nautical miles from the landing threshold of runway 12. The data indicates the aircraft was at an ADSB reported altitude of 225 feet mean sea level (149.4 feet above ground level) and a groundspeed of 110 knots.

**Figure 3 - Illustrates the groundspeed and altitude of N9448B at 0.10 nautical miles from the landing threshold of runway 12.**

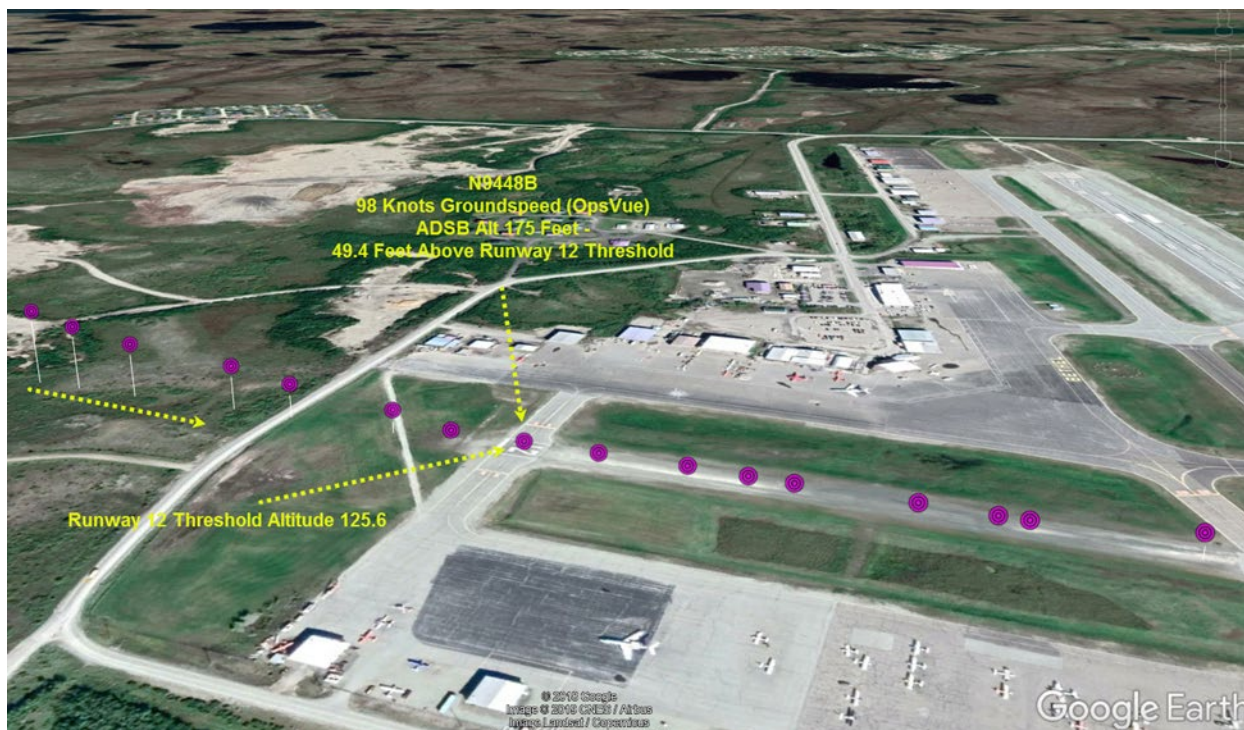
Figure 4 illustrates the groundspeed and altitude of N9448B over the landing threshold of runway 12. The data indicates the aircraft was at an ADSB reported altitude of 175 feet mean sea level (49.4 feet above ground level) and a groundspeed of 98 knots.

Figure 4 - Illustrates the groundspeed and altitude of N9448B over the landing threshold of runway 12
