**Photo 1 – Accident airplane after recovery from the ocean waters.**

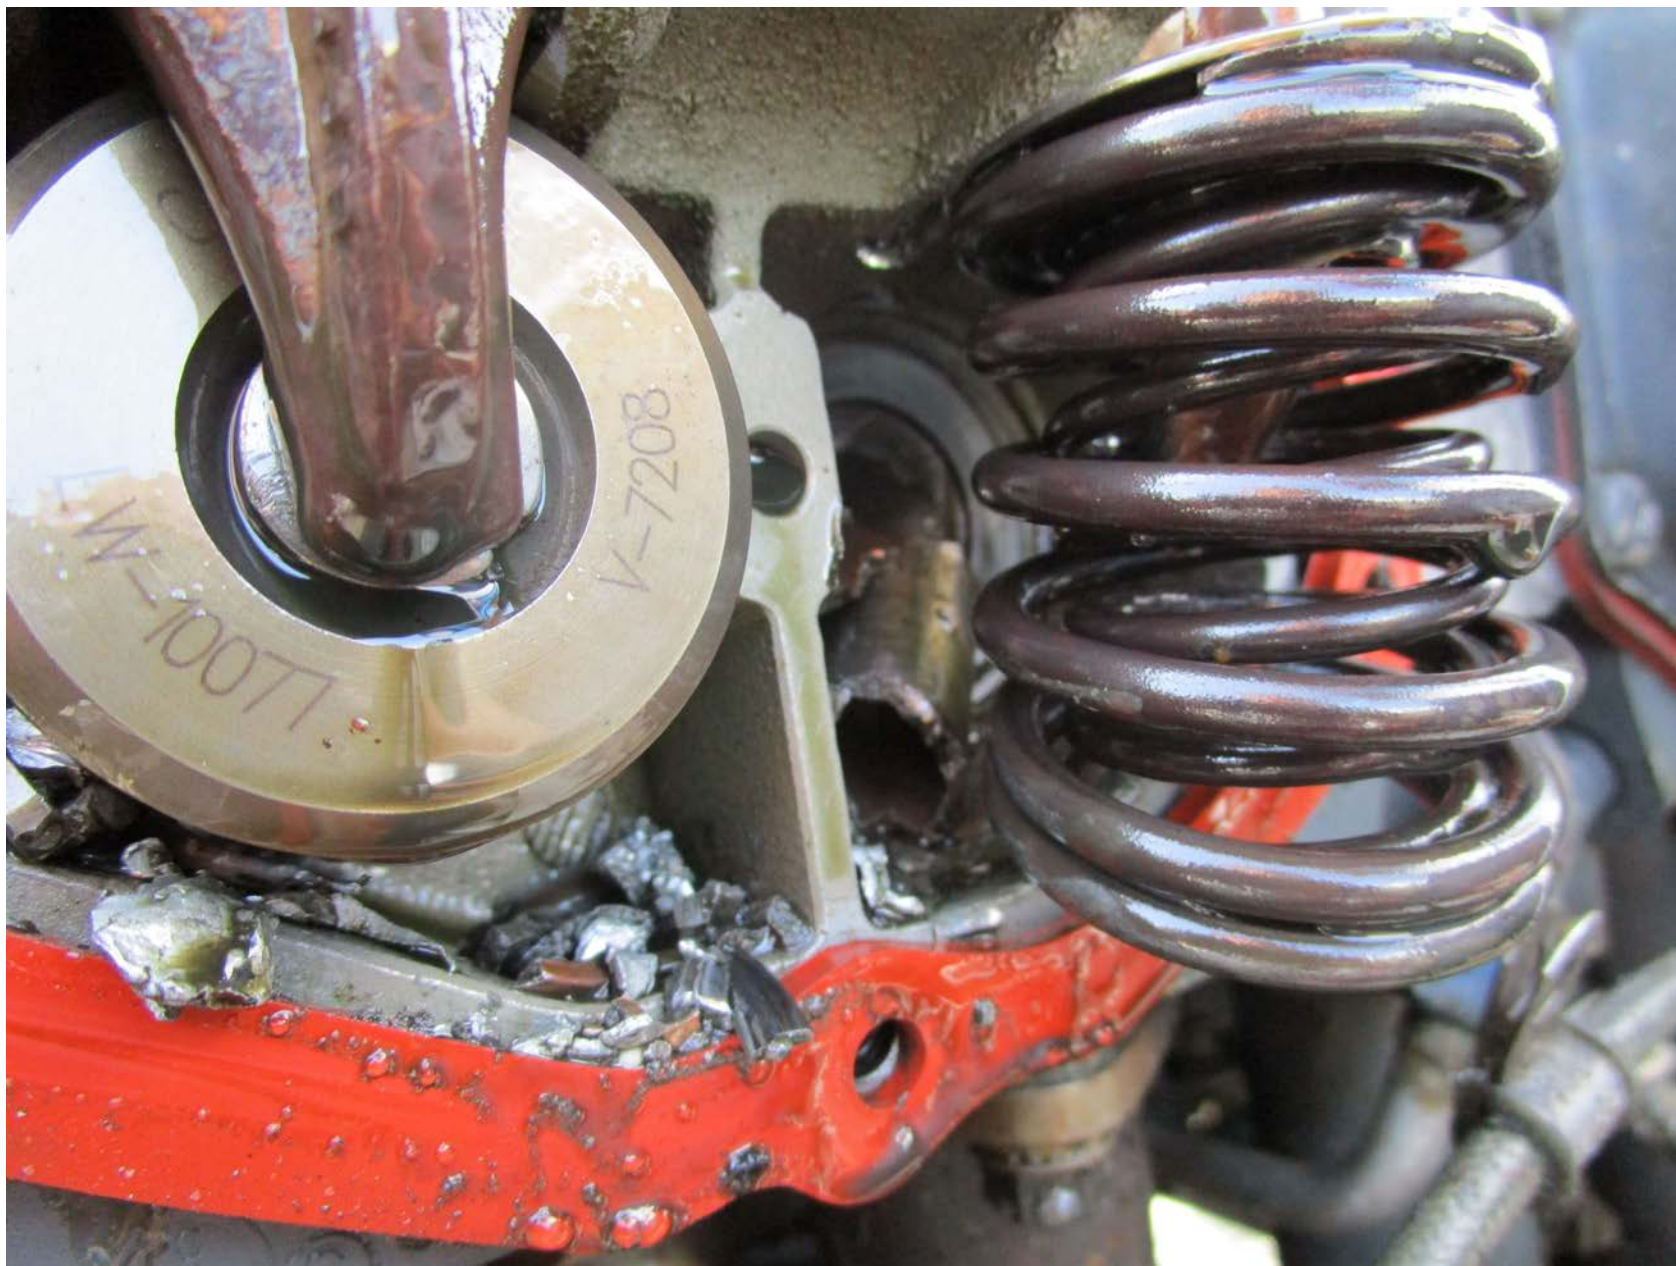
**Photo 2 – Number 2-cylinder exhaust valve spring.**

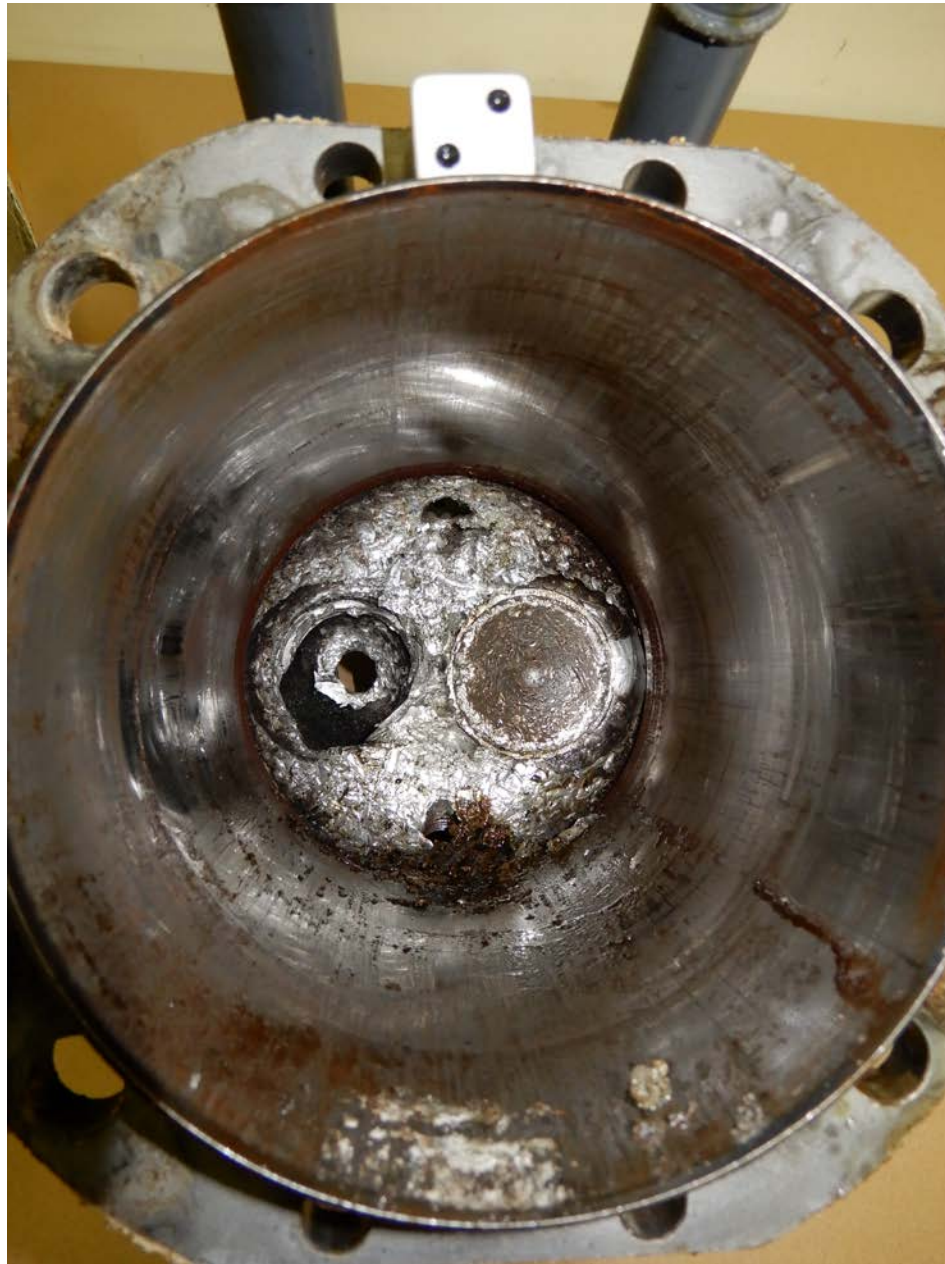
**Photo 3 – Interior of number 2-cylinder.**

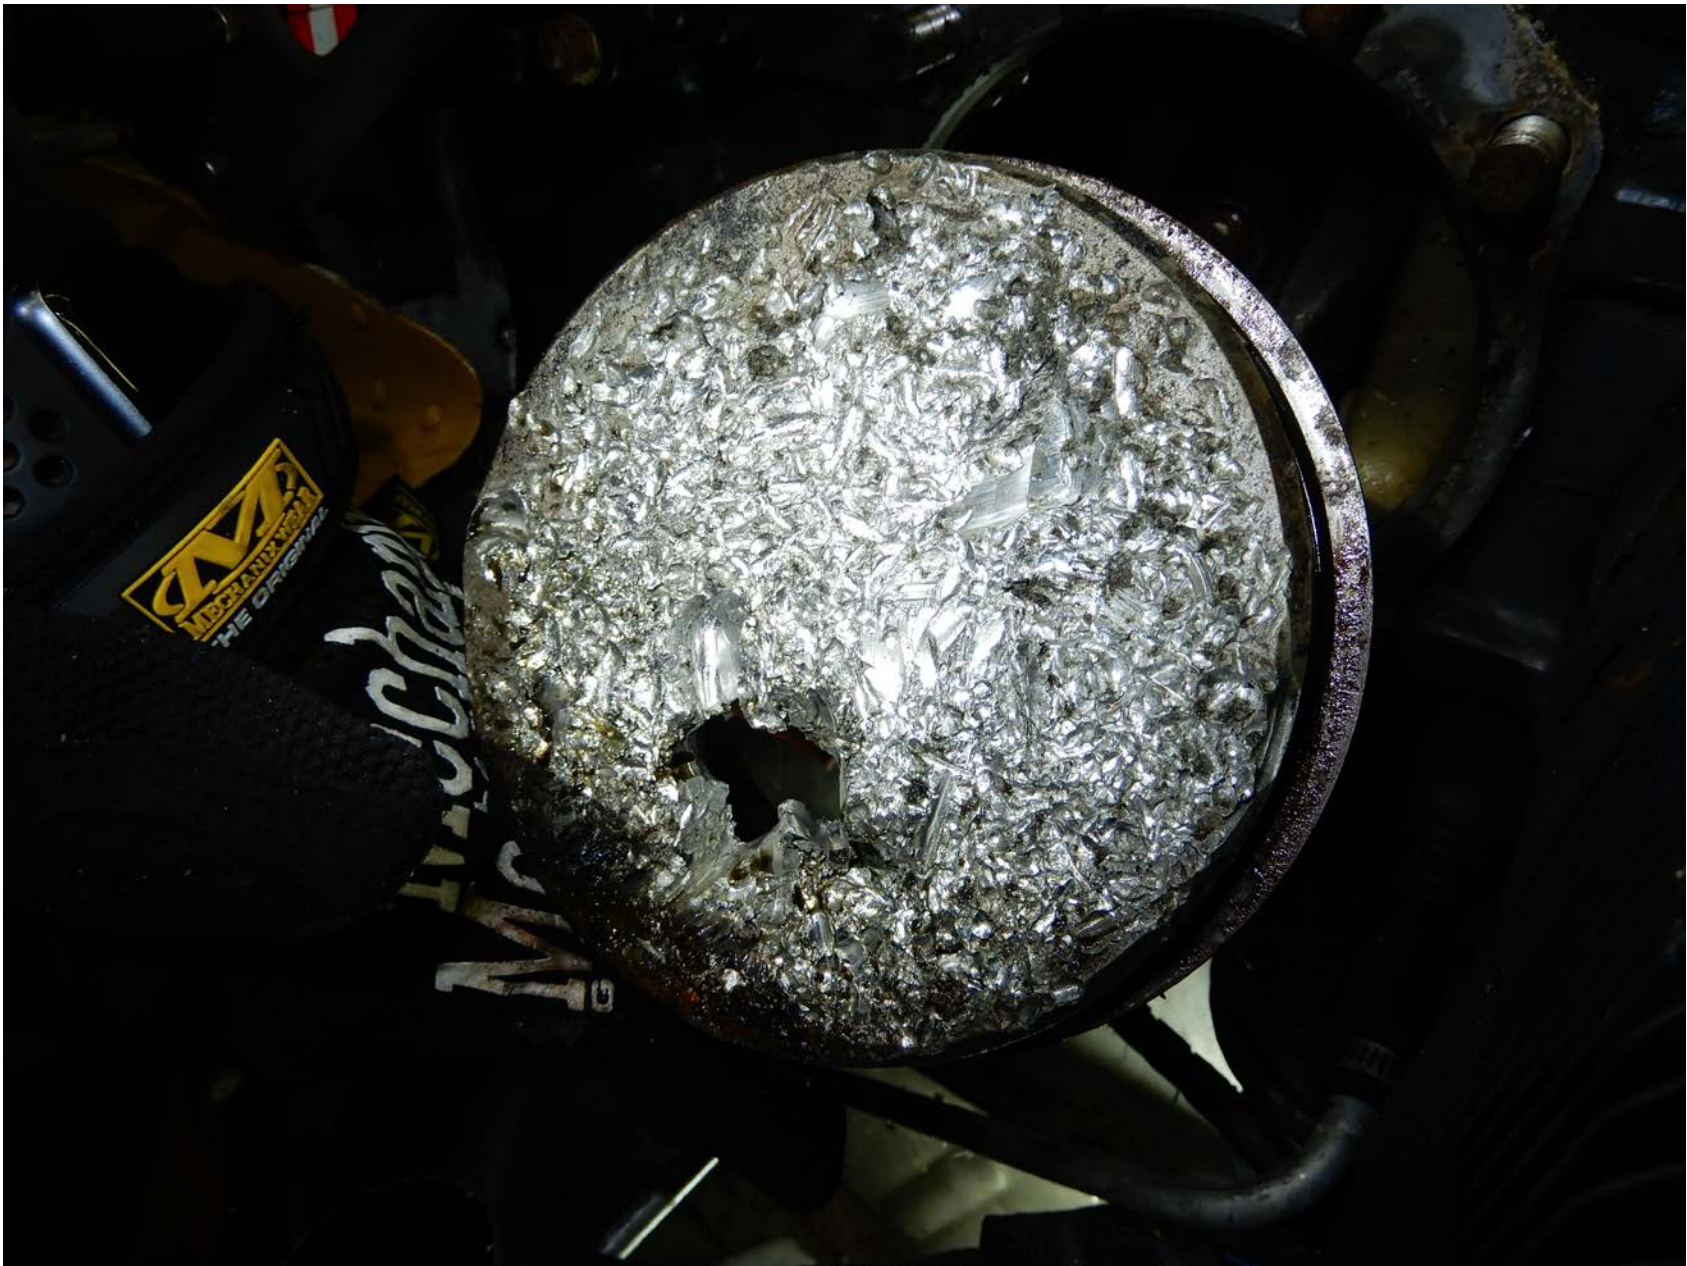
Photo 4 – Number 2-cylinder's piston face.
