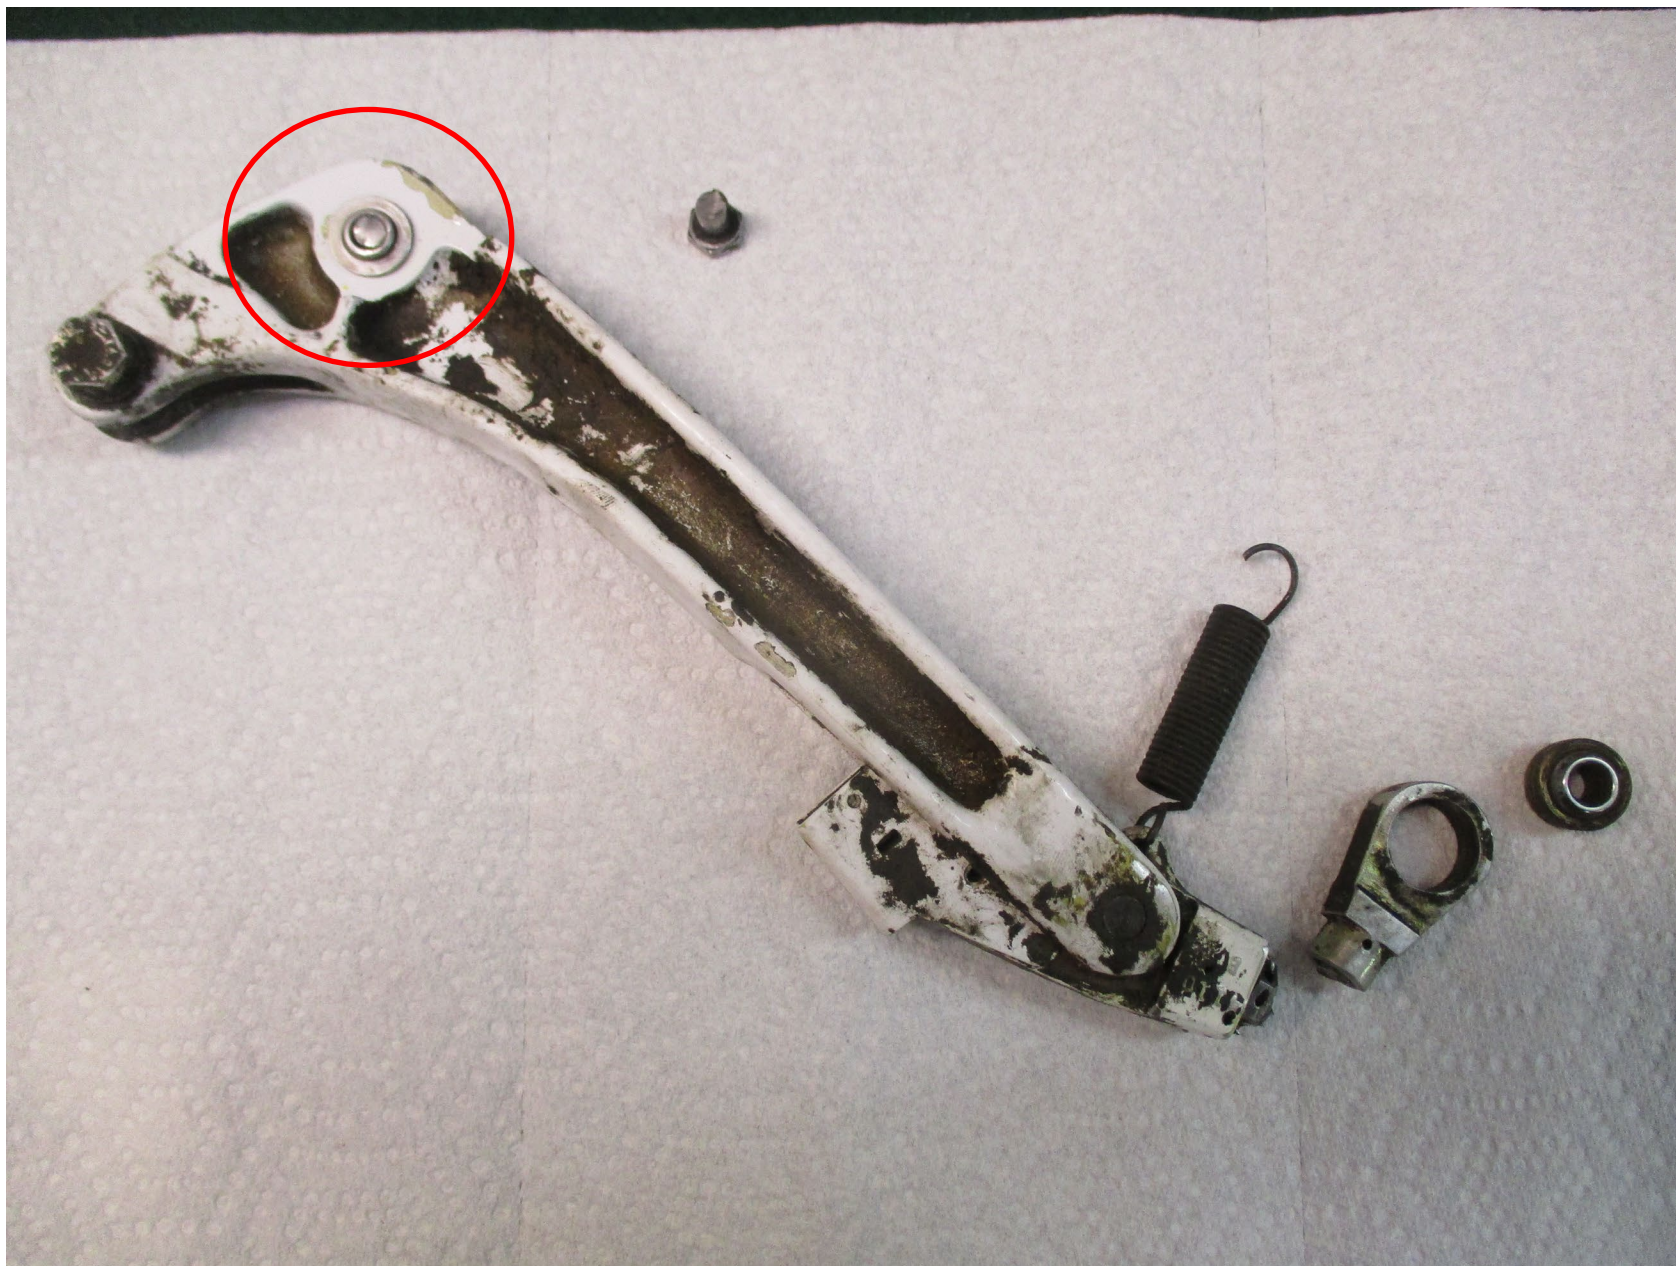
**Photo 1 – Accident airplane's right main landing gear bellcrank assembly. Sheared bellcrank pivot bolt outlined in red circle.**

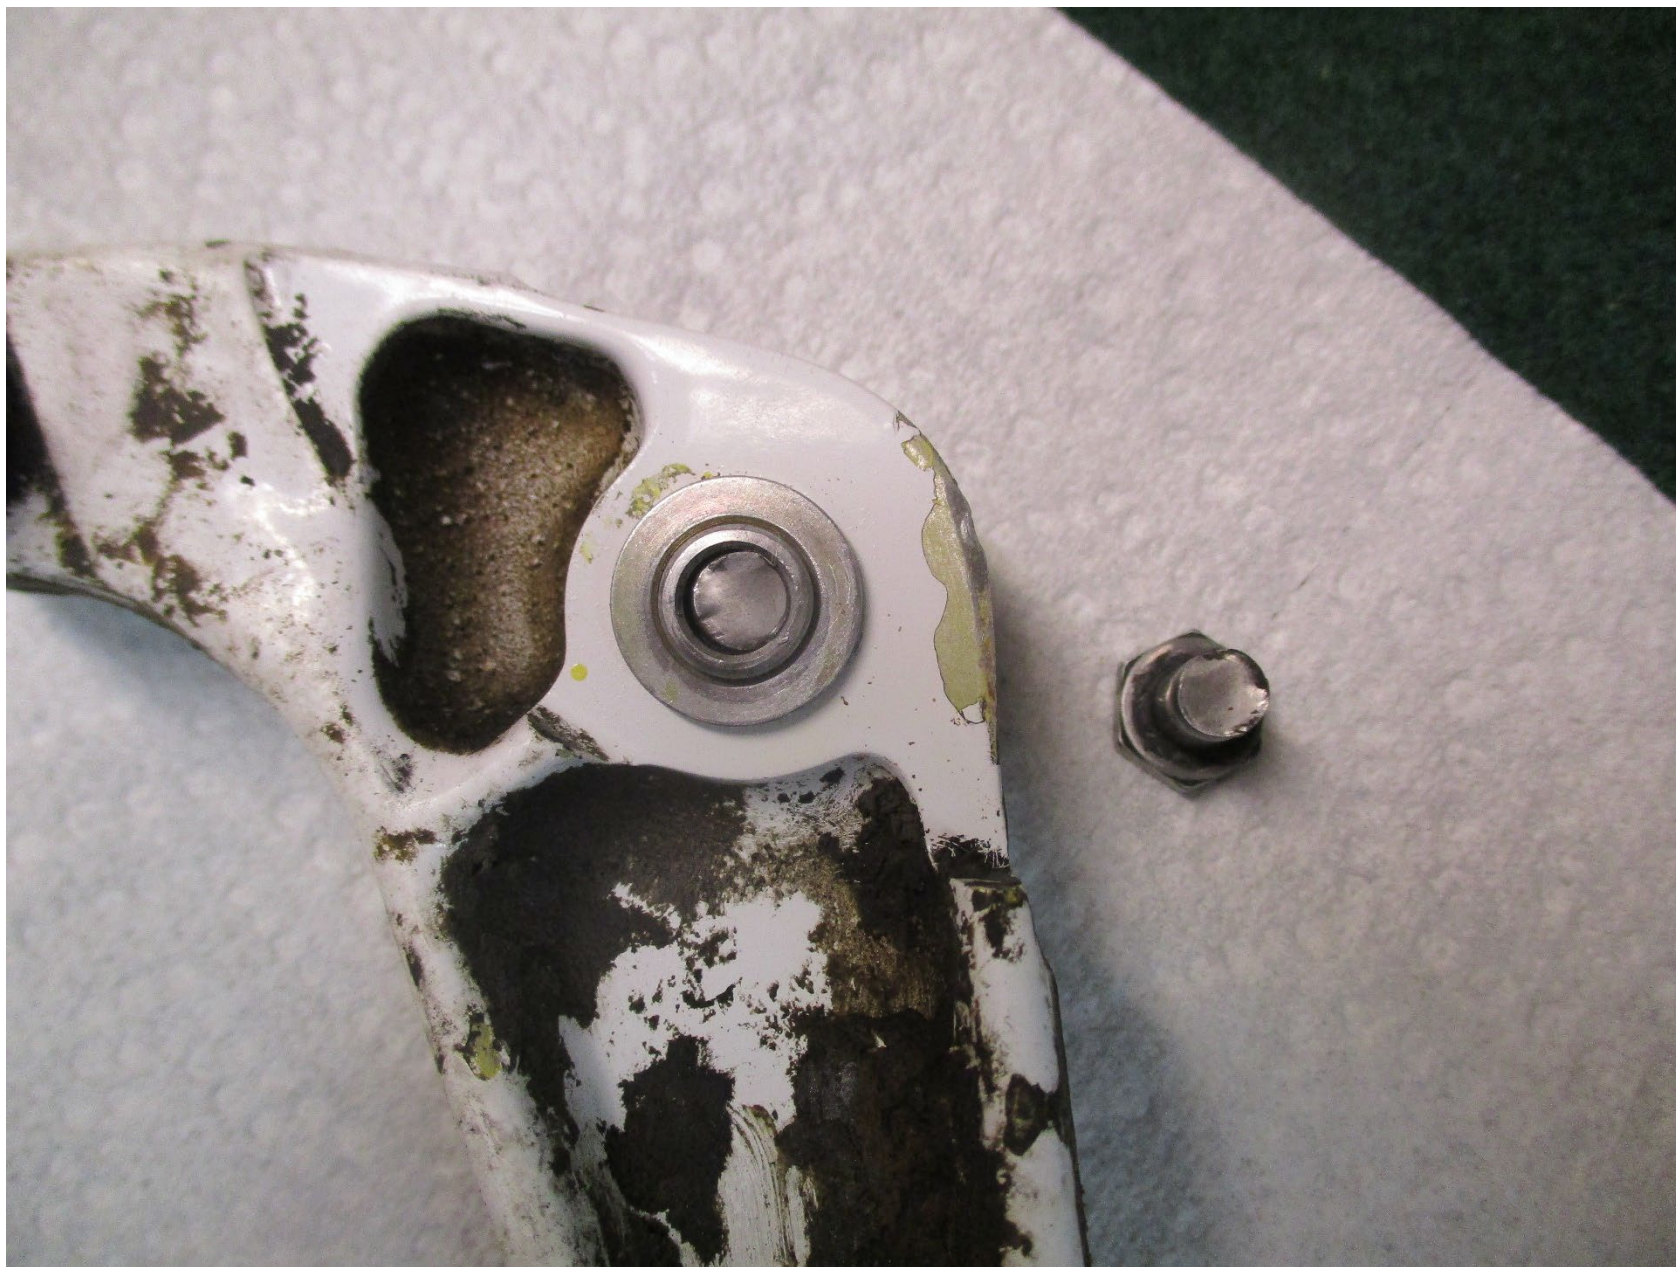
**Photo 2 – Accident airplane's sheared bellcrank pivot bolt with smeared fracture features and deformation consistent with ductile overstress fracture from shear loading.**
