## **NATIONAL TRANSPORTATION SAFETY BOARD**

### **EXAMINATION SUMMARY**

| <b>NTSB Number:</b> | <b>ANC19LA040</b> |
| <b>Aircraft:</b> | N3934D Cessna 182 |

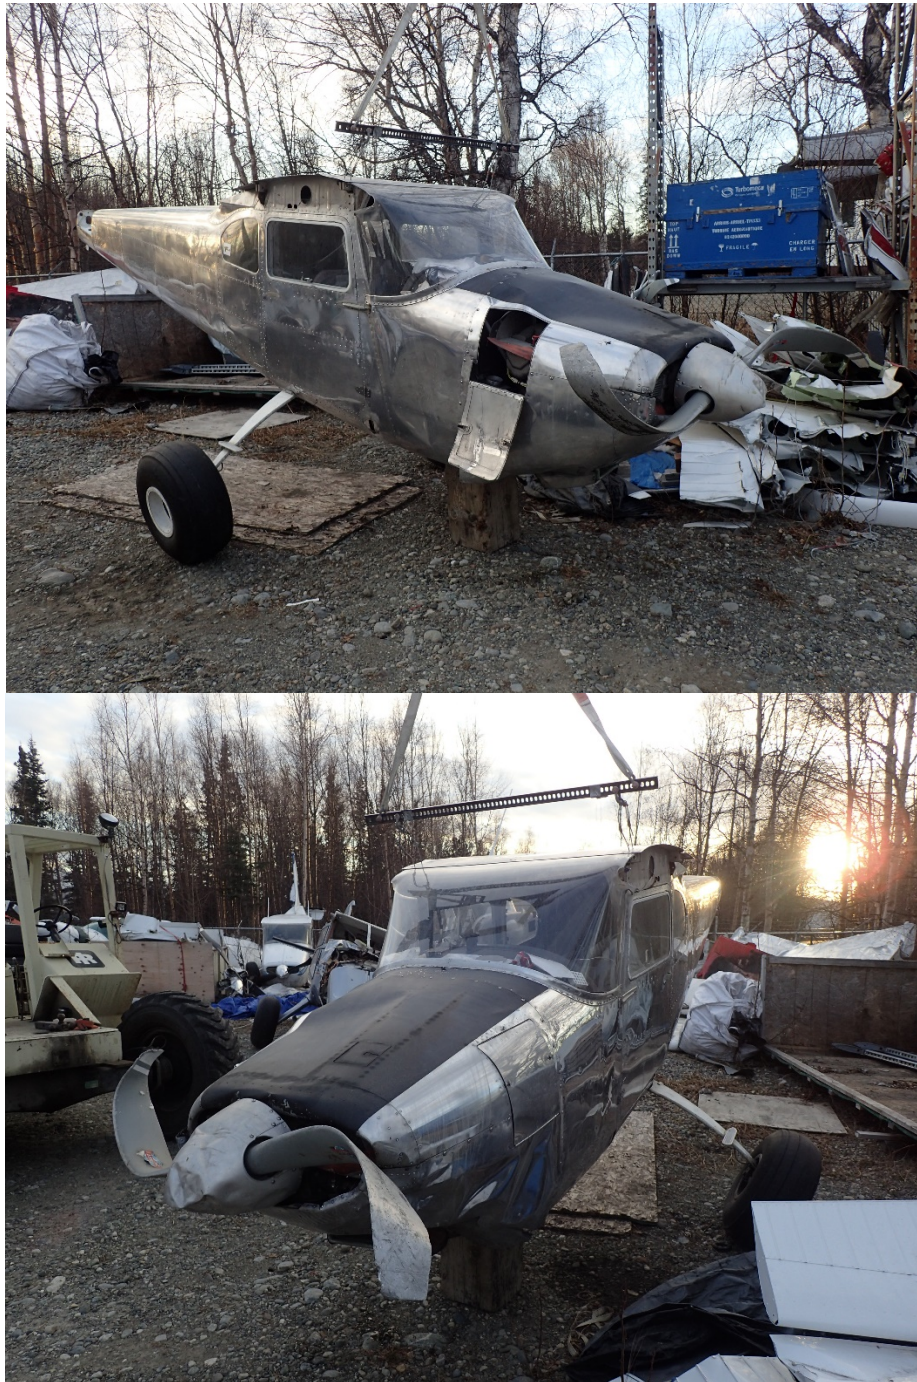
The airplane was defueled and the wings and empennage were removed during the recovery. The exam was conducted at the recovery facility in Wasilla, Alaska. The engine remained attached to the fuselage which was supported by a hoist system due to damaged and sheared landing gear. The fuselage sustained buckling deformation at the left and right lower forward fuselage. The left wheel attachment was deformed outward. See figure 1.

*Figure 1. Fuselage during the examination.*

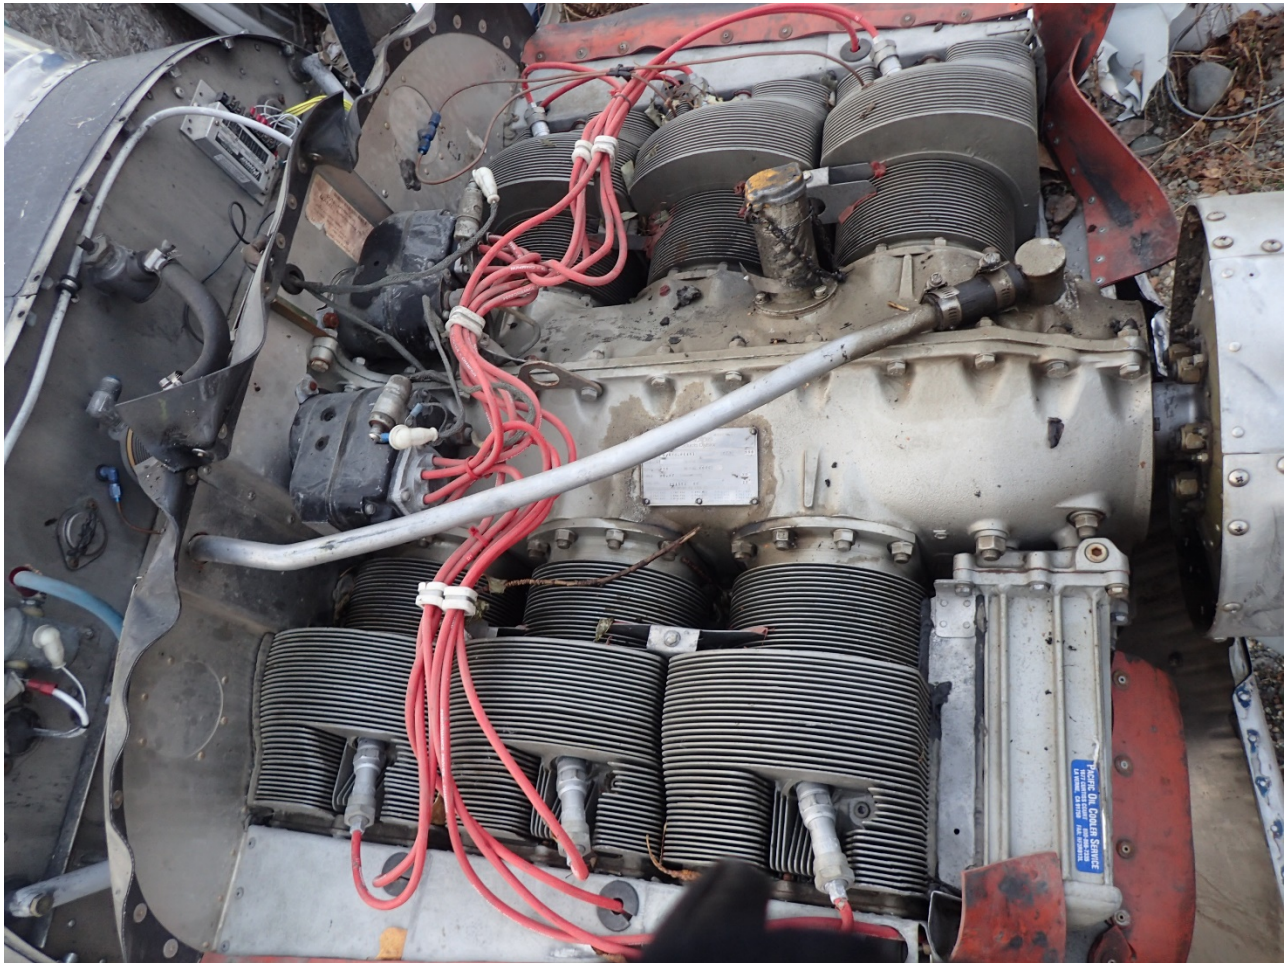
Engine control continuity was established between the throttle, mixture and carburetor heat to the carburetor. The carburetor was attached and intact. The airbox exhibited some impact crush damage. See figure 2.

*Figure 2. Continental O-470 engine.*
