**National Transportation Safety Board**  
Office of Research and Engineering  
Washington, D.C. 20594

## Airplane Performance Study

**Location:** Kapalua, Hawaii  
**Date:** August 18, 2019  
**Time:** 2038 GMT (1038 HST)  
**Airplane:** Cessna 208B Caravan, N879MA  
**NTSB Number:** ANC19LA046

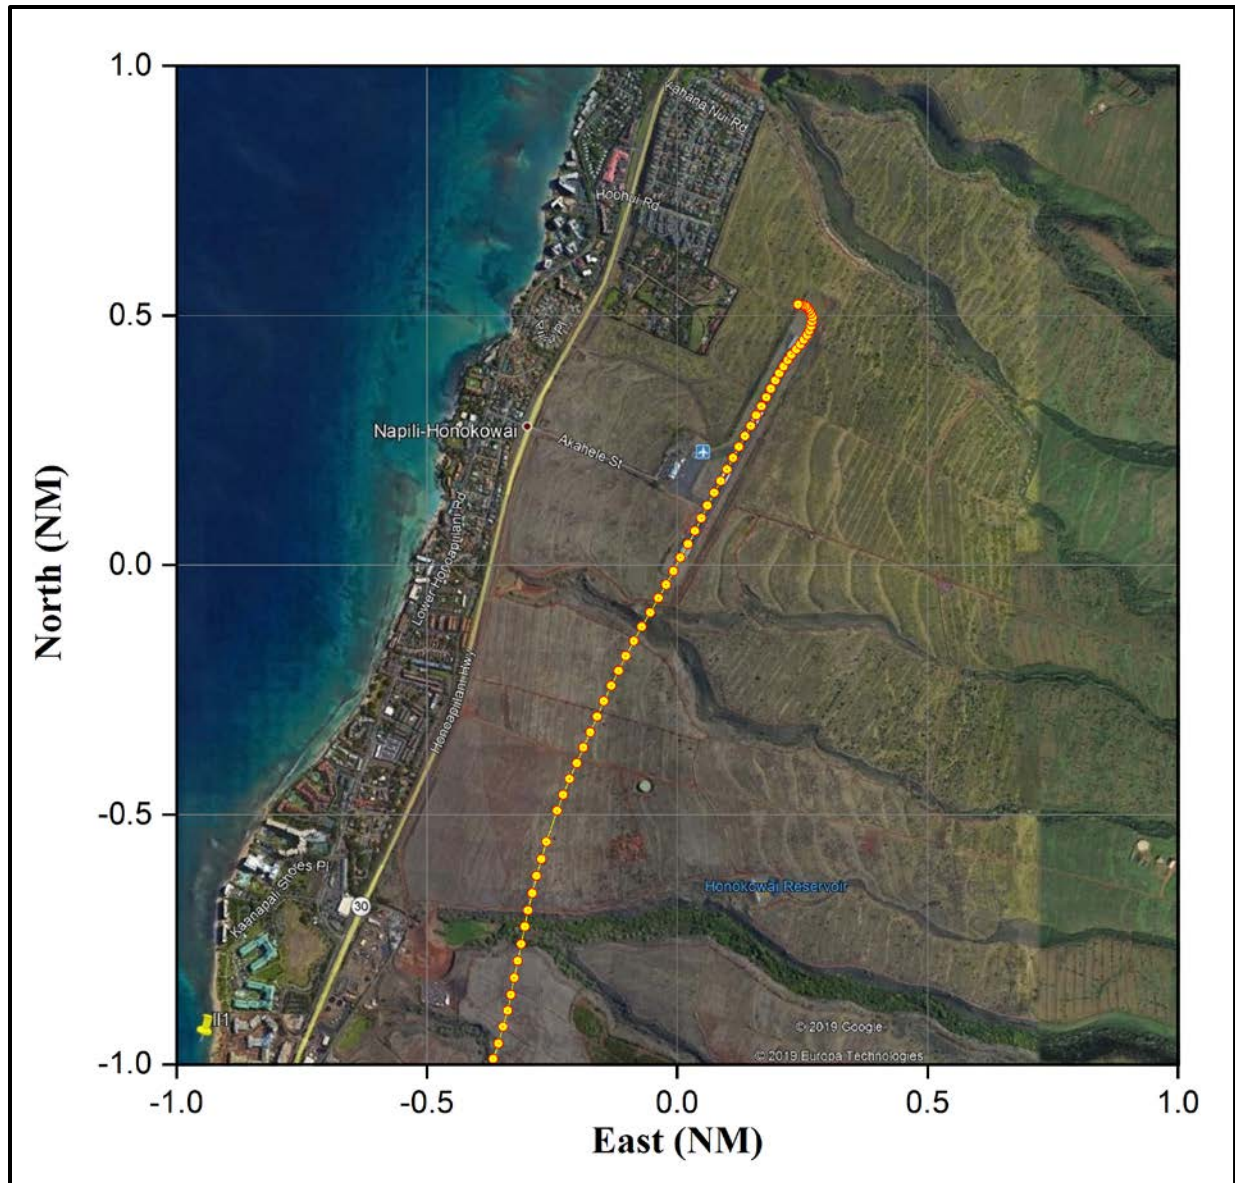
The runway markings, including the runway threshold, are shown in Figure 4. Figures 5 and 6 show the airplane's ground track recorded on the G1000 during the approach to Kapalua airport's runway 2 as well as the final off-runway resting place of the airplane. A rear view of the airplane in a ditch is shown in Figure 7.

Figure 5: Kapalua Airport with Ground Track Recorded on Recovered G1000

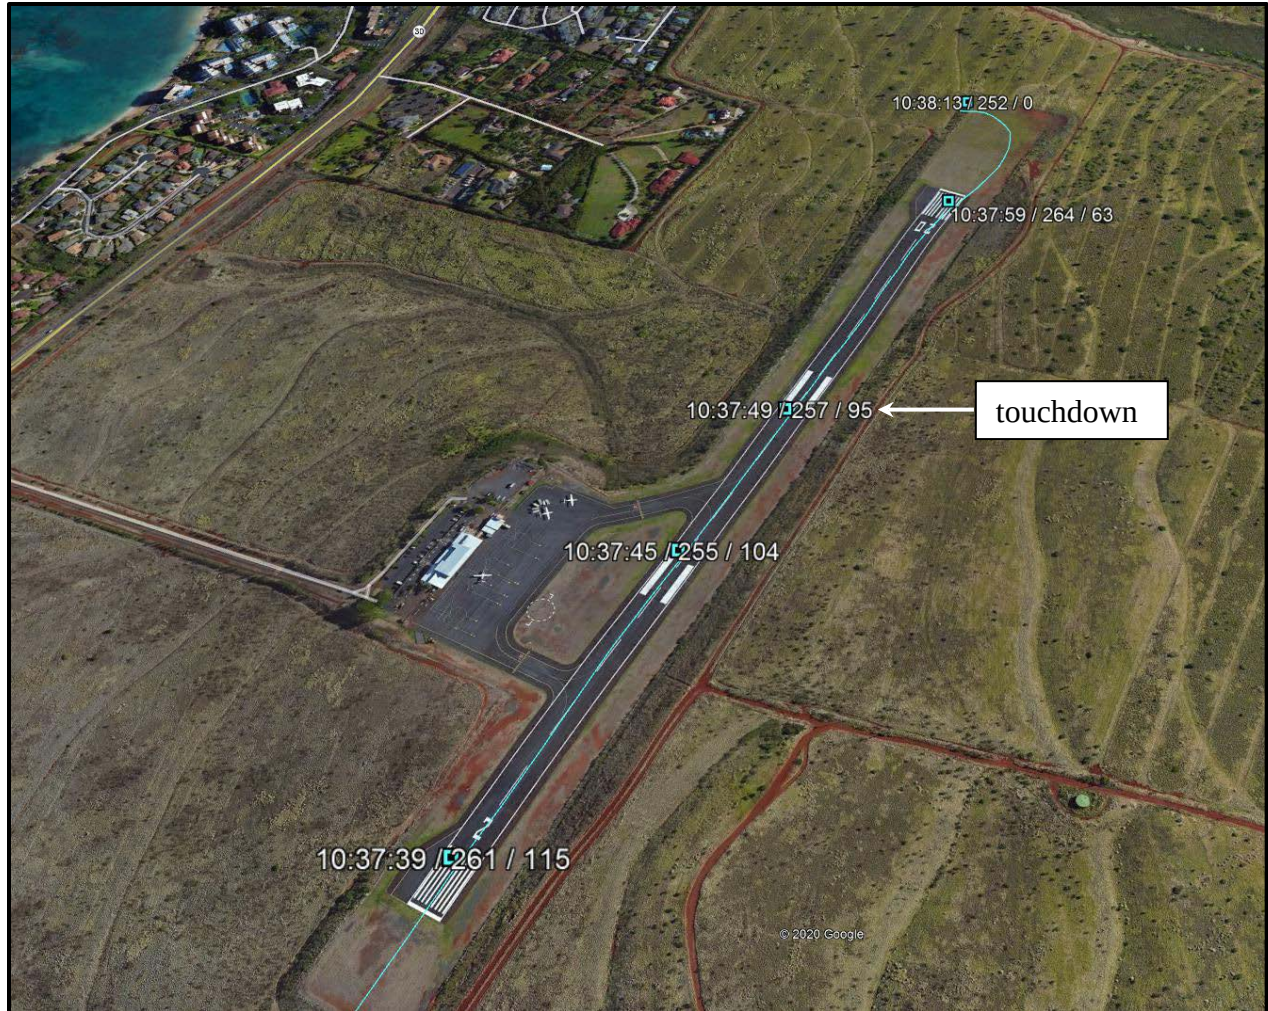
The normal acceleration<sup>4</sup> recorded on the G1000 is shown in Figure 11. The touchdown point could not be determined by normal acceleration alone. However, position, airspeed, engine torque<sup>5</sup>, and airplane pitch data shown in Figures 6, 10, 12, and 13, respectively, suggest that the airplane touched down between 1037:45 and 1037:49 HST. The airplane was approximately two thirds down the 3,000 ft runway at touchdown.

**Figure 6: HJH with Time (HST) /Altitude (ft) / Indicated Airspeed (kt) Recorded on G1000**  
**(Note: runway slopes up approximately 15 ft from runway 2 threshold to runway 20.)**

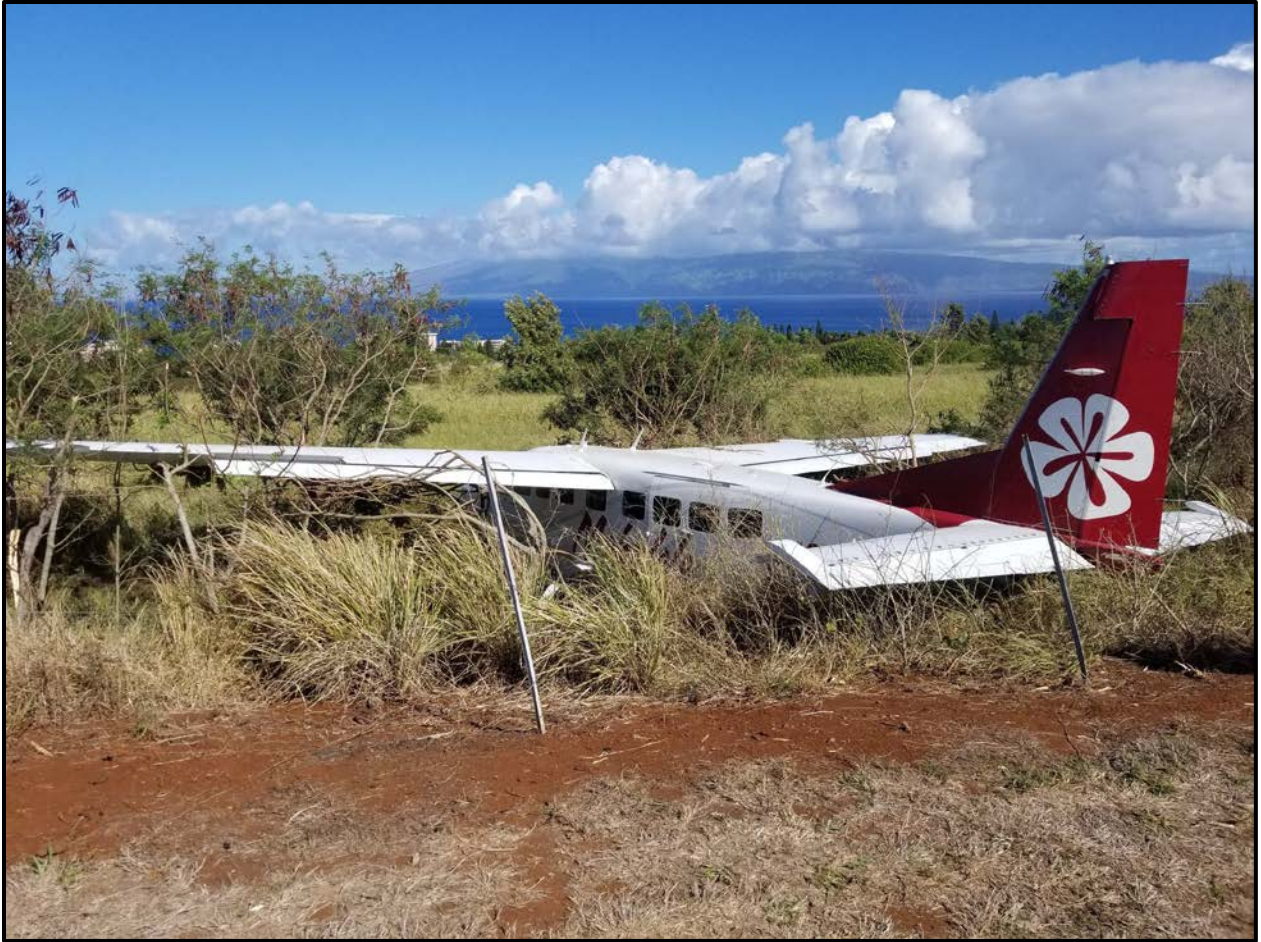
**Figure 7: Rear View of the Airplane in a Ditch (Photo courtesy of the operator.)**

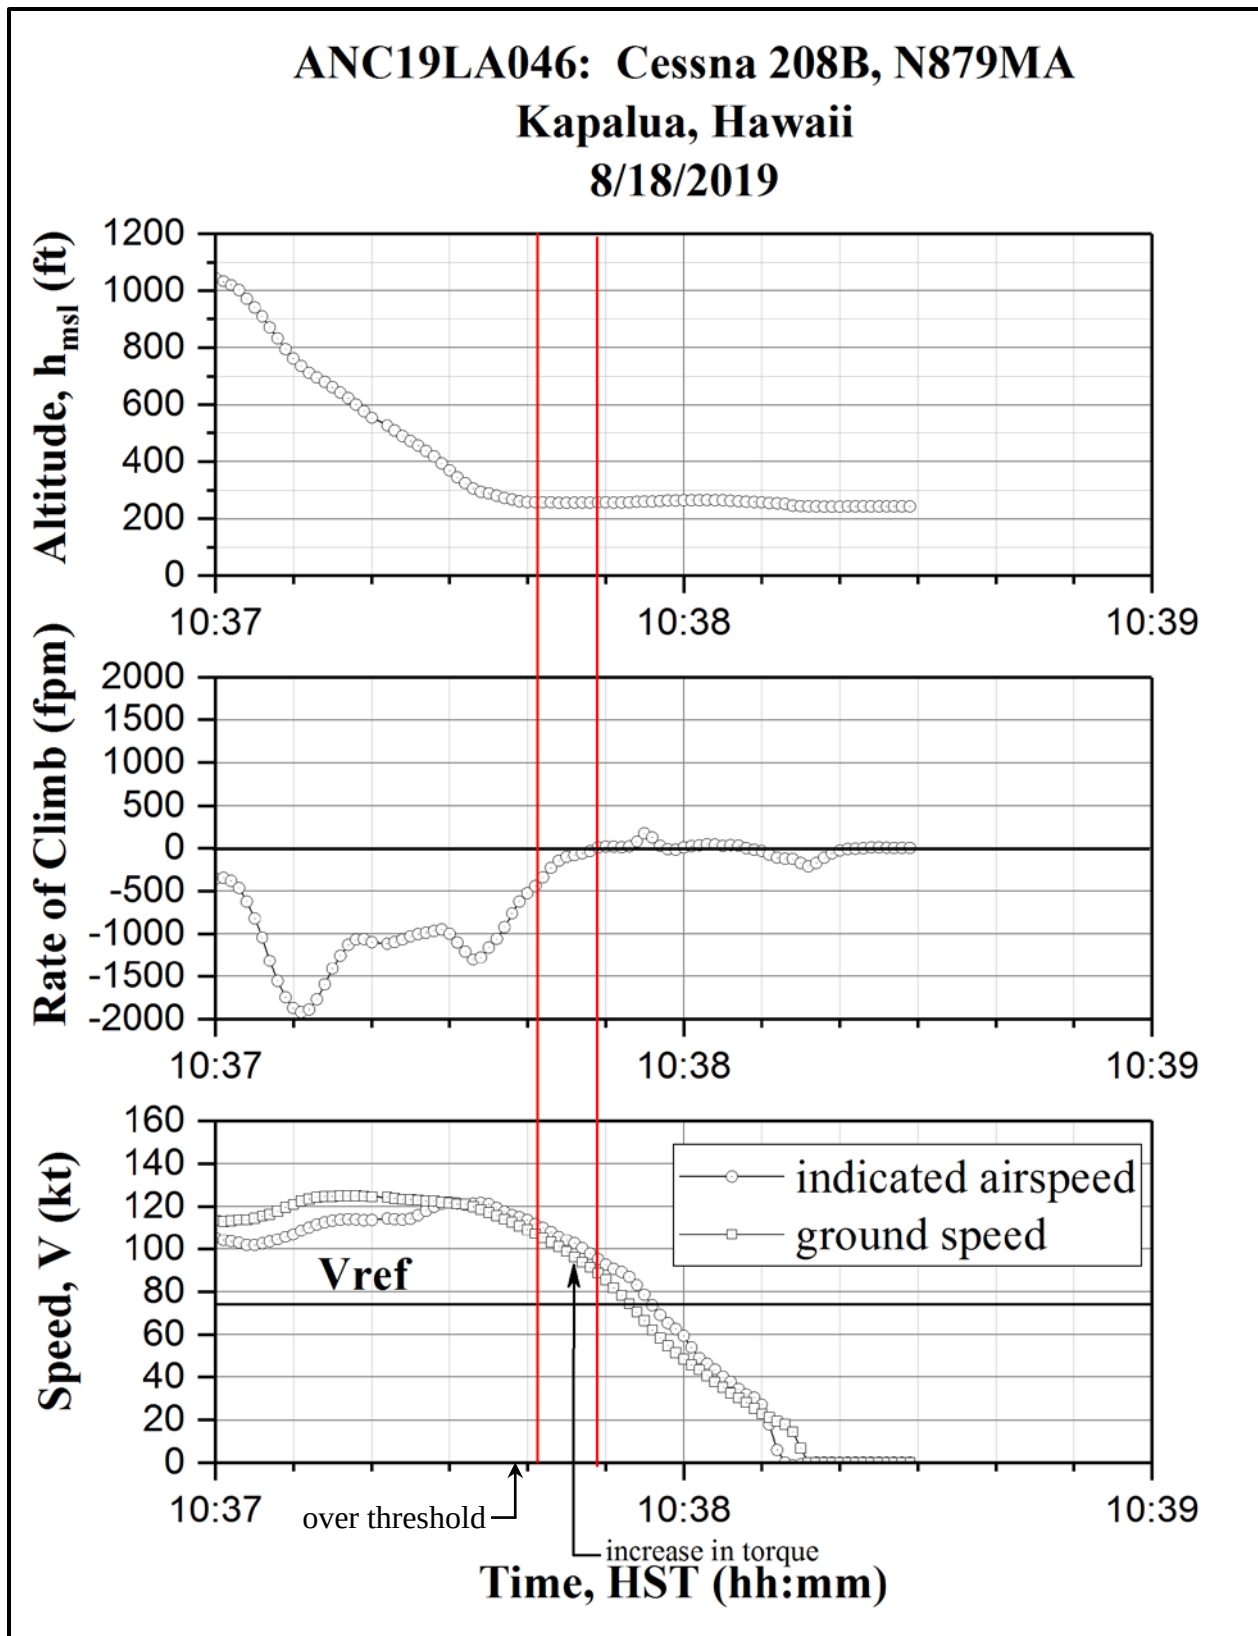
Figure 10 highlights the final two minutes of the flight and shows that the indicated airspeed was approximately 115 kt when the airplane was crossing over the runway threshold<sup>2</sup> at 1037:39. The touchdown "window" is shown by the vertical red lines<sup>3</sup>.

The crew of Mokulele airlines flight 504 crossed the runway 2 threshold at Kapalua airport at about 115 kt, between 25 and 30 kt faster than current company guidance. The airplane touched down about 2,000 ft down the runway before overrunning the end of the 3,000 ft runway. Landing performance data from the airplane manufacturer indicate that there was not enough runway remaining to stop the airplane.

Figure 10: Altitude and Speed for Final Two Minutes with Touchdown Estimate

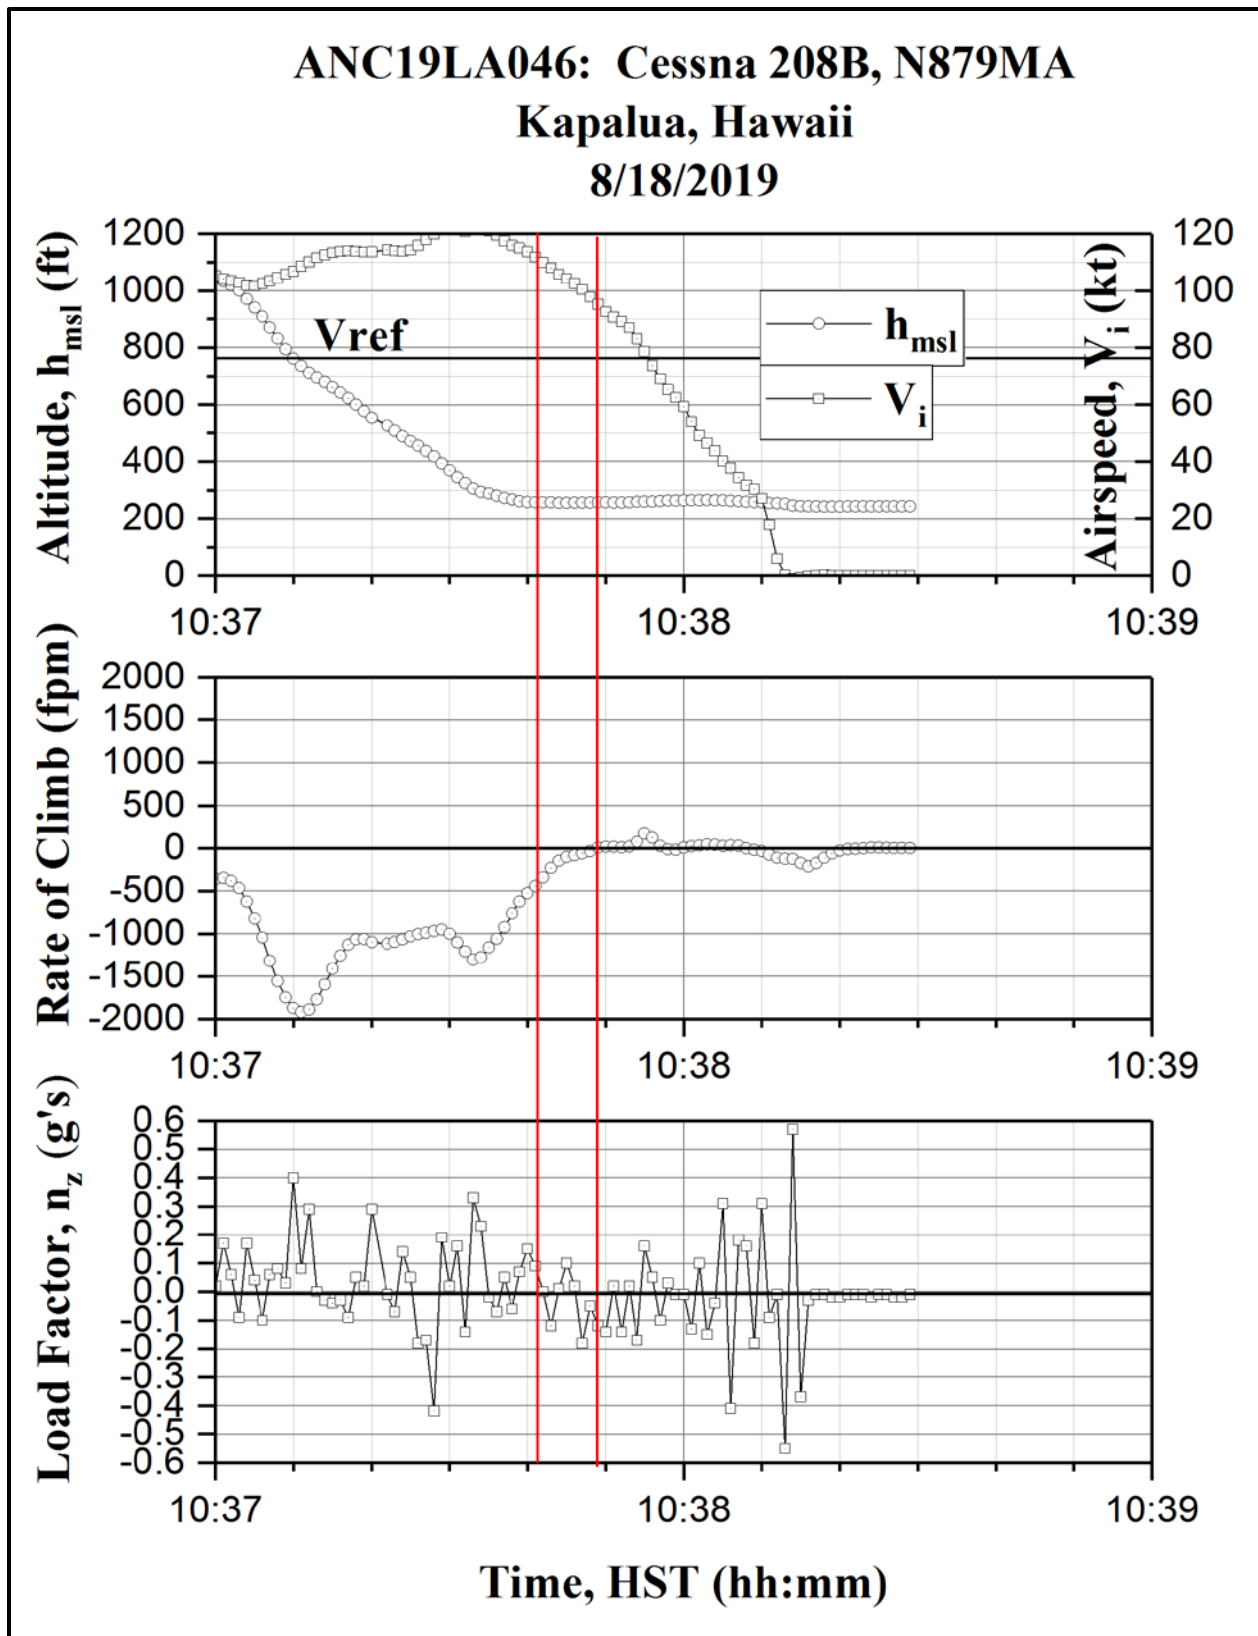
Figure 11: Altitude and Load Factor for Final Two Minutes with Touchdown Estimate

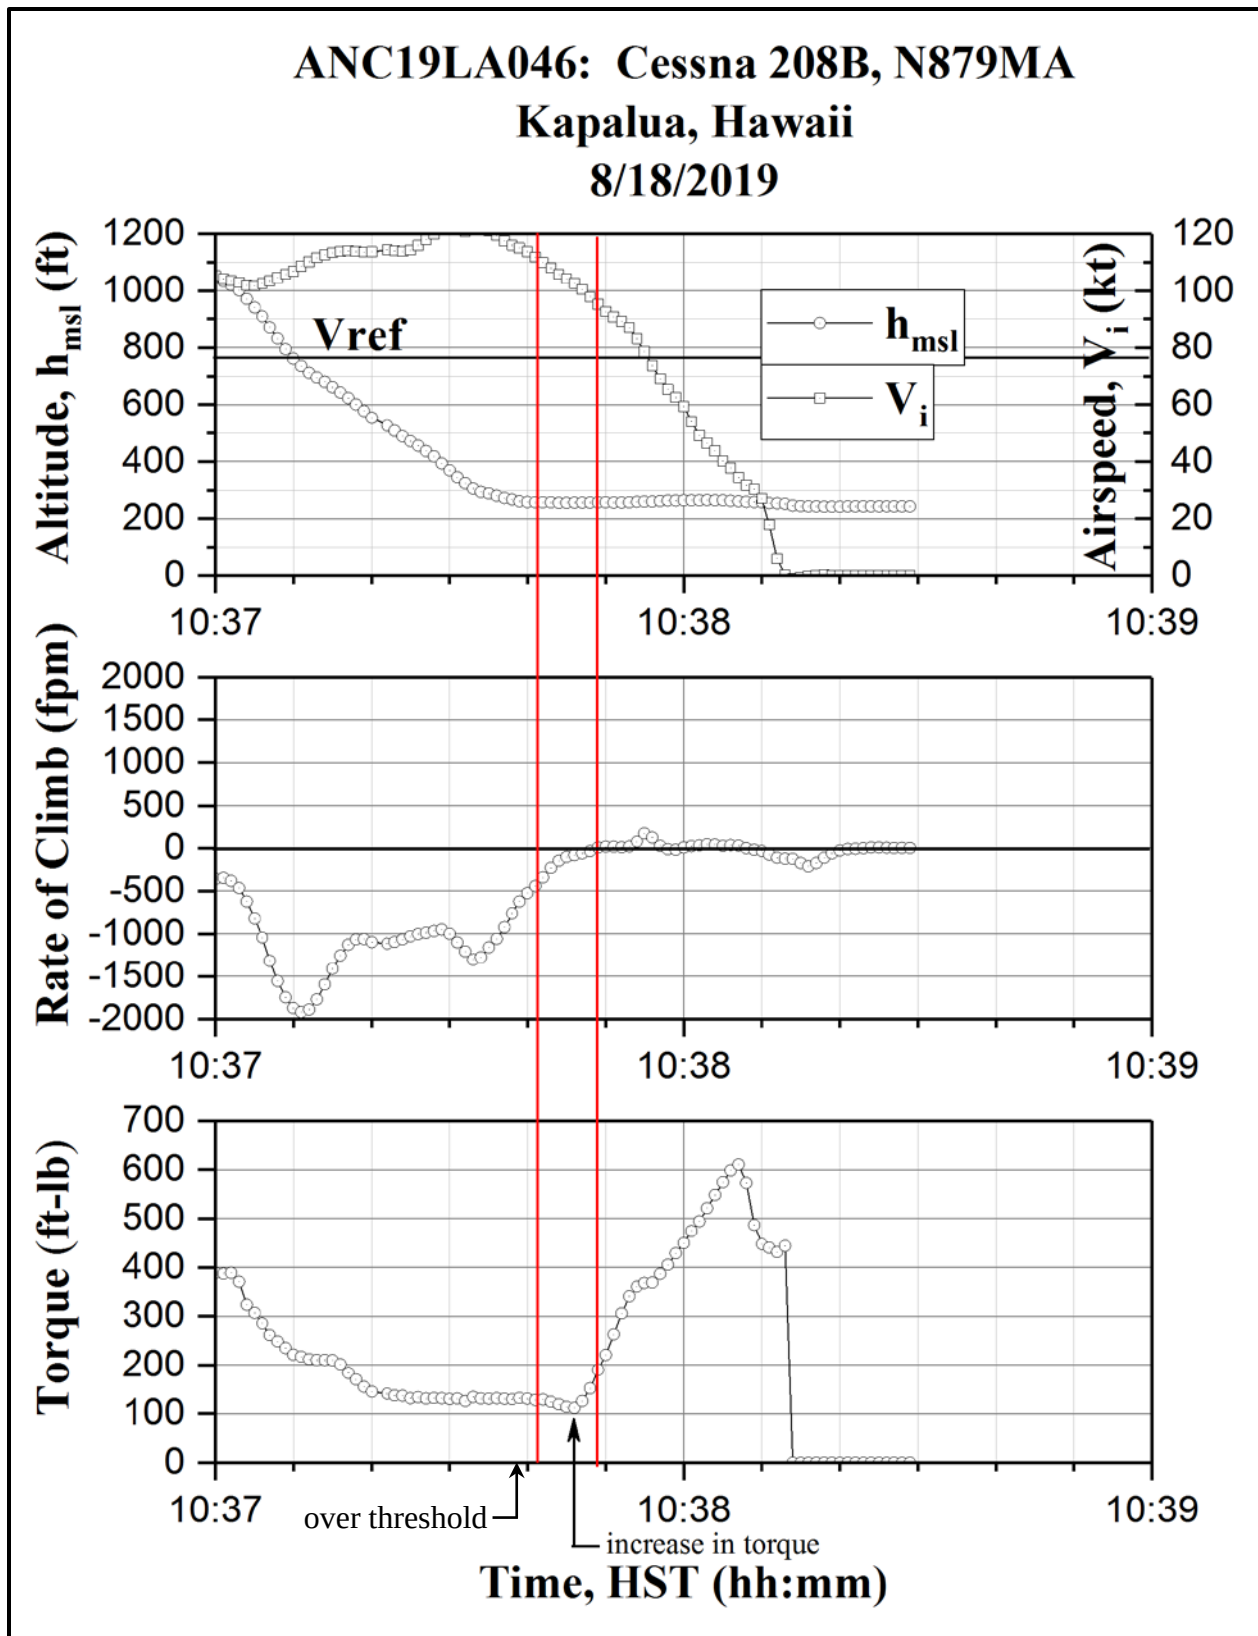
Recorded engine data show that engine torque increased around the time of touchdown; however, propeller blade angle is not recorded. As a result, the position of the propeller could not be determined, e.g., below effective thrust angle or “BETA” mode<sup>7</sup>.

Figure 12: Altitude and Engine Torque for Final Two Minutes with Touchdown Estimate

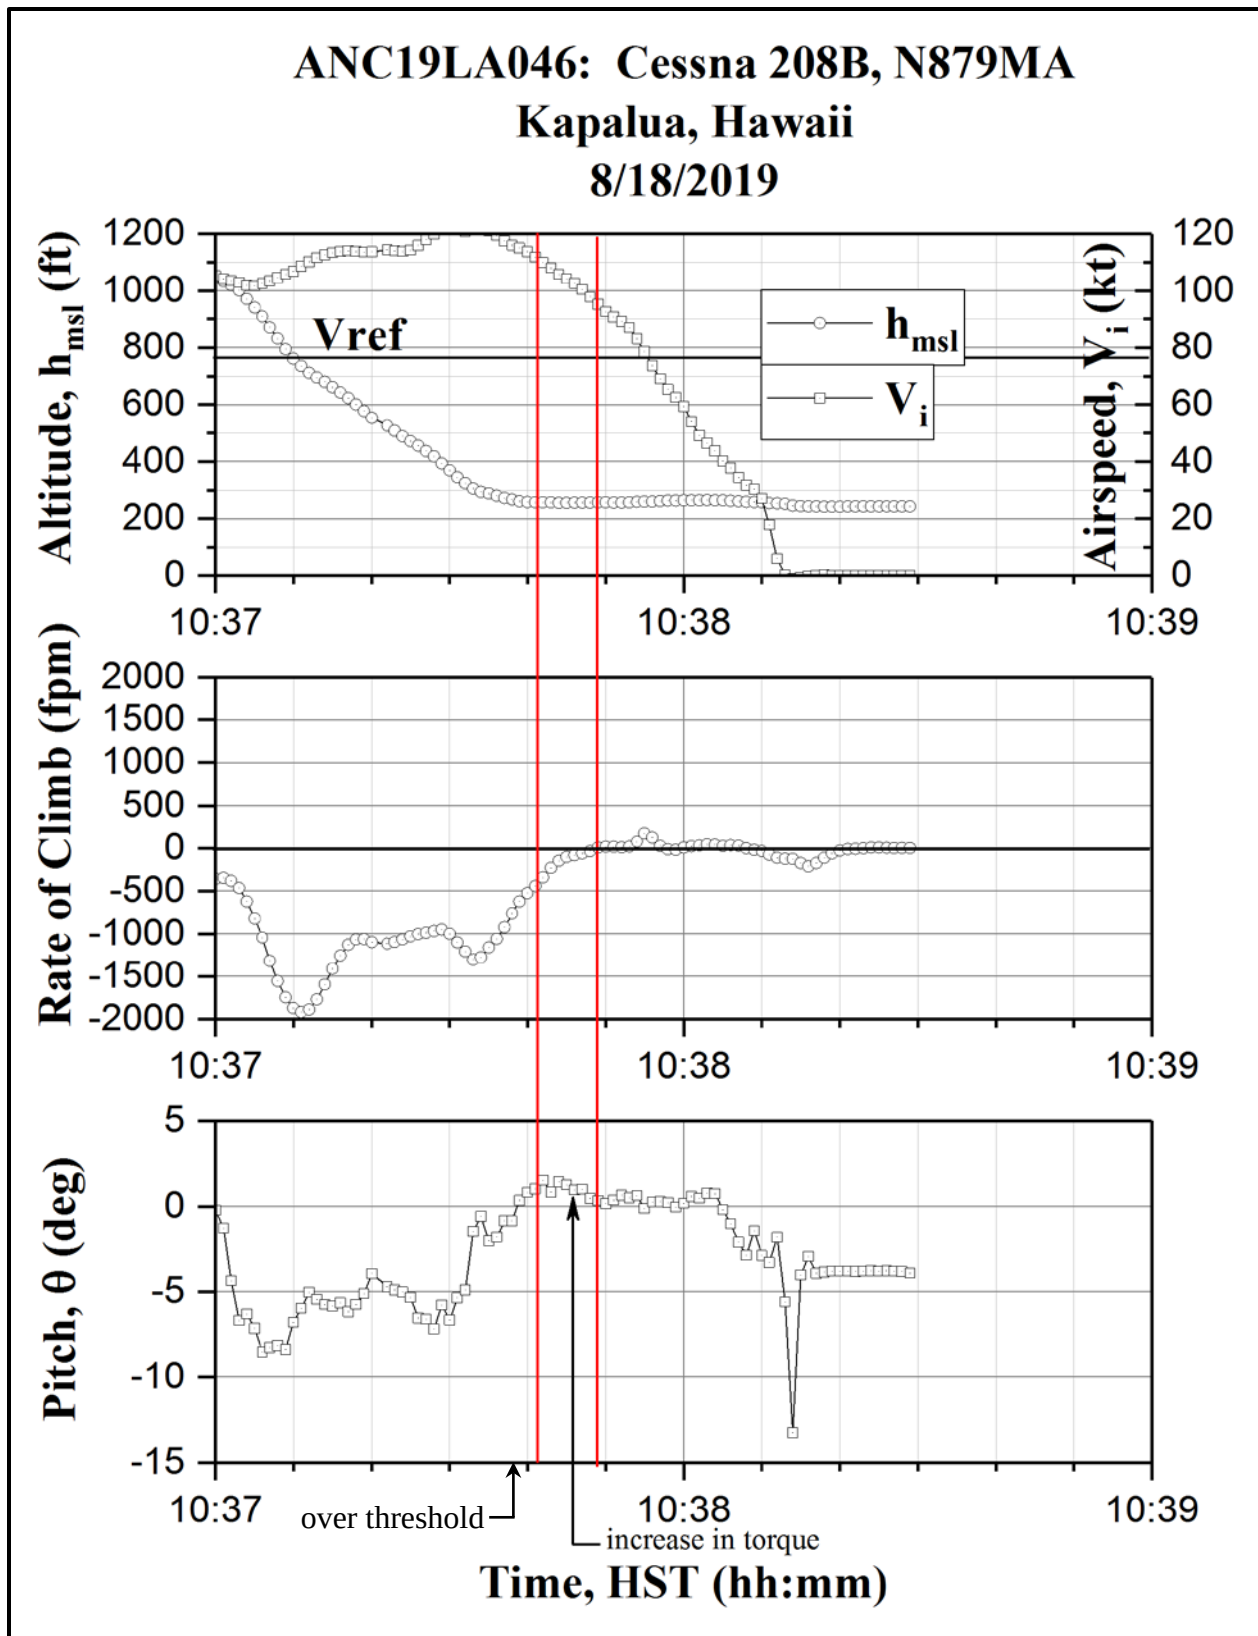
Figure 13: Altitude and Pitch for Final Two Minutes with Touchdown Estimate
