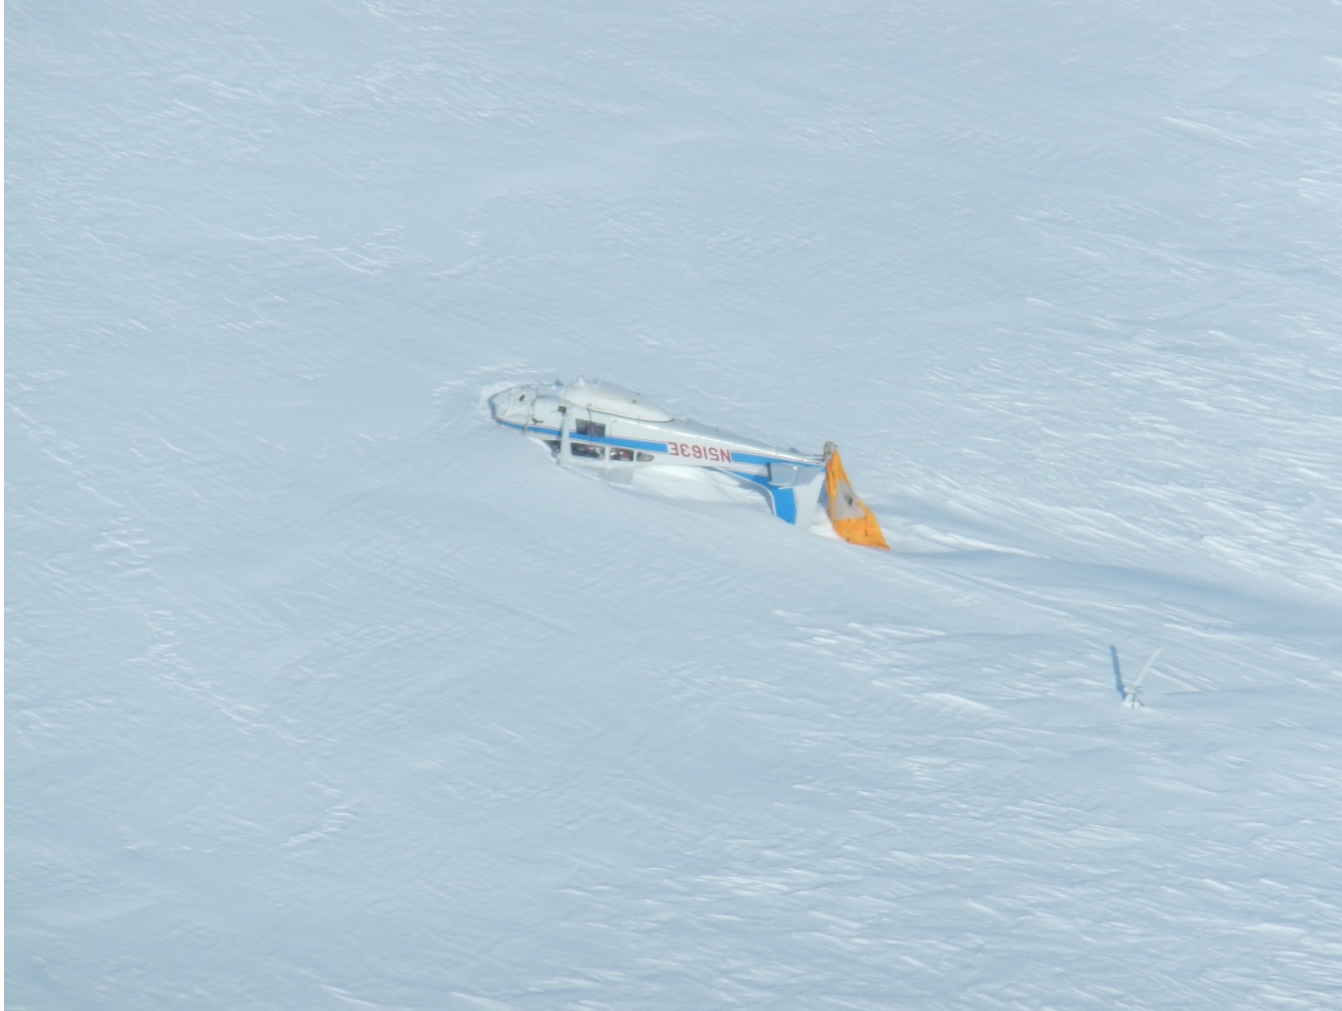
**Photo 1 –Aerial photograph of N5163E Cessna 185 inverted fuselage in deep snow at the accident site.  
(Source: Department of Interior (DOI))**

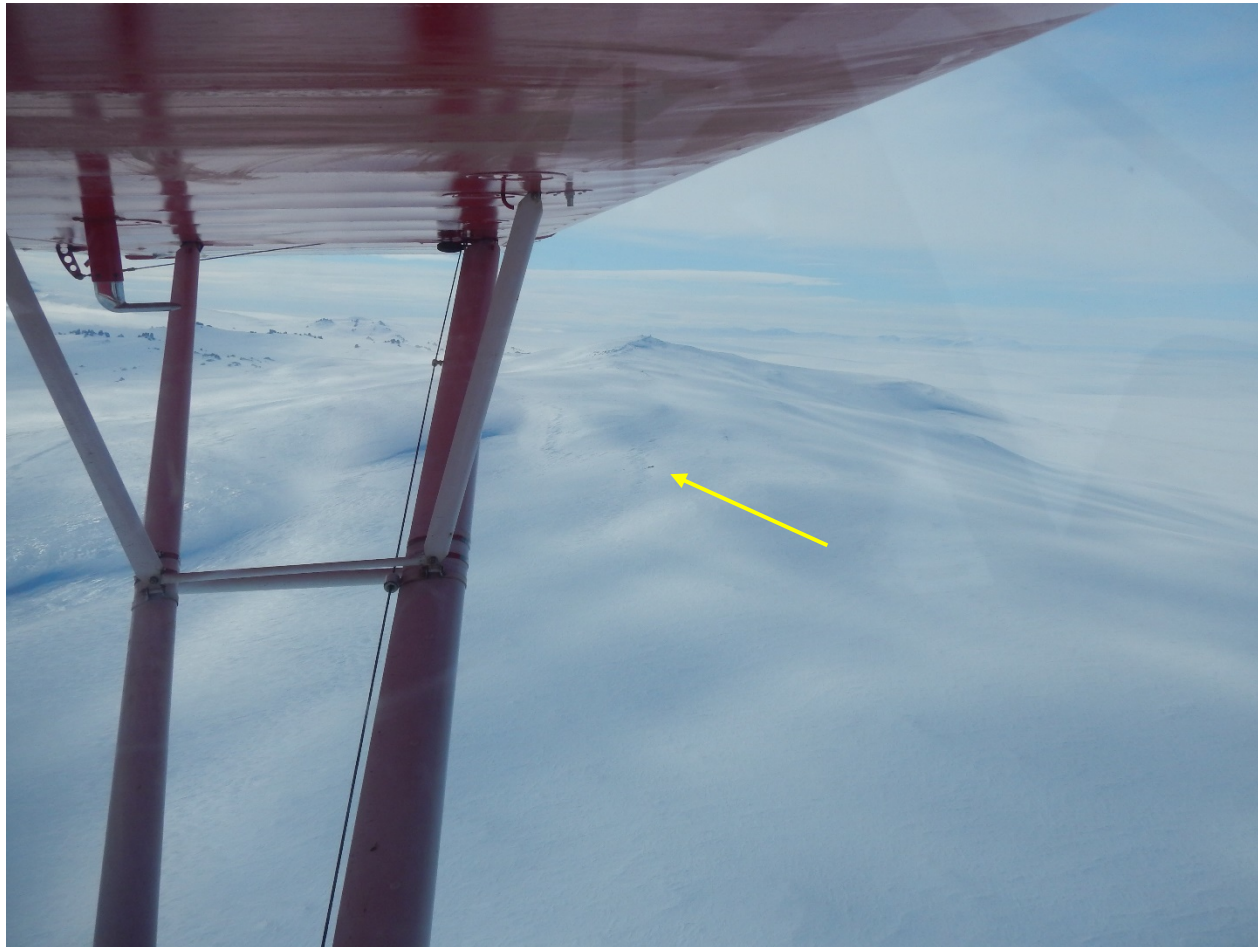
**Photo 2 - Distant aerial photograph of the wreckage at the scene of the accident. (Source: DOI)**

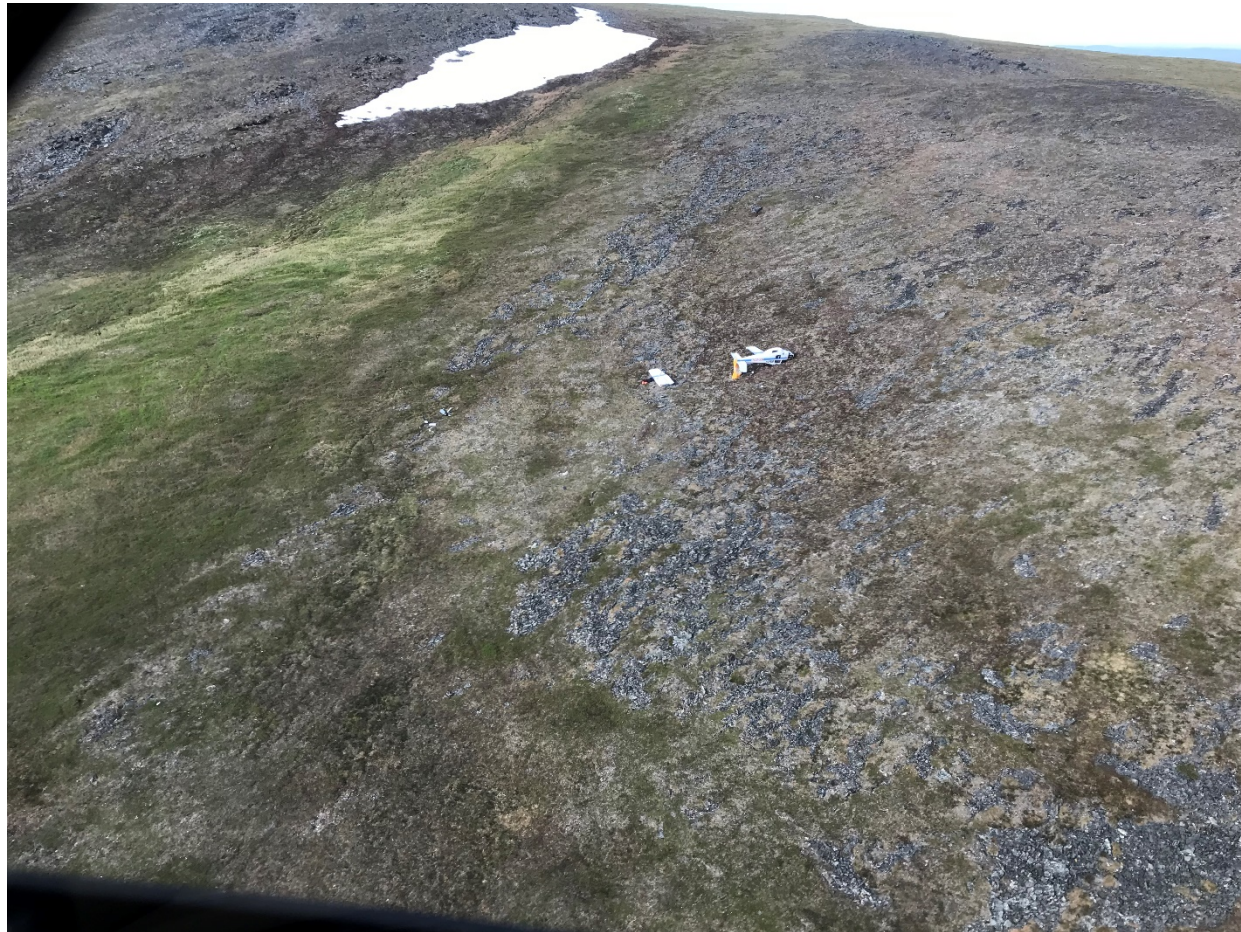
**Photo 3 - Aerial photograph of the main wreckage and separated left wing about two months after the accident.  
(Source: DOI)**

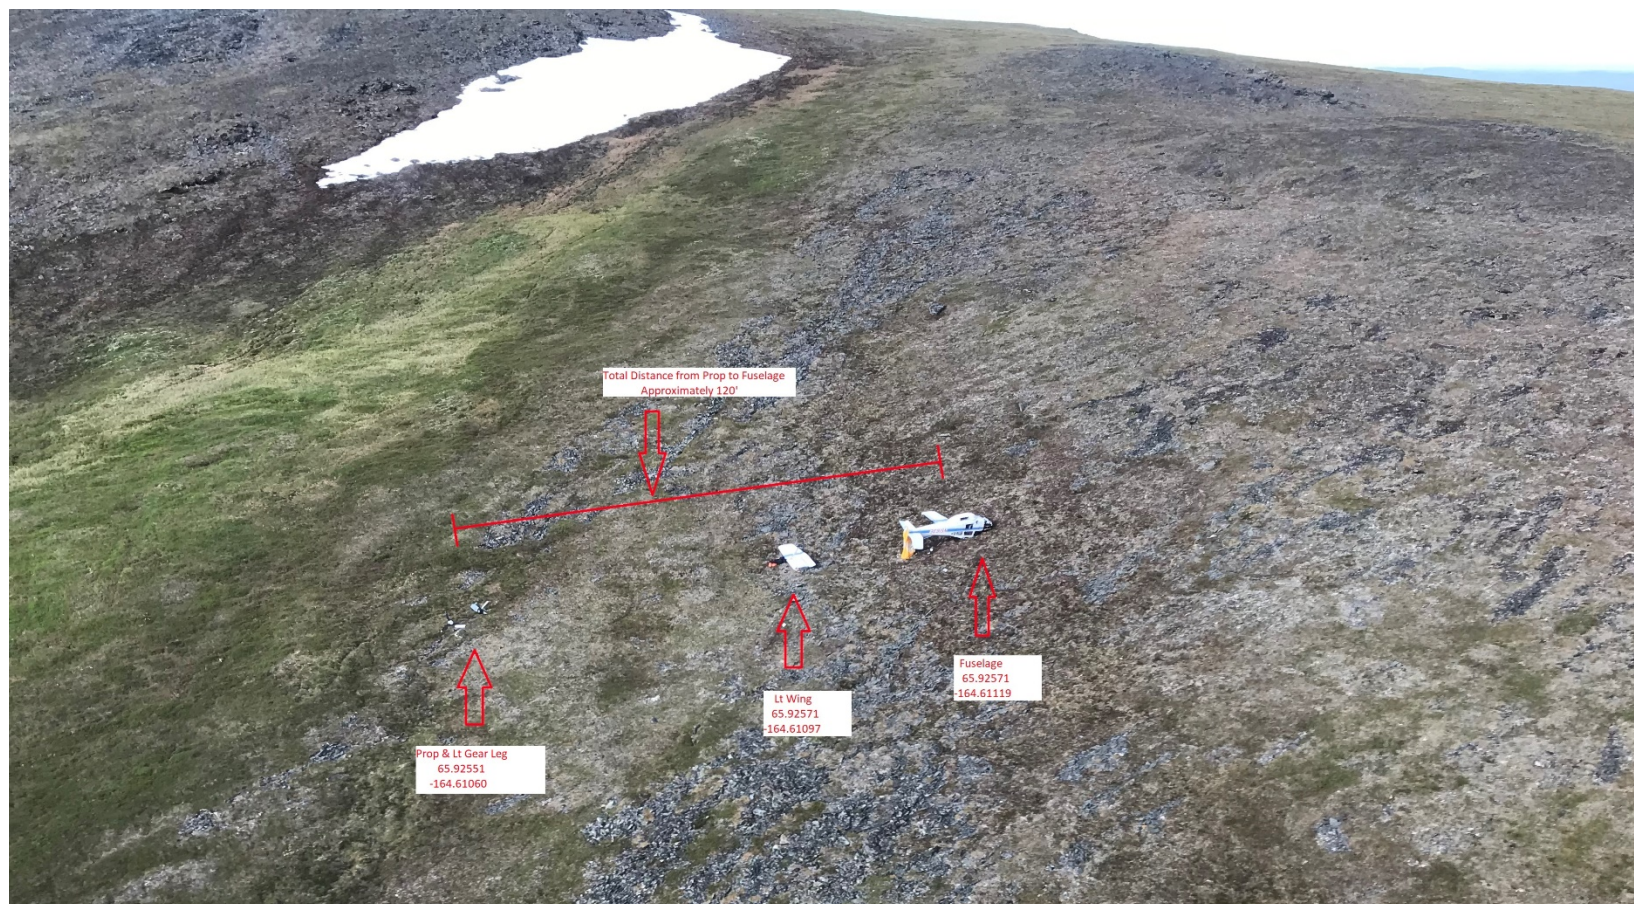
**Photo 4. - Wreckage at the accident site after the snow melted and before recovery showing the propeller and left landing gear, the left wing, and fuselage. (Source: DOI)**

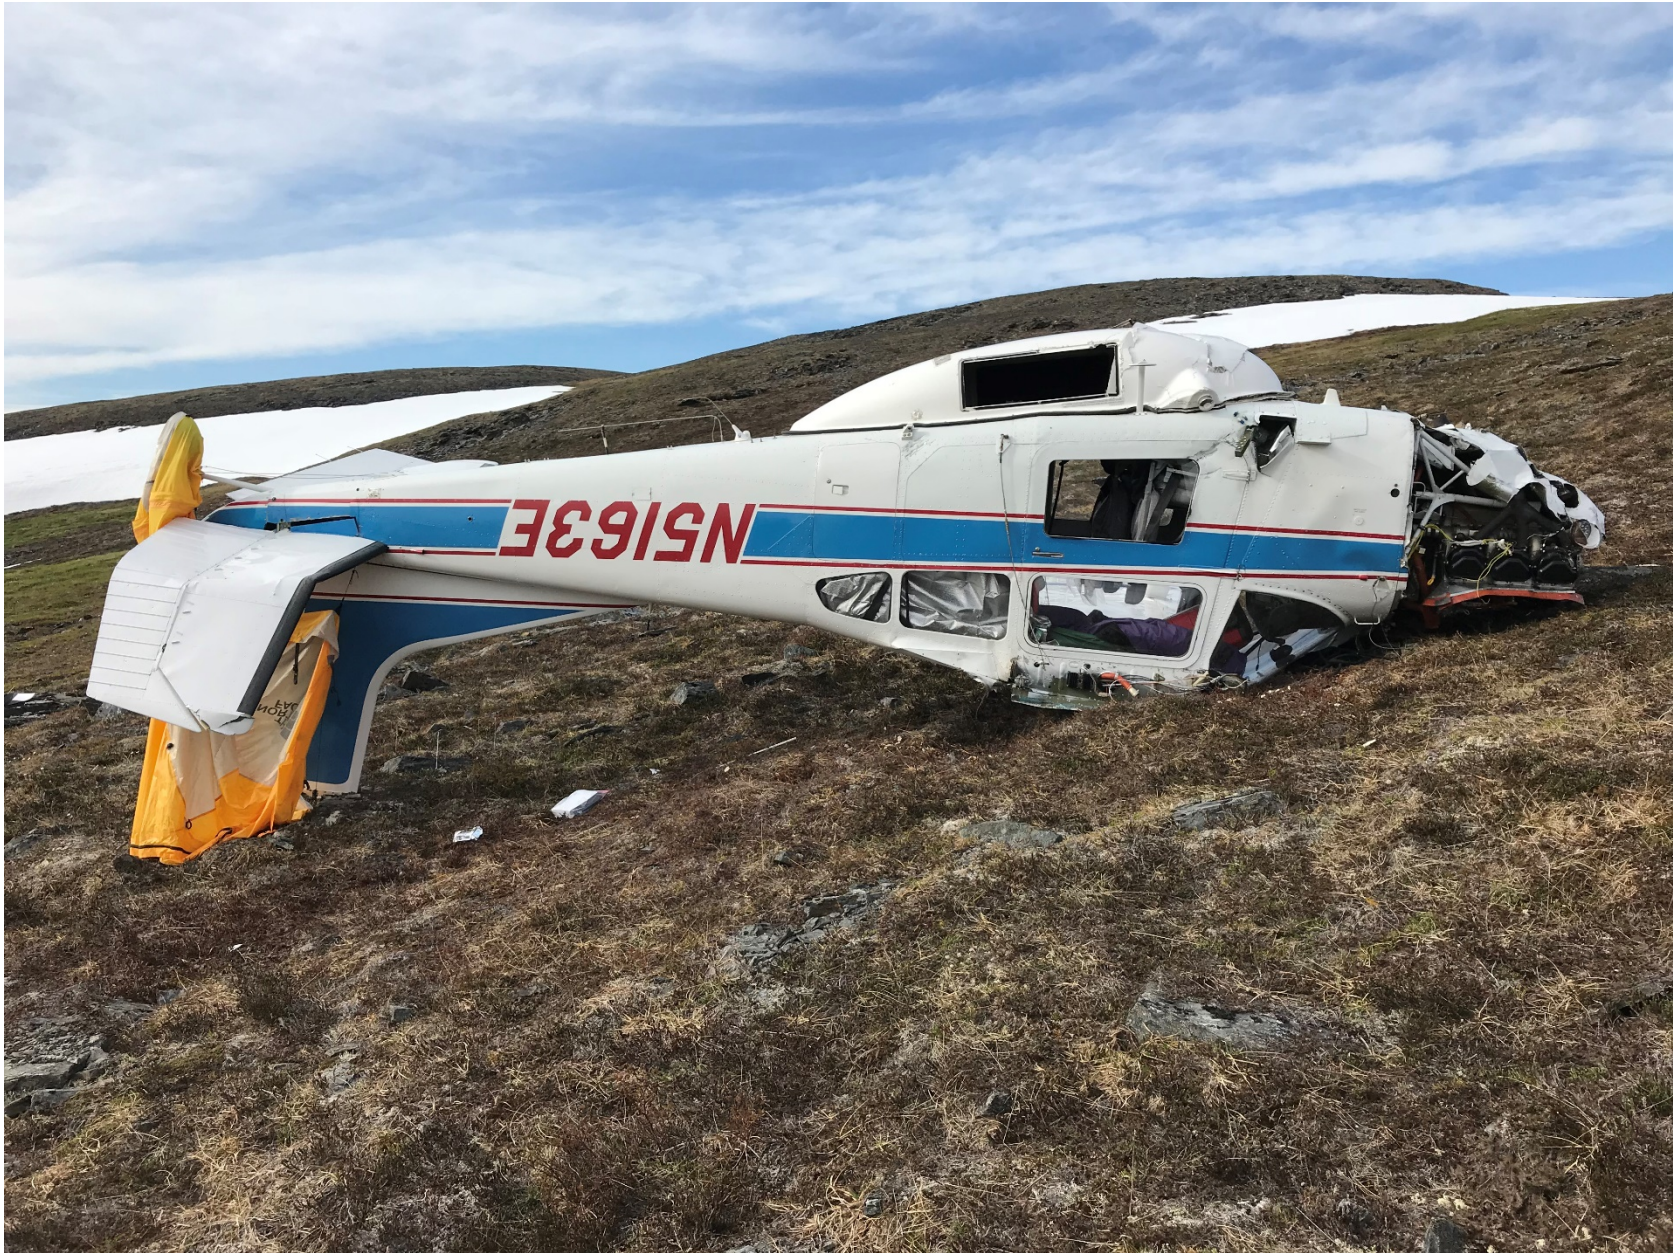
**Photo 5 - Inverted fuselage wreckage. (Source: DOI)**

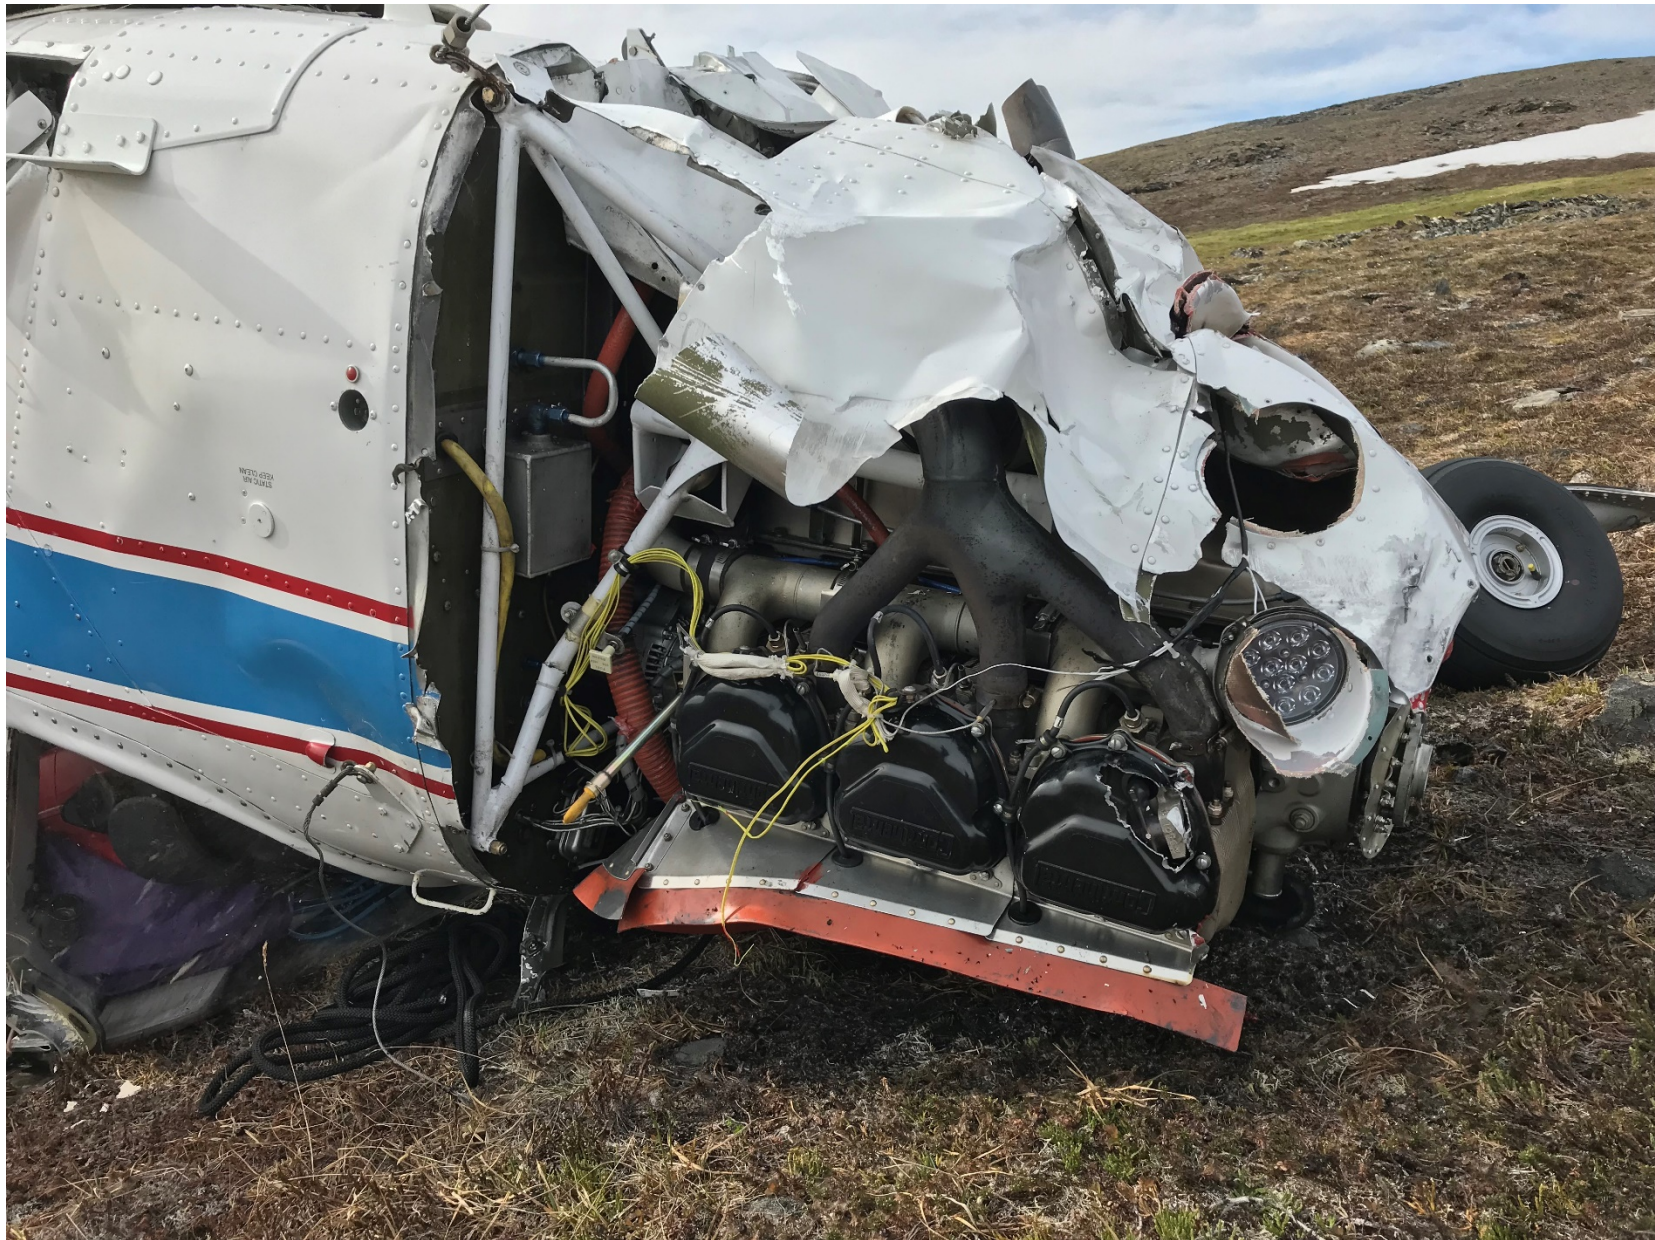
**Photo 6 - Left side of engine area. (Source: DOI)**

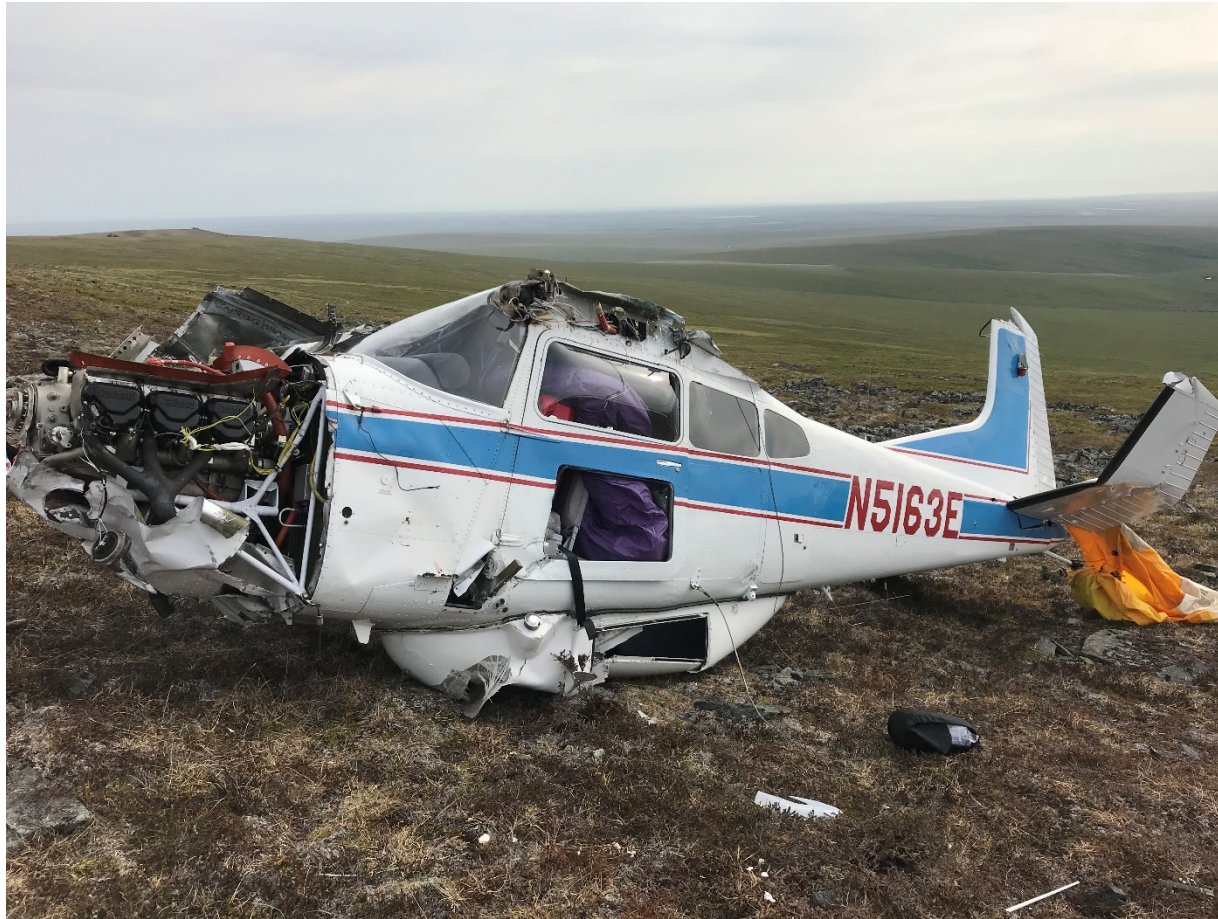
**Photo 7 - Upright fuselage during recovery efforts. (Source: DOI)**
