### **Wreckage Examination Summary**

NTSB ACCIDENT NUMBER: ANC20FA017

AIRCRAFT REGISTRATION/AIRCRAFT TYPE: N7632C, Piper PA-32R  
ACCIDENT LOCATION: Tuntutuliak, Alaska

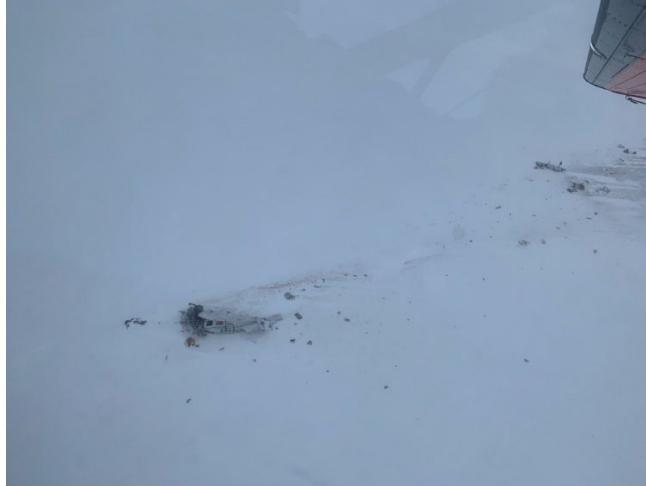
Initial aerial photo of accident scene.  
Courtesy Alaska Department of Safety.

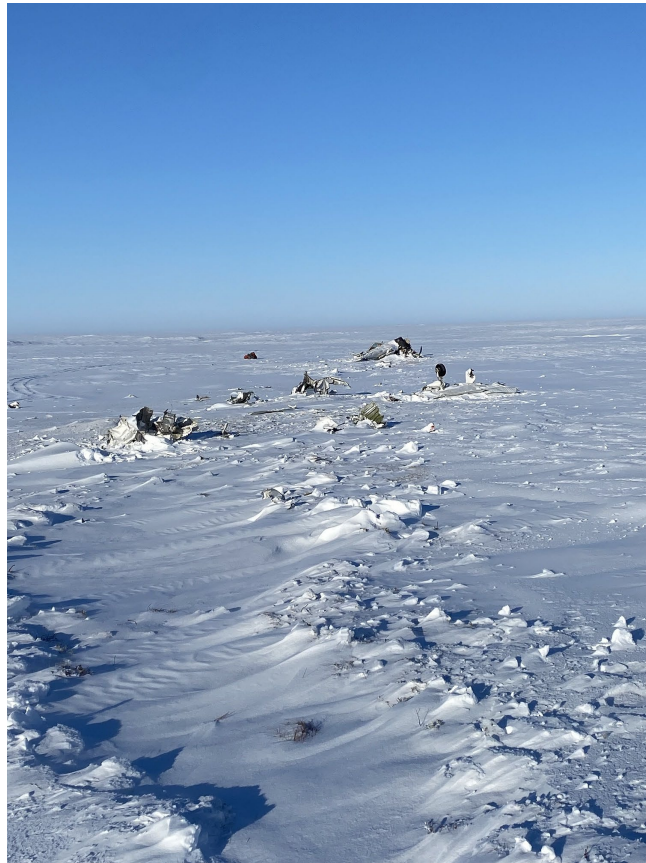
Initial on scene photo of accident site.

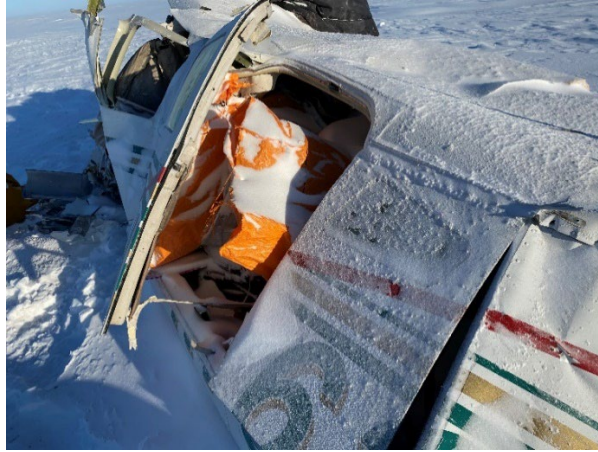
Fuselage exhibited extensive impact damage. The forward cabin and cockpit, forward baggage area, and engine remained connected, but all sustained significant impact damage. The forward cabin roof was impact separated from the cabin at the tops of the window frames, and the windows were shattered. The forward cabin door was impact separated and fragmented. The nose baggage door was impact separated from the baggage compartment. The nose gear remained mounted to the engine mount and appeared to be in the retracted position. The aft cabin doors remained attached to their respective door frames. The main wing spar carry through was fragmented through the spar webs.

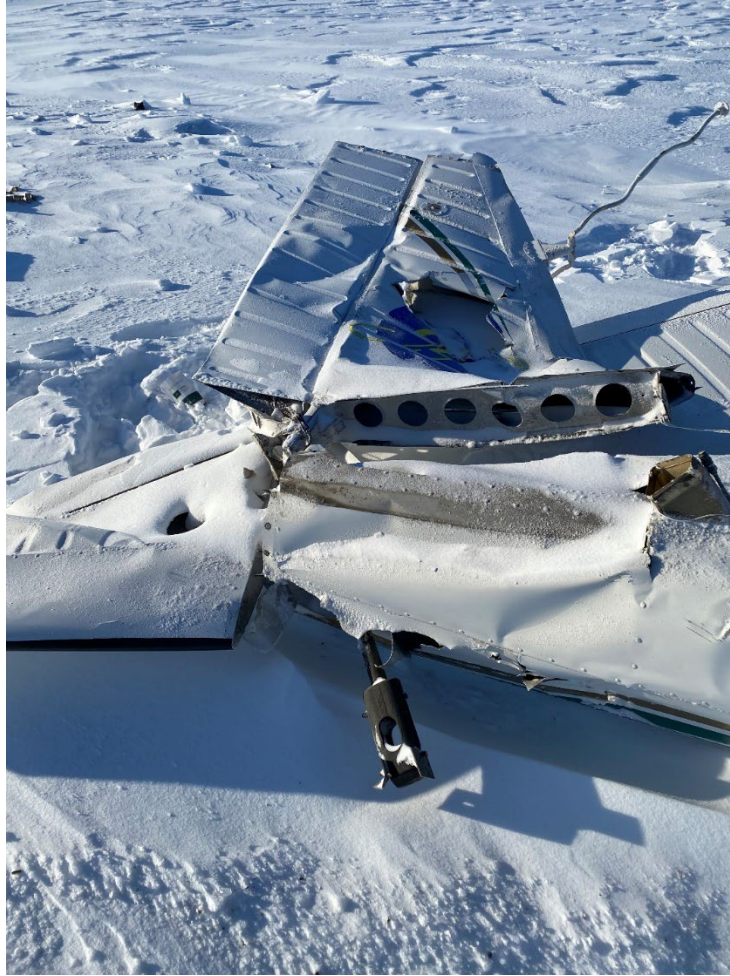
The empennage was buckled and crushed. The ELT bracket remained mounted within the empennage interior.

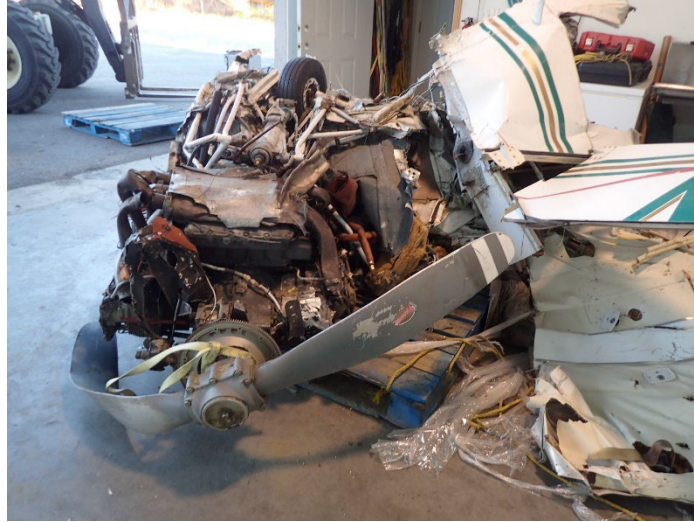
The engine sustained extensive impact to the underside, and front portion of the engine. The exhaust tubes were extensively crushed, bent, and folded, producing sharp creases that were not cracked or broken along the creases. The engine remained attached to the crushed engine mount. Additional impact damage was observed to the oil sump and #2-cylinder head. The fuel servo was impact separated from the engine. The dual magneto, vacuum pump, and propeller governor remained mounted to their respective mounting pads and appeared undamaged.

The propeller remained mounted to the engine. The dome was impact separated. One propeller blade was bent aft about 90° and was twisted. The other propeller blade was bent aft about 30° and twisted.

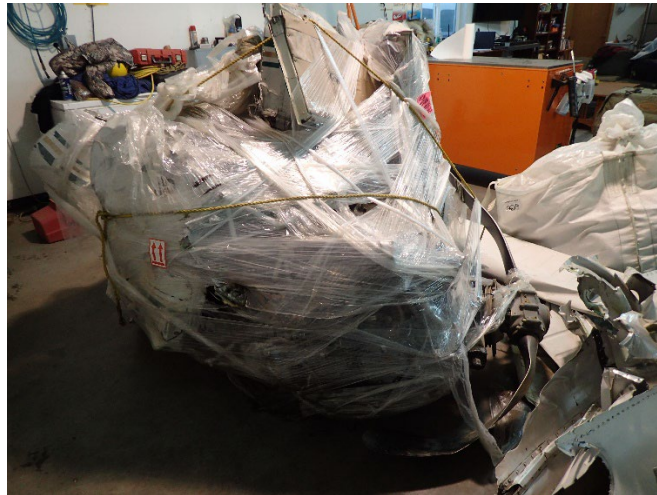
- Photo of wreckage as received in Wasilla, Alaska

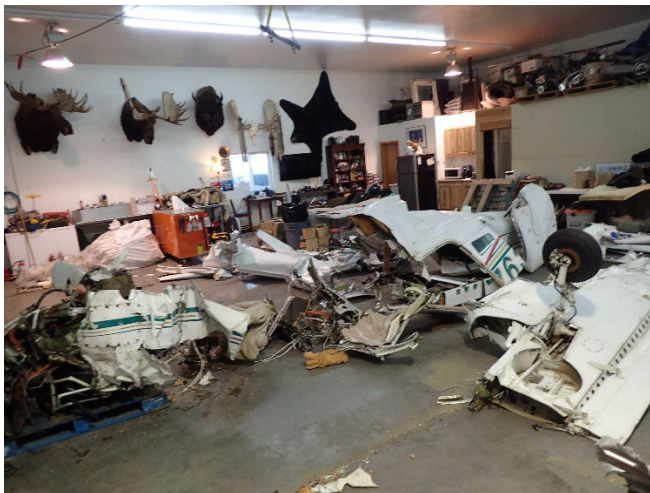
- Photo of wreckage after unpackaging

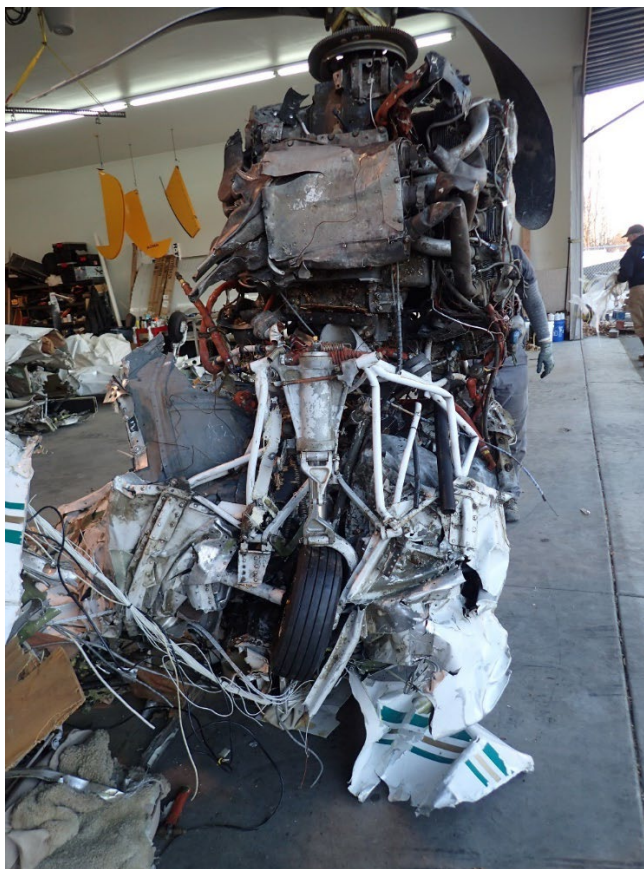
- Engine assembly, firewall, nose landing gear, and portion of cockpit area

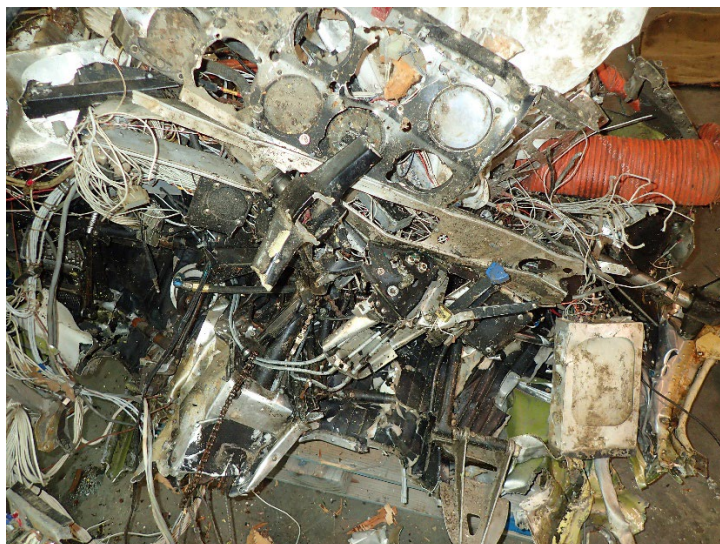
The instrument panel was impact damaged, and many instruments had impact separated. The engine control levers were impact damaged; the throttle was noted in the mid-travel position, and the propeller and mixture levers were fully forward. The alternate air lever was in the off position. The magneto switch was impact damaged. The key remained in the magneto switch, but damage precluded determination of its position.

- Cockpit and instrument panel

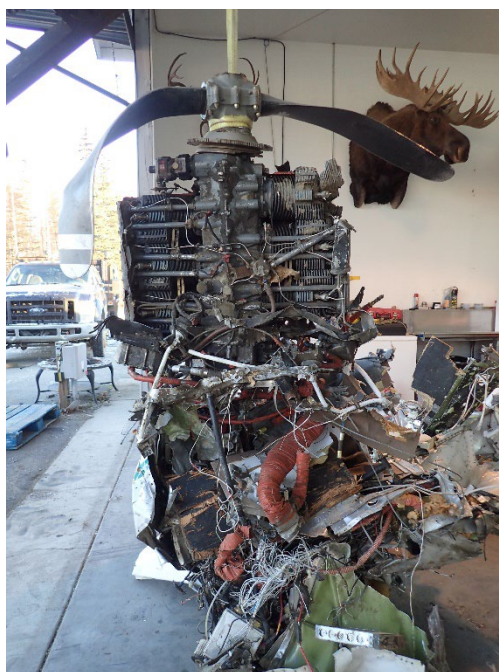
- Engine and Propeller

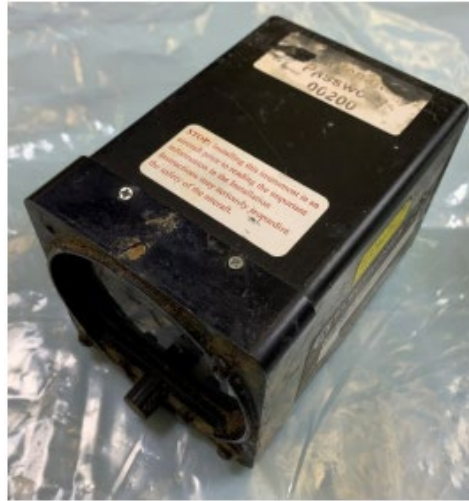
**Engine Data Monitor**

An Electronics International CGR-30P engine data monitor unit, S/N: 157626, was recovered and sent to the NTSB's Vehicle Recorder Division for download (see Engine Monitoring Device - Specialist Factual Report located in the docket for this accident).
