# NATIONAL TRANSPORTATION SAFETY BOARD

## MATERIALS LABORATORY FACTUAL REPORT

Report No. 20-037

Place : Mokuleia, Hawaii  
Date : February 22, 2020  
Vehicle : Cessna Ector 305A, N65070  
NTSB No. : ANC20FA024  
Investigator : Noreen Price, AS-ANC

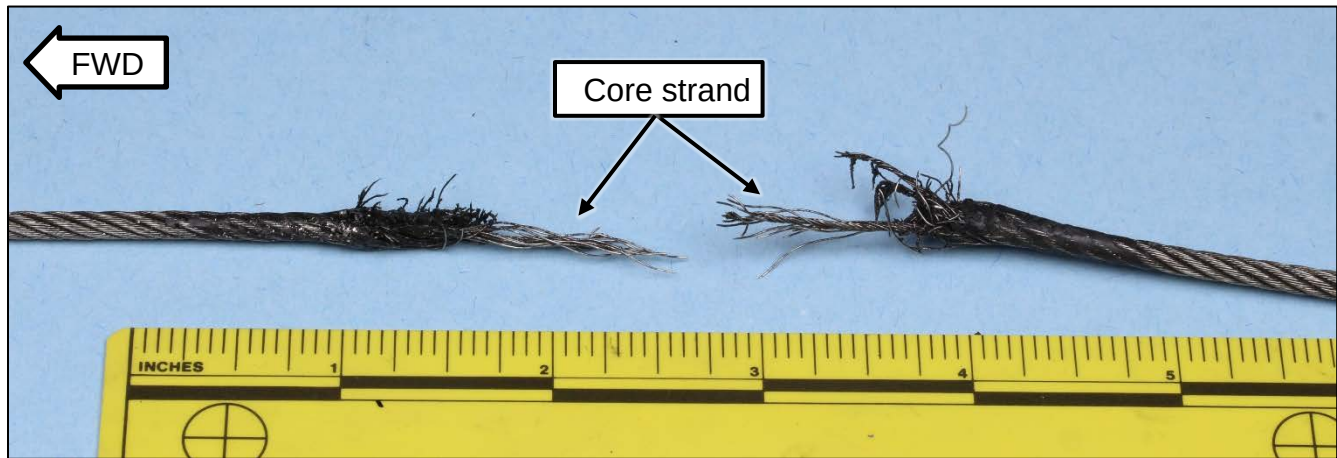
A close view of the fractured ends of the rudder control cable is shown in figure 2, and closer views of each end of the fracture are shown in figure 3. On the forward piece, 17 wires from the core strand extended approximately  $\frac{1}{2}$  to 1 inch beyond the rest of the wires, and on the aft piece, 16 wires from the core strand extended approximately  $\frac{1}{2}$  to  $\frac{3}{4}$  inch beyond the rest of the wires. Many wires associated with the outer strands surrounding the core strand were bent back. However, the lengths of almost all of the wires in the bent outer strands were shorter than the remaining core strand on each side of the fracture, indicating that segments were missing from most of the wires from the outer strands in the area of the fracture.

Figure 2. Fractured ends of the submitted rudder cable pieces. The core strand extended approximately an inch beyond other strands on each side of the fracture, and most of the surrounding strand wires were bent back and covered in black deposits.

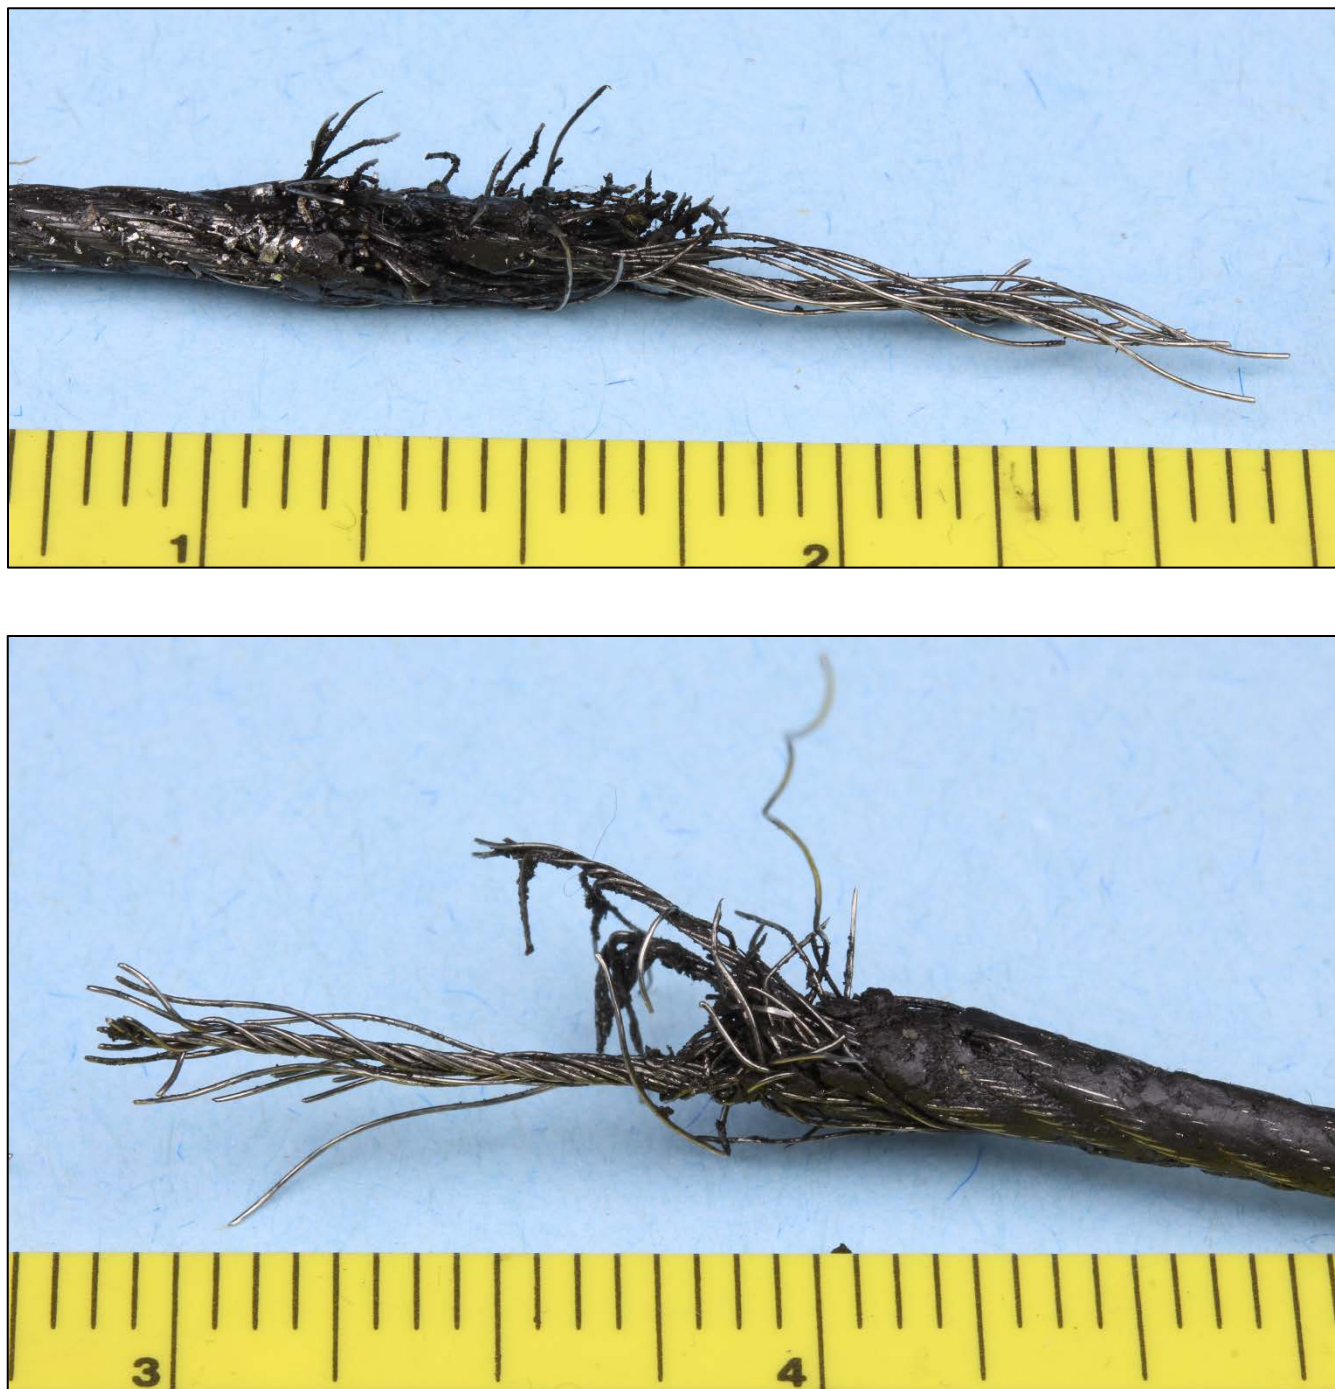
Figure 3. Closer views of the fracture surfaces on the forward (upper image) and aft (lower image) cable pieces showing bent strands and black deposits on the cable near the fracture.

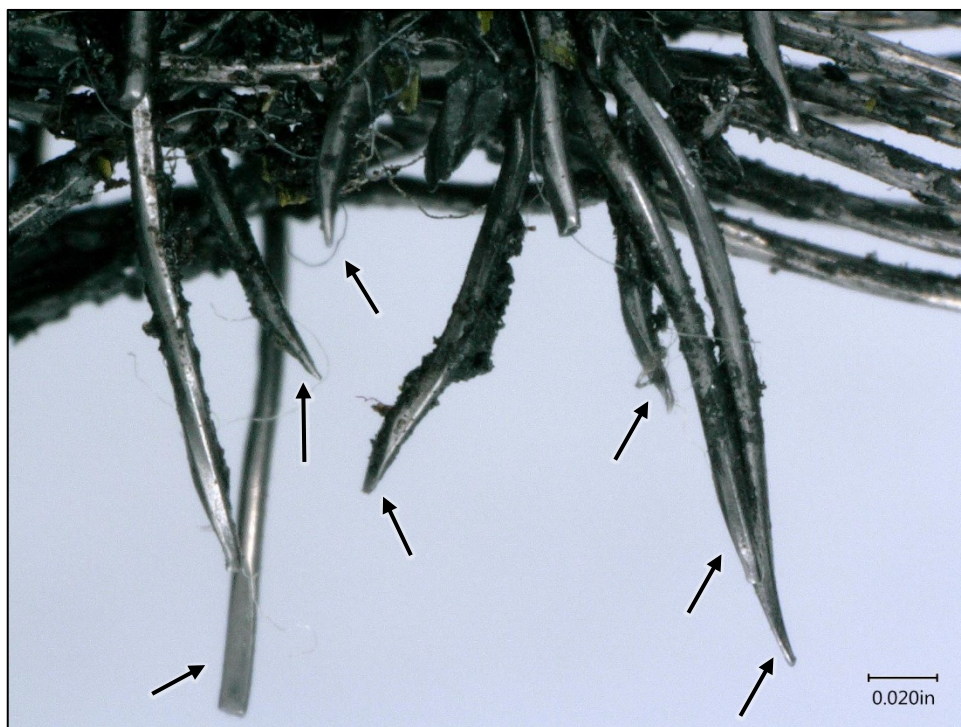
A closer view of the ends of several bent wires on the forward side of the fracture is shown in figure 4. Most of the wires were thinned to a chisel-like tip consistent with wear. Unlabeled arrows in figure 4 indicate wire ends showing a chisel-like wear pattern. Among the wires from the core strand that extended past the surrounding strands, 9 of the 17 wires on the aft side were thinned through at least half the wire diameter, and 7 of 16 wires on the forward side were thinned through at least half the wire diameter.

Figure 4. Closer view of individual wires from strands that were bent back. The ends of many wires from the outer strands were worn to a chisel-like end such as the wires indicated with unlabeled arrows.

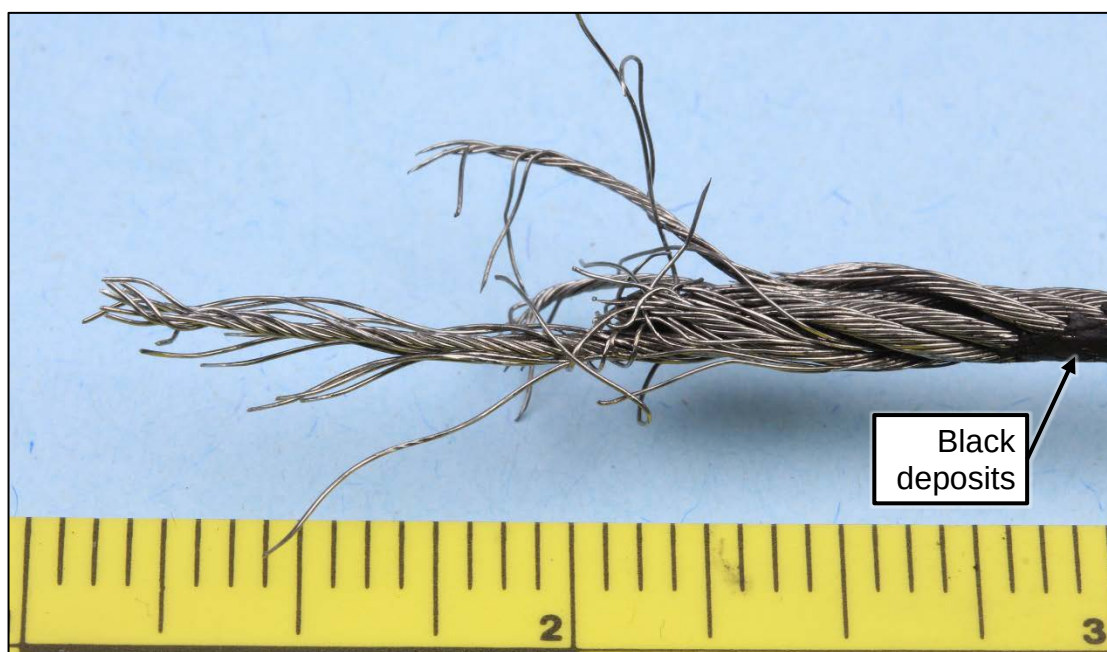
Black deposits covered the surface of the cable in the area of the fractured and bent wires within 2.5 inches both forward and aft of the core strand fracture. The fractured end on the aft cable piece was submerged in a beaker of acetone while cleaned for 5 minutes using an ultrasonic cleaner. A view of the resulting cleaned fracture is shown in figure 5. The cleaned fracture was further examined using a scanning electron microscope (SEM), and an SEM image of fractured core strand wires at the forward end of the cleaned cable piece is shown in figure 6. Nine of the wires from the core strand showed necking deformation<sup>1</sup> consistent with ductile overstress fracture.

Figure 5. Overall view of the fracture on the aft cable piece after cleaning for 5 minutes in an ultrasonic cleaner while submerged in acetone. Some black deposits remained on the cable after cleaning as indicated.

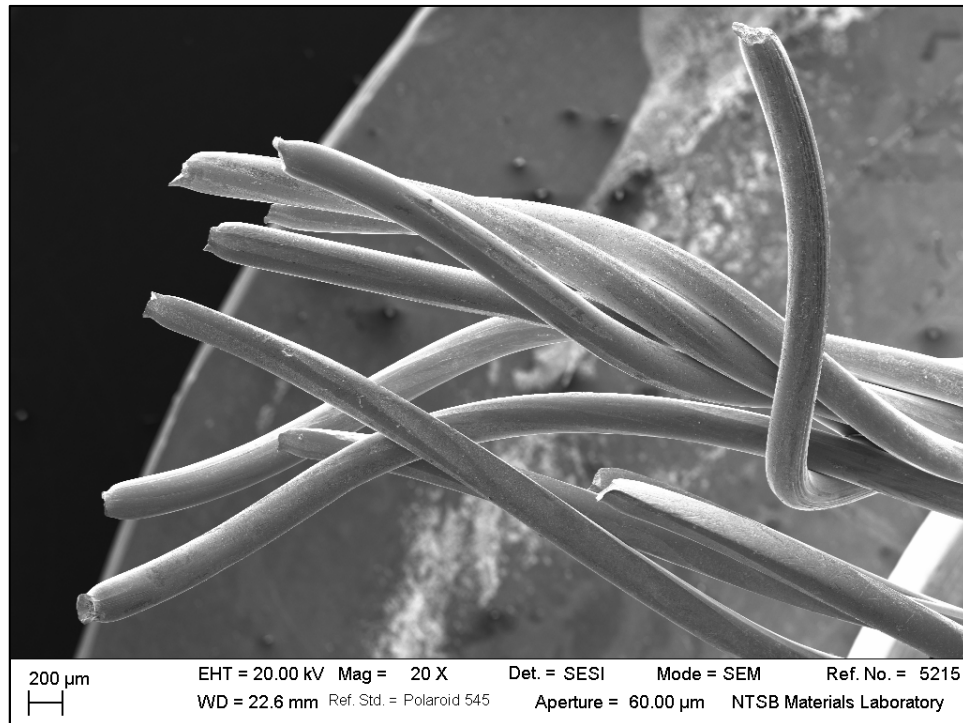
Figure 6. SEM image of individual wires from the core strand on the aft cable piece showing necking deformation associated with fractures on several wires.

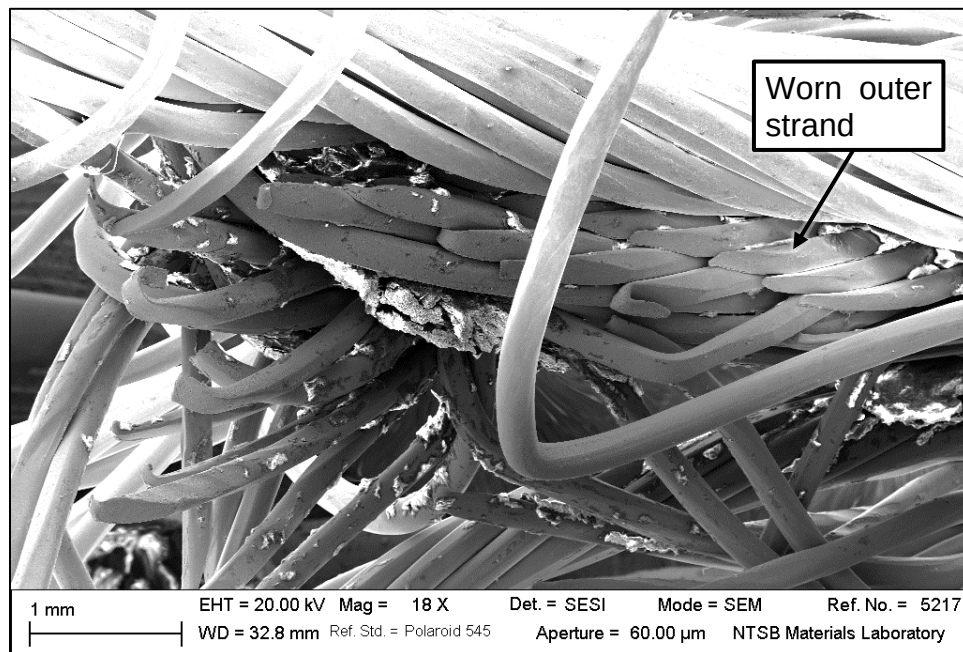
A view of wire ends on outer strands are shown in figure 7. Most of the wires on the indicated outer strand were worn to a chisel-like tip as were many of the other wire ends visible in figure 7. Some of the chisel-like ends were also bent back and deformed into a curled shape.

Figure 7. SEM image of wire ends on an outer strand on the aft cable piece showing wear through the thickness of wires in the strand, leaving chisel-shaped wire ends.

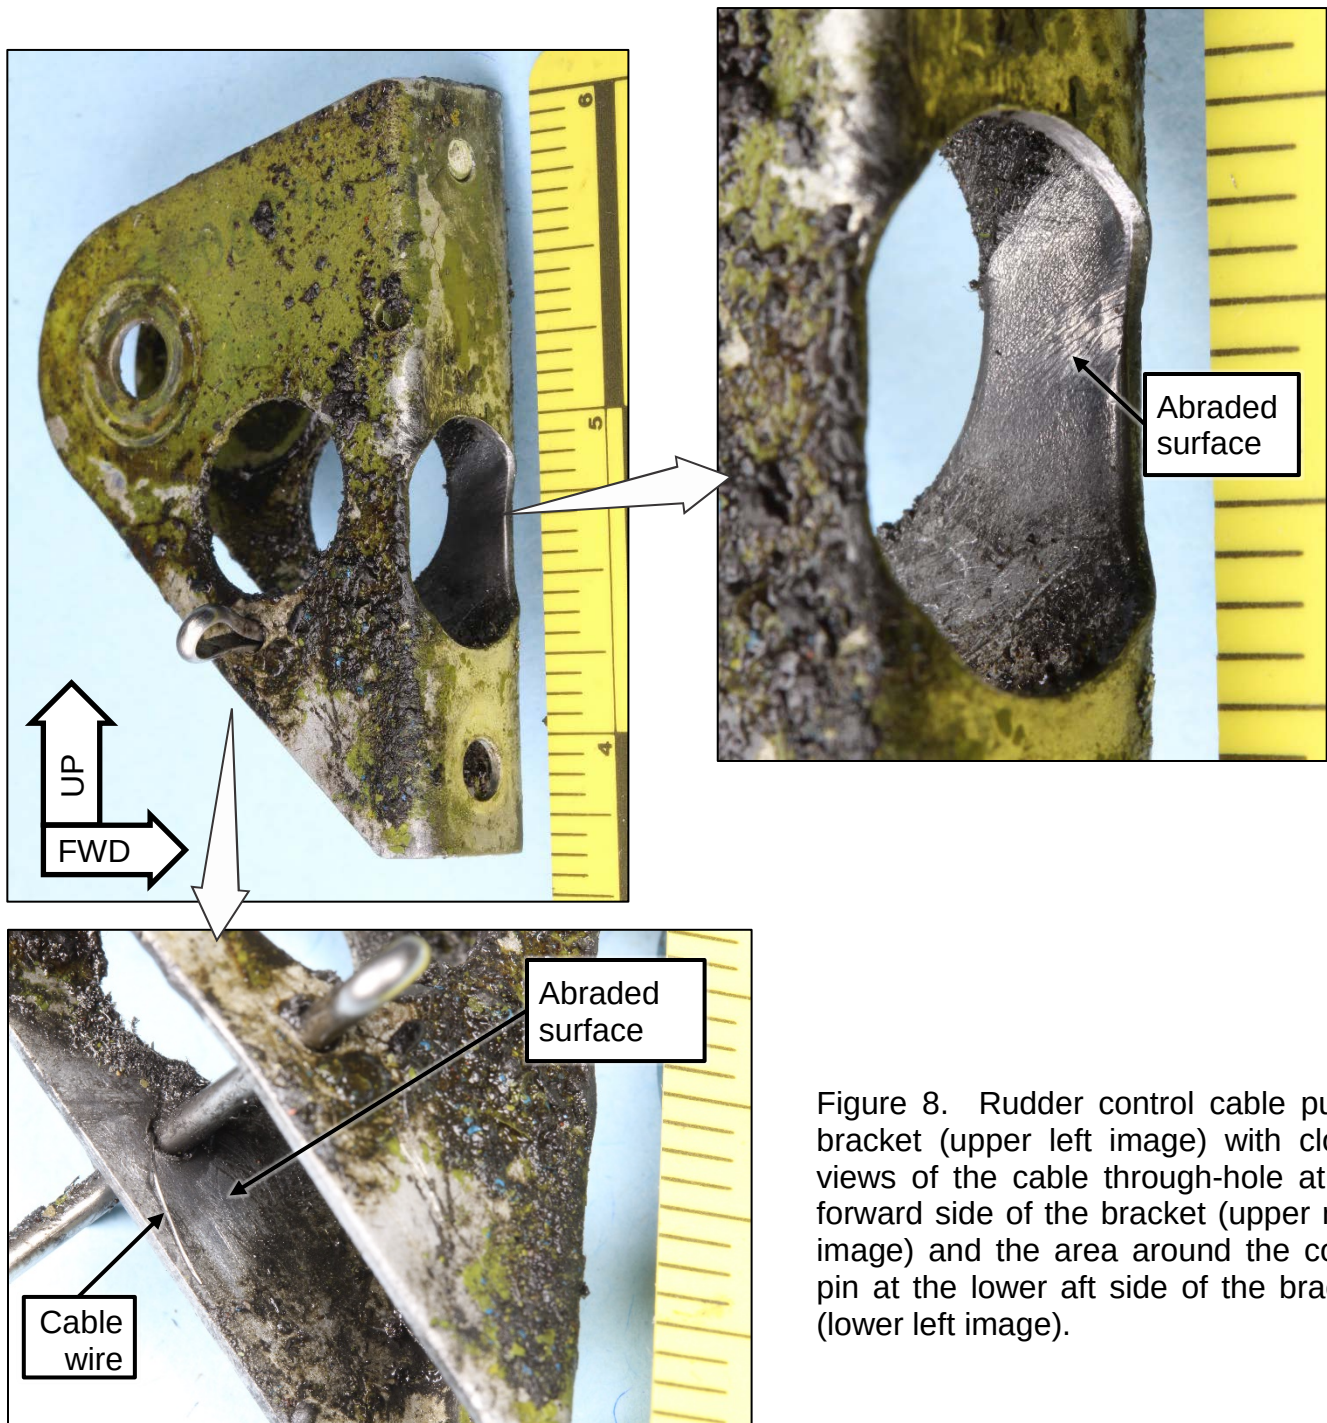
Close views of the rudder pulley bracket are shown in figure 8. The bracket was partly covered with black deposits. Areas around the through-hole at the forward side of the bracket and near the cotter pin at the lower aft side of the bracket had missing paint and had a relatively reflective textured appearance consistent with abrasion from contact with cable wires as indicated in the upper right and lower left images in figure 8. A cable wire was observed lodged in the hole for the cotter pin in the lower aft side of the bracket as indicated in the lower left image in figure 8.

Figure 8. Rudder control cable pulley bracket (upper left image) with closer views of the cable through-hole at the forward side of the bracket (upper right image) and the area around the cotter pin at the lower aft side of the bracket (lower left image).

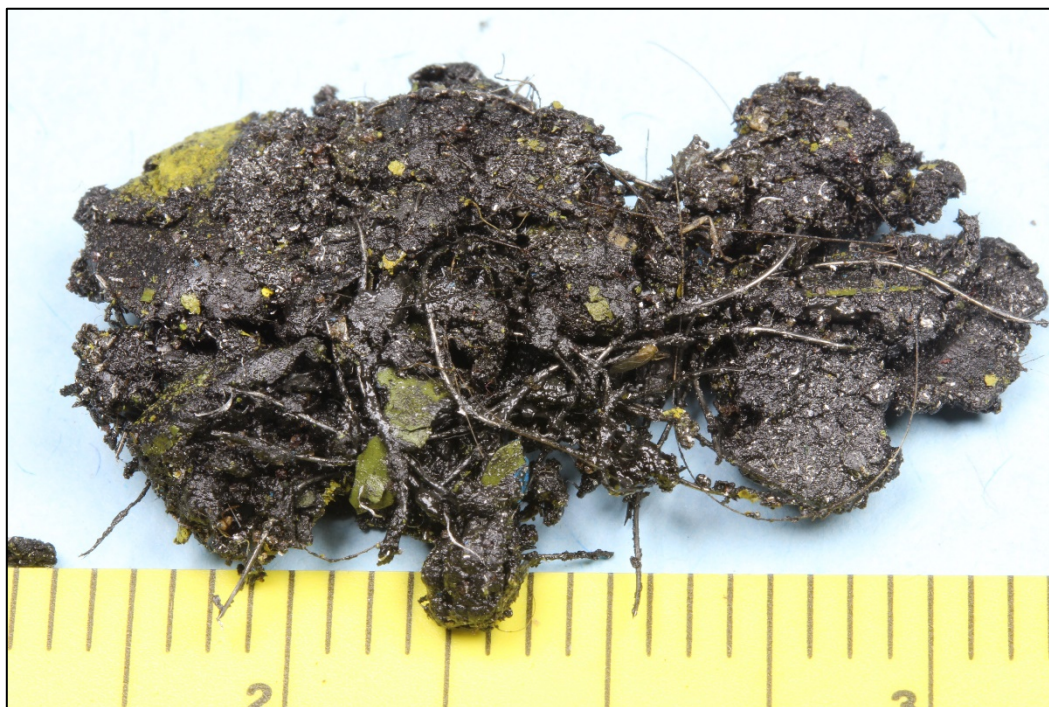
A close view of a sample of the deposits collected from the area near the rudder pulley is shown in figure 9. Silvery flecks consistent with chips of aluminum were observed scattered throughout the sample. However, it was noted that the sample was collected after cutting and drilling operations were completed to remove the cockpit floor to gain access to the rudder control cable and pulley components. The sample also contained flakes of green material appearing consistent with green primer. Finally, the sample contained many wire pieces consistent with worn control cable wire segments.

Samples of black deposits were taken from surfaces of the control cable near the fracture and from the deposits collected from the area near the rudder pulley. The samples were analyzed using a Varian IR600 Fourier-transform infrared (FTIR) spectrometer with a diamond attenuated total reflectance (ATR) accessory in accordance with ASTM E1252-98 (American Society for Testing Materials E1252-98: Standard Practice for General Techniques for Obtaining Infrared Spectra for Qualitative Analysis. Results showed spectra consistent with grease.

Figure 9. Sample of deposits collected from the rudder pulley area. Black deposits were mixed with chips of green primer, metal shavings, and wire fragments.

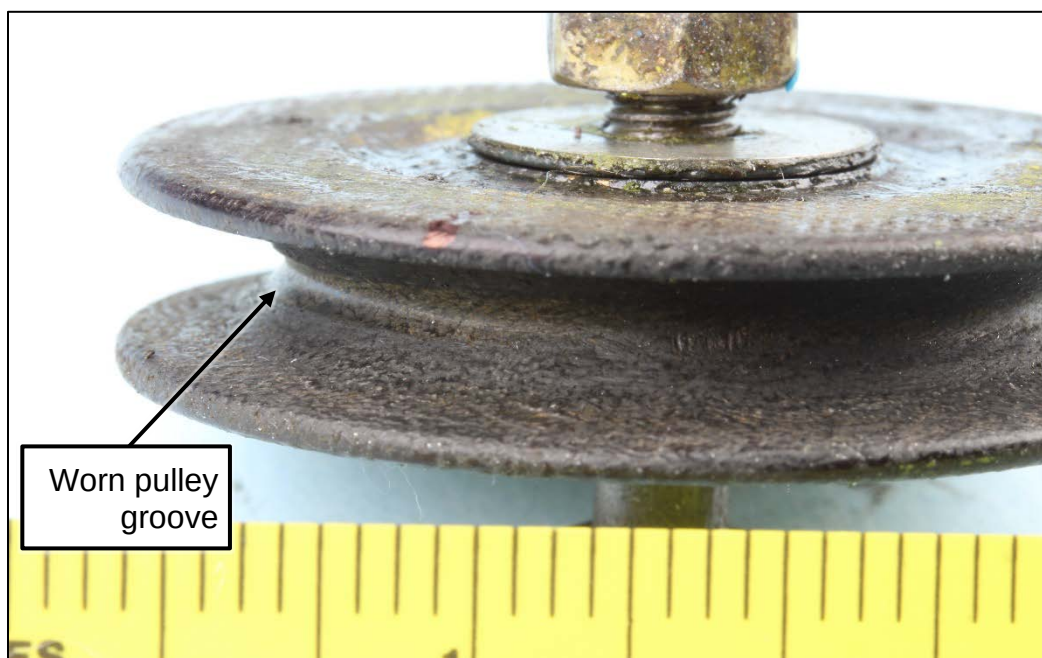
A close view of the pulley is shown in figure 10. The pulley overall had an appearance consistent with a fiber-reinforced polymer construction around a central bearing. In examining the cable guide groove in the pulley, the groove appeared deeper with a smaller root radius around approximately one quarter of the circumference, features consistent with cable contact wear as indicated in figure 10. Views of the groove profile in the worn quadrant and in another area of the pulley are shown in figure 11. The dashed line in the upper image in figure 11 is a trace of the profile in the lower image, which shows the difference in wear in the worn quadrant. The pattern of wear in the one quadrant of the pulley relative to the other quadrants was consistent with the pulley not rotating while in contact with the moving control cable.

Figure 10. Close view of the pulley showing wear at the root of the pulley groove.

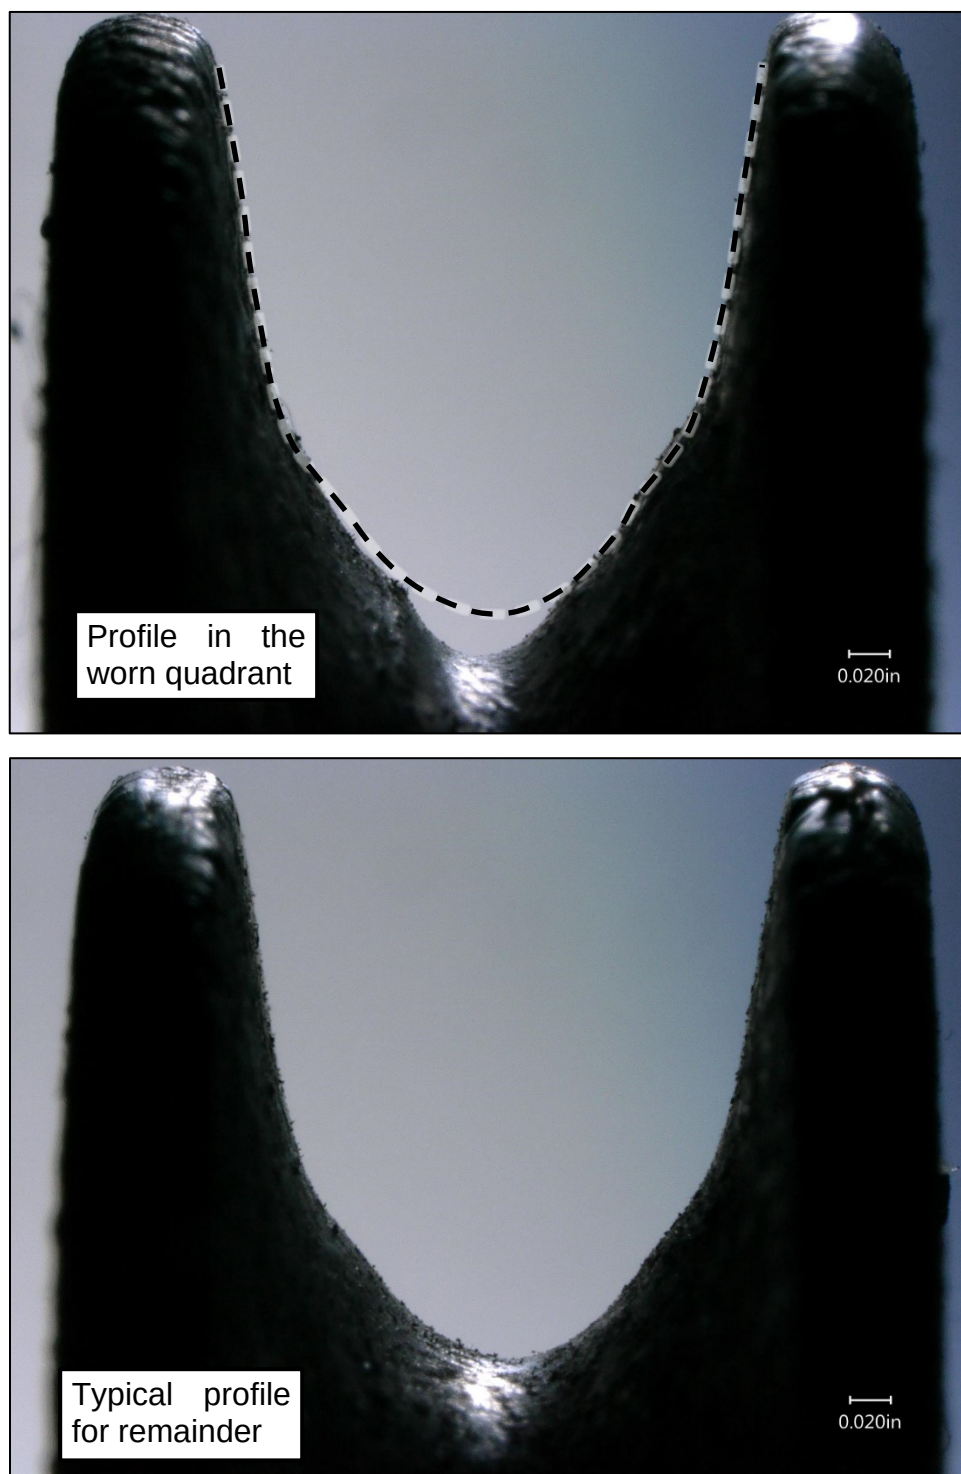
Figure 11. Profile view of the rudder pulley groove in the worn quadrant (upper image) and a typical groove profile for the remainder of the pulley circumference (lower image). A dashed line in the upper image represents a trace of the groove profile shown in the lower image.
