## **NATIONAL TRANSPORTATION SAFETY BOARD**

### **Examination Summary**

February 25, 2020  
Dillingham Airfield, Hawaii

NTSB Number: ANC20FA024  
Location: Mokuleia, Hawaii  
Date: February 22, 2020  
Aircraft: Ector Cessna 305A, S/N 2035  
Engine: Continental O-470-11B, S/N T-101575

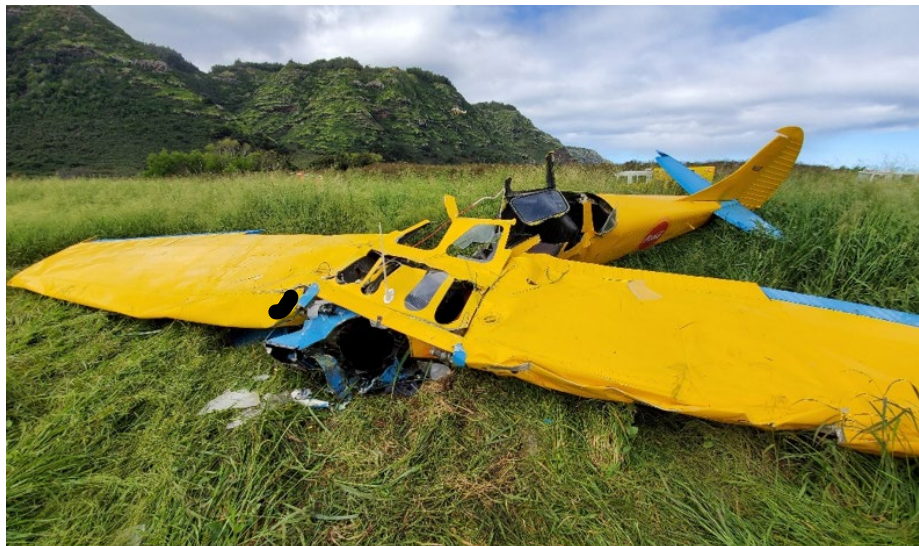
The wreckage had been taken partially apart by emergency response personnel for access to the front cockpit area. The top of the cabin, sidewalls and wings were cut and moved apart. Refer to figure 1 for a photograph of the wreckage before disassembly.

*Figure 1. Wreckage at the accident scene. (Source: Honolulu Police Department)*

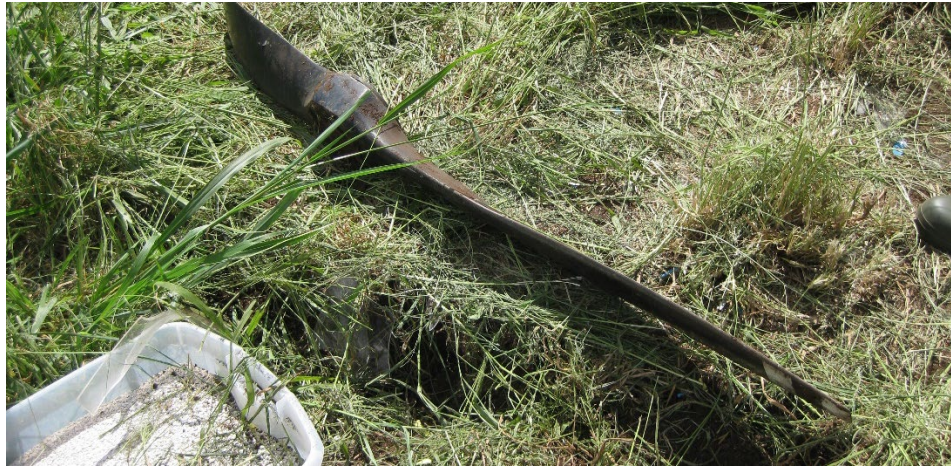
The wreckage was located in a field of long grass about 1000 ft south of the runway near an access road. The airplane came to rest slightly nose down, upright on the fuselage in a slightly left wing down attitude heading about 100°. All major components were located at the scene. The forward fuselage and left wing leading edge sustained significant crush damage. The propeller was separated from the engine at the flange and located in a 6 inch depression about 4 ft in front of the wreckage. See figure 2.

*Figure 2. Propeller and ground depression.*

One propeller blade was straight with no damage and the other was bent back about 40° at the midspan with minor leading edge scratches. The fuselage exhibited buckling on the left side mid-section and the engine was displaced to the left. The left wing fuel tank was breached with fuel leaking from the wing section. A few gallons of fuel were present in the right wing fuel tank and the fuel was free of contamination and had characteristics of avgas.

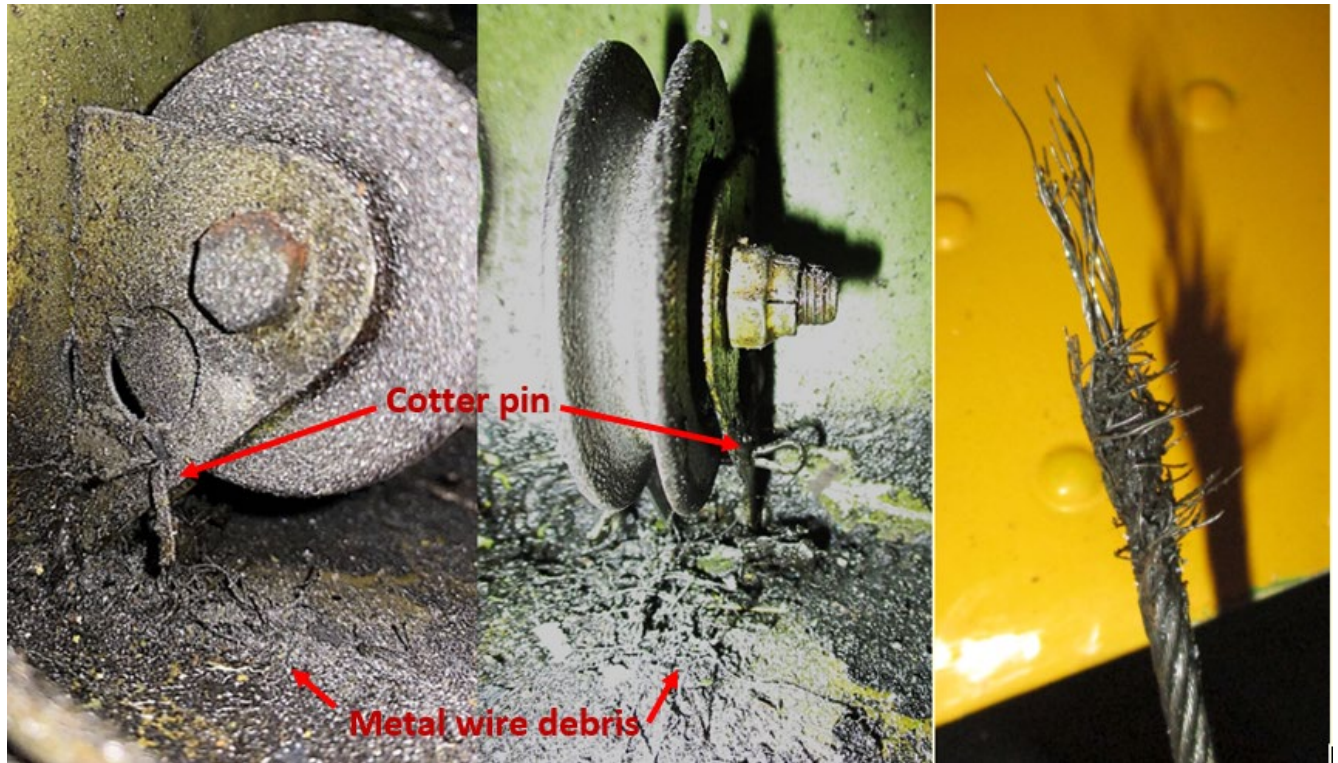
The flight controls in the cockpit were unmovable due to crush damage of the fuselage floor. The elevator control cables were continuous and connected. The aileron controls were continuous from the control stick to the wing roots where the left wing root cables exhibited clean cuts and the right-wing cable exhibited broomstraw signatures at the separation, consistent with overload separation. The front flap handle was in the down (retracted) position and the rear flap handle was removed by responders. The left rudder cable was separated at the rudder pulley area behind the rear seat floor with a combination of severely frayed and fractured strands with tension overload signatures. The under floor pulley bracket had a cotter pin extended with metal shavings evident in the thick grease like debris around the pulley. See figure 3.

*Figure 3. Left rudder cable pulley, bracket and rudder cable forward fractured end.*

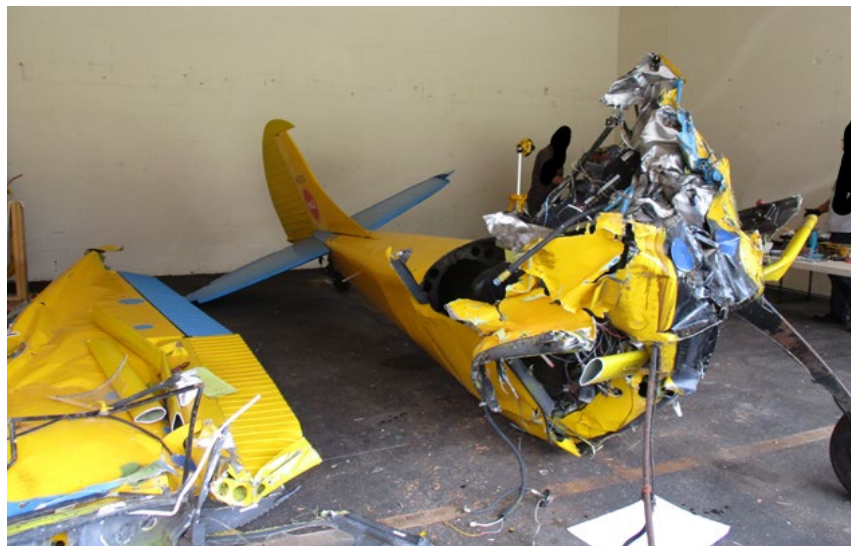
*Figure 4. Wreckage during detailed examination.*

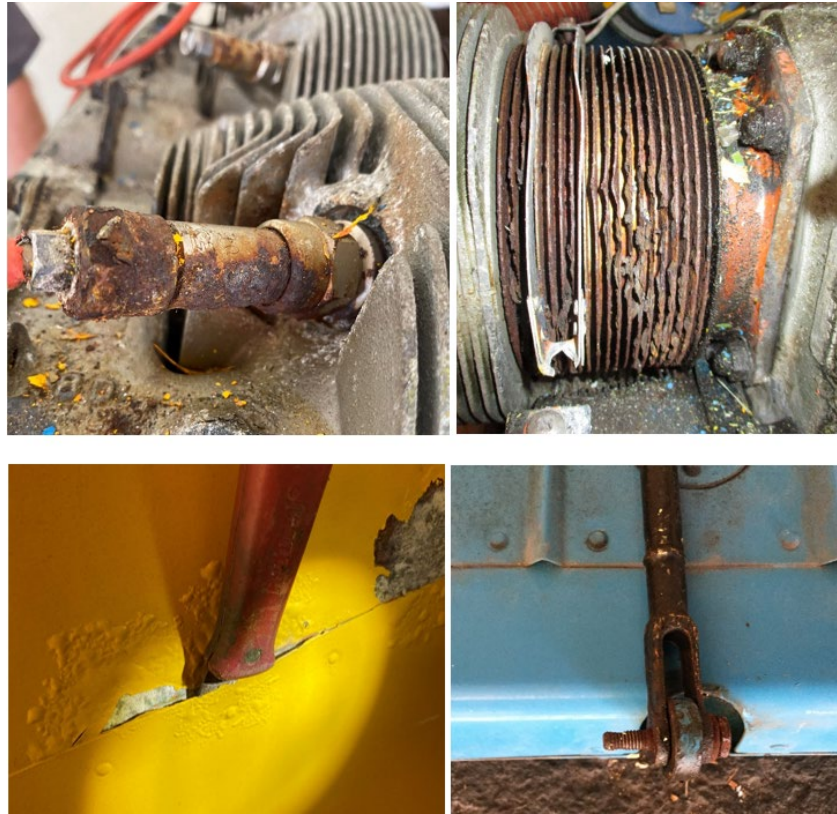
The wreckage was recovered to a hangar at the airfield and examined by the NTSB IIC with the assistance of a mechanic. The airplane exhibited extensive corrosion damage on the engine cylinder cooling fins, wing surfaces, elevator control rod connections, elevator trim chain and control rod, tailwheel assembly, rudder control rod connections, and ignition harness leads. See figure 5.

*Figure 5. Photographs of evident corrosion.*

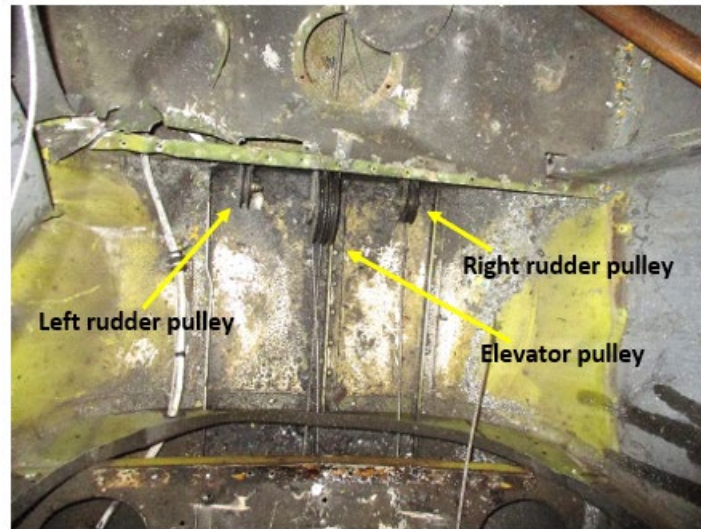
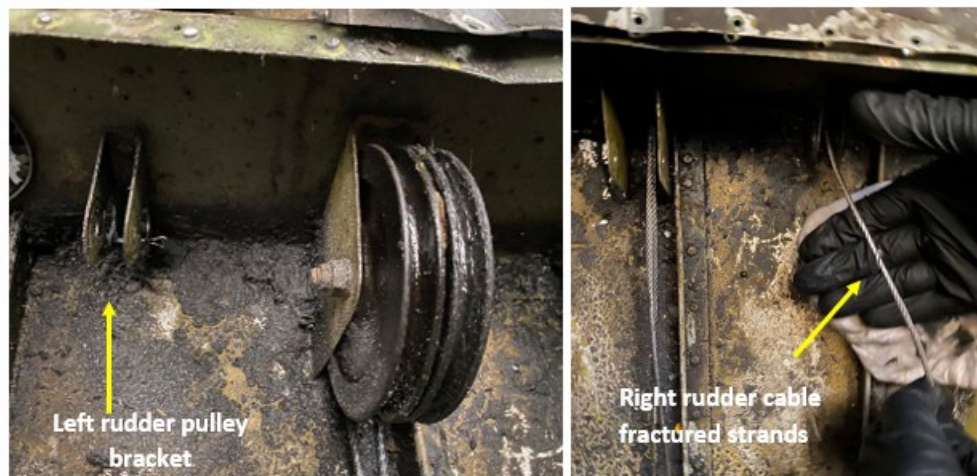
The three pulleys in the under-floor area each had thick black grease deposits. The elevator cables and right rudder cable had multiple frayed cables and shiny degraded areas that indicated excessive wear. The right- and left-wing aileron cables in the area of the upper fuselage pulleys also exhibited areas of frayed strands. See figures 6 and 7. The left rudder cable bracket, pulley and cable sections at the separation were removed and sent to the NTSB material laboratory for examination.

*Figure 6. Under floor pulley area.*

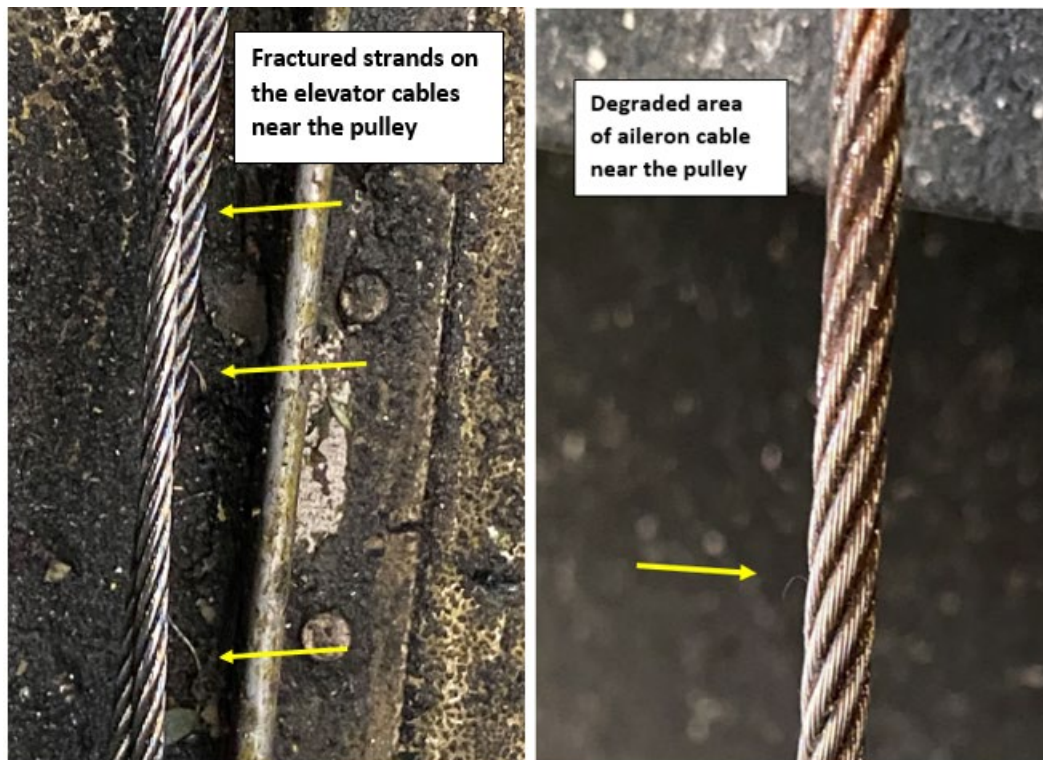
*Figure 7. Fractured and damaged flight control cables.*

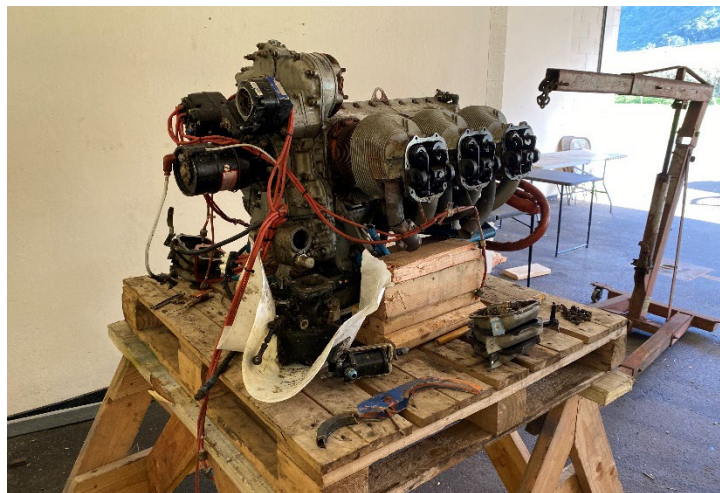
*Figure 8. Continental O-470 engine during the examination.*

The engine airframe mounts were fractured. The case and cylinders were intact with corrosion evident on the cooling fins and some connections. The accessories were attached. The left and right magnetos housings were fractured and ignition lines partially cut near the connections. The magnetos were removed and rotated by hand. Ignition spark was produced at each terminal. The crank shaft was rotated manually

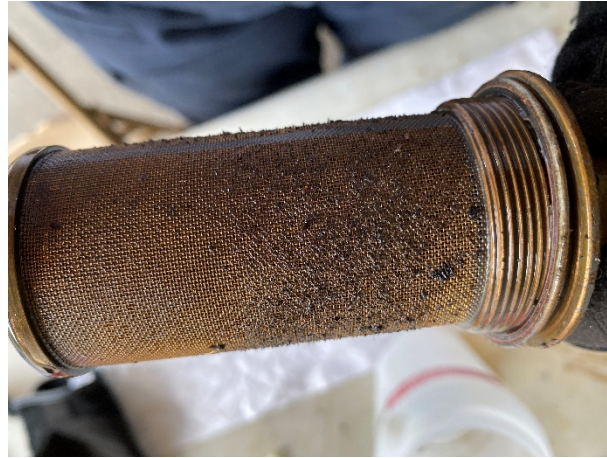
The engine oil was grey in appearance. The oil filter screen had a moderate amount of non-metallic debris present. See figure 9.

*Figure 9. Oil filter screen.*

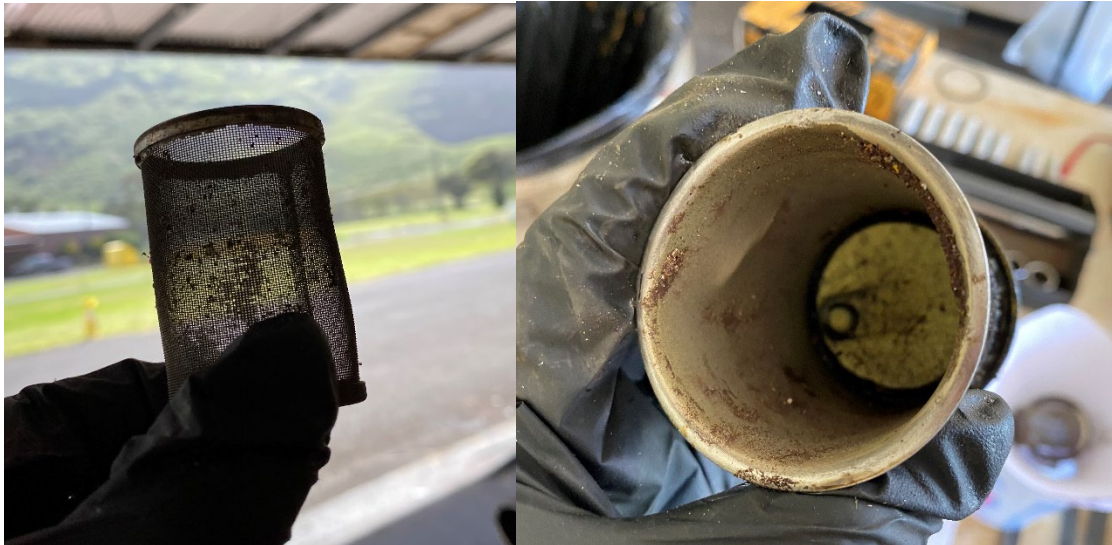
The airframe fuel filter and bowl contained a small amount of dirt like debris, as well as the gasket area of the bowl, which may indicate the debris intruded into the filter during the impact or recovery. See figure 10.

*Figure 10. Fuel filter.*
