**NATIONAL TRANSPORTATION SAFETY BOARD  
Office of Research and Engineering  
Vehicle Recorder Division  
Washington, D.C. 20594**

**SPECIALIST'S FACTUAL REPORT OF INVESTIGATION**

**ANC20LA015**

## **Cockpit Voice Recorder**

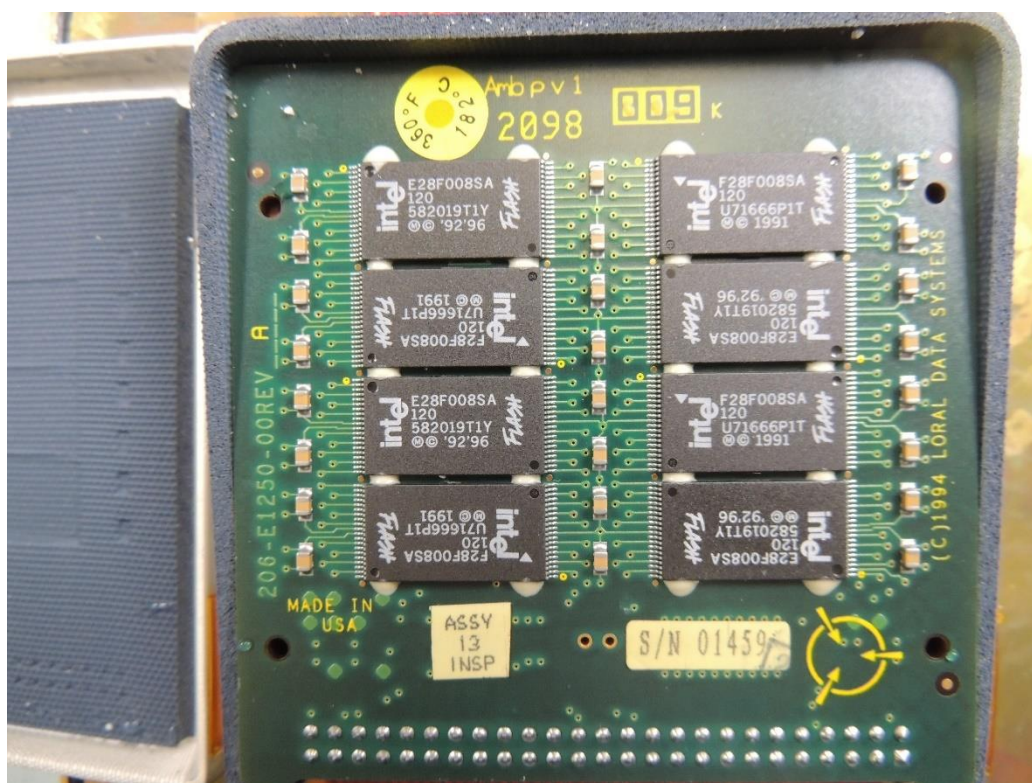
The recorder arrived at the Vehicle Recorder laboratory partially submerged in water. The outer case, which appeared undamaged, was removed, and opening the interior crash-protected case revealed minor water intrusion around the memory chips, as seen in figure 1. This corresponded to minor corrosion noted around some memory chip connections. The corrosion was cleaned using laboratory methods, and the digital audio was successfully downloaded from the crash-survivable memory unit (CSMU).

Figure 1. CSMU interior showing minor water intrusion.
