# NATIONAL TRANSPORTATION SAFETY BOARD

## MATERIALS LABORATORY FACTUAL REPORT

Report No. 20-028

Place : Kalapana, Hawaii  
Date : March 5, 2020  
Vehicle : Airbus Helicopter EC130-B4, N11QK  
NTSB No. : ANC20LA028  
Investigator : Brice Banning, ASI-ANC

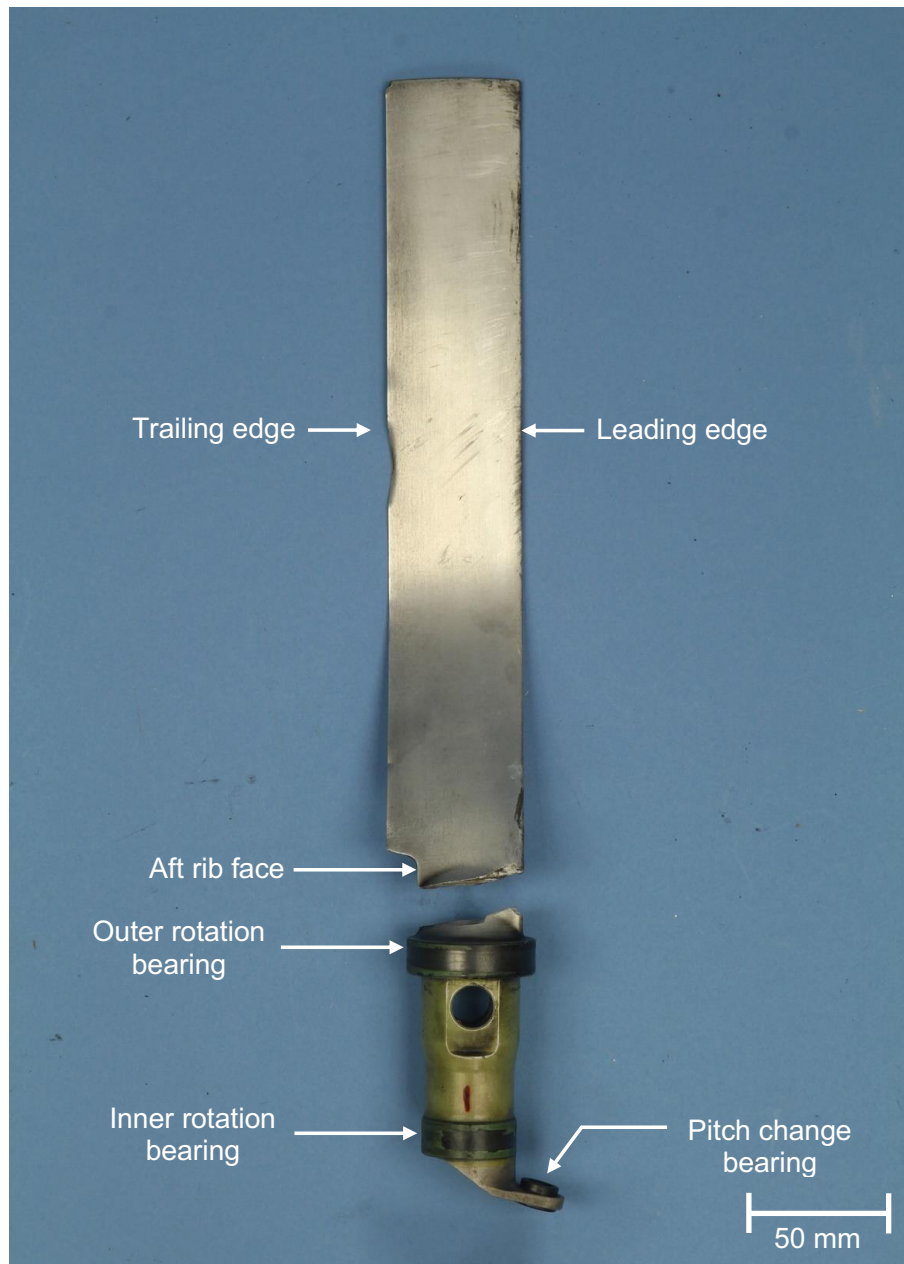
The ten blades were examined visually and with the aid of a stereomicroscope. Blade number 1 was fractured near the root end of the airfoil in the flat rib face section at the level of the drain hole outlet. Photographs of the two fracture faces, the root side and the airfoil side, are shown in figures 5a and b, respectively. The fracture surfaces were comparatively flat toward the trailing edge of the blade, transitioning to 45° inclined fractures toward the leading edge. Visual examination of the flat fracture region revealed curvilinear crack progression marks that were consistent with a progressive fracture that originated at or near the drain hole at the aft rib face. The chordwise linear fraction and area fraction of the flat fracture region were measured on the root-side fracture surface using images taken on a digital optical microscope, as shown in figures 6a and 6b, respectively. The chordwise linear fraction was approximately 0.62 and the area fraction was approximately 0.66. Later, the airfoil-side fracture surface was sent to Airbus Helicopter for examination and an independent evaluation resulted in a 0.66 linear fraction and 0.68 area fraction for the flat fracture region.

**Figure 3:** Image of fenestron blade number 1, fractured in two pieces.

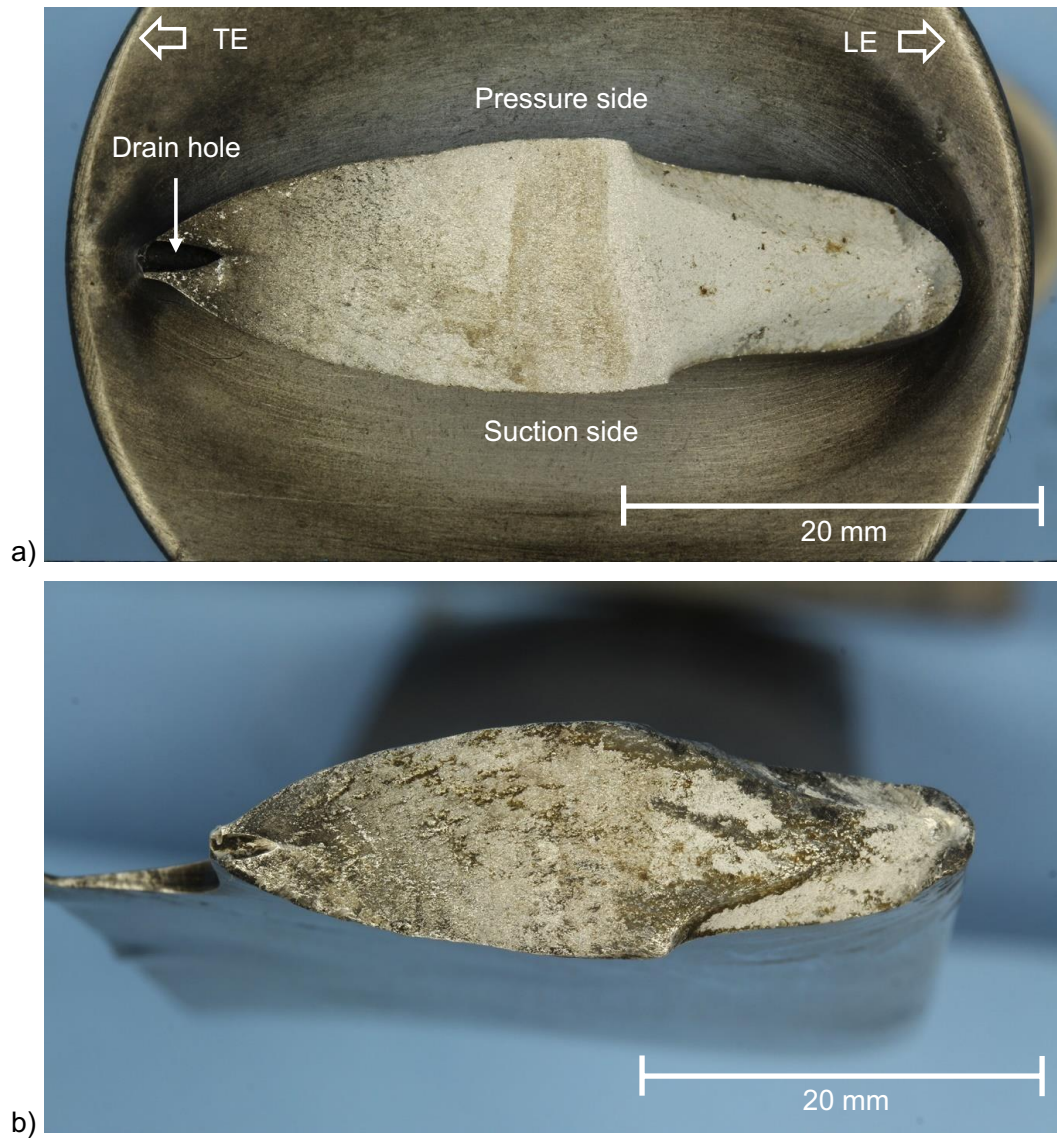
The fracture surface in its as-received condition exhibited dark deposits as shown in figure 5a, particularly in the vicinity of the drain hole (compare to the fracture surface after cleaning, shown in figure 6a). Prior to cleaning, acetate tape was used to lift some of the debris from the fracture surface for chemical analysis. The tape was softened with acetone, pressed against the fracture surface, allowed to harden, and then mechanically removed. The replica was sputter-coated with a gold/palladium alloy and examined in a scanning electron microscope (SEM) equipped with an energy dispersive x-ray spectrometer (EDS). Some regions of the tape consisted predominantly of magnesium (Mg), silicon (Si), and aluminum (Al) oxides, as shown in figure 12a. Other regions also exhibited an abundance of sodium (Na), calcium (Ca), chlorine (Cl), and sulfur (S), as shown in figure 12b.

**Figure 5:** Images of the two fracture faces: a) root-side and b) airfoil-side.

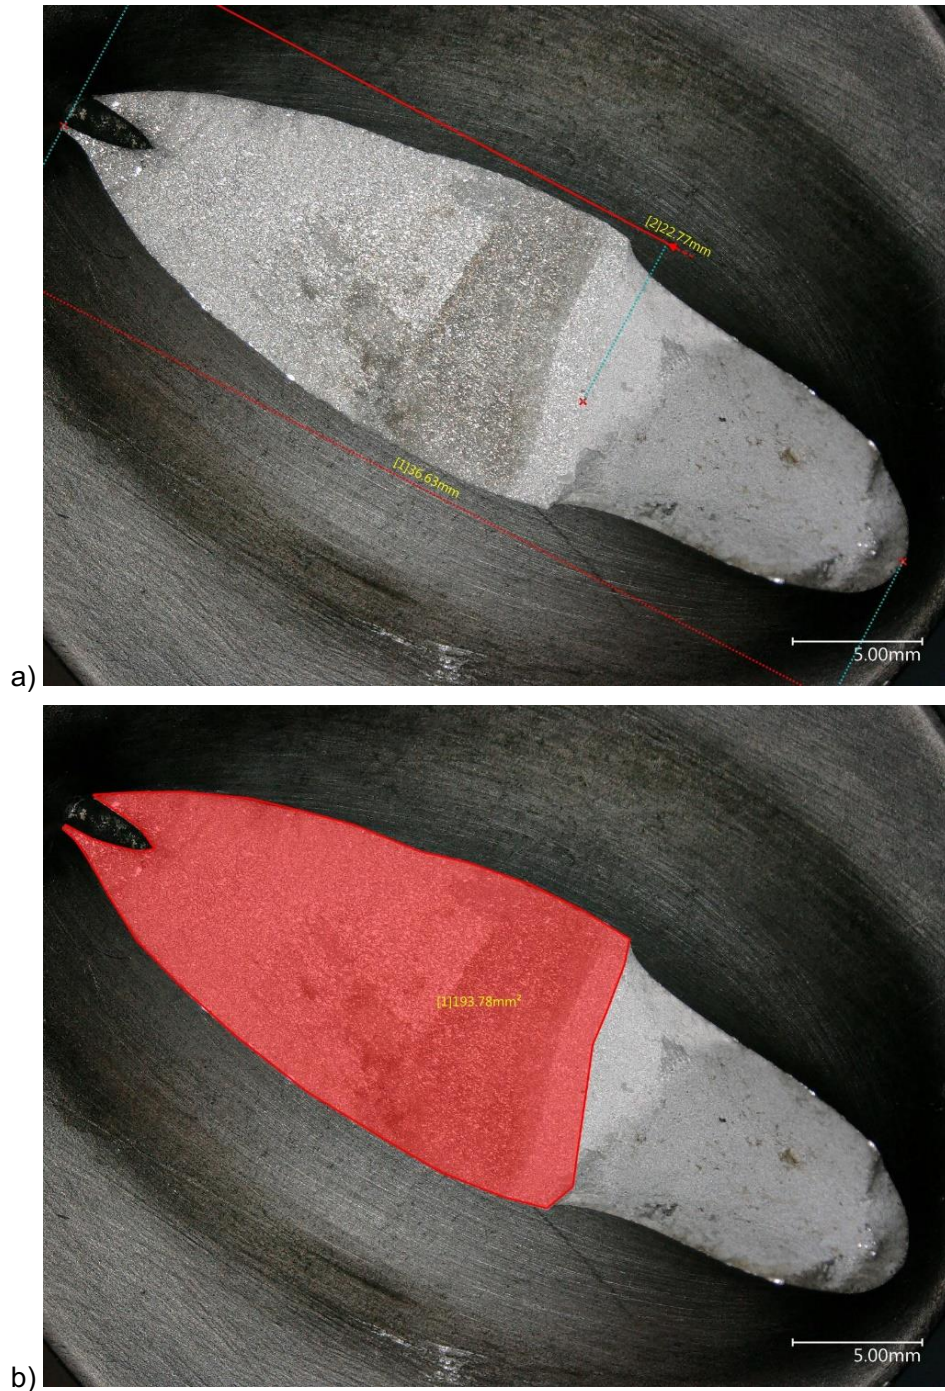
**Figure 6:** Digital optical microscope image used for measuring; a) linear chordwise fraction of flat fracture region and b) area fraction of flat fracture region.

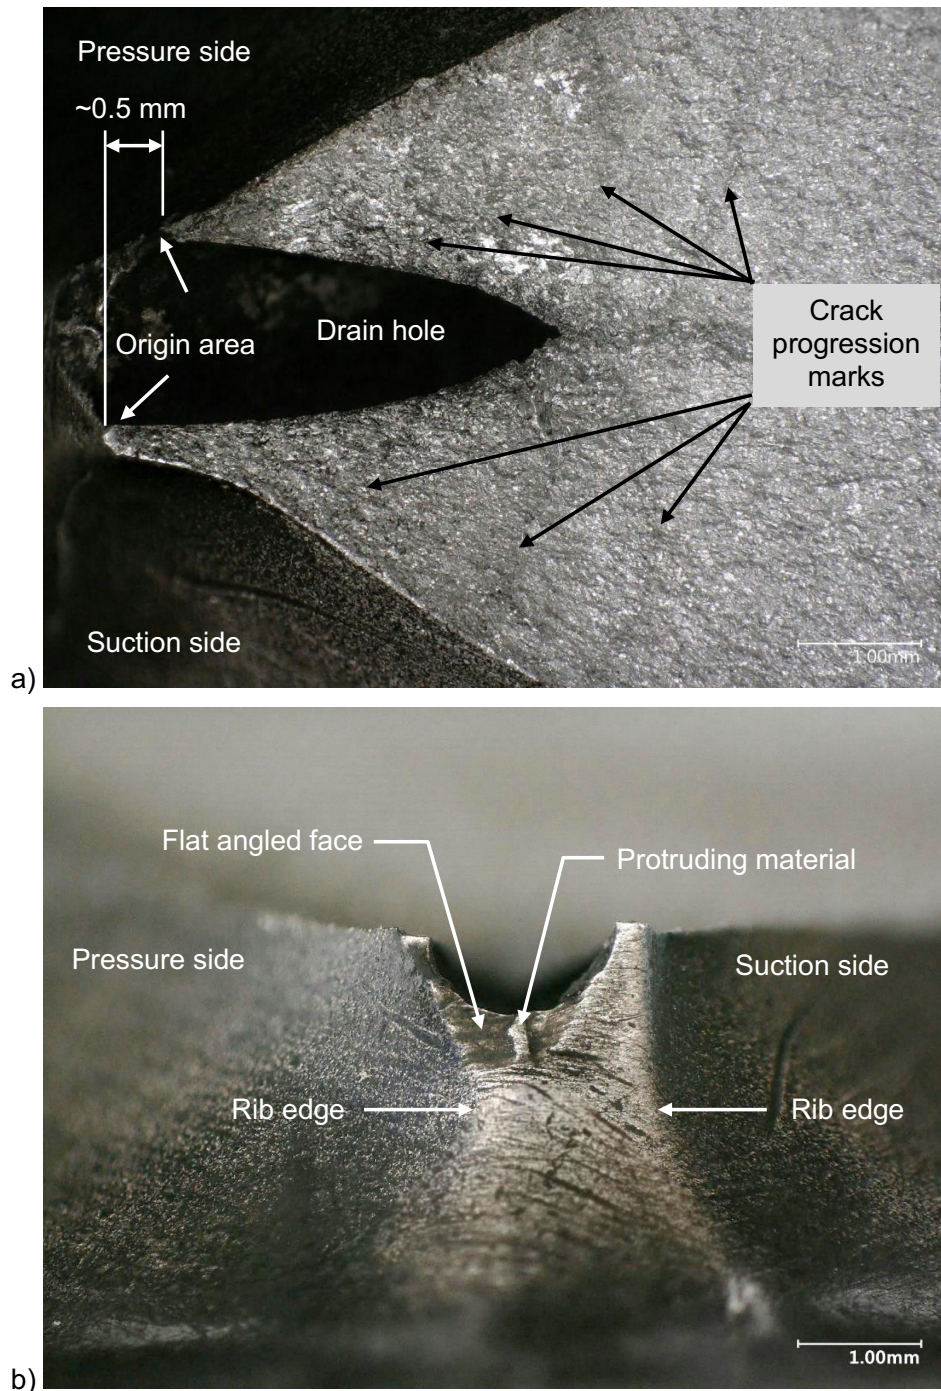
The flat fracture region initially rose at an incline as it progressed chordwise from the aft rib face toward the leading edge. On the suction side, the inclination was approximately 9° for the first 14 mm, after which it continued parallel to the platform to the onset of the overstress region. On the pressure side, the inclination was approximately 5.5° from the aft rib face to the onset of the overstress region. Higher magnification examination of the fracture surface around the drain hole revealed crack progression marks on either side of the hole, consistent with two separate origins, one on either side of the drain hole at or near the aft rib face, as indicated in figure 7a.

Visual examination of the aft rib face revealed a morphological anomaly below and to the pressure side of the drain hole, as shown in figure 7b. According to the engineering drawing, the aft rib face is orthogonal to the blade platform and nominally orthogonal to the chordwise direction of airfoil. However, below and toward the pressure side of the drain hole, the face exhibited an off-orthogonal angled region, bringing the aft face on the pressure side of the drain hole forward. Measurements on the image in figure 7a indicated that as a result, there was an approximately 0.5 mm difference in the chordwise location of the aft face on the pressure and suction sides of the drain hole. In addition, within the off-angle region and below the drain hole, there was an approximately 0.50 mm by 0.15 mm region that protruded from the surrounding material, as indicated in figure 7b.

**Figure 7:** Digital microscope images of the fracture surface around the drain hole: a) plan view of the fracture surface; b) aft looking forward showing the lower portion of the drain hole and geometric anomaly around the hole.

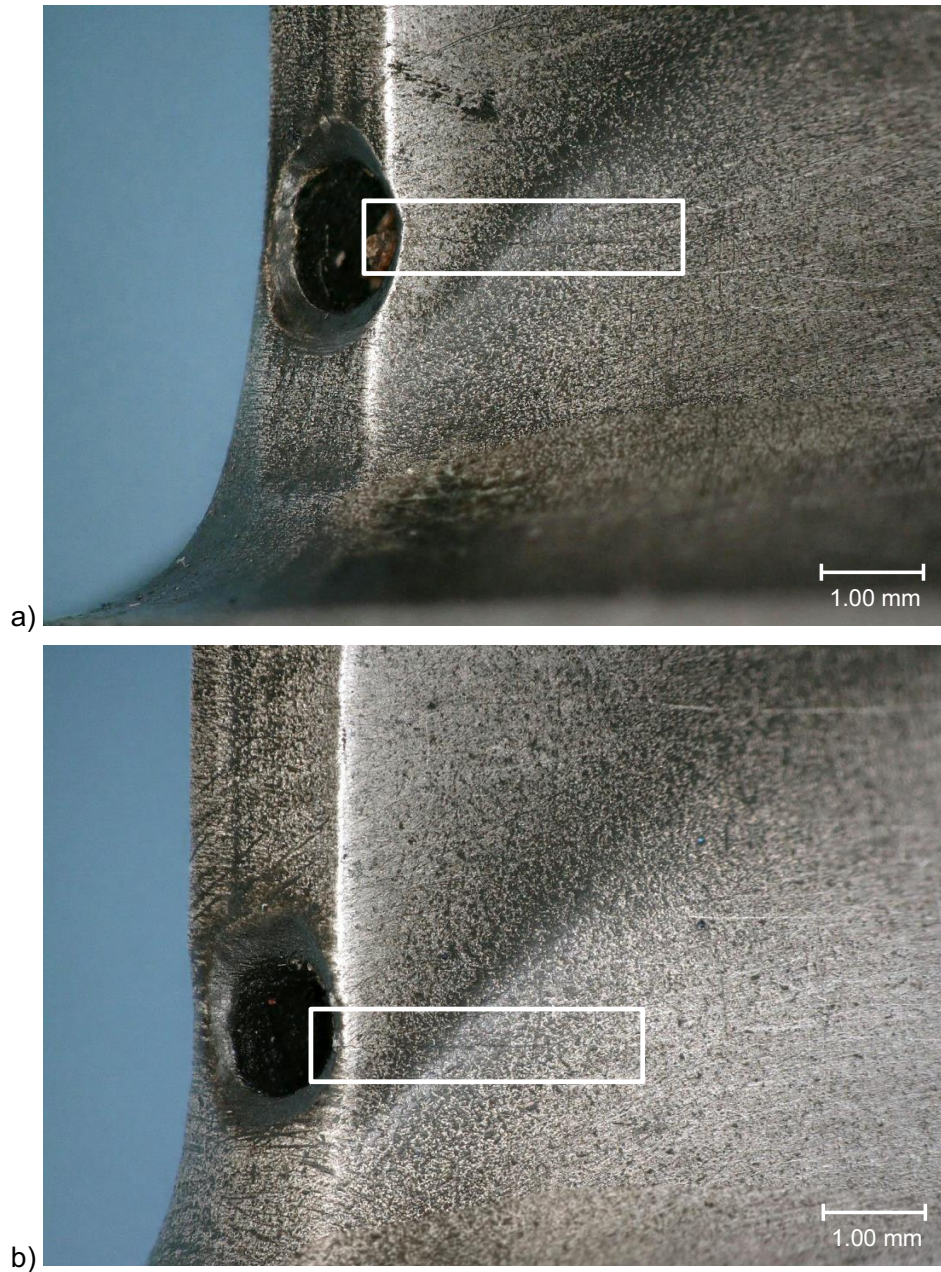
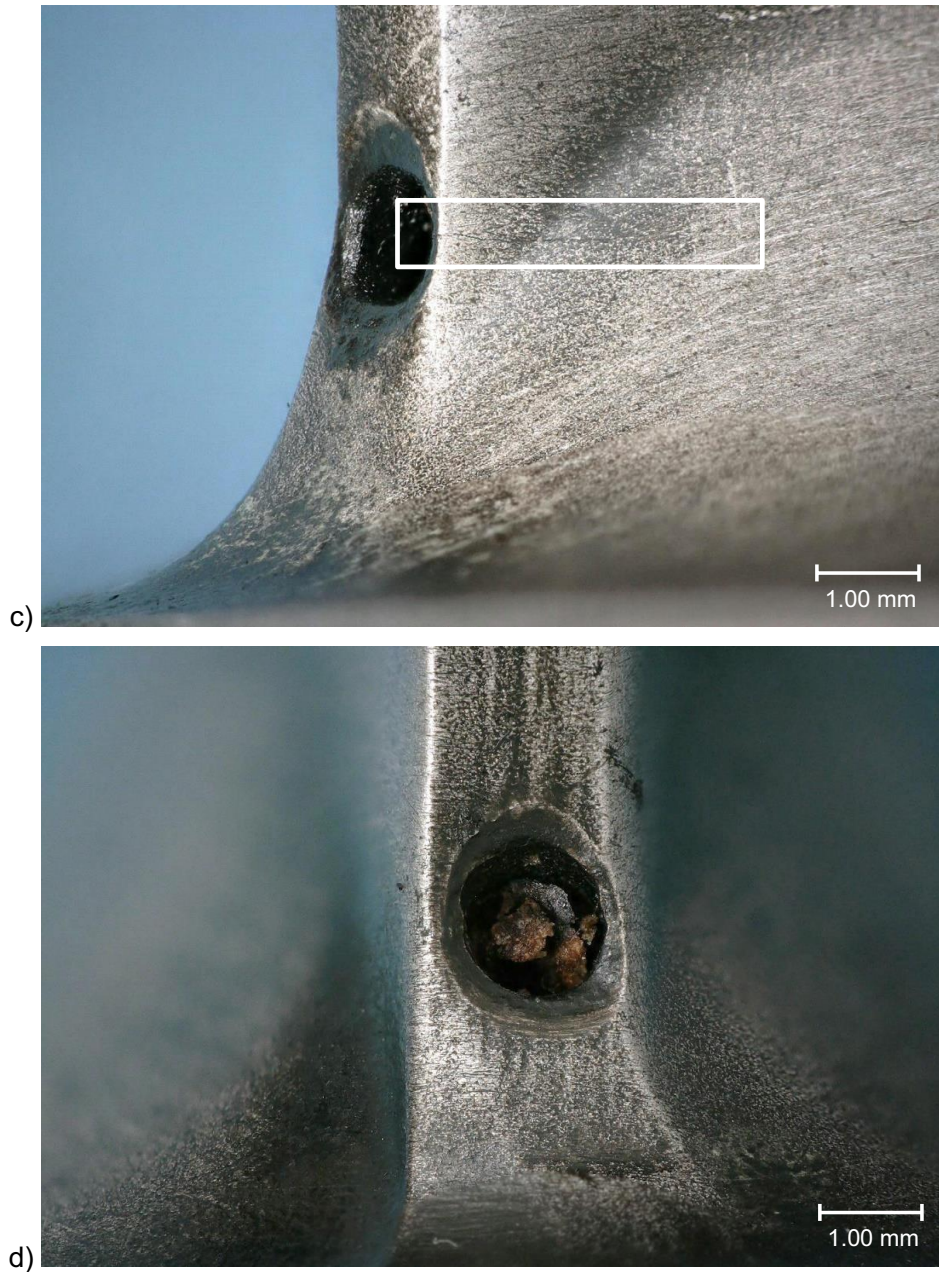
The nine intact blades were examined using a stereomicroscope with a focus on the area surrounding the drain hole. As shown in figures 8a – c and indicated in table 1, blades 2, 4, and 10 exhibited cracks on the suction side of the drain hole that progressed forward 2 mm to 3 mm. There were no visually identifiable cracks on the pressure side of the drain hole on any of the intact blades. Foreign debris was observed in the number 2 blade drain hole passage, as shown in figure 8d, but not in any other intact blade.

**Figure 8:** Images of additional cracks in other fenestron blades: a) crack on suction side of blade number 2; b) crack on suction side of blade number 4;

**Figure 8 (cont.):** c) crack on suction side of blade number 10; and d) image showing foreign debris in the drain hole of blade number 2.

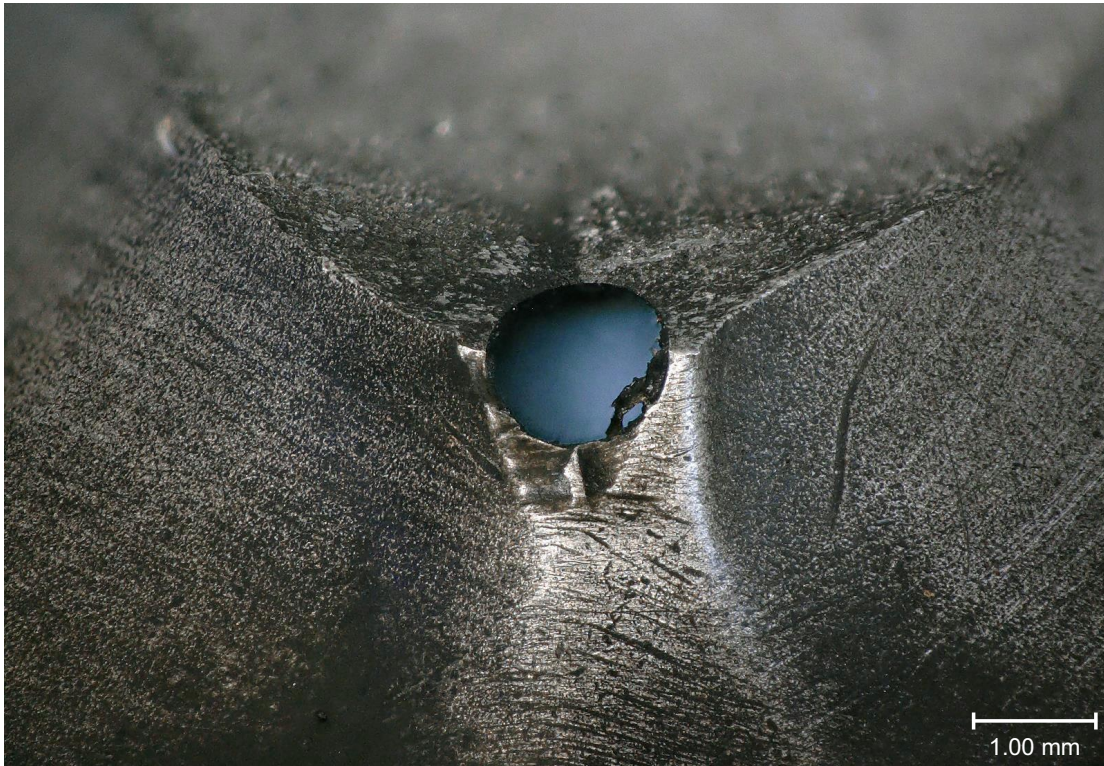
Prior to cutting the fracture surface from the blade root, the piece was sent to an external lab for X-ray computed tomography (X-ray CT) scanning of the blade root in the vicinity of the drain hole to measure the drain hole diameter, inclination angle, and to check for any internal obstructions. The report is included in Appendix A. The drain hole diameter and inclination angle were 1.50 mm and 20.07°, respectively, in accordance with the requirements on the engineering drawing. Deposits were observed on some regions of the drain hole passage, but no obstructions were observed. Later, a fiber optic light was placed inside the blade root cavity and the illumination could be seen at the drain hole outlet, as shown in figure 9, consistent with an open drain hole.

**Figure 9:** View along the longitudinal axis of the drain hole. Backlighting from a fiber optic light is visible through the passage, consistent with no obstruction.

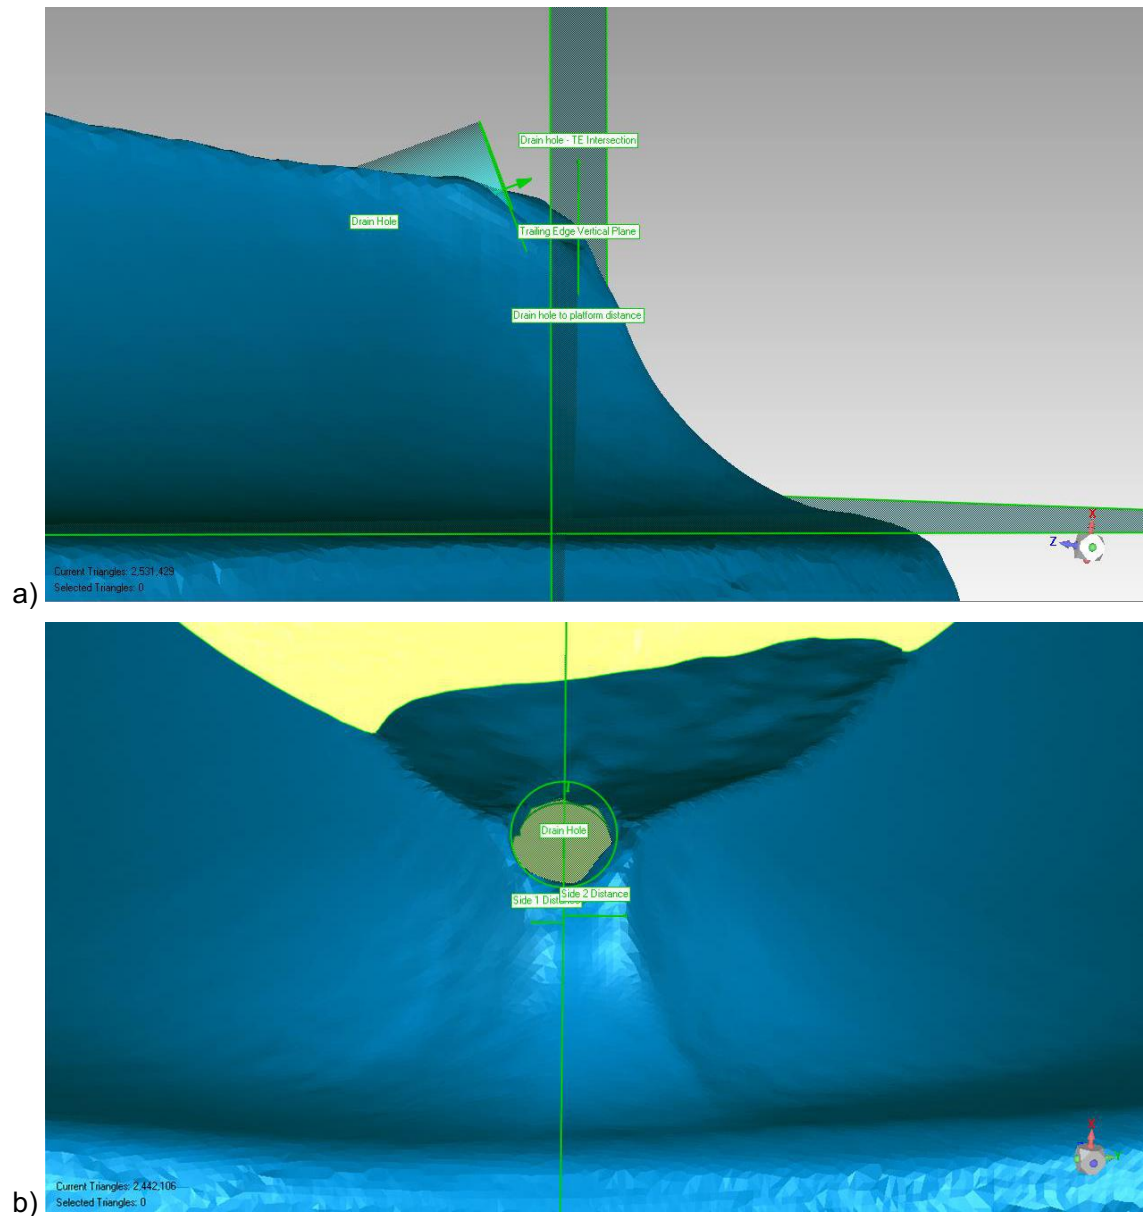
The height of the drain hole outlet above the blade platform and drain hole offset in the rib thickness direction were measured using the 3-dimensional mesh generated by laser scanning, as shown in figures 11a and 11b. The exit height was measured by fitting a cylinder to the drain hole and a plane to the blade platform (see figure 11a). A second plane was constructed that contained the drain hole cylindrical axis and was orthogonal to the blade root platform. A third plane was constructed that was orthogonal to both planes. This third plane was nominally parallel to the aft rib face and was positioned to be coincident with it. The drain hole cylindrical axis was then projected to this plane and its height above the blade platform was calculated to be 3.8 mm, in accordance with the engineering drawing. Using the same fitted and constructed objects, the center offset of the drain hole was determined by picking points on each edge of the rib face (suction and pressure side edges) and measuring the distance of each point from the plane that was constructed through the drain hole axis (see figure 11b). The distance on the pressure side (left side in figure 11b) was 0.5 mm and the distance on the suction side (right side in figure 11b) was 0.9 mm, for a calculated center offset of 0.2 mm, at the acceptance limit on the engineering drawing.

The offset calculated from the 3D scan data was similar in magnitude to the point spacing of the scan data (approximately 0.1 mm spacing between scan points and 0.2 mm for the measured offset). Therefore, the offset was also measured on an image acquired by a digital optical microscope and with a camera and lighting system that was integrated with the SparkMVP. The measured offset on the digital microscope image was measured to be 0.23 mm and the offset values from the SparkMVP, measured twice, were 0.242 mm and 0.205 mm.

**Figure 11:** a) Cylinder, plane, and point objects fit to the model to measure the exit height above the blade platform of the drain hole and b) objects fit to the model to measure the drain hole offset.

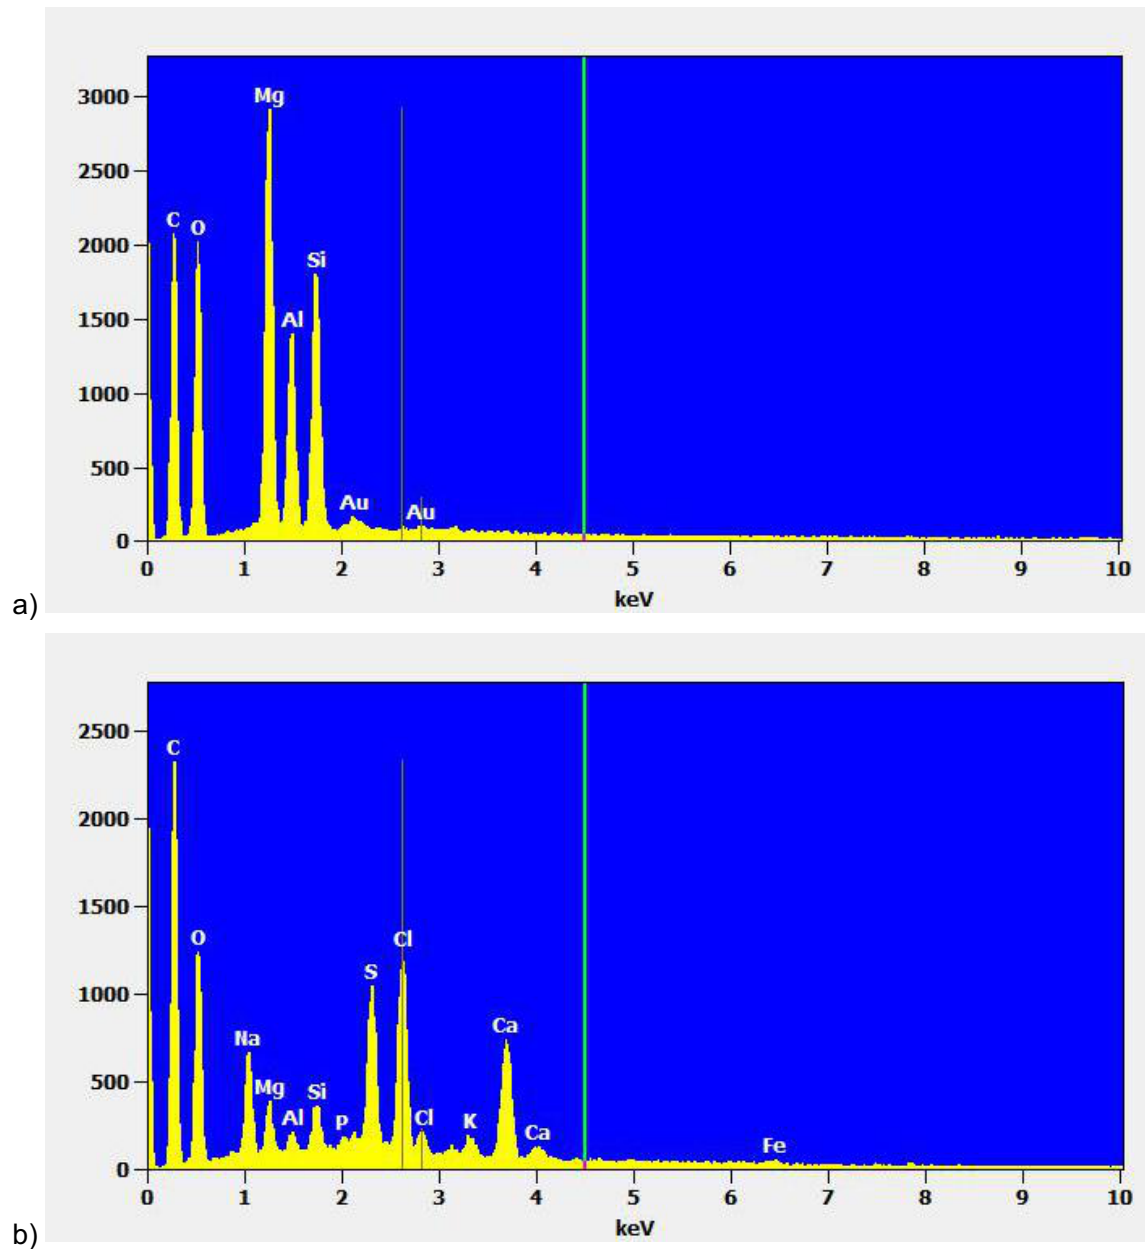
**Figure 12:** EDS spectra from debris removed from the fracture surface by replica tape: a) spectrum exhibiting magnesium (Mg), aluminum (Al), silicon (Si), and oxygen (O) and b) spectrum additionally exhibiting an abundance of sodium (Na), calcium (Ca), chlorine (Cl), and sulfur (S).

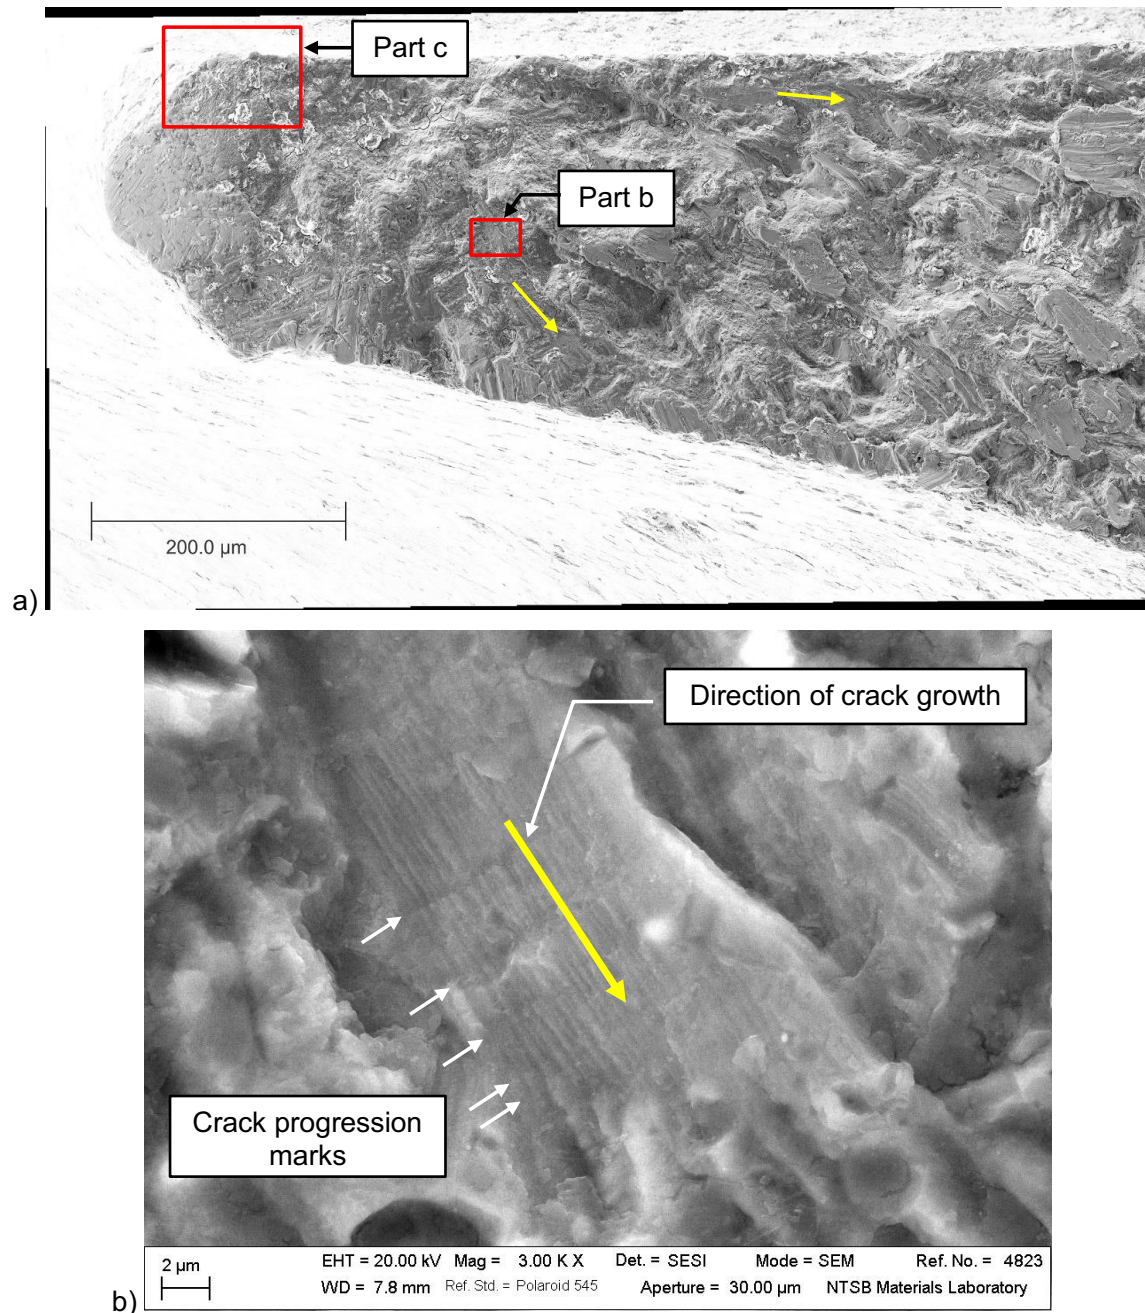
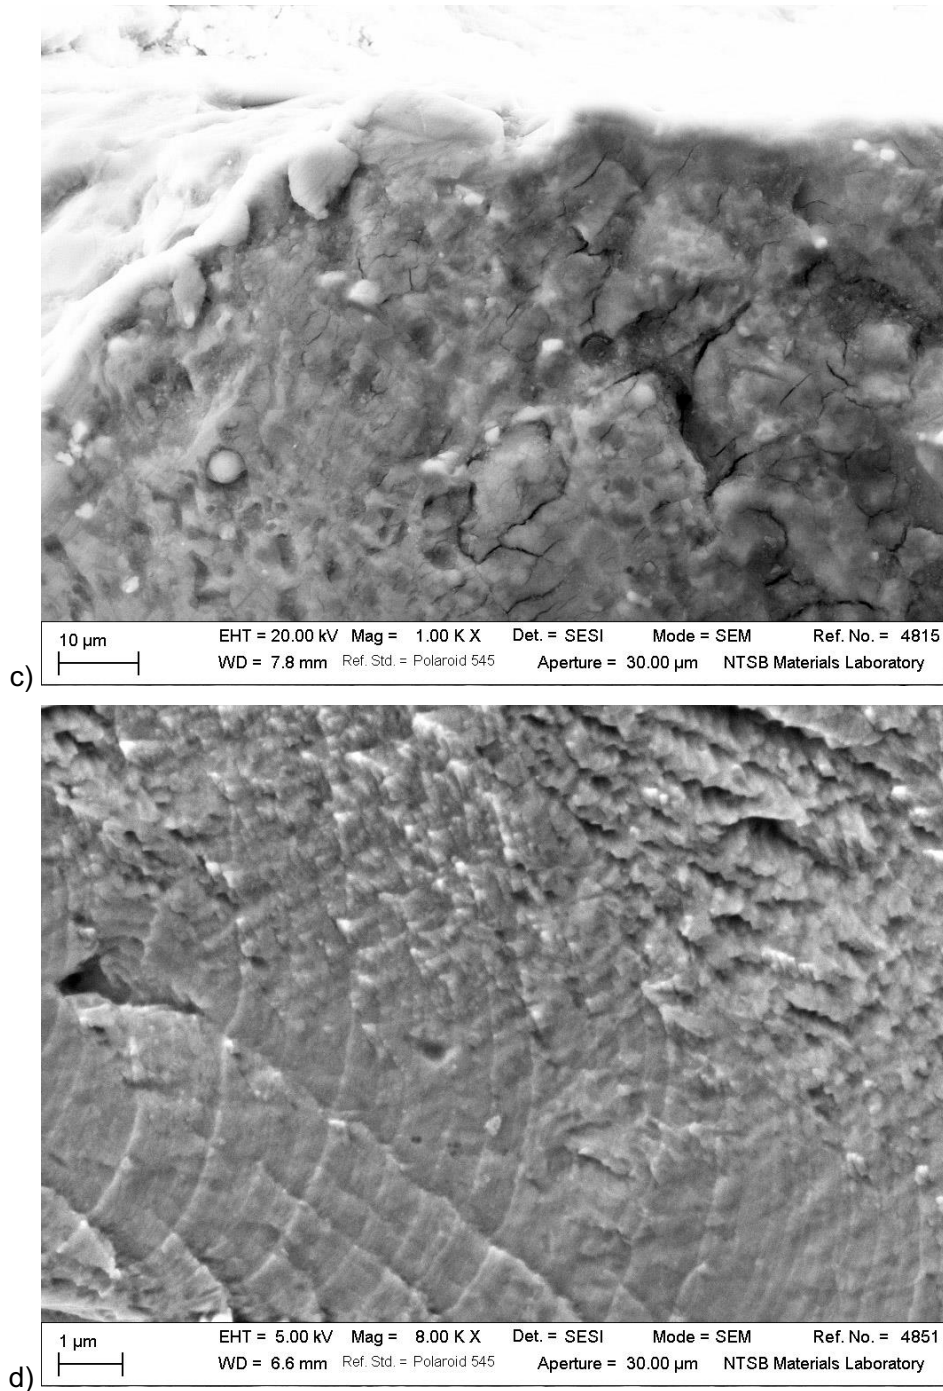
The fracture features were then examined in the SEM. Mosaic SEM images of the fracture on the suction side and pressure side of the drain hole, where it intersected the aft rib face, are shown in figures 13a and 14a, respectively. Much of the fracture surface in this region exhibited contact damage, oxidation, and surface debris. However, some regions exhibited identifiable fracture features such as the region shown in figure 13b. The region exhibited a flat feathery appearance and crack progression marks that were perpendicular to the direction of crack growth (indicated by the yellow arrow in the figure). Other areas exhibited a similar appearance and yellow arrows have been drawn on figures 13a and 14a to indicate the direction of crack growth on either side of the drain hole. The features indicated that the failure started from two separate origins, one on either side of the drain hole at or near its intersection with the aft rib face. The origin areas were examined at higher magnifications, as shown in figures 13c and 14b, but the surfaces had been damaged and there were no identifiable features. Further from the origin, variable-spaced fatigue striations could be observed as shown in figure 14d, consistent with crack growth due to high-cycle fatigue.

The SEM mosaic images were used to measure the chamfer angles in the fracture plane where the drain hole met the aft rib face. On the suction side the angle measured approximately 45° while on the pressure side, the angle measured approximately 107°.

**Figure 13:** a) SEM mosaic of the fracture surface on the suction side of the drain hole and b) higher magnification image at the location shown in part b. Crack progression marks are visible on the fracture surface emanating away from the drain hole in the vicinity of its intersection with the aft rib face.

**Figure 13 (cont.):** c) higher magnification image near the origin at the intersection of the drain hole with the aft rib face; and d) image taken 13.7 mm from the origin, near the center of the blade (thickness direction), showing variable-spaced fatigue striations.

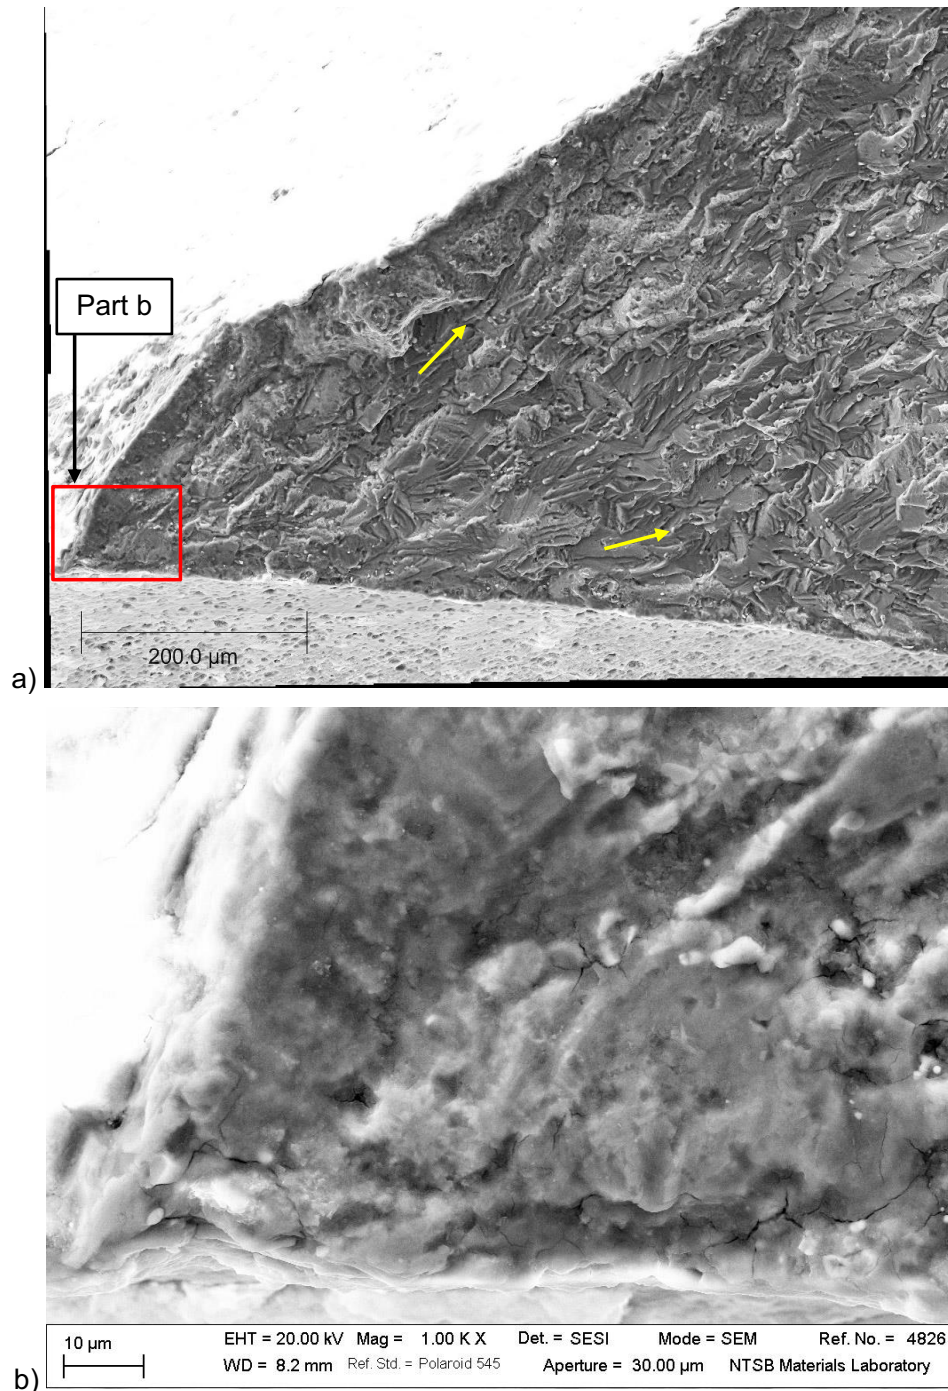
**Figure 14:** a) SEM mosaic of the fracture surface on the pressure side of the drain hole and b) higher magnification image near the origin at the intersection of the drain hole with the aft rib face.

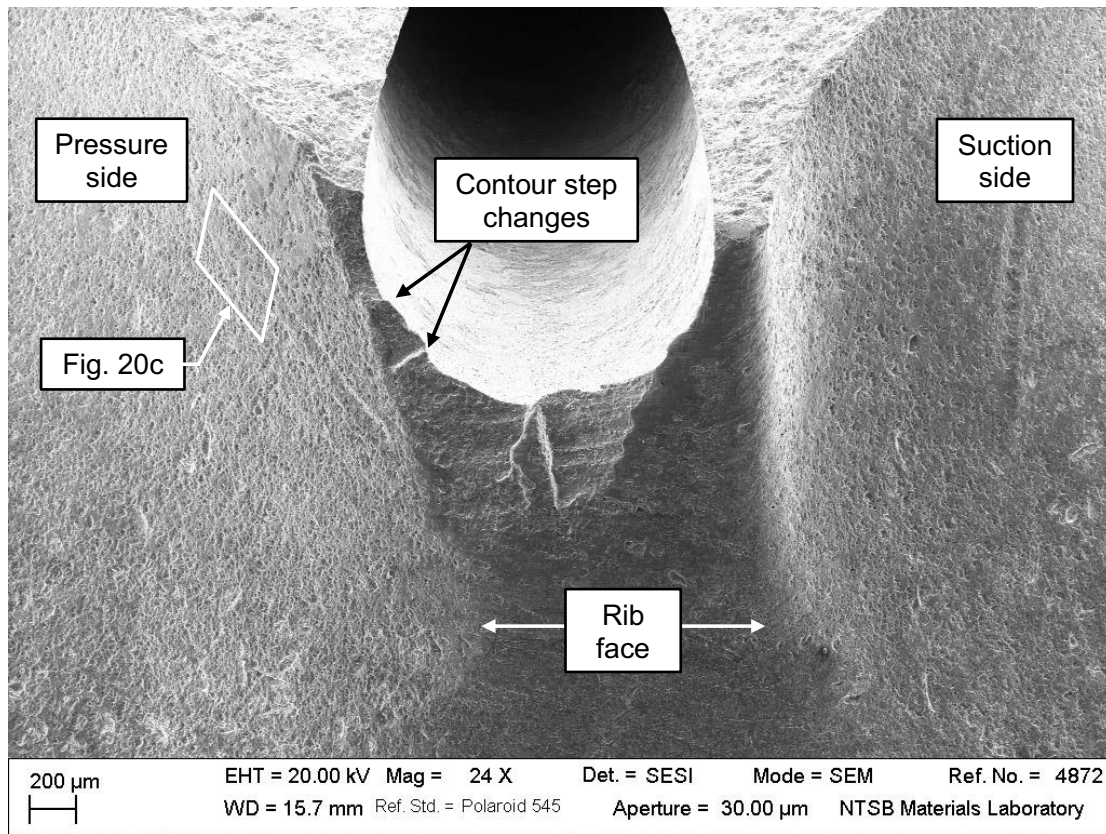
The blade root surfaces along and around the drain hole were examined by SEM and EDS. A low magnification image of the drain hole at the aft rib face is shown in figure 15. The approximate position and width of the rib at the root is indicated in the figure. As previously discussed, the drain hole and rib face were not centered in the thickness direction, with the drain hole located toward the pressure side. On the suction side, the rib face extended vertically up to the fracture. Below the hole and on the pressure side, the surface had an off-angle profile that moved the rib face forward (toward the leading edge). On the pressure side and within this angled region, there were two contour step changes below the fracture as indicated in figure 15.

**Figure 15:** Overview image of the drain hole and rib region.

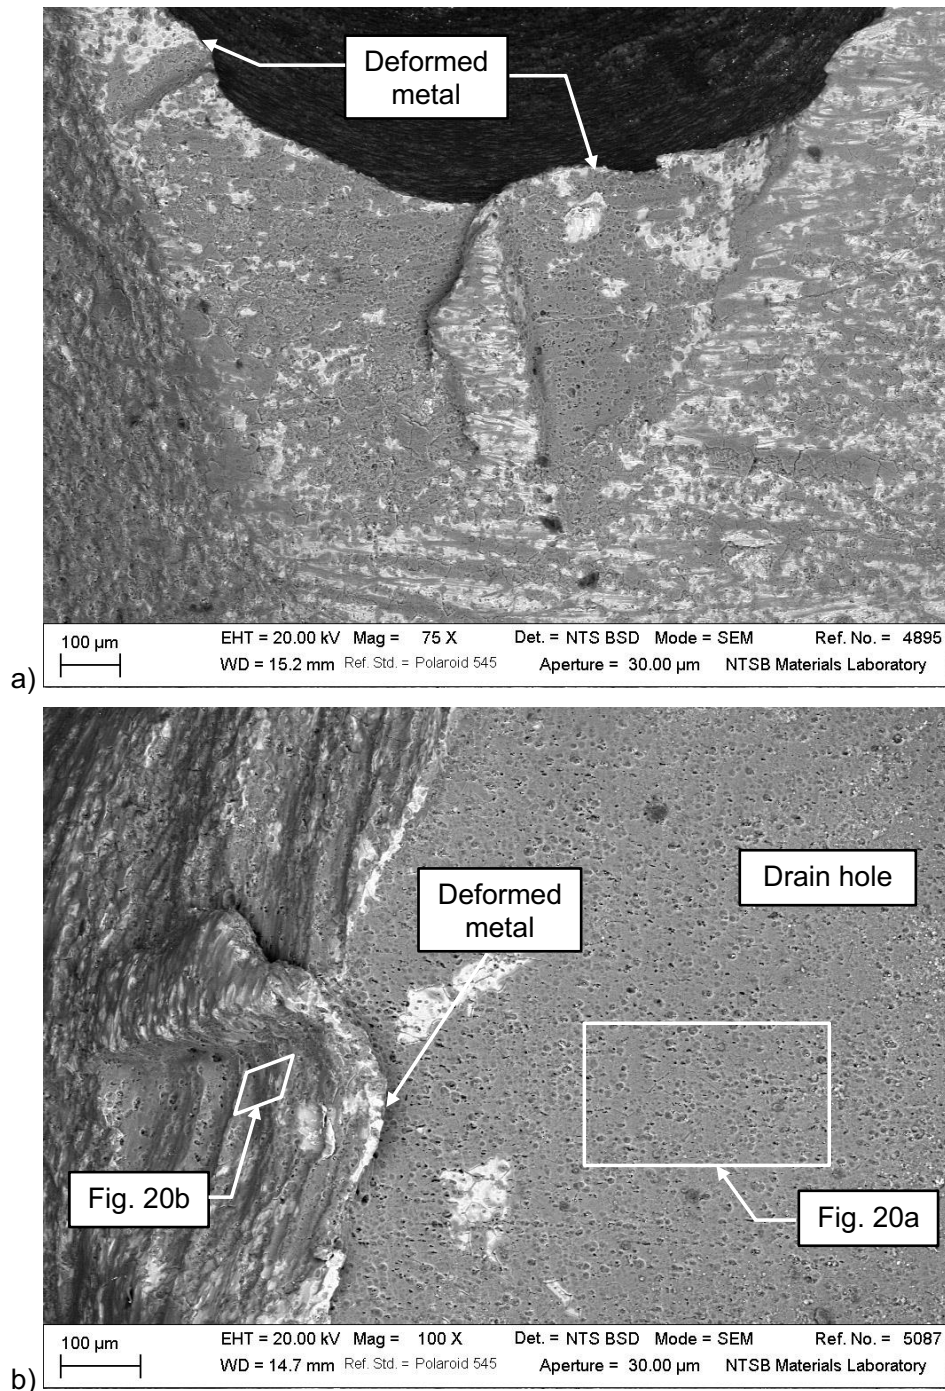
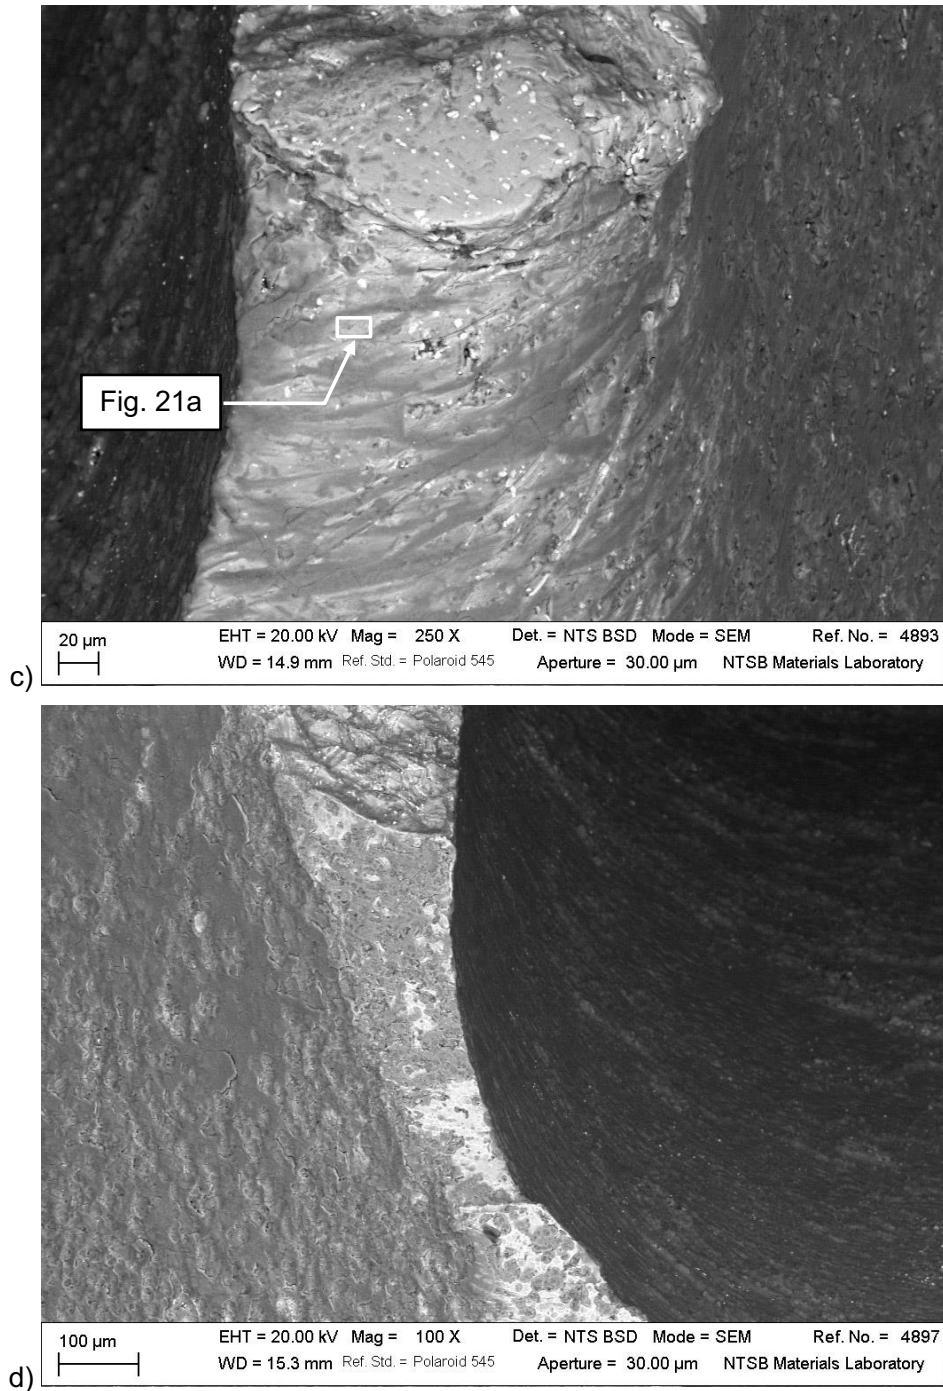
Figure 16a shows a backscatter electron image of the region below the drain hole at higher magnification. The piece of protruding material below the hole appeared to be coplanar with the original rib face contour and the material on either side of appeared to be displaced forward. Deformed material was observed at several locations along the drain hole/rib face edge, as indicated in figures 16a and 16b. Much of the off-angle region exhibited a dark oxidized/pitted appearance, similar to that of the drain hole, as shown in figures 16a and 16b, respectively. The protruding material and the far-field rib surface exhibited lateral grinding/sanding marks and a mixture of light and dark contrast regions. Differences in the rib face surface condition were observed on the suction and pressure

sides of the drain hole as shown in figures 16c and 16d, with the suction side exhibiting grinding/sanding features and the pressure side exhibiting the oxidized/pitted features.

**Figure 16:** Backscatter electron images in the drain hole/rib region: a) rib face immediately below the drain hole; b) surface of drain hole passage at the outlet to the aft face;

**Figure 16 (cont.):** c) aft rib face at suction side of drain hole outlet; and d) aft rib face at pressure side of drain hole outlet.
