# NATIONAL TRANSPORTATION SAFETY BOARD

## MATERIALS LABORATORY FACTUAL REPORT

Report No. 20-028

Place : Kalapana, Hawaii  
Date : March 5, 2020  
Vehicle : Airbus Helicopter EC130-B4, N11QK  
NTSB No. : ANC20LA028  
Investigator : Brice Banning, ASI-ANC

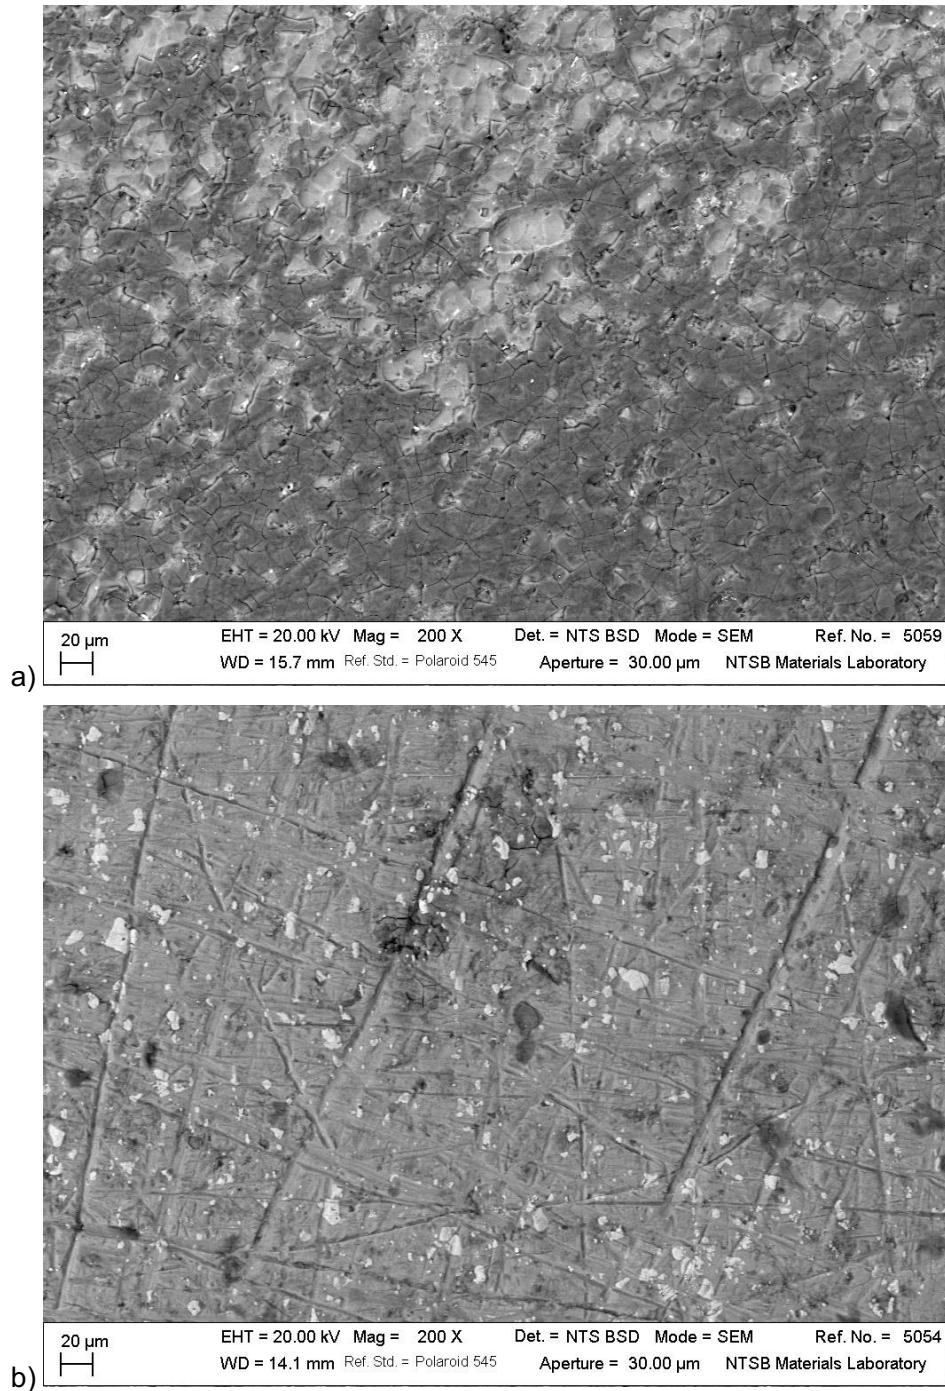
Variations in backscatter images were also observed along the pressure and suction side airfoil surfaces. Both surfaces were examined by SEM just below the fracture starting at the aft rib face and proceeding forward. Pen markings were placed on each surface at 2mm intervals starting at the rib and proceeding forward as shown in figure 17. From the aft rib to approximately 2 mm, the surface exhibited an oxidized/pitted appearance, similar to that noted previously, and backscatter images exhibited both dark and bright regions. Examples for the pressure side and suction side 2 mm forward of the rib face are shown in figures 18a and 19a, respectively. At approximately 4 mm, the surface began to exhibit scratch marks and by 12 mm, the transition to a scratched/abraded texture was nominally complete. Examples for the pressure side and suction side 20 mm forward of the rib face are shown in figures 18b and 19b, respectively.

**Figure 18:** Backscatter SEM images taken along the pressure side airfoil surface forward of the aft rib face (see figure 17): a) 2 mm forward; b) 20 mm forward.

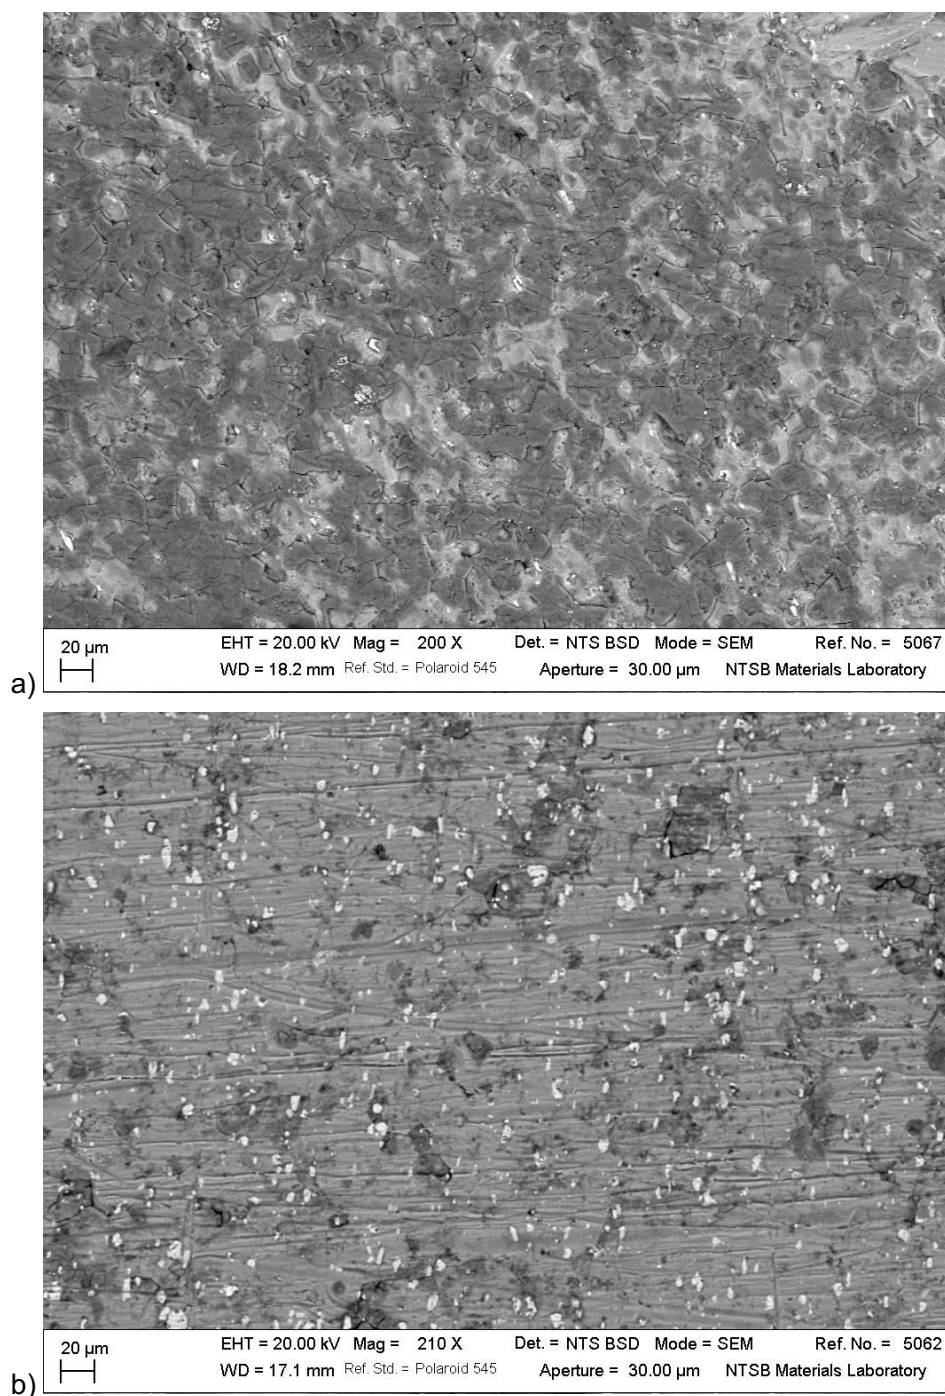
**Figure 19:** Backscatter SEM images taken along the suction side airfoil surface forward of the aft rib face (see figure 17): a) 2 mm forward; b) 20 mm forward.

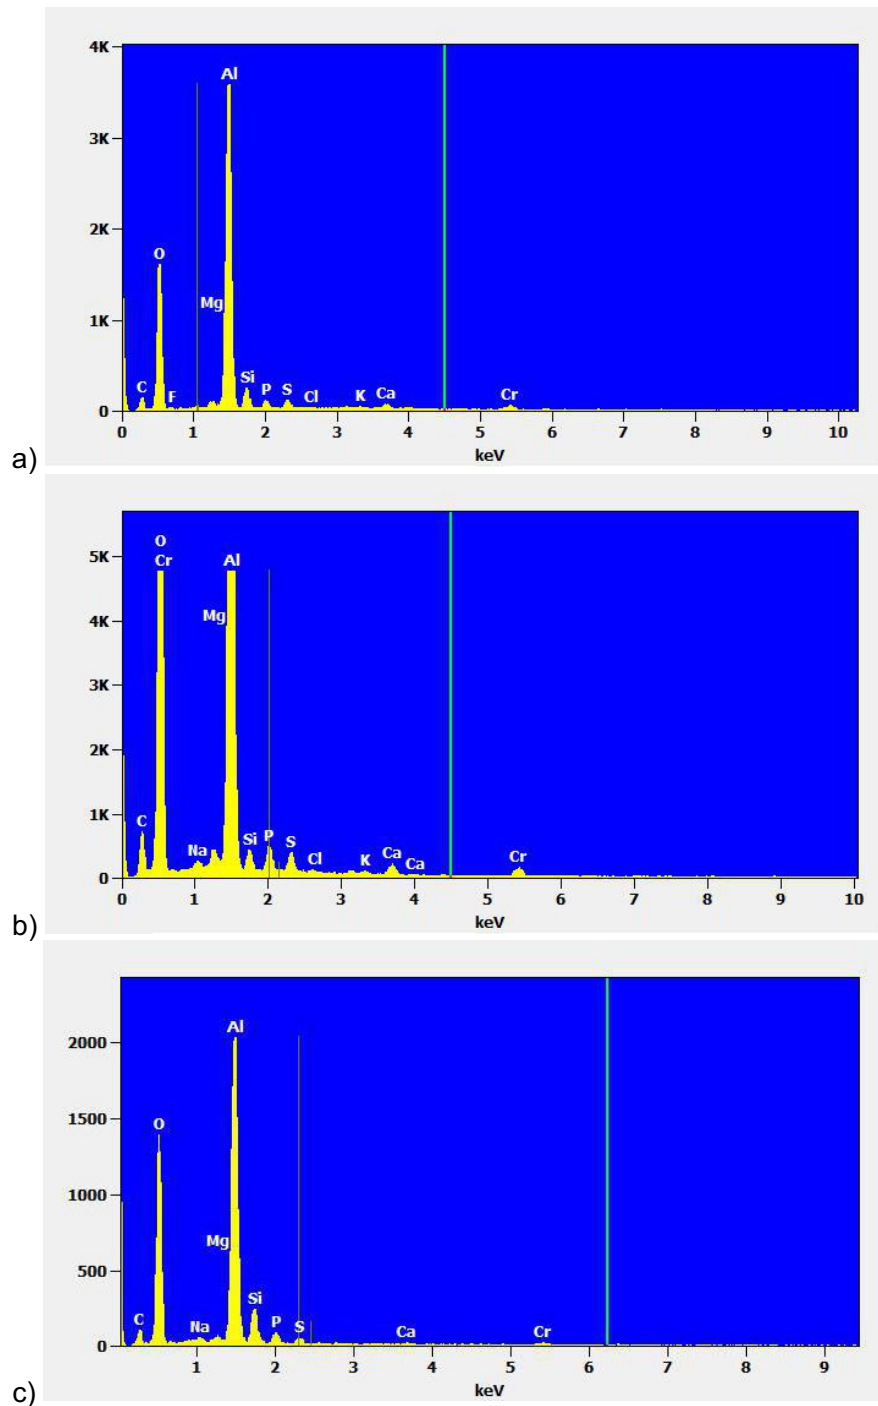
The composition of the dark contrast oxidized/pitted regions and the bright contrast scratched/abraded regions were examined in the SEM using EDS. Spectra for the drain hole passage (see figure 16b), material below the drain hole (figure 16b), and a spot on the pressure side of the blade (figure 15) are shown in figures 20a – c, respectively. These regions all exhibited the oxidized/pitted appearance and the dark backscatter contrast. Spectra for a scratched region on the suction side of the rib face (figure 16c) and a scratched/abraded region on the suction side of the blade are shown in figures 21a and b. These regions displayed bright backscatter contrast. The spectra in figure 20 all exhibited a chromium (Cr) peak and comparatively large oxygen peak. By comparison, neither of the spectra in figure 21 exhibited a chromium peak and the oxygen peak was comparatively less abundant. Information provided by Airbus Helicopter indicated that the blades are anodized using a process that contains chromic acid. In addition, the aircraft operator indicated that the blades were periodically cleaned using an abrasive scrubbing pad to remove accumulated dirt.

**Figure 20:** EDS spectra showing the presence of chromium and a comparatively abundant oxygen peak: a) drain hole passage; b) displaced/off angle region below drain hole; and c) oxidized/pitted region on pressure side of airfoil.

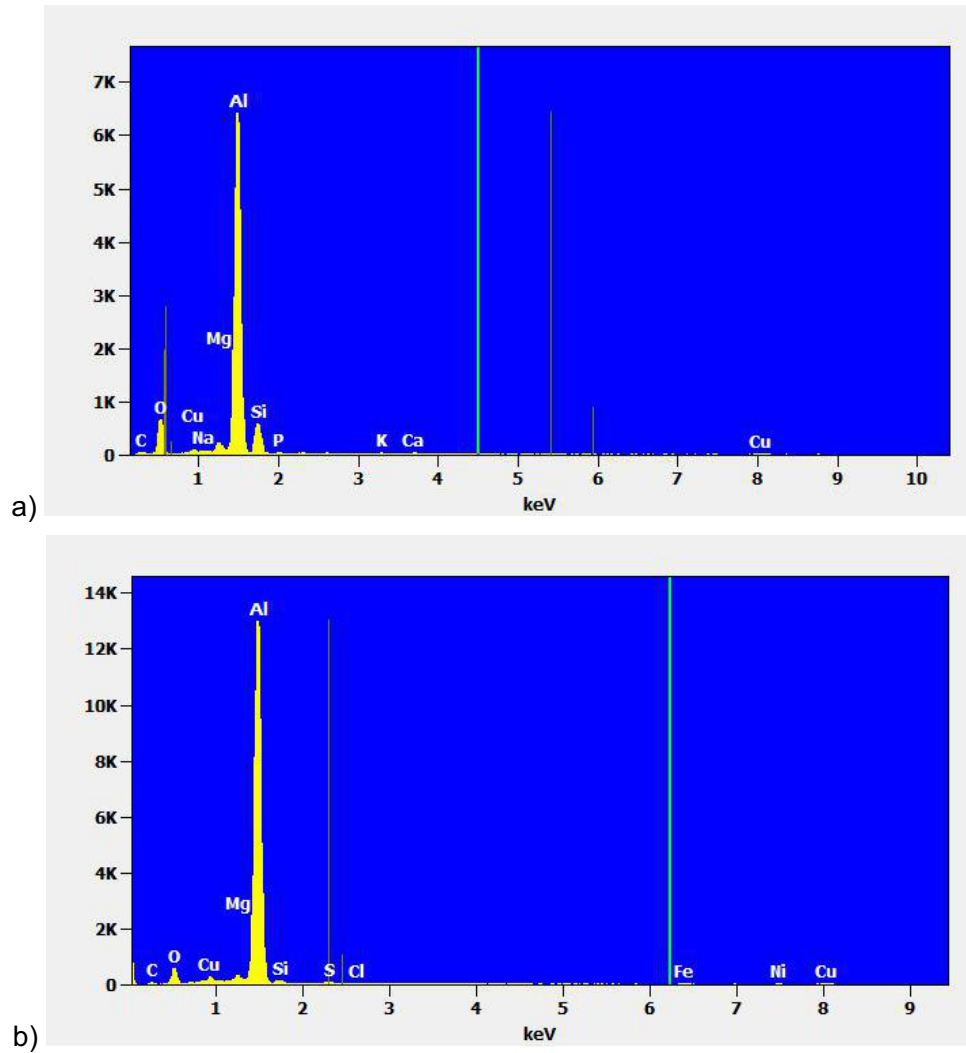
**Figure 21:** EDS spectra showing primarily aluminum: a) abraded region on aft rib face – suction side of drain hole and b) abraded surface region on suction side of the airfoil.

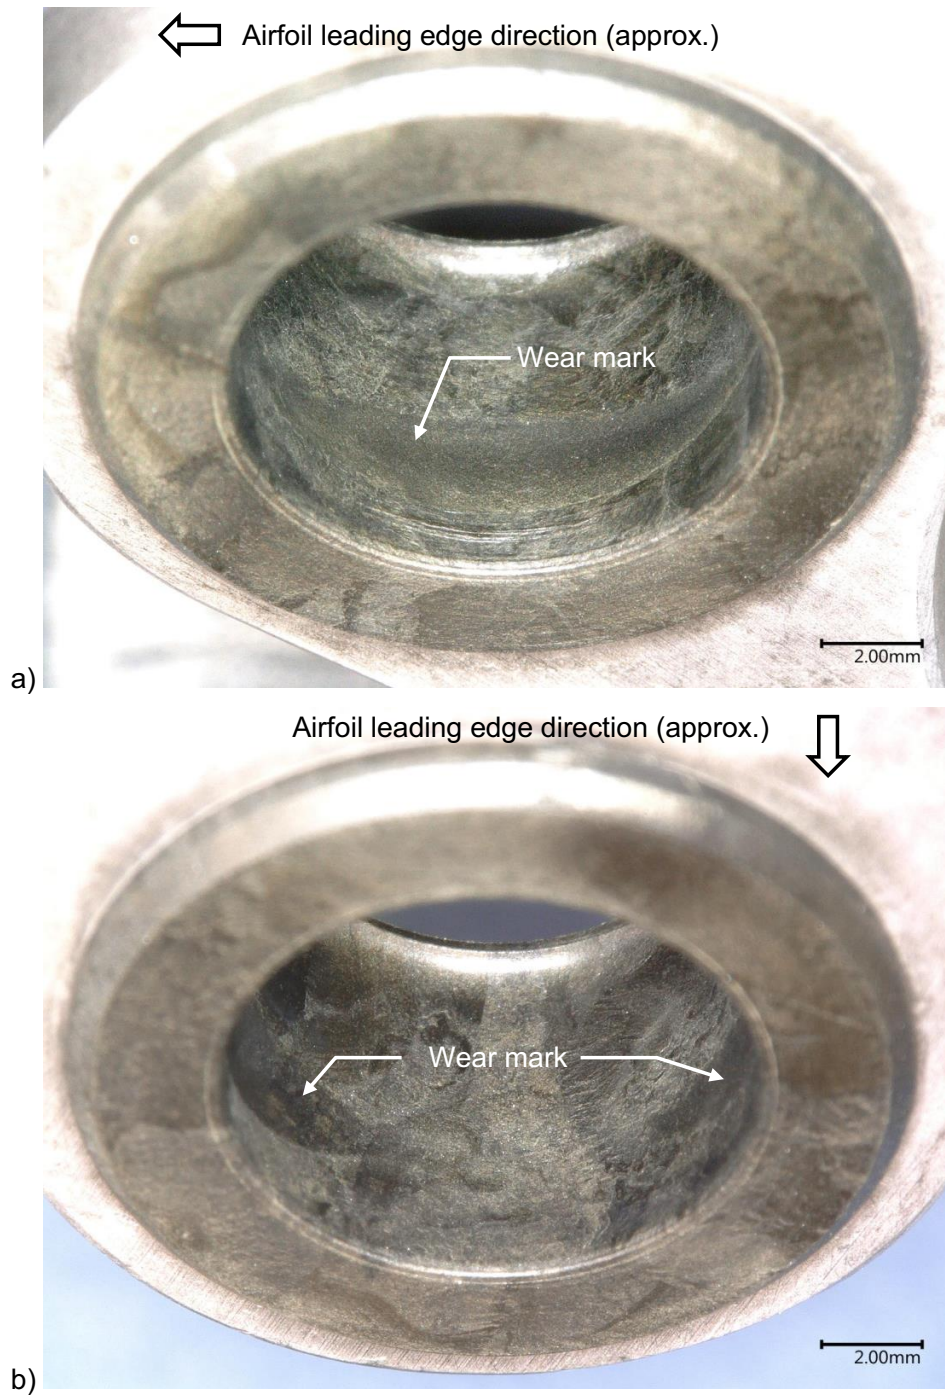
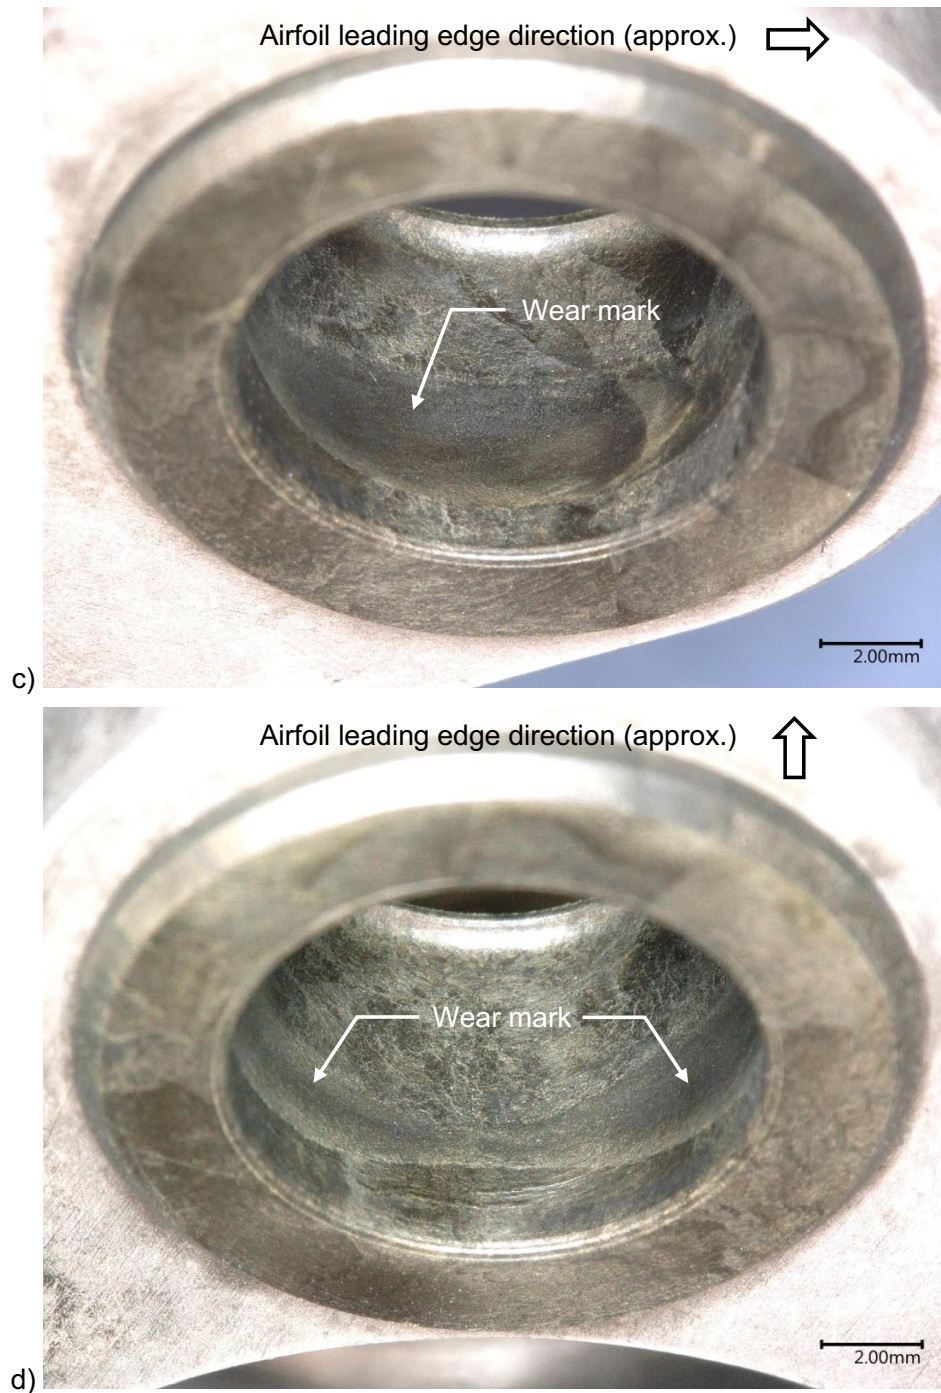
The pitch change bearing (see figures 3 and 22) was examined with the aid of a stereomicroscope and exhibited wear on the bearing face. Images of the wear marks were taken using a digital optical microscope, as shown in figures 23a – d and indicated in figure 22, starting toward the suction side of the airfoil and proceeding clockwise (the blade viewed radially outward as in figure 22).<sup>1</sup> Wear marks were observed toward the suction and pressures sides of the bearing, as seen in figures 23a and c. The two wear marks extended around the bearing face and met near the trailing edge direction as seen in figure 23d.

**Figure 23:** Images of the pitch change bearing surface showing the location and extent of wear marks: a) oriented toward the suction side b) oriented toward the leading edge

**Figure 23 (cont.):** c) oriented toward the pressure side; and d) oriented toward the trailing edge.

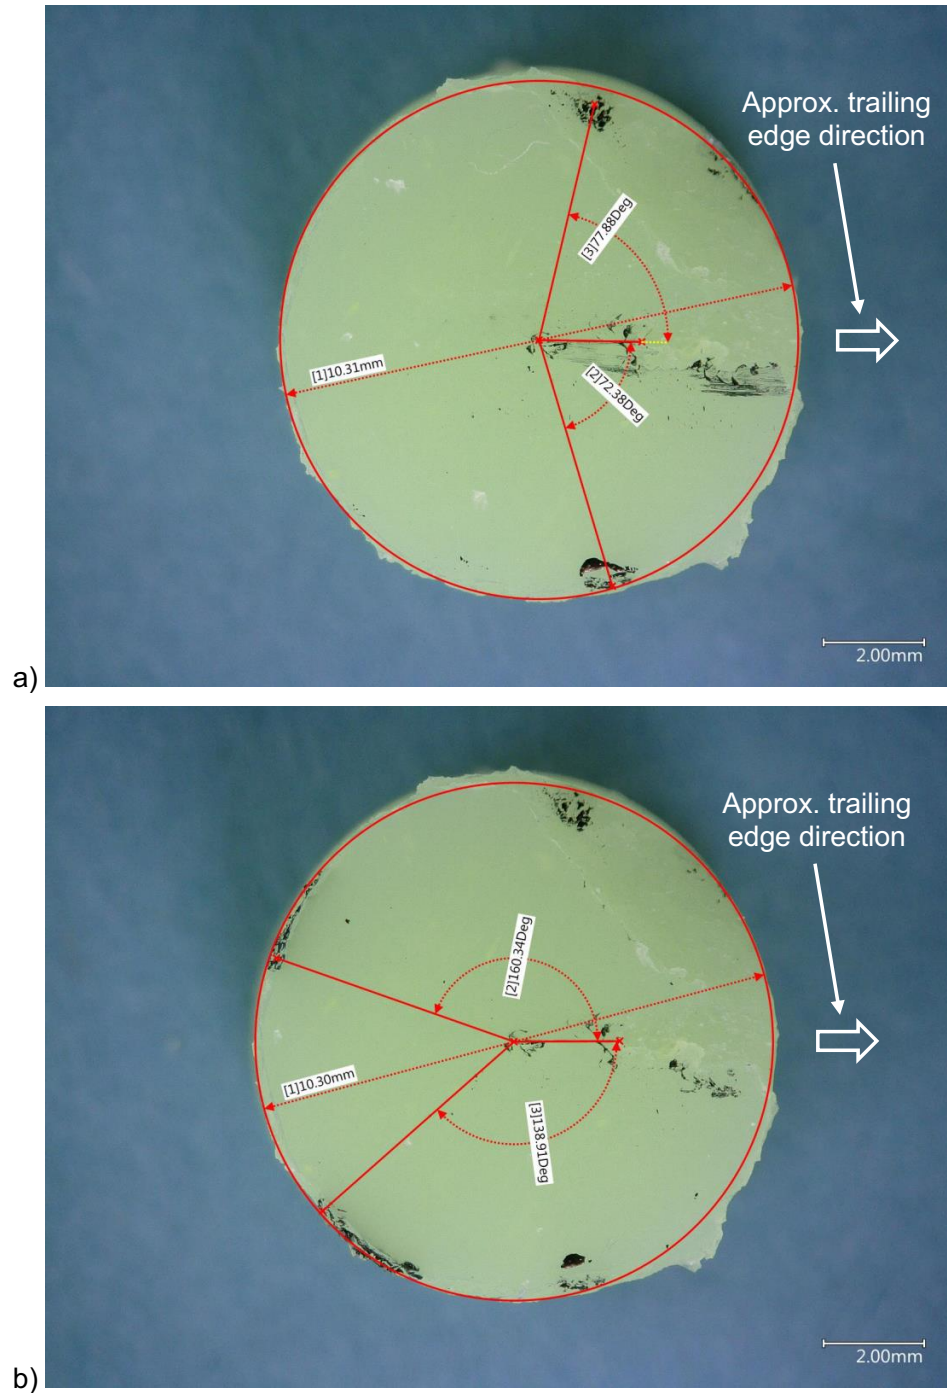
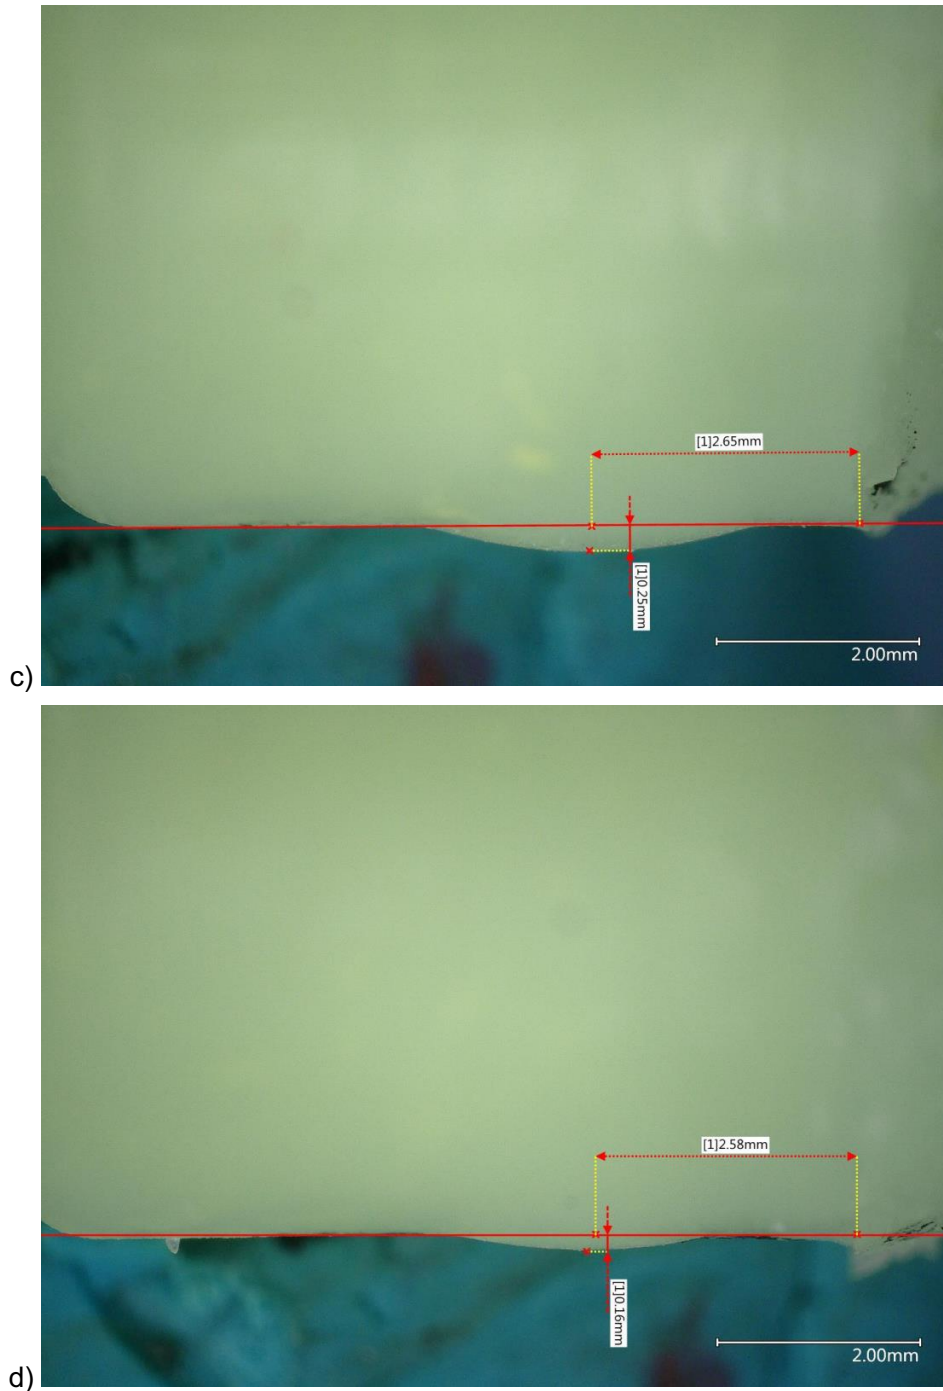
was extruded from the cavity. The replica was viewed under a stereomicroscope and both the angular position of greatest wear mark width and the angular extent of each wear mark was indicated on the replica. Starting from the nominal trailing edge direction, the wear mark widths were greatest at  $77.9^\circ$  in the counterclockwise direction (toward the pressure side) and  $72.4^\circ$  in the clockwise direction (toward the suction side), as shown in figure 25a. The arc angle of each wear mark was approximately  $160^\circ$  in the counterclockwise direction and  $139^\circ$  in the clockwise direction, as shown in figure 25b.

The maximum wear depth at its greatest width and the distance of the maximum depth from the (radially inward) end face of the bearing were also measured off the replica as shown in figures 25c and 25d. In the counterclockwise direction (toward the pressure side), the maximum wear depth was approximately 0.25 mm at 2.65 mm from the bearing end face. In the clockwise direction (toward the suction side), the maximum wear depth was approximately 0.16 mm at 2.58 mm from the bearing end face.

**Figure 25:** Rubber mold with measurements: a) the angular position where the wear mark was greatest in width; b) the arc angle of each wear mark;

**Figure 25 (cont.):** c) depth of wear and distance from bearing end face for the wear mark closer to the pressure side of airfoil; and d) depth of wear and distance from bearing end face for the wear mark closer to the suction side of airfoil.

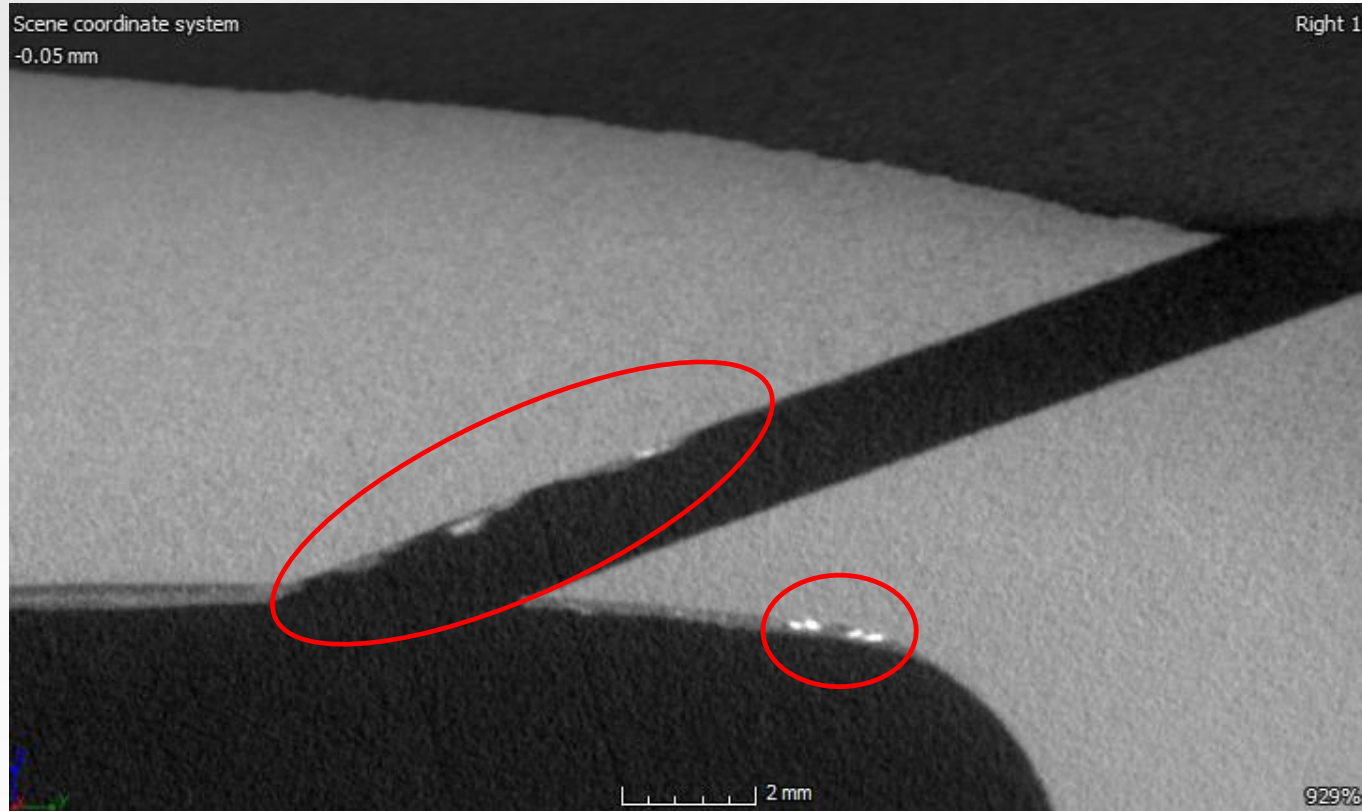
# Drain Hole Foreign Material

- Variation in brightness in indicated areas suggest the presence of foreign material along the wall of the drain hole
- Brighter Areas = Higher Density Material
- Darker Areas = Lower Density Material
