**NATIONAL TRANSPORTATION SAFETY BOARD**  
**Office of Aviation Safety**  
**Washington, D.C. 20594**

**HELICOPTER SPECIALIST'S FACTUAL REPORT**

**NTSB No: ANC20LA028**

Operator: Blue Hawaiian Helicopters LLC  
Aircraft: Airbus EC-130 B4, N11QK  
Location: Kalapana, HI  
Date: March 5, 2020  
Time: 1130 HST

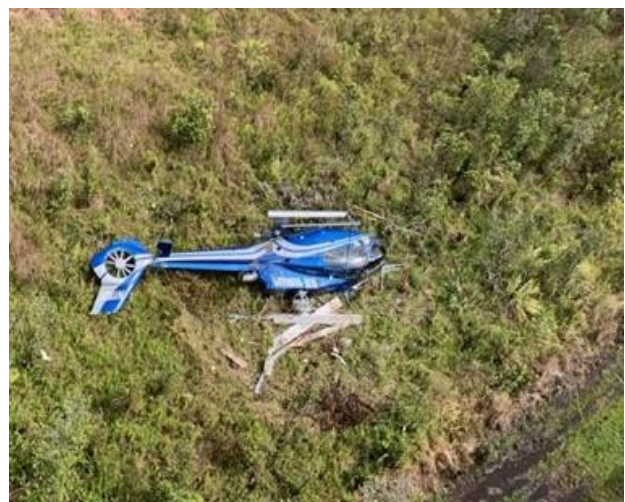
Photo 1 - Overhead photo of accident site.

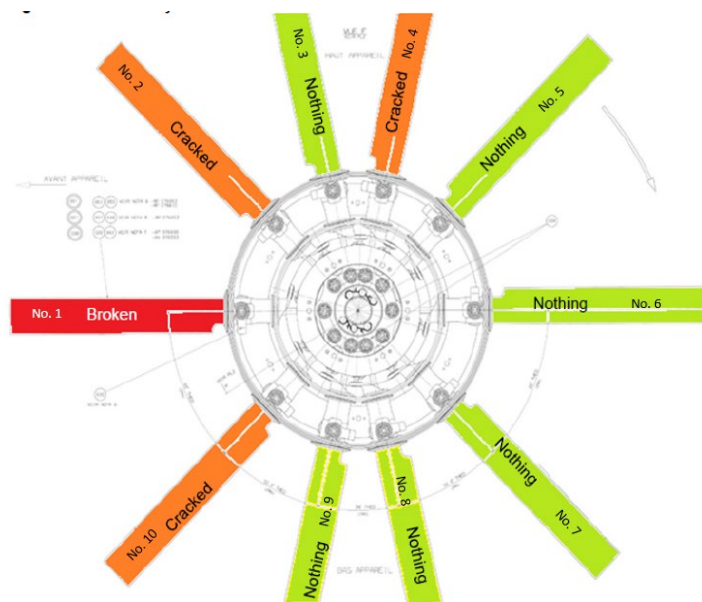
All 10 of the fenestron blades assemblies were in the hub. One of the blades (S/N M8916) had been liberated at the blade root, nearest the blade's drain port; the blade root end remained attached and installed to the fenestron hub. The liberated blade section was located within the fenestron outer fairing/shell. The fenestron blades were numbered 1-10 by the investigative team, with No 1 being the subject liberated blade. The fracture surface on the root end of the liberated blade had a discolored area at the trailing edge, the mid-section was flat, and the forward section exhibited shear lips. The trailing edge of the blade that was marked as Blade # 5 exhibited trailing edge damage approximately 1 cm in diameter near the root. All 10 blades were sent to the NTSB lab for further examination.

Figure 3 - Illustration identifying the location of the ruptured, cracked, and non-cracked blades.<sup>3</sup>

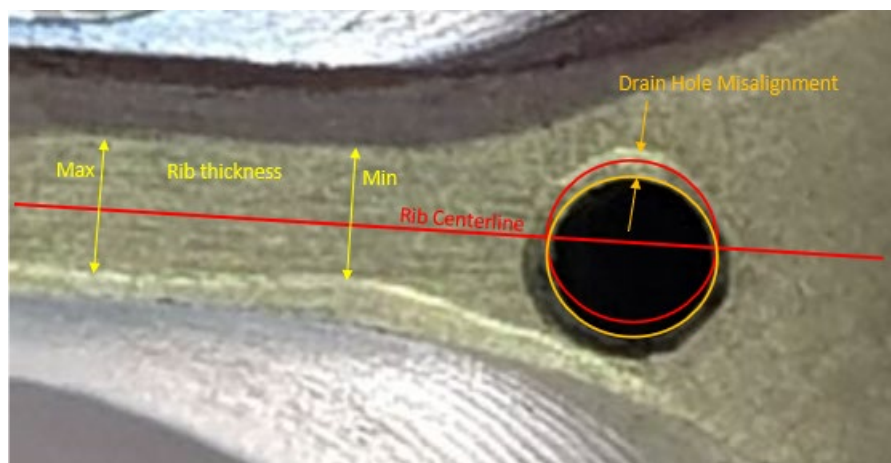
Figure 5 - Measurement location illustration

The Airbus Laboratory concluded that blade 1 failed in the drain hole area from fatigue crack propagation. Blades 2, 4, and 10 are cracked on the suction side of the blade in the drain hole area, and crack features were consistent with fatigue. The crack initiation location for blades 2, 4, and 10 were characterized by burrs. Additionally, it was noted that the rib thickness on blade 1 was irregular and showed evidence of rework<sup>7</sup>. Blades 2, 5, 6, 7, 9, and 10 also showed evidence of rework.

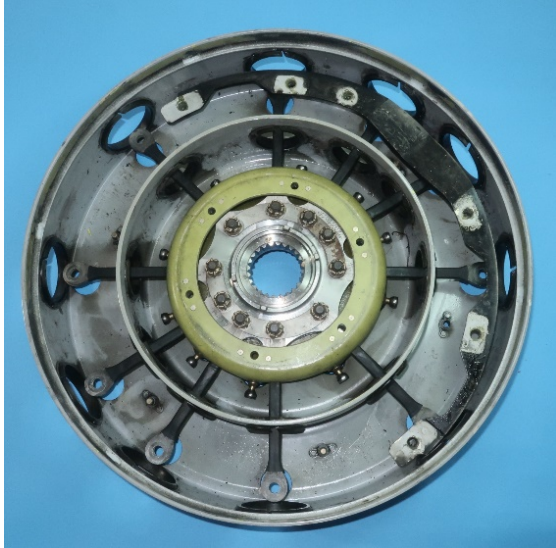
*Photo 1 - Fenestron hub as received*

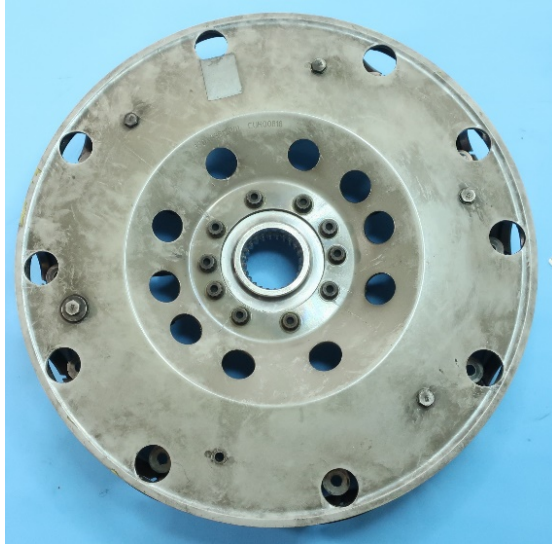
*Photo 2 - Fenestron hub as received*

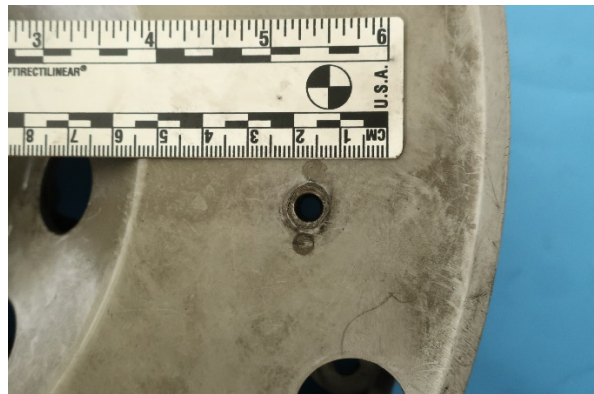
The fenestron hub is able to receive up to 6 balance bolts on the inboard (right) side of the hub which are installed depending on the balancing requirements. Only 5 of the bolts were observed installed. A shadowing of soot from a balance bolt that had been installed, existed around the hole that was missing its balance bolt. The empty/missing bolt hole also happened to be the one nearest the fenestron blade that was liberated. A review of the maintenance records compared with the hour meter installed in the helicopter showed that the total hours on all the fenestron blades were 4,410.9 at the time of the accident. The fenestron fairing interior circumference had score marks aligned with the tip path of the fenestron blades. An 18-inch-long hole along the fenestron blade tip path and outboard of the fenestron drive shaft had been cut out. The leading edge of the fenestron fairing had a hole the shape of the blade end over the tail rotor drive shaft cover. The broken fenestron blade was located within the fenestron fairing.

*Photo 3 - Closeup of missing balance weight location.*

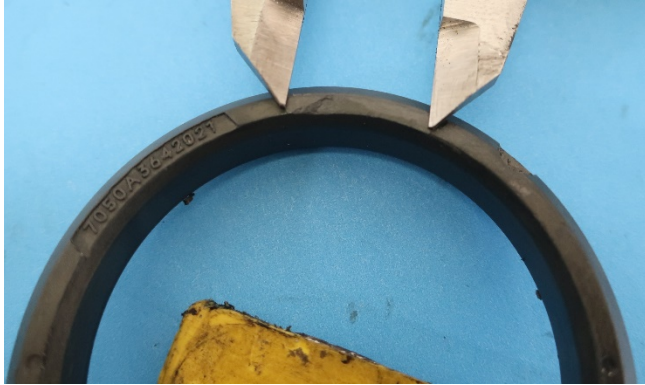
The number 1 bearing exhibited a 15.6 mm abrasion on the outboard face.

*Photo 4 - No. 1 outer bearing showing abrasion mark on the outer face.*

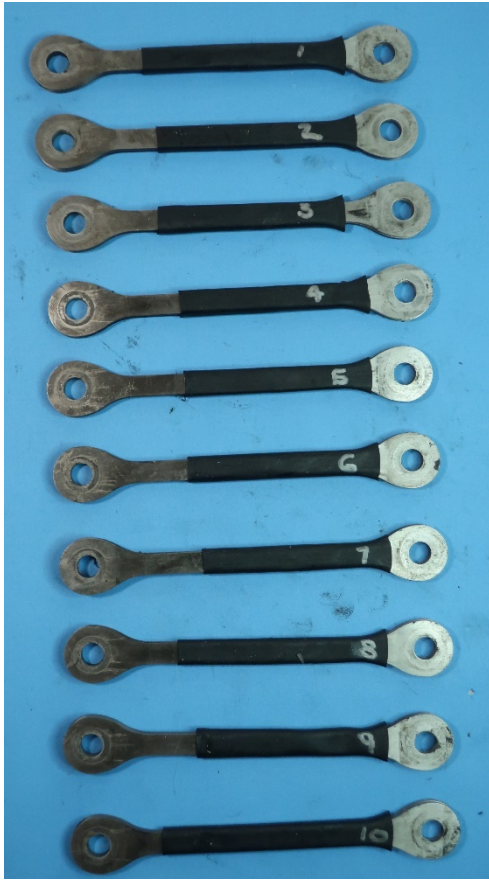
*Photo 5 - Torsion bars, front sides*

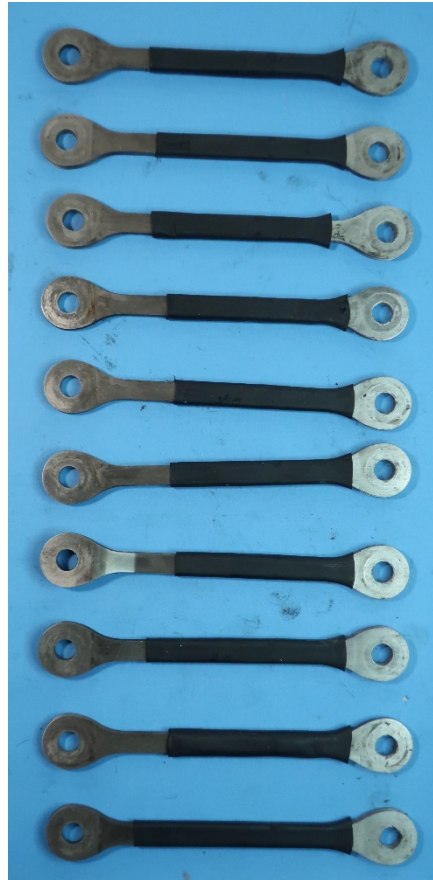
*Photo 6 - Torsion bars, back sides*
