**National Transportation Safety Board**  
Office of Research and Engineering  
Washington, D.C. 20594

## Airplane Performance Study

**Location:** Eagle River, Alaska  
**Date:** April 11, 2020  
**Time:** 2025 Alaska daylight time  
**Airplane:** Cessna A185E, N185RN  
**NTSB Number:** ANC20LA043

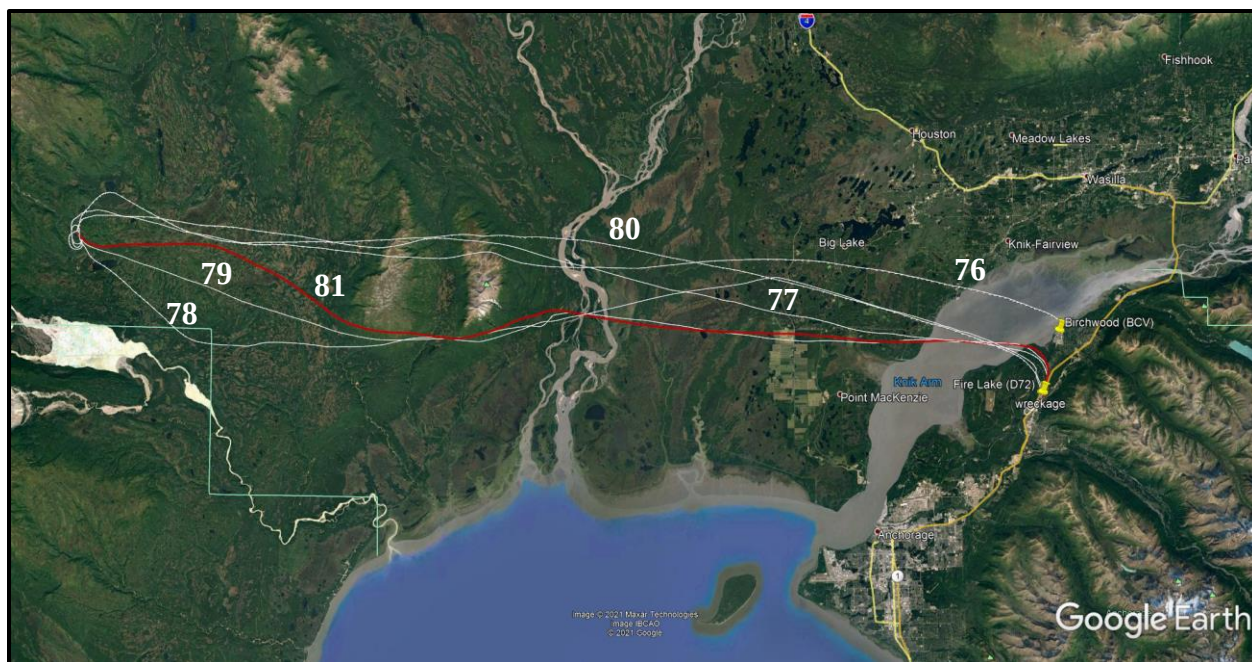
**Figure 3: GPS Recorded Ground Tracks including Accident Flight, Airlog 81**

The GPS data were unremarkable and did not indicate any problems. The accident occurred shortly after the end of Airlog 81 as shown in Table 1 as N185RN was returning to Fire Lake from camp, about 75 miles away. Note: the logs start at Birchwood airport (BCV) where N185RN last filled up with fuel. BCV is located approximately 4 NM north of Fire Lake. See Figures 4 thru 7.

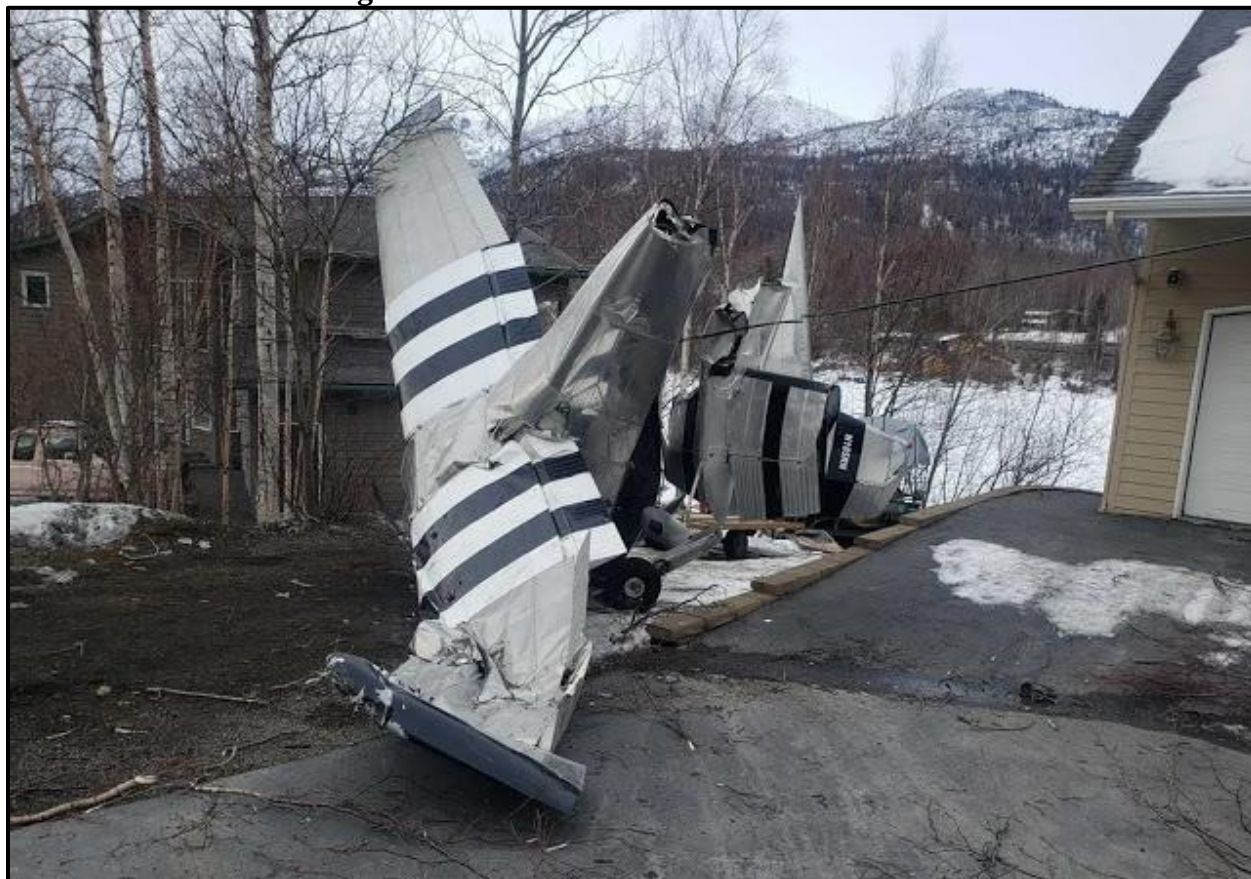
**Figure 8: Wreckage**

Figure 8 is a picture of the wreckage. Assuming N185RN exhausted its fuel supply on the day of the accident<sup>3</sup>, the average fuel burn would have been approximately 19 GPH based on the maximum useable fuel and the total time from Table 1: 78 gallons/4.1 hr = 19 GPH. However, as stated previously, detailed airplane performance with the Continental IO-550-D engine do not exist.

<sup>3</sup> The FAA inspector that documented the wreckage site observed no fuel on the ground, no odor of fuel, and no post-accident fire.
