# NATIONAL TRANSPORTATION SAFETY BOARD

## MATERIALS LABORATORY FACTUAL REPORT

Report No. 20-041

Place : Ambler, Alaska  
Date : May 31, 2020  
Vehicle : Zenith STOL CH-701, N324WS  
NTSB No. : ANC20LA053  
Investigator : Noreen Price, AS-ANC

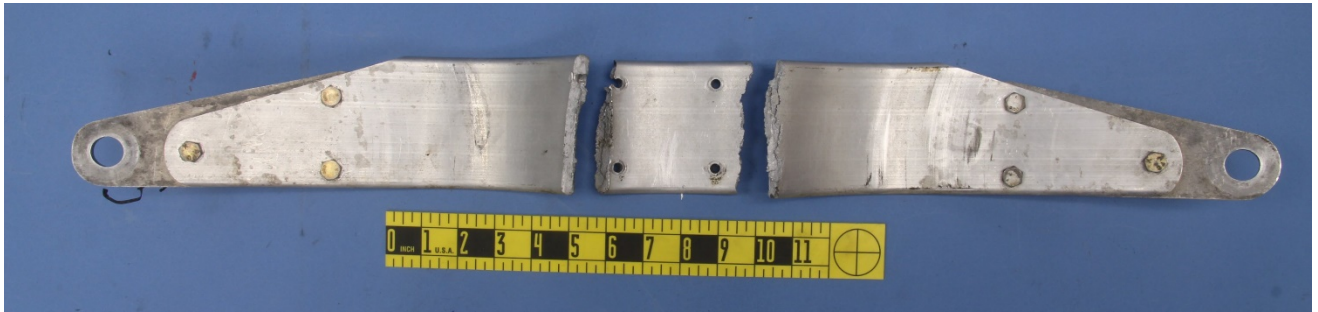
Figure 1 through Figure 3 show the pieces of the fractured nose wheel fork, as received. The component had fractured into three fragments at two fracture locations. The fracture locations were located at or near the four attachment bolt holes. The fractures were both oriented perpendicular to the longitudinal rolling, or forging, direction of the fork.

The interior, or concave, surfaces exhibited some circular wear marks, located on both tangs (see Figure 1 and Figure 3). These marks contained alternating dark streaks, consistent with rubber residue from the adjacent tire, and reflective metallic marks, consistent with gouges in the concave surfaces of the fork. These features were consistent with heavy contact from the adjacent wheel.

Figure 1 – The three fork pieces, as received, viewed from the bottom surface upward, laid flat.

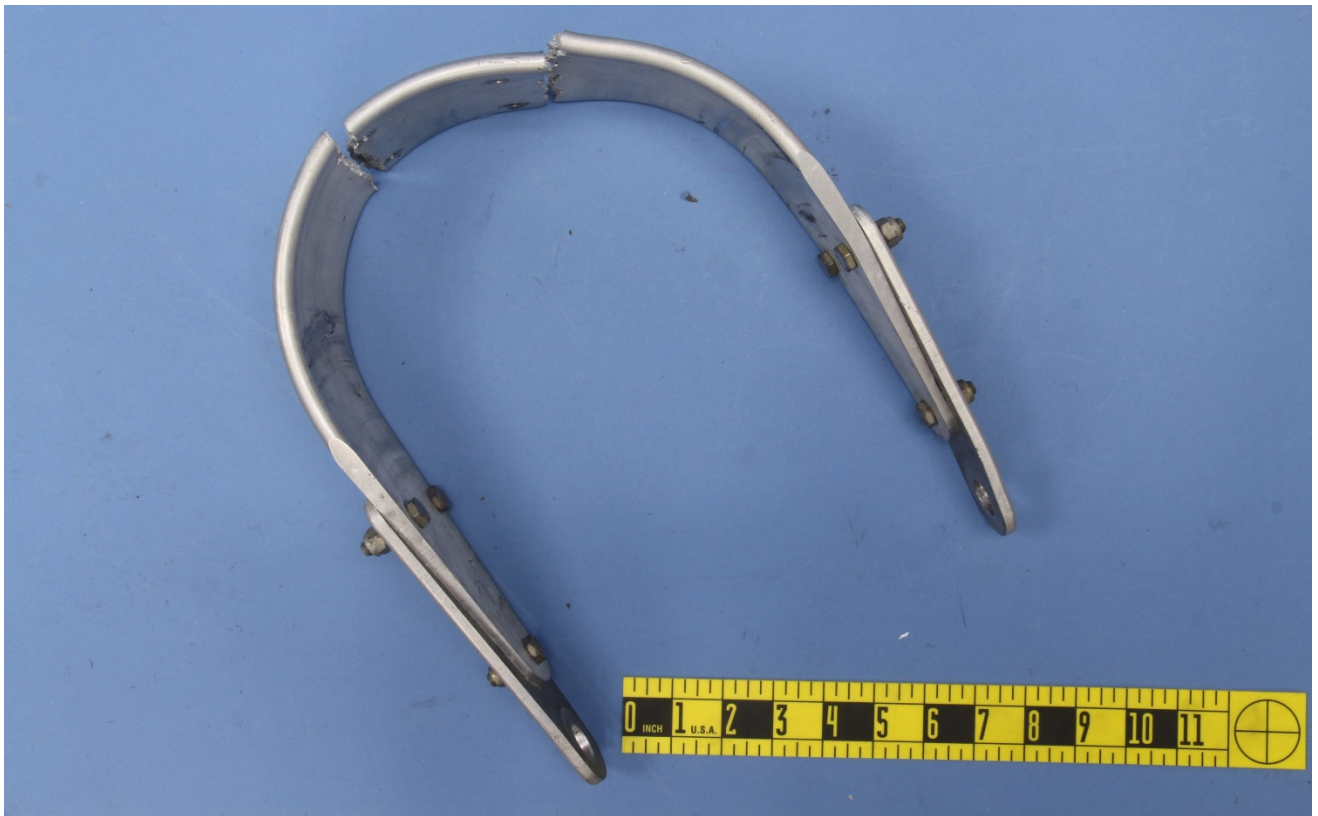
Figure 2 and Figure 4 demonstrate the relative positions of the fractured fork pieces at the time of fracture. The fracture surfaces were located just outside the darker square area seen in Figure 4. This area was consistent with residue from environmental exposure

Figure 2 – The three fractured fork pieces, positioned in their locations at fracture, viewed from the side.

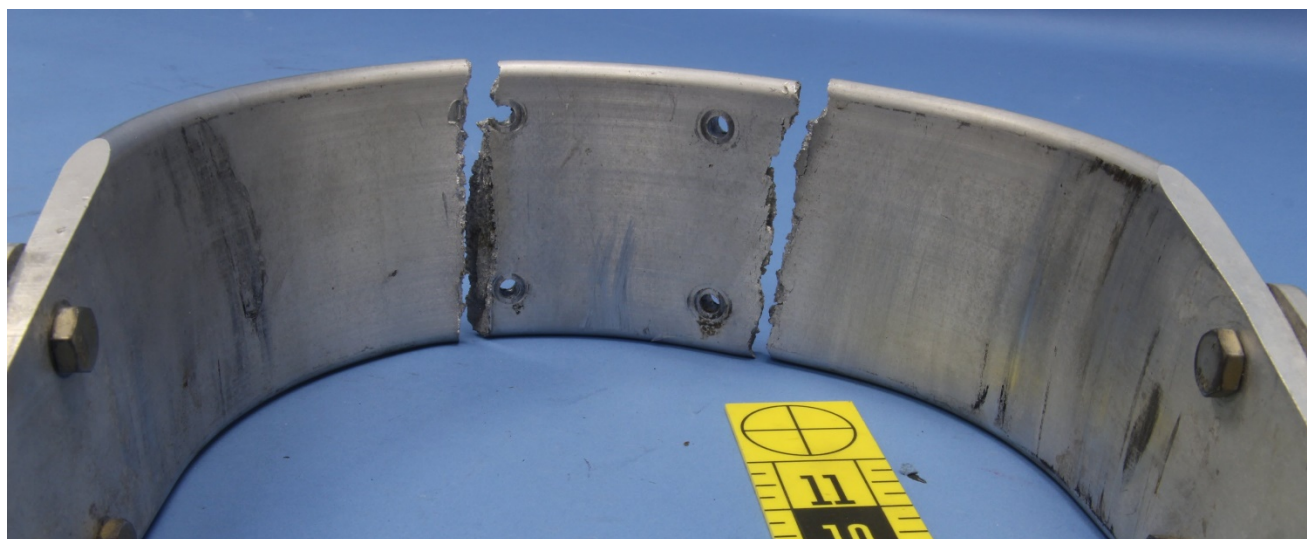
The outer surfaces adjacent to the fracture surfaces in Figure 4 exhibited material exuding outward, with some outward lip-like deformation features. In contrast, the material adjacent to the fracture surfaces on the inside concave surface in Figure 3 did not exhibit any outward deformed material. Instead, some smaller cracks were observed next to the fracture surface, oriented parallel to the fractures. These features were consistent with upward bending of the two tangs of the downward-facing wheel fork.

Figure 3 – Closer view of the two fractures of the fork pieces, viewed from the inner (concave) surface.

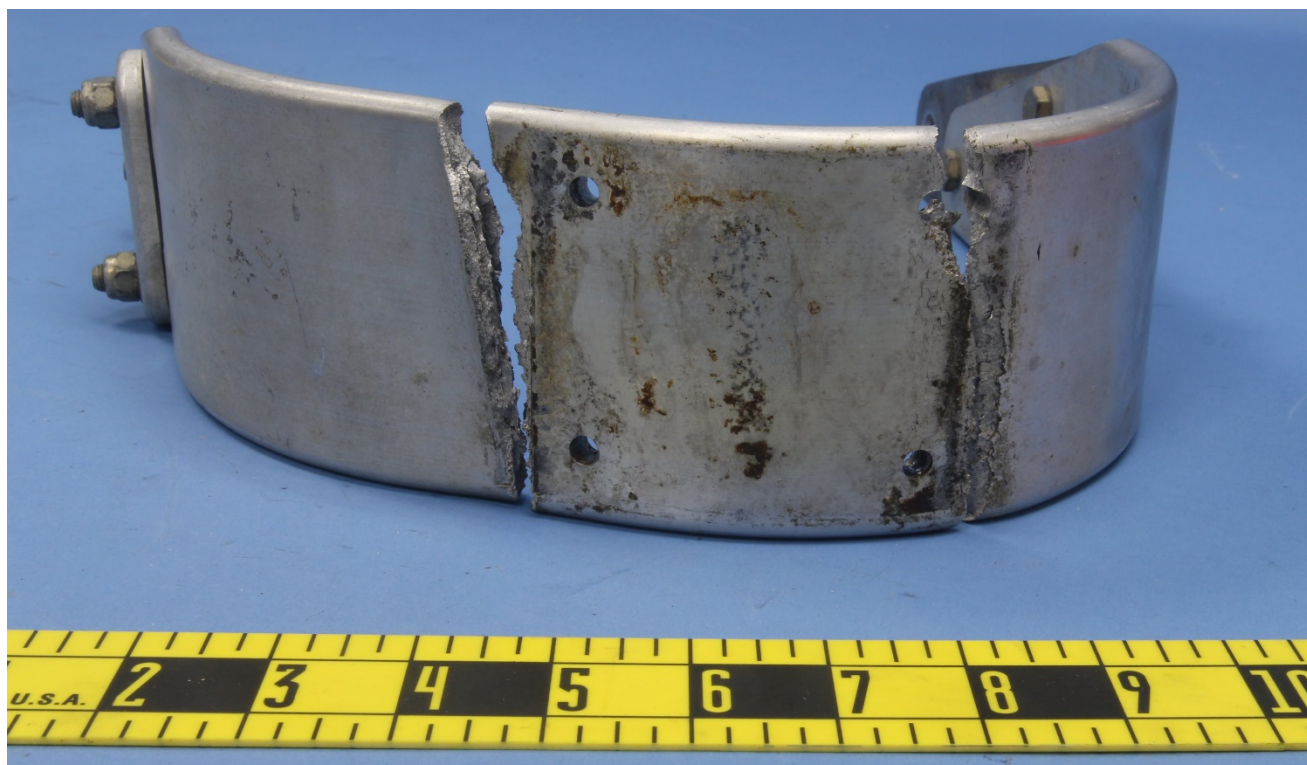
(i.e. entrapped water) where the mating attachment fitting would have been fastened. No indications of macroscopic wear damage were observed adjacent to this darker region.

Figure 4 – Closer view of the two fractures of the fork pieces, viewed from the outer (convex) surface.

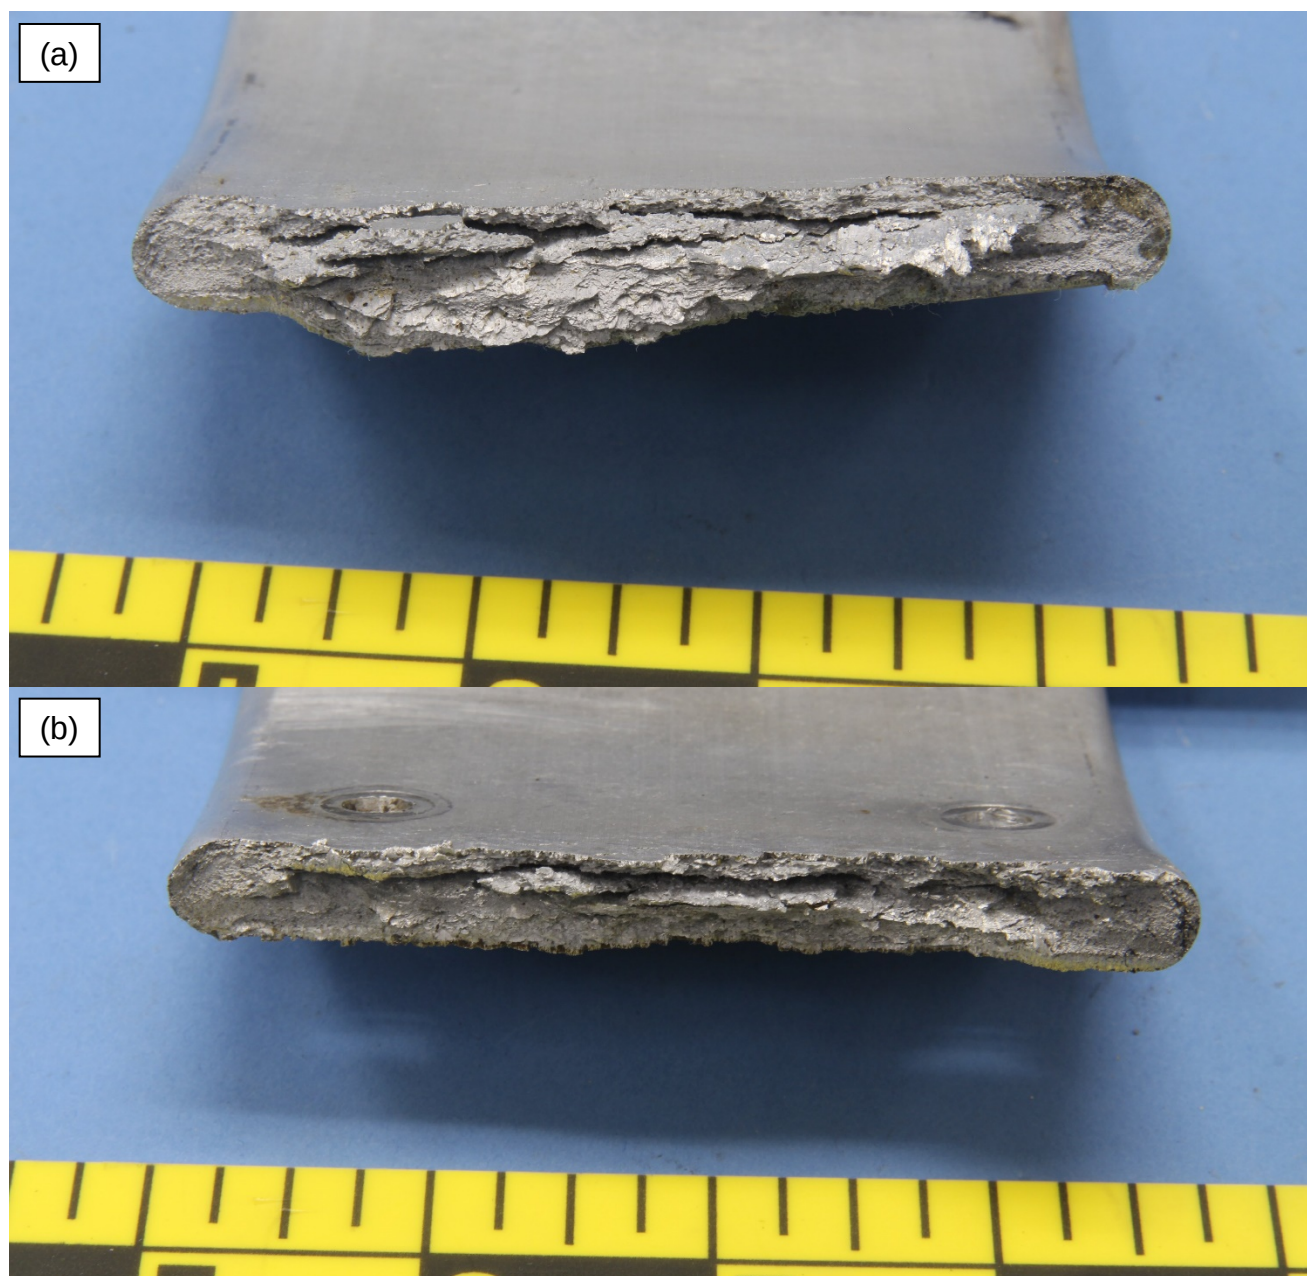
The mating fracture surfaces from the left side of Figure 1 are shown in Figure 5 (a and b), and the mating fracture surfaces from the right fracture in Figure 1 are shown in Figure 6 (a and b). Both mating fracture surfaces exhibited high surface roughness, with visible peaks and valleys present on both sides. The fractures were generally dull in luster, with a fibrous morphology. There was evidence of secondary cracking, oriented perpendicular to the main fracture surfaces, but parallel to the expected rolling direction of the fork. The right fracture exhibited a slanted orientation, whereas the left fracture showed a cup-shaped orientation on one side (Figure 5b) and a cone-shaped orientation on the other (Figure 5a).

Figure 5 – The mating right side fractures from Figure 1 through 3, showing the (a) outer right piece fracture surface and (b) the right fracture surface of the middle piece.

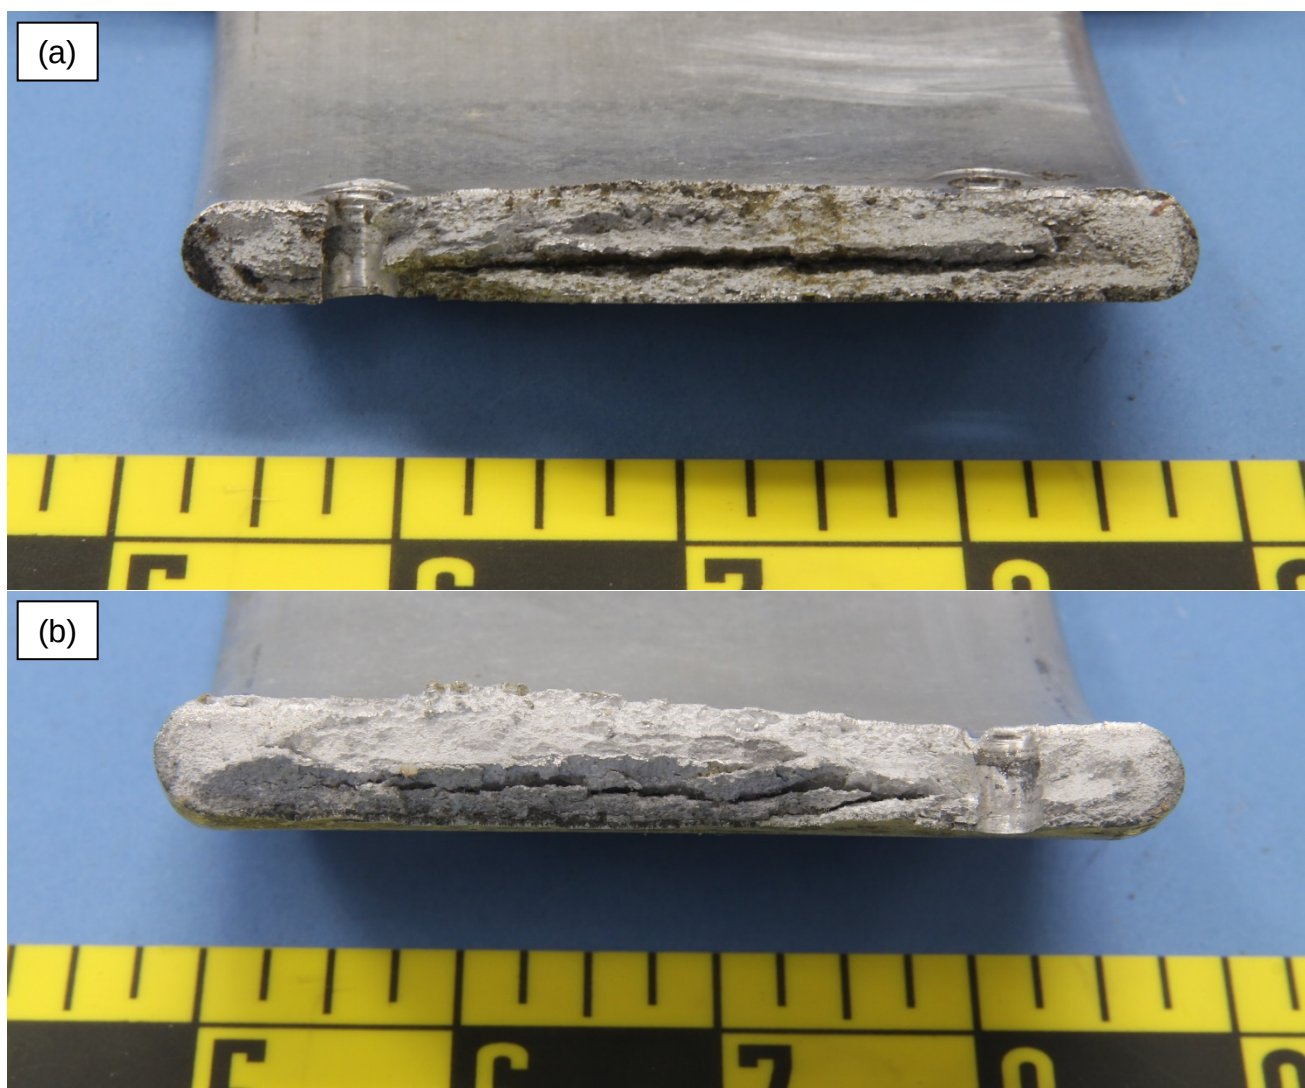
Figure 6 – The mating left side fractures from Figure 1 through 3, showing the (a) the left fracture surface of the middle piece and (b) outer left piece fracture surface.

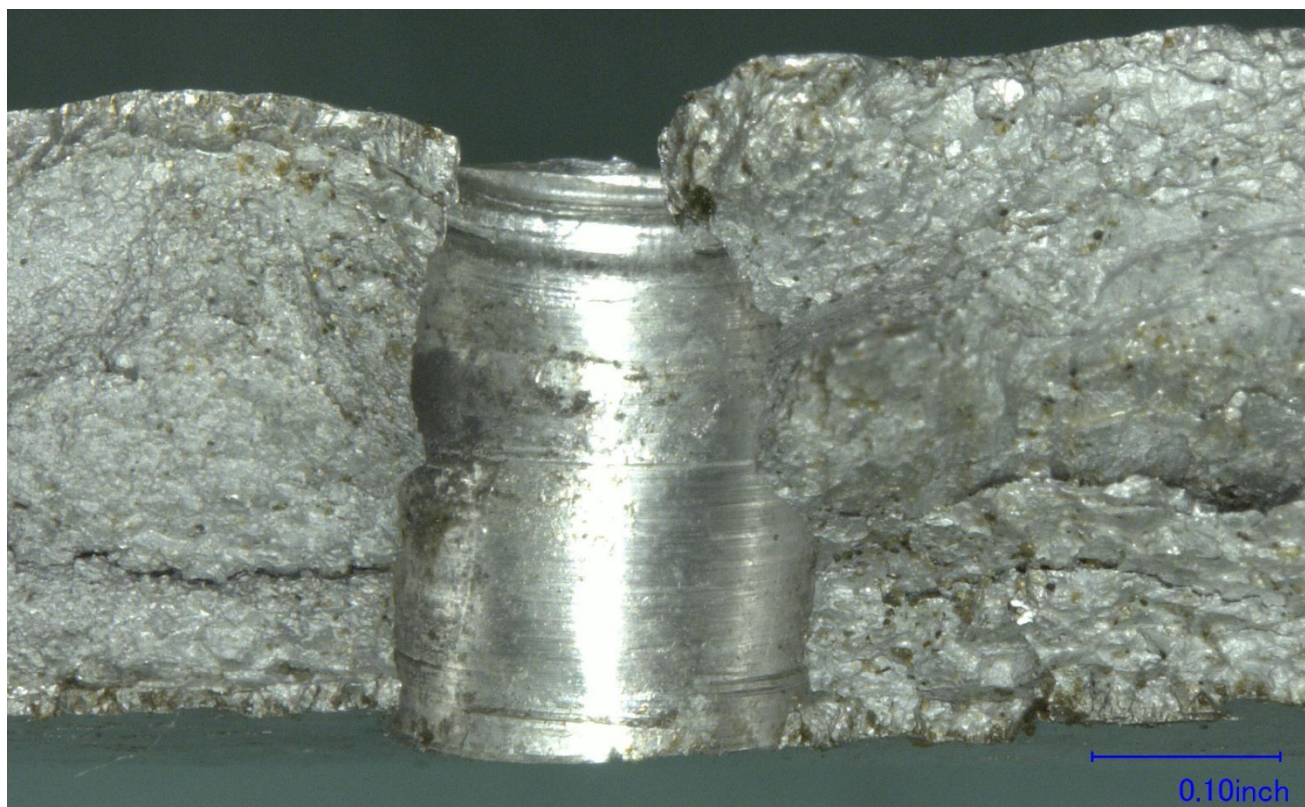
Figure 7 shows a closer view of the fracture surface located through one of the bolt holes. The fracture surface contrasted duller in luster against the reflective machined bolt hole bore. The dull, fibrous fracture surface features were consistent along the surface examined, including the fracture surface regions adjacent to the bolt hole in Figure 7. There were no indications of pre-existing cracks, wear marks, or corrosion along the fracture surface edge at the bolt hole.

Figure 7 – A closer view of the fracture surface features around the bolt hole in Figure 6a.

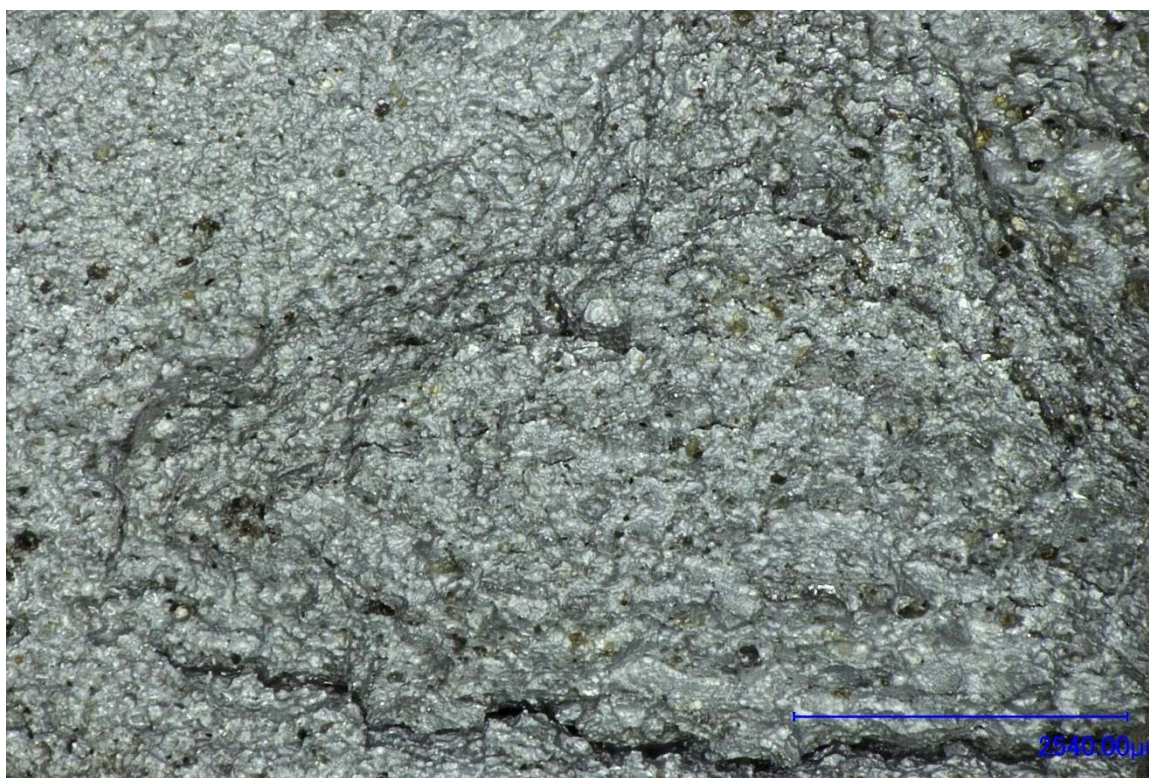
This fracture surface was cleaned using acetone and examined using optical and scanning electron microscopes (SEM). Figure 8 shows a typical area of the fracture surface, showing a rough surface with dull, fibrous features. Although not obvious in Figure 8, when examined using a SEM, much of the fracture surface was rounded and smoothed, consistent with post-fracture damage. Figure 9 shows a typical area of the undamaged portions of the fracture surface. This figure demonstrates dimpled rupture, consistent with overstress fracture. Full examination of the fracture surface in Figure 6a found no other features consistent with other fracture modes.

Figure 8 – Closer view of the fracture surface in Figure 7.

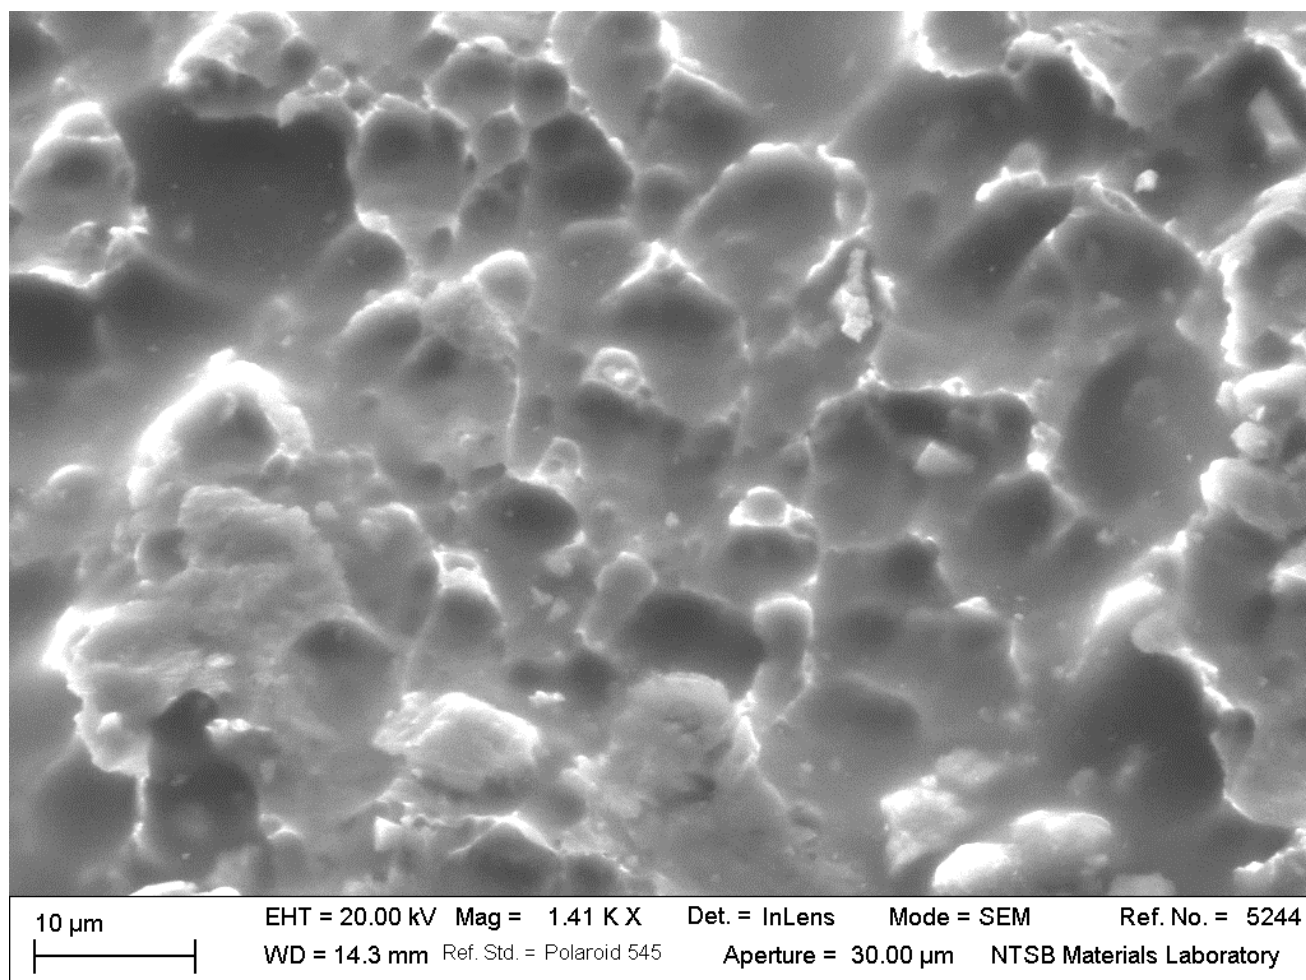
All these combined fracture features were consistent with overstress fracture in upward bending of the nose wheel fork.

Figure 9 – Secondary electron micrograph of a typical area of the fracture surface in Figure 8, showing dimpled rupture.
