## RECORD OF CONVERSATION

**Date: June 3, 2020**  
**Persons Contacted: David Shrader, pilot and owner/builder**  
**NTSB Accident Number: ANC20CA053 N324WS Ambler, Alaska**

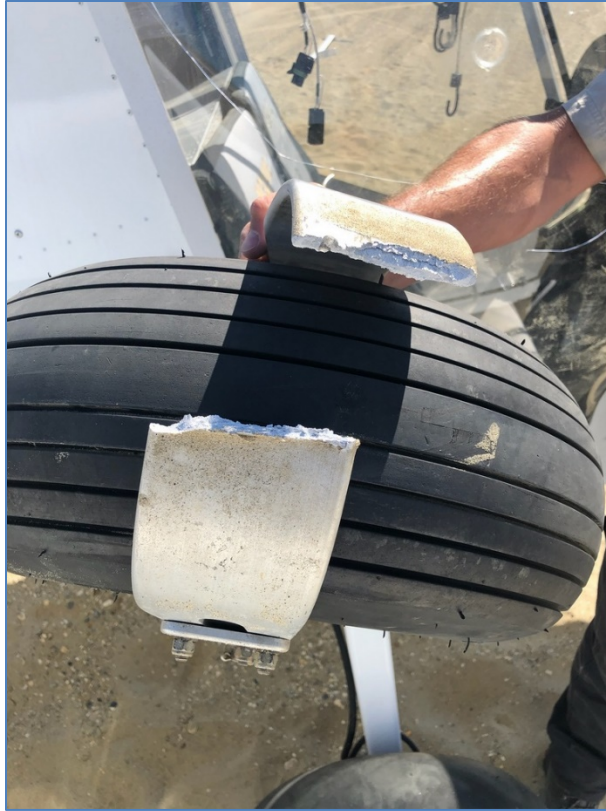
He stated that he landed on the sand dunes and shut down for about 45 minutes. Then he started up and took off in the same direction, but he could not recall what direction that was in. He stated that the winds were about a 5 to 10 knot crosswind. During the takeoff roll, the airplane experienced some bumps, but nothing significant. When the airplane was almost at rotate speed, about 45 mph, it hit a bump and unexpectedly “leaped into the air.” The attitude was nose high when the airplane came back to the ground and the nosewheel collapsed immediately and the airplane flipped over on its back. Upon post accident inspection, the nose gear fork was sheared from the strut; however, the strut was not deformed at all. He provided two photographs. (See figures 1 and 2)

Mr. Shrader stated that he altered the Zenith nose wheel fork by adding 3 inches for more “leverage.” He said that perhaps the extension is what caused the failure, and if so, then it is his fault. He will provide more photographs and keep the nose fork for analysis.

*Figure 1. Fractured nosewheel fork*

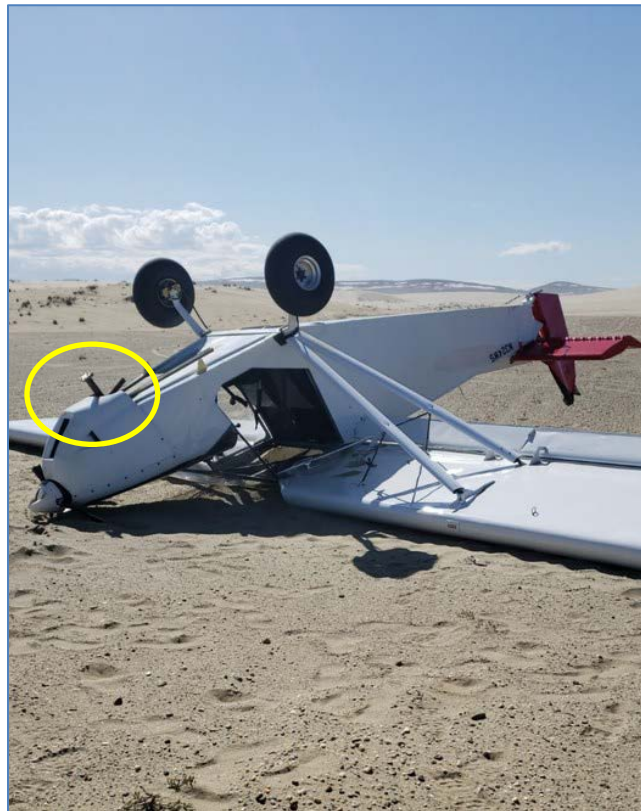
He reported that the damage included a crushed rudder, buckled fuselage at the forward door jam, wrinkled wings, wrinkled wing struts.

*Figure 2. Airplane at the accident site.*
