**NATIONAL TRANSPORTATION SAFETY BOARD**  
Office of Aviation Safety

**STRUCTURES GROUP CHAIRMAN'S RUDDER LOADS STUDY**

**ANC20LA059**

Operator: Private  
Location: Anchorage, Alaska  
Date: June 8, 2020  
Time: 0945 Alaska Daylight Time (ADT)  
Aircraft: Piper PA-12  
Registration: N3188M

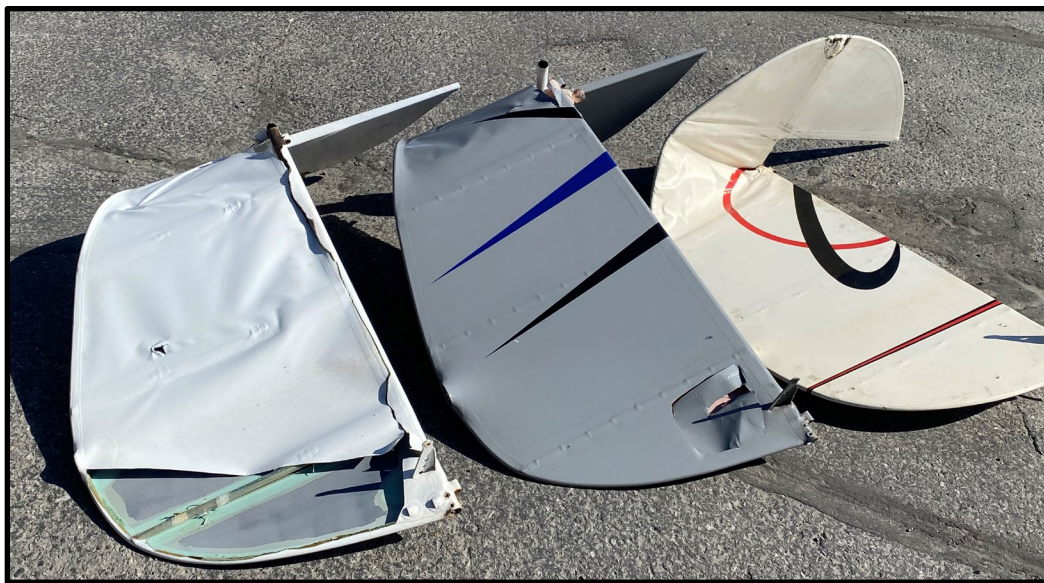
The accident airplane was equipped with a 160 HP<sup>1</sup> Lycoming O-320 engine and a McCauley propeller. The airplane had EDO 2000 floats installed per an STC. The rudder post was fractured at the upper end of the upper hinge barrel and the top of the rudder was folded over to the left. There was a Whelen Model 9052051 LED strobe light installed at the top of the rudder post. The data tag on the strobe light indicated it weighed 0.65 lb. A LED tail navigation light/strobe was also installed on the rudder trailing edge in place of the original navigation light.

*Figure 1-PA-12 fractured rudders; grey rudder is from accident airplane.*

Available information indicated that the white painted rudder came off a wheel equipped PA-12 airplane with a 180 HP Lycoming O-360 engine and the cream painted rudder came off a wheel/ski equipped PA-12 airplane with a 150 HP Lycoming O-320 engine. The white painted rudder post was fractured about ½ inch above the upper edge of the upper hinge barrel and the top of the rudder was folded over to the left. There was evidence of a light being installed at the top of the rudder post, but it wasn't installed when received. The cream painted rudder post was fractured about 1 inch above the upper edge of the upper hinge barrel and the top of the rudder was folded over to the right. There was evidence of a light being installed at the top of the rudder post, but it wasn't installed when received.

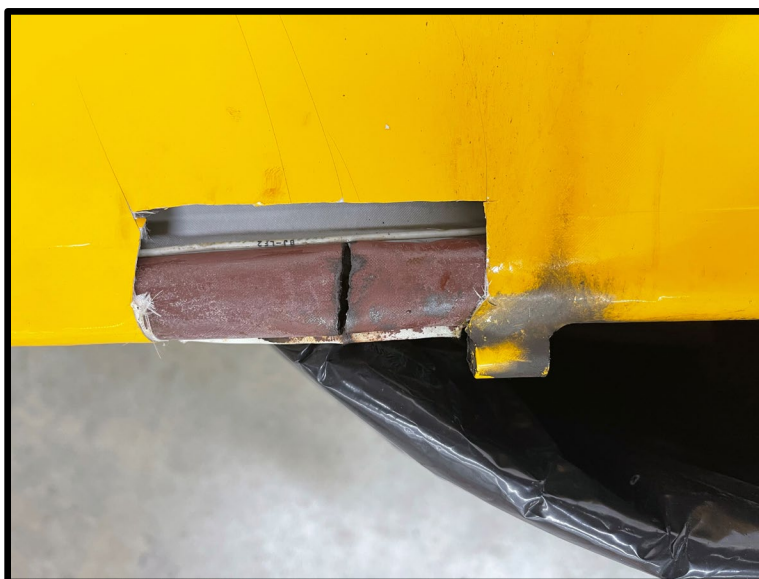
*Figure 2-PA-18 fractured rudder post.*
