# NATIONAL TRANSPORTATION SAFETY BOARD

## Engine Monitoring Device

**Specialist's Factual Report**  
**By Sean Payne**

Location: Birch Creek, AK  
Date: July 14, 2020  
Aircraft: Air Tractor AT802A  
Registration: N80166  
Operator: Aero Spray Inc  
NTSB Number: ANC20LA069

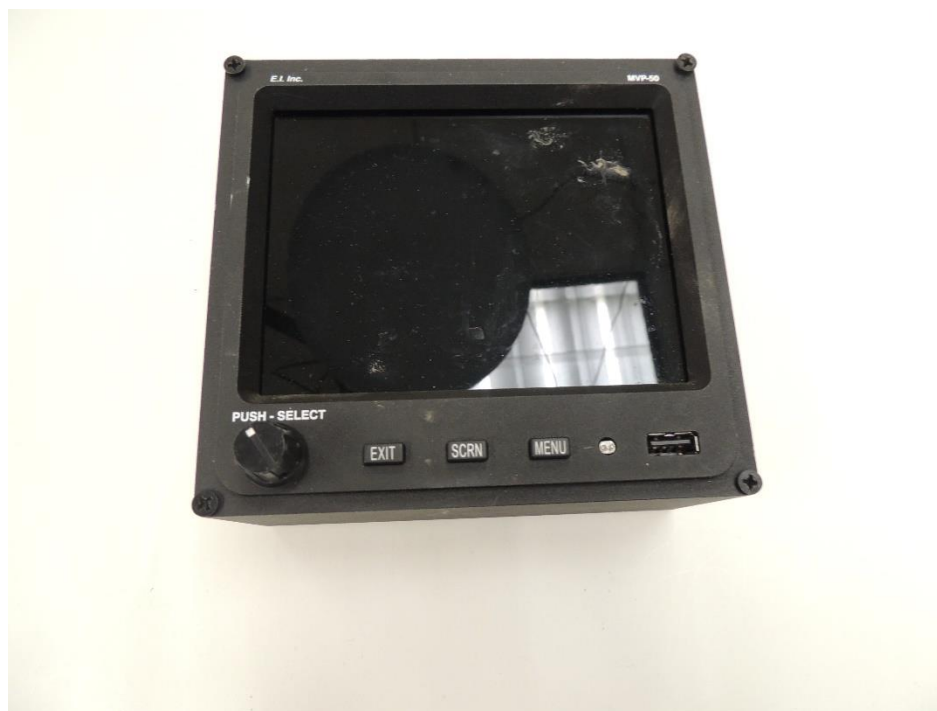
Upon arrival at the Vehicle Recorder Division, an initial examination revealed the unit had been relatively undamaged. The unit was powered on the bench as per the wiring diagram and booted. The unit was unable to dump flight data to a USB stick via the default manufacturer instructions. Instead, the unit was opened and the internal microSD card was extracted. The microSD card was found to be in good condition and was downloaded via commercially available data forensics software.

**Figure 1. Condition of EI MVP-50T received by the Vehicle Recorders Division**

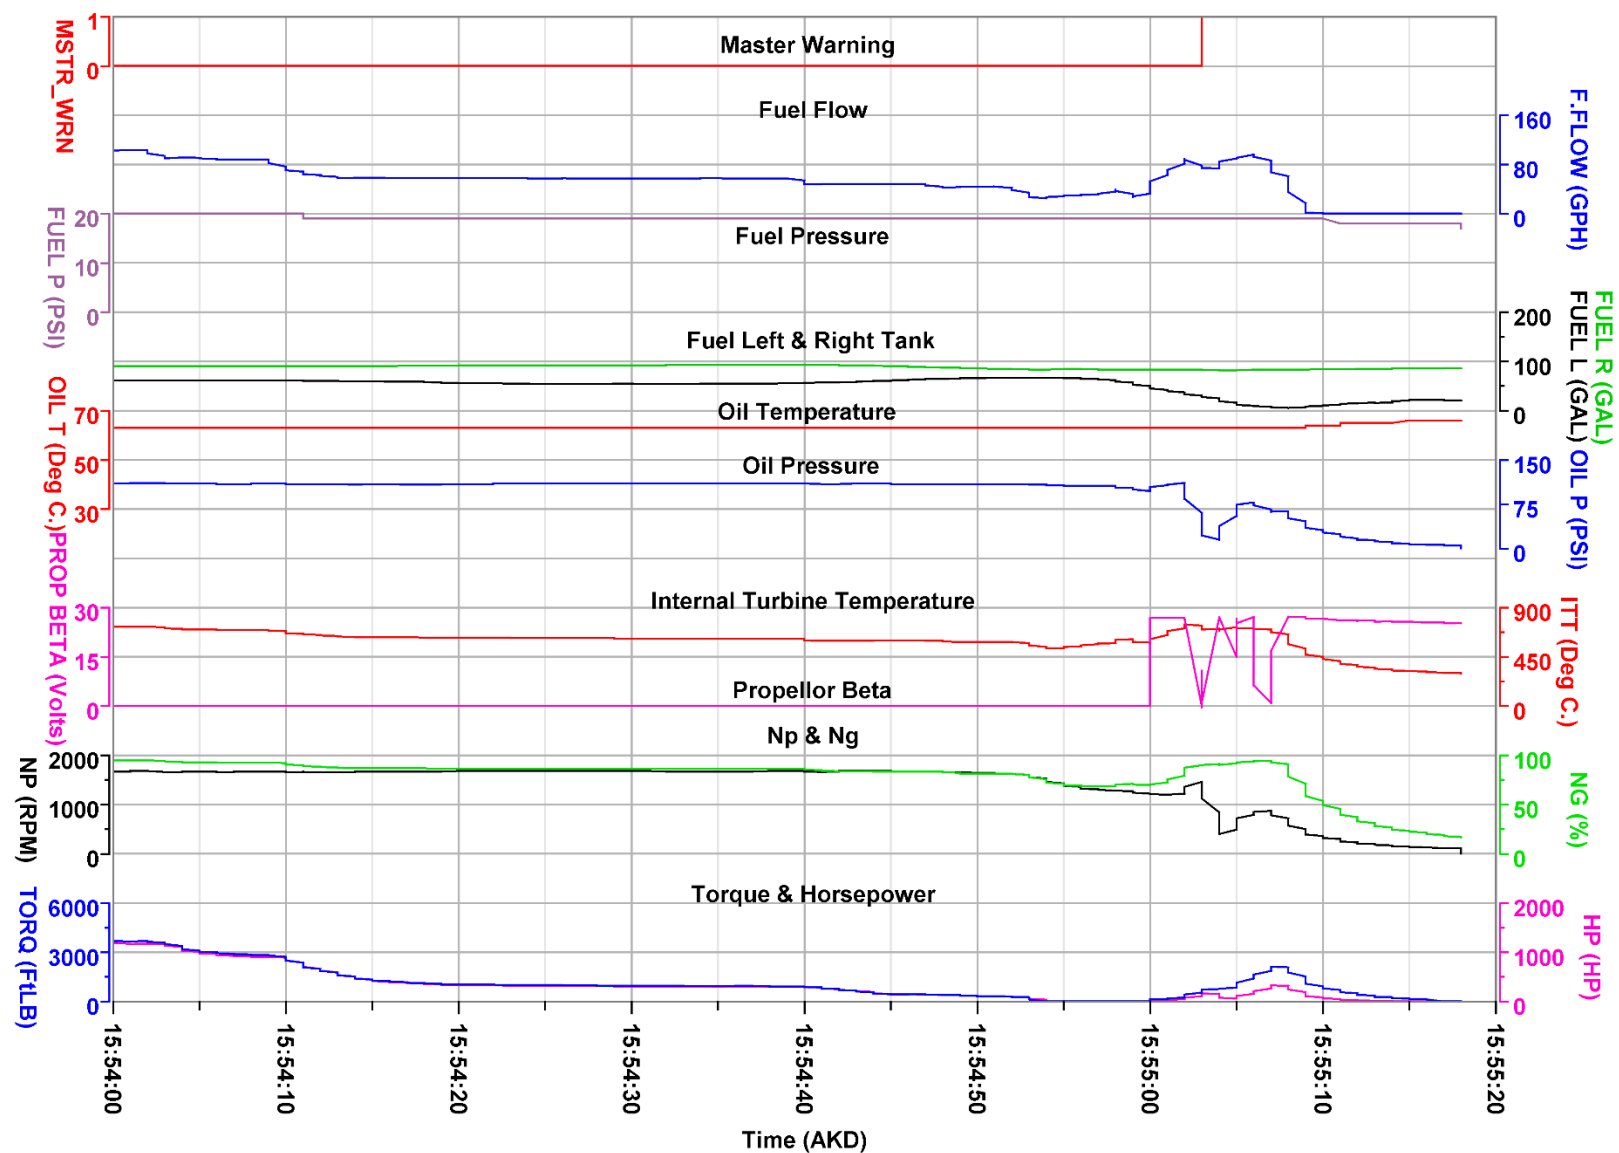
Figure 5 is a plot of the approximate last minute of the accident flight. The plotted time interval is between 15:54:00 AKD and 15:55:20 AKD. Around 15:55:00, the PROP BETA parameter shows a change in voltage from 0 volts to approximately 27 volts. The aircraft manufacturer states that the PROP BETA parameter is a signal indicating when the propellor control had entered a beta state. There is no differentiation in voltage as to the magnitude of the lever motion. Any motion past the propellor beta gate will register as a near 27 volt reading.

Figure 5. A plot of the approximate last minute of the accident flight. The plotted time interval is between 15:54:00 AKD and 15:55:20 AKD.
