# ALERT SERVICE BULLETIN

### DOORS – Sliding doors

#### Inspection of the upper rail and roller of the LH and/or RH sliding doors

[ASB AS350-52.00.54](#)

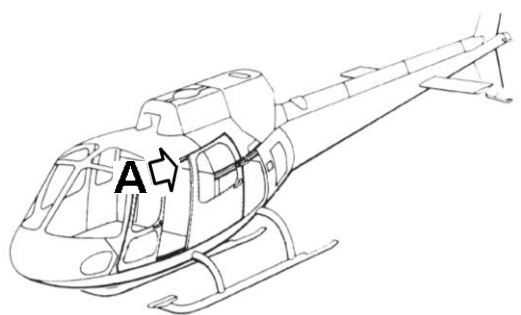
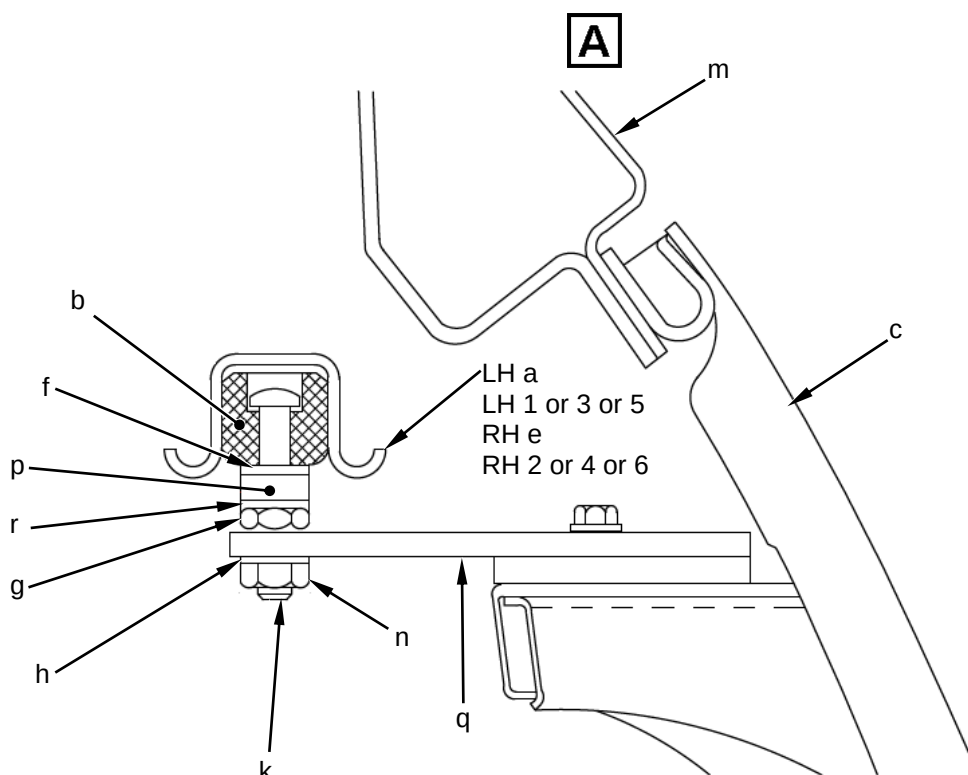
Figure 1

Airbus Helicopters has been informed of a new case of sliding door flight loss on an AS350 B3 helicopter. The loss occurred during a flight with the door locked in the open position. The loss of this part had no consequence for the helicopter, the crew and persons on the ground. The latest analyses of the degradations found on the fixed parts of the helicopter and on the sliding door indicate that the loss of the sliding door resulted from the disengagement of the roller from the upper rail, which led to the separation of the door.

- Check the upper rail.
- Make sure that the parallelism between the sliding door and its frame is correct.
- Make sure that the front roller is in good condition.
- Make sure that the installation of the front roller is correct.

- Check the upper rail (a) ((e) for the RH side) as per Work Card 52-91-10-601 (MET) or Task 52-12-00, 6-1 (AMM).
- . If necessary, replace the upper rail (a) by an upper rail (1) or (3) or (5) ((e), (2) or (4) or (6) for the RH side) as per Work Card 52-12-01, 4 (SRM) or 52-91-10, 01 (MRS).
- . If necessary, adjust the sliding door (c) as per Work Card 52-91-10-501 (MET) or Task 52-12-00, 5-1 (AMM).
- Make sure that the parallelism between the sliding door (c) and its frame (d) (not shown) does not exceed 1.5 mm (.059 in) on a length of 1200 mm (47.24 in) as per Work Card 52-91-10-501 (MET) or Task 52-12-00, 5-1 (AMM).

- Remove the sliding door (c) as per Work Card 52-91-10-401 (MET) or Task 52-12-00, 4-1 (AMM).
- Make sure that the front roller (b) is in good condition, in compliance to the specific criteria as per Work Card 52-91-10-601 (MET) or Task 52-12-00, 6-1 (AMM).
- . If necessary, replace the front roller (b) by a front roller as per Work Card 52-91-10-403 (MET) or Task 52-12-00, 4-3 (AMM).

- Make sure of the correct stacking under the front roller (b) as per Detail A.
- On the screw (k) there are:
  - . the front roller (b),
  - . the washer (f),
  - . the spring washer (p),
  - . the washer (r) and the nut (g).
- The whole, front roller (b), washer (f), spring washer (p), washer (r), and the nut (g) are on the bracket (q) using the washer (h) and the nut (n).
- If necessary, correctly install the front roller (b) as per Work Card 52-91-10-403 (MET) or Task 52-12-00, 4-3 (AMM).
- Install the sliding door (c) as per Work Card 52-91-10-401 (MET) or Task 52-12-00, 4-2 (AMM).
