## **NATIONAL TRANSPORTATION SAFETY BOARD**

#### **Airframe and Engine Examination Summary**

NTSB Number: ANC20LA093

Aircraft: Piper PA-22-135, N8875C

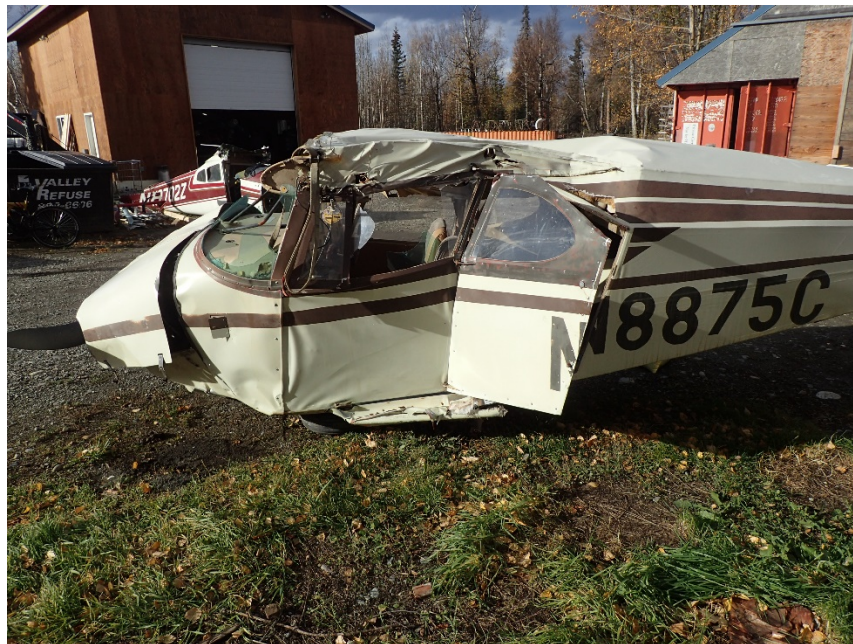
The forward half of the fuselage exhibited buckling in the top and bottom frame structure. The cockpit overhead exhibited extensive downward crush on the right side and some bucking forward of the rudders. The engine firewall was significantly buckled rearward in the lower half. The nosewheel, strut and airframe attachment areas were deformed rearward. See figure 1.

*Figure 1. The airplane with the wings removed.*

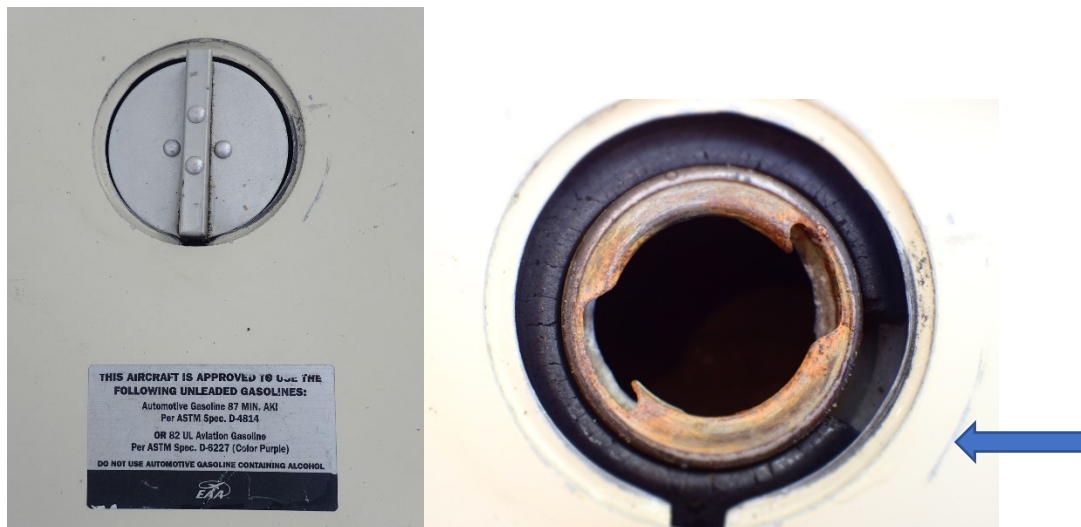
The right wing fuel tank cap was installed and secure. A placard was present that stated the airplane is approved for the use of automotive gasoline. The cap was removed. A thick black gasket with evident cracking and crumbling was installed around the filler neck and had a 1 inch piece missing. The filler neck exhibited orange and brown surface corrosion over 25%. The fuel tank was intact and dry. See figure 2.

Figure 2. Right wing fuel tank cap (left) and filler neck (right) with incomplete gasket (blue).

The examination uncovered anomalies in the airframe fuel system, specifically the presence of corroded fuel tank filler necks, degraded gasket on the right fuel tank filler, and fractured fuel tank at the right fuel filler neck. The gascolator had no fuel present, likely due to an impact displacement. Fuel was present in the fuel line from the gascolator to the carburetor; however, a fuel/water mix was present in the carburetor. Engine valve train and drive shaft continuity was established. No anomalies in the engine cylinders, induction system, and ignition system were observed.

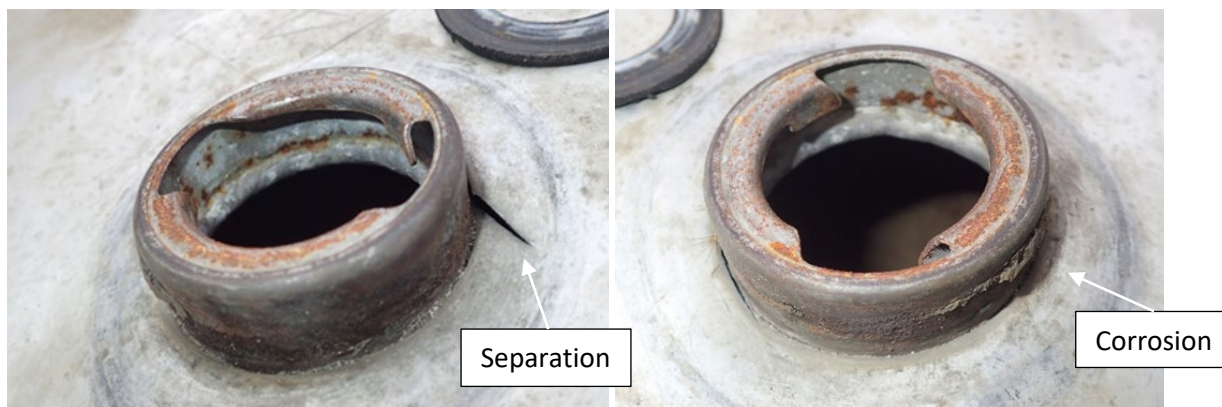
The wing panel above the left wing fuel tank was previously removed by the recovery crew. The left wing fuel tank was intact and empty. The cap was installed and secure and was a different model type than the right wing fuel tank. A thin black gasket with minor wear and orange corrosion deposits (from filler neck) was in place in the cap. The filler neck exhibited about 40% corrosion on the surface with significant crumbling oxidation on the exterior. The fuel tank exhibited a 3 inch area of separation at the filler neck base. See figure 3.

Figure 3. Left wing fuel tank filler neck separation (left) and filler neck (right) corrosion.

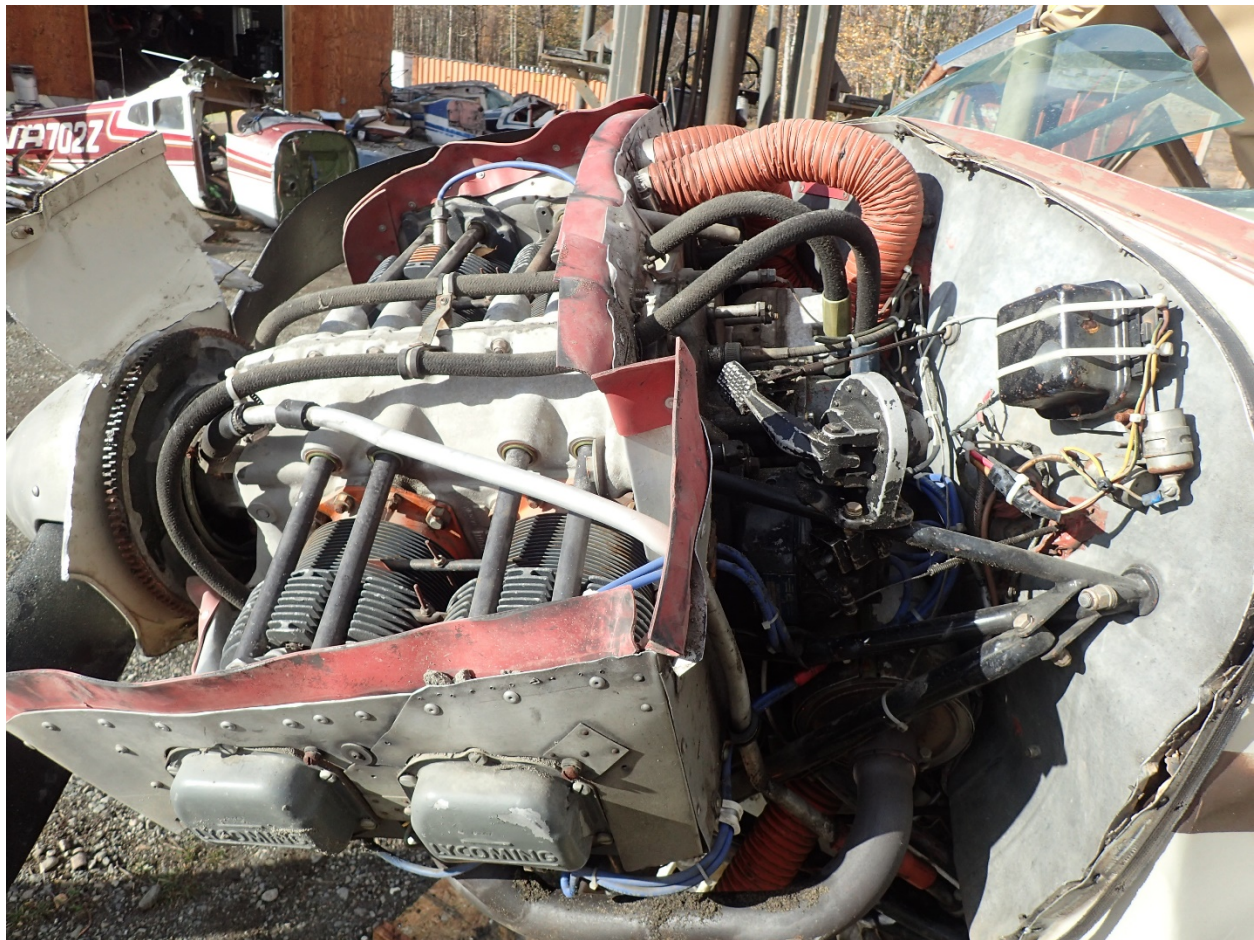
The engine was attached at the airframe mounts and all fuel, hoses, electric lines, and accessories were attached and secure. Some deformation and rearward crushing was present on the bottom, resulting in damage to the oil cooler, carburetor and airbox and firewall. The engine was leaning to the left, attached to the airframe mounts on deformed airframe structural tubes. The case and cylinders were intact. Sand was present throughout the engine compartment. See figure 5.

*Figure 4. Lycoming O-290 engine during the examination.*

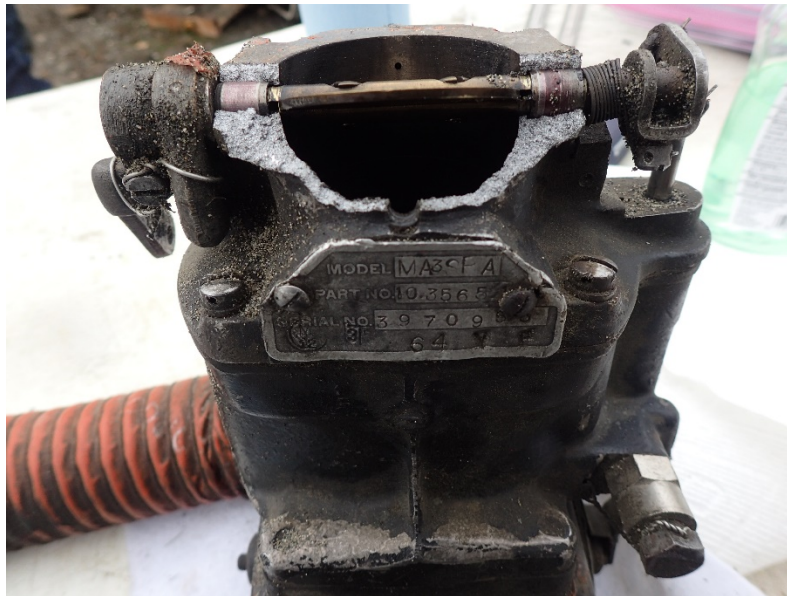
The carburetor (Marvel Schebler MA3SPA P/N 10-3565, S/N 3970955) was attached to the oil sump and exhibited fractures (dull dimpled fracture surfaces) at the throttle valve housing. The airbox and carb heat box were attached. The carburetor was removed and disassembled. The fuel inlet finger filter was wet and clear of debris. The accelerator pump functioned when the throttle lever was cycled. After cycling the pump 3 times, about 2 tablespoons of liquid was present in the pump reservoir. The sample tested positive for water when a Sar-Gel paste test was conducted. The liquid was a mix of auto fuel and brownish water. A small amount of sand debris was present in the carburetor bowl, which was wet and smelled of auto gas. The throttle and mixture levers were attached and safety wired appropriately, although slightly deformed due to impact damage. See figure 5.

*Figure 5. Carburetor*

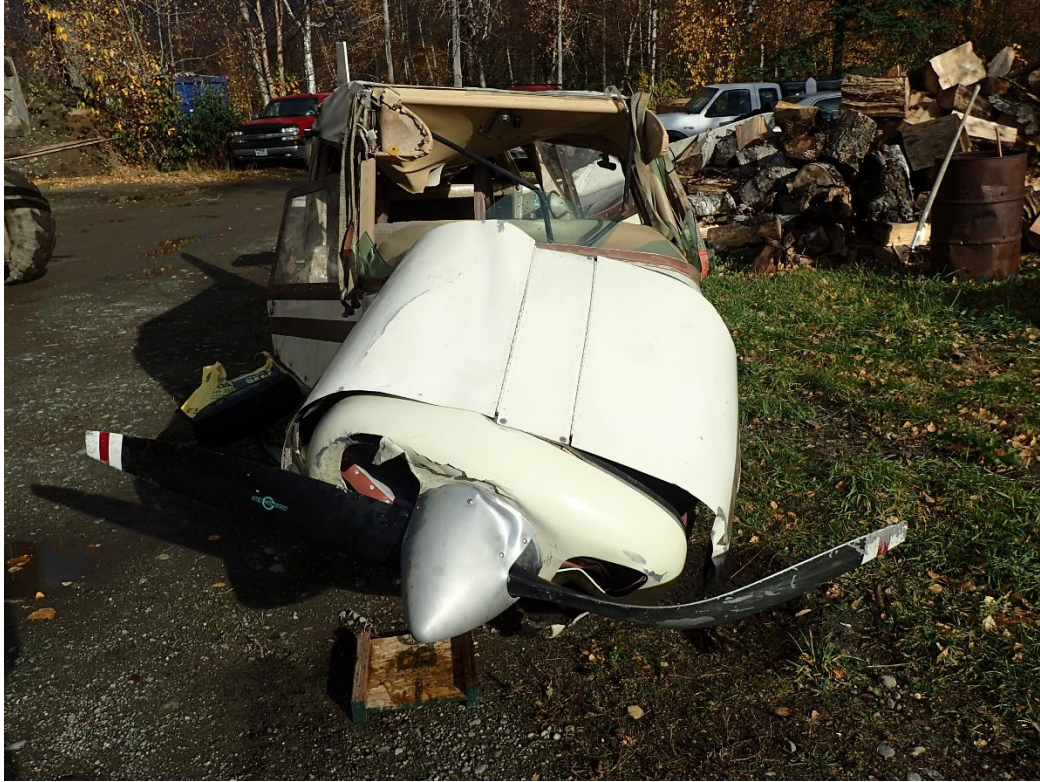
The 2 bladed Sensenich propeller (model 74DM-6-058) was attached to the crank shaft. The spinner exhibited minor twist buckling. One blade was secure and straight and the other indicated a rearward bend and leading edge impact damage at the outer 18 inches with some chordwise scratching. See figure 6.

*Figure 6. Engine cowling and propeller.*
