**Photo 1 – Accident airplane at accident site. Photo provided by unknown.**

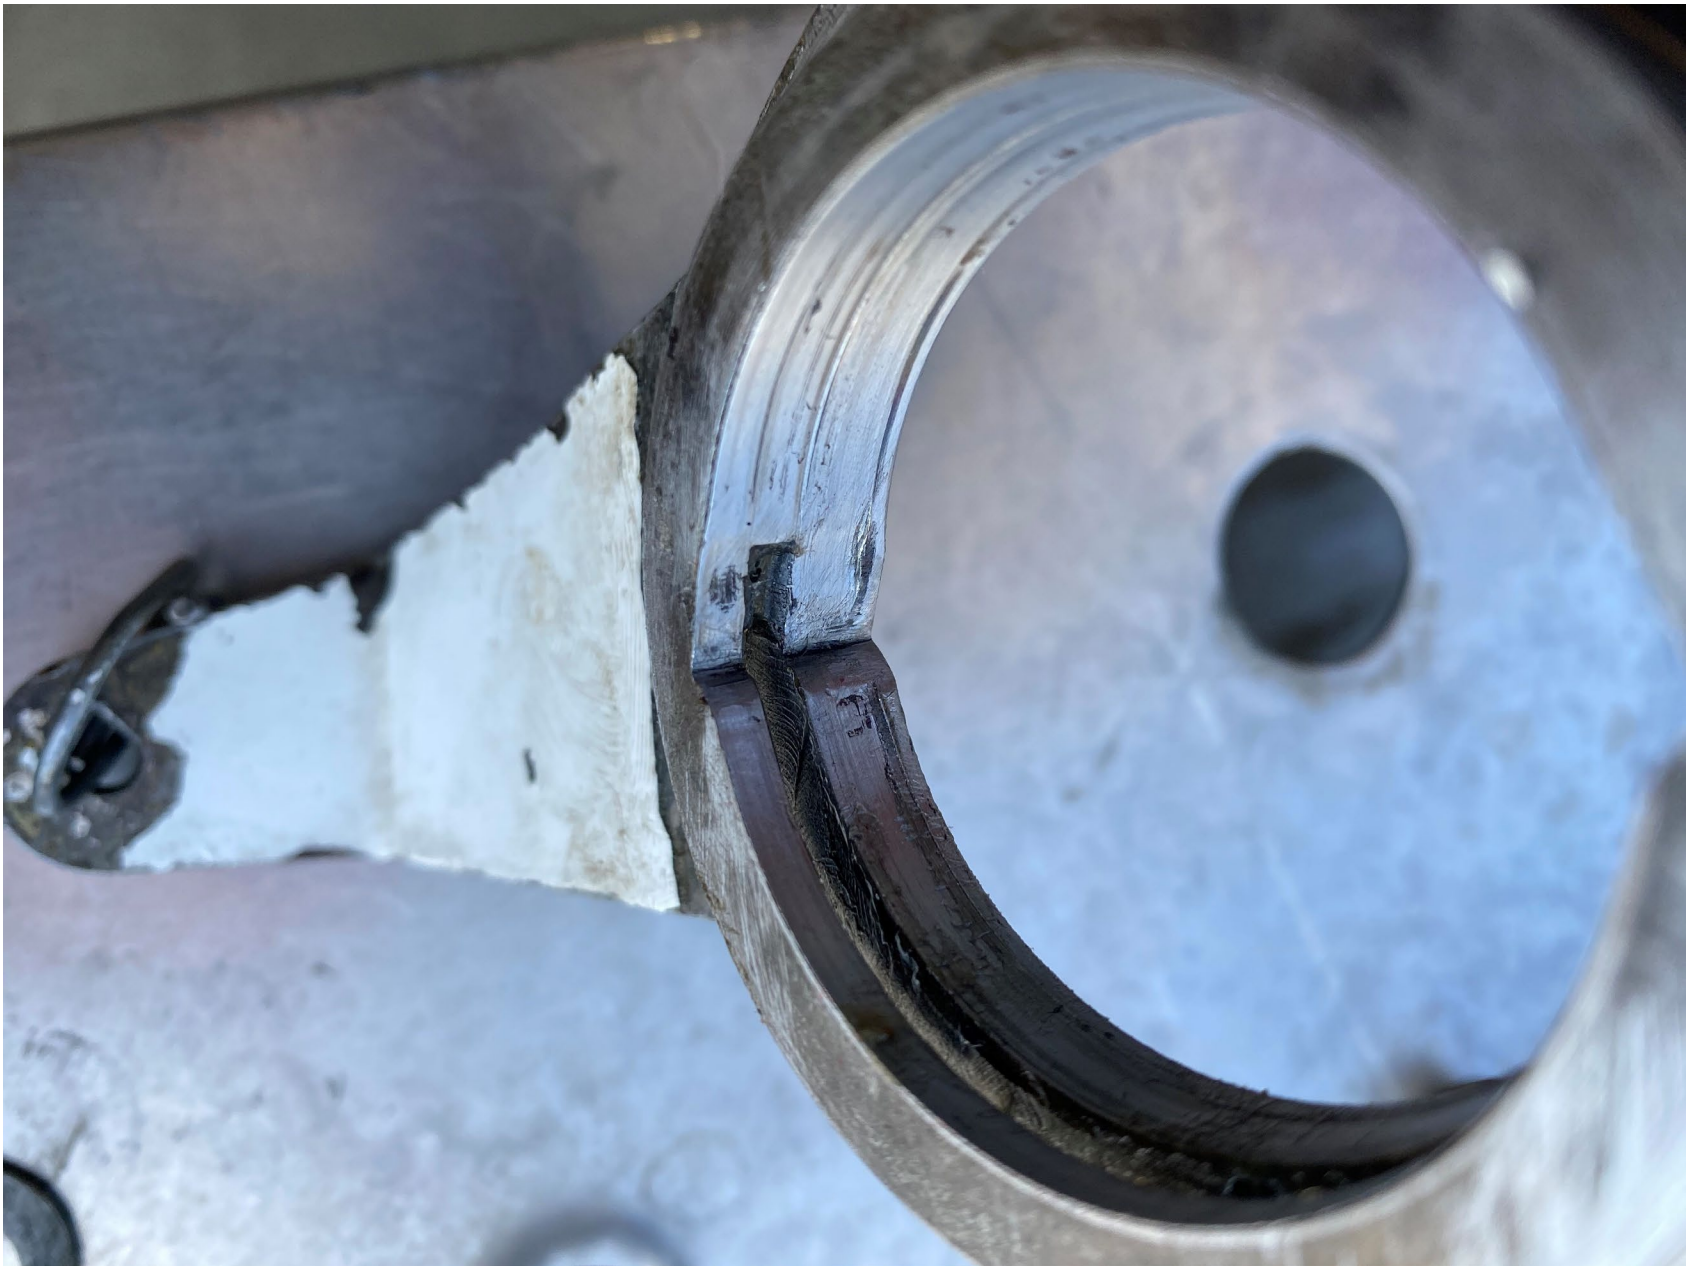
**Photo 2 – Tailwheel steering arm's scored and damaged inside radius.**

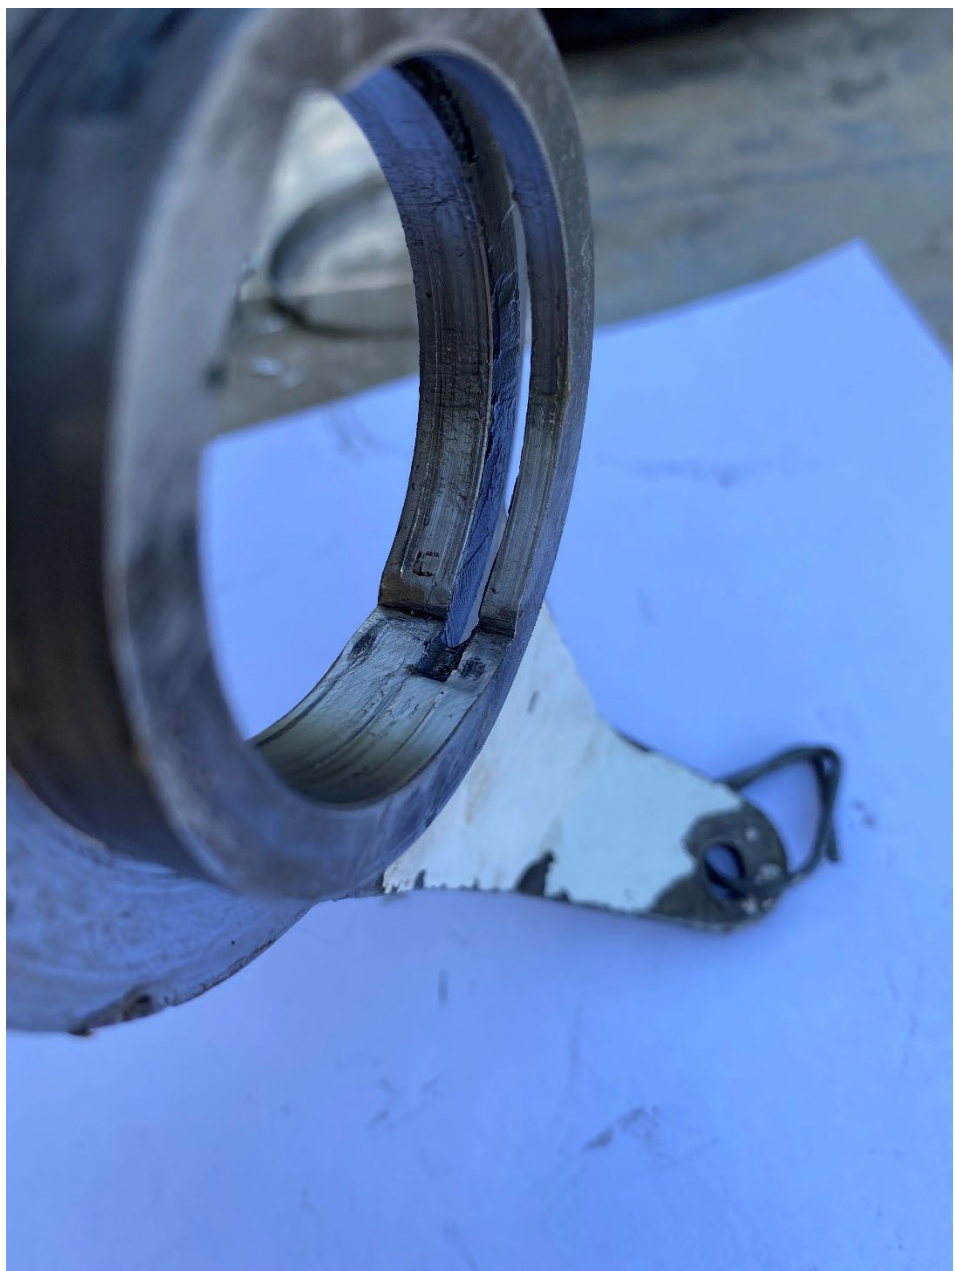
**Photo 3 – Tailwheel steering arm’s scored and damaged inside radius.**

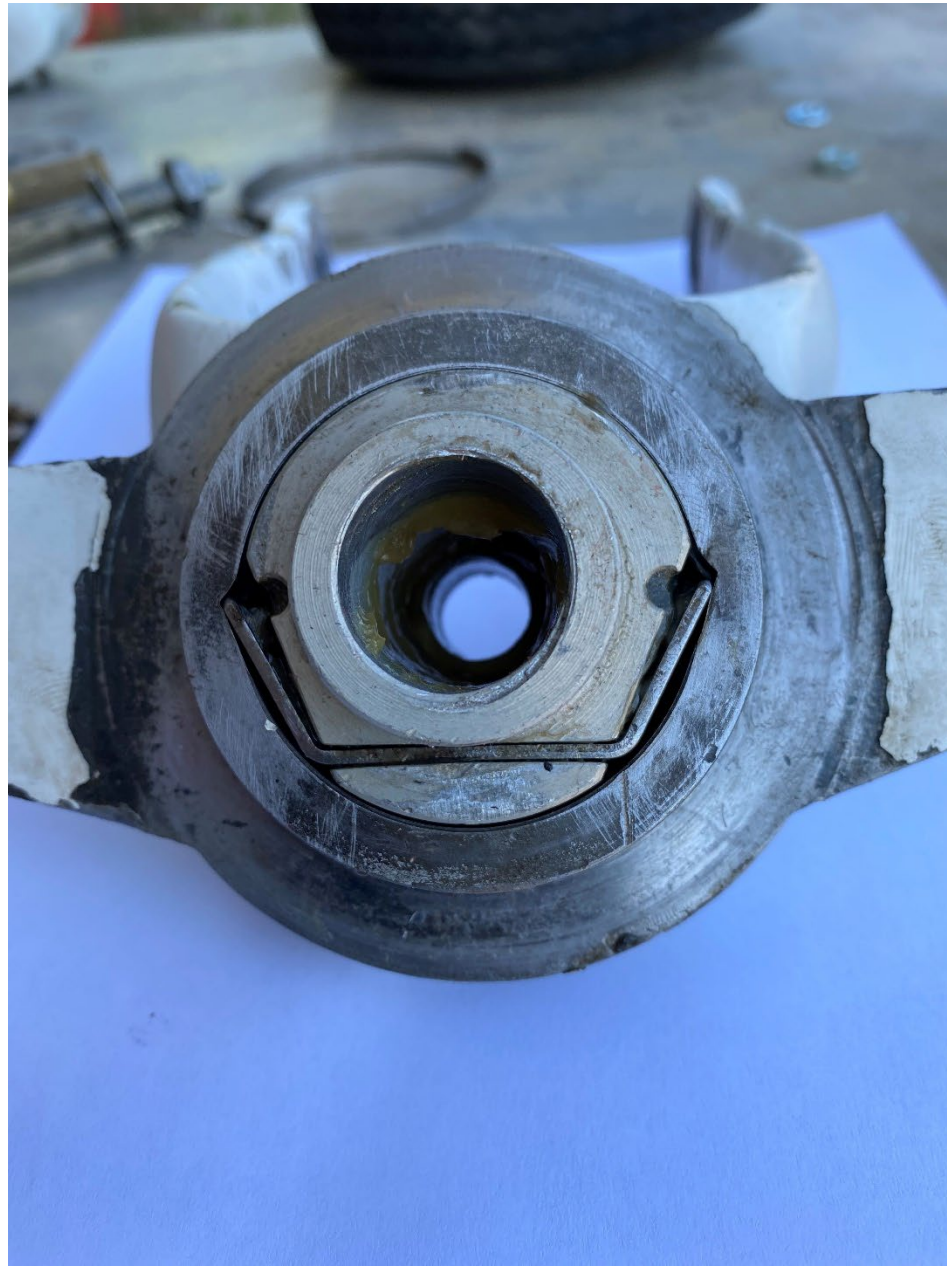
**Photo 4 - Compression spring in its respective attach point. Note, no spacer present.**

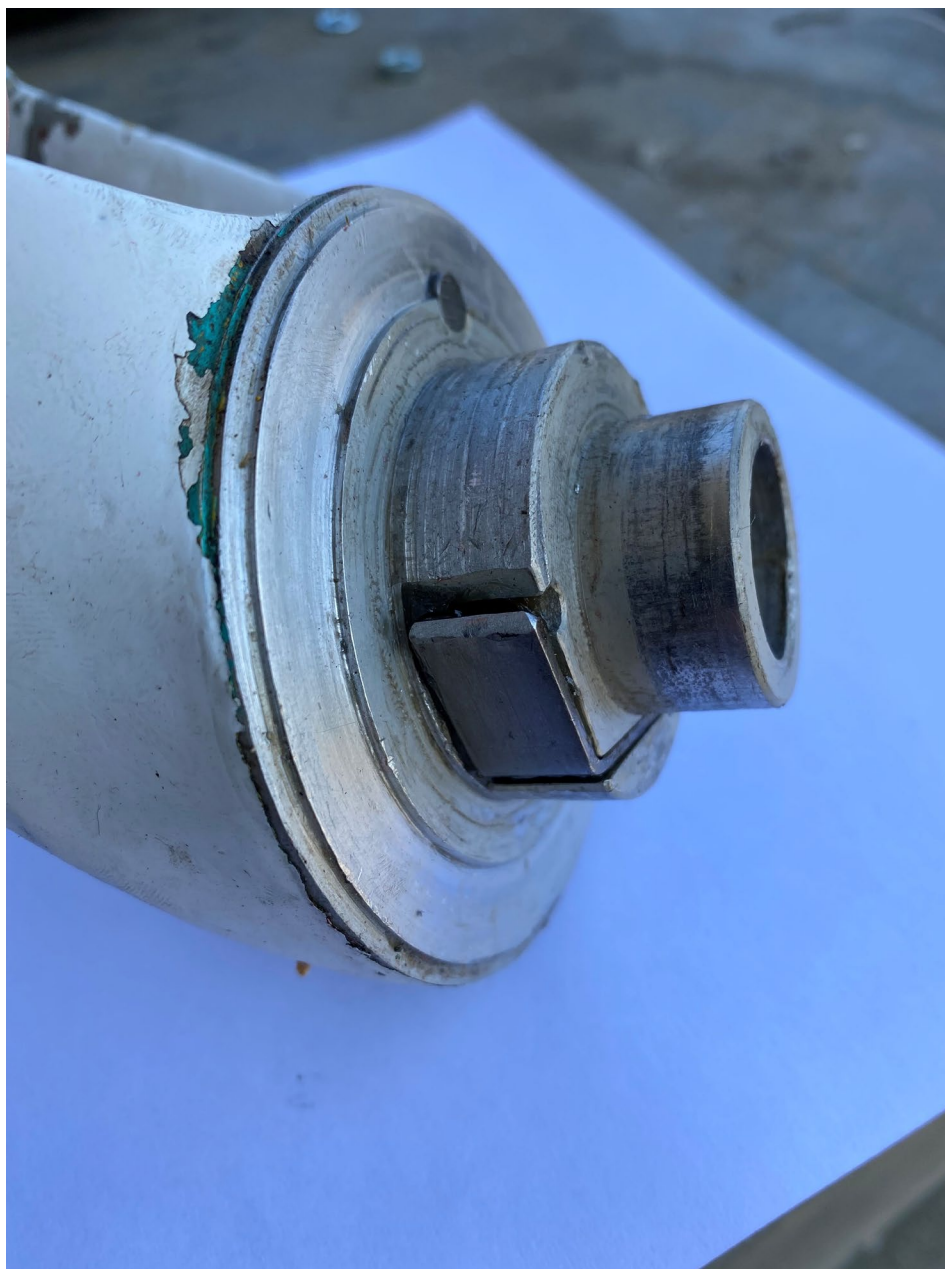
**Photo 5 - Compression spring's sharp and damaged spring end.**
