## **Tailwheel Examination Summary**

NTSB ACCIDENT NUMBER: ANC20LA100

AIRCRAFT REGISTRATION/AIRCRAFT TYPE: N926LL, Cessna 180H

ACCIDENT LOCATION: Tok, Alaska

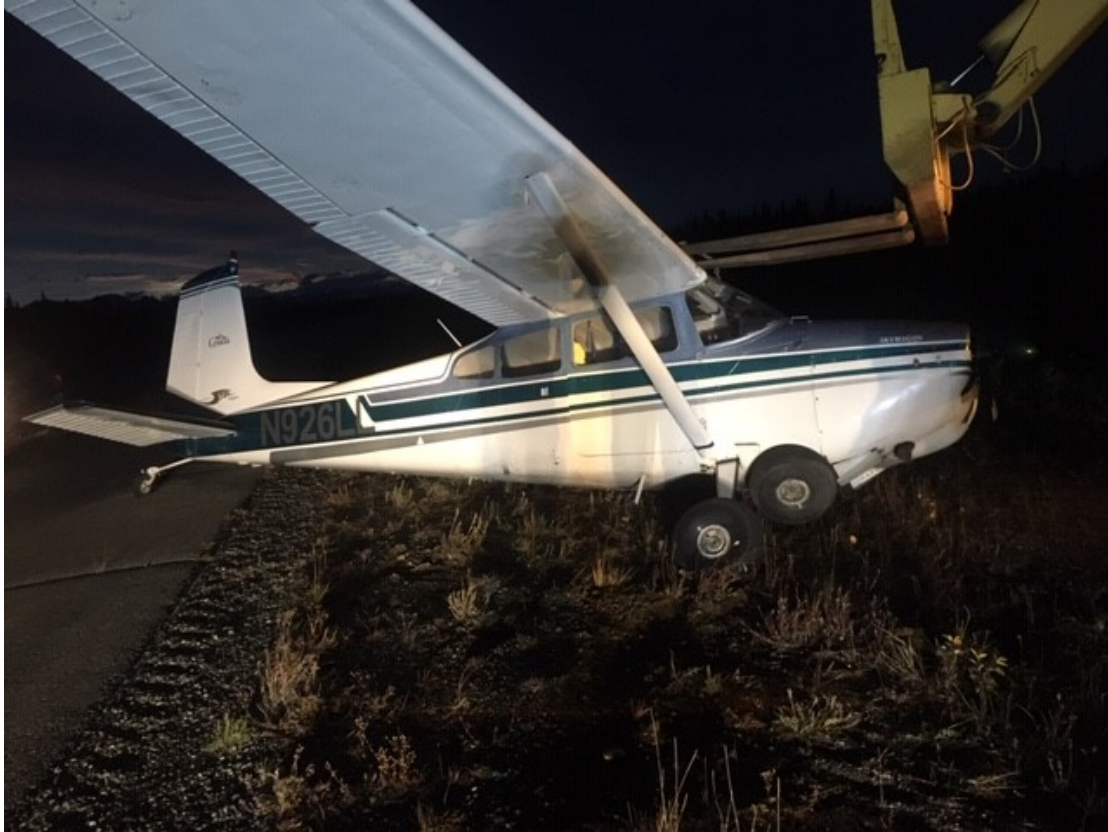
Photo 1 - Accident airplane at accident site.

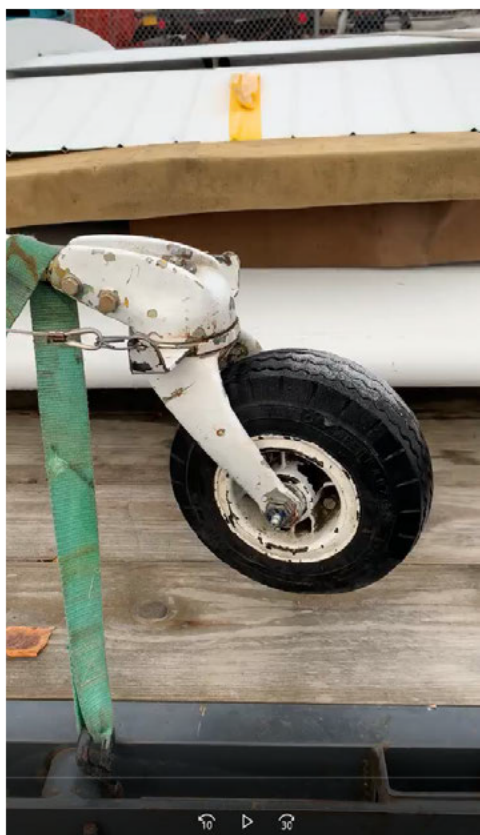
Photo 2 - Accident airplane's tailwheel.

- 9-29-2020 Tach 5467.7 Logbook entry revealed the tailwheel bearings were replaced and the tailwheel was repaired.

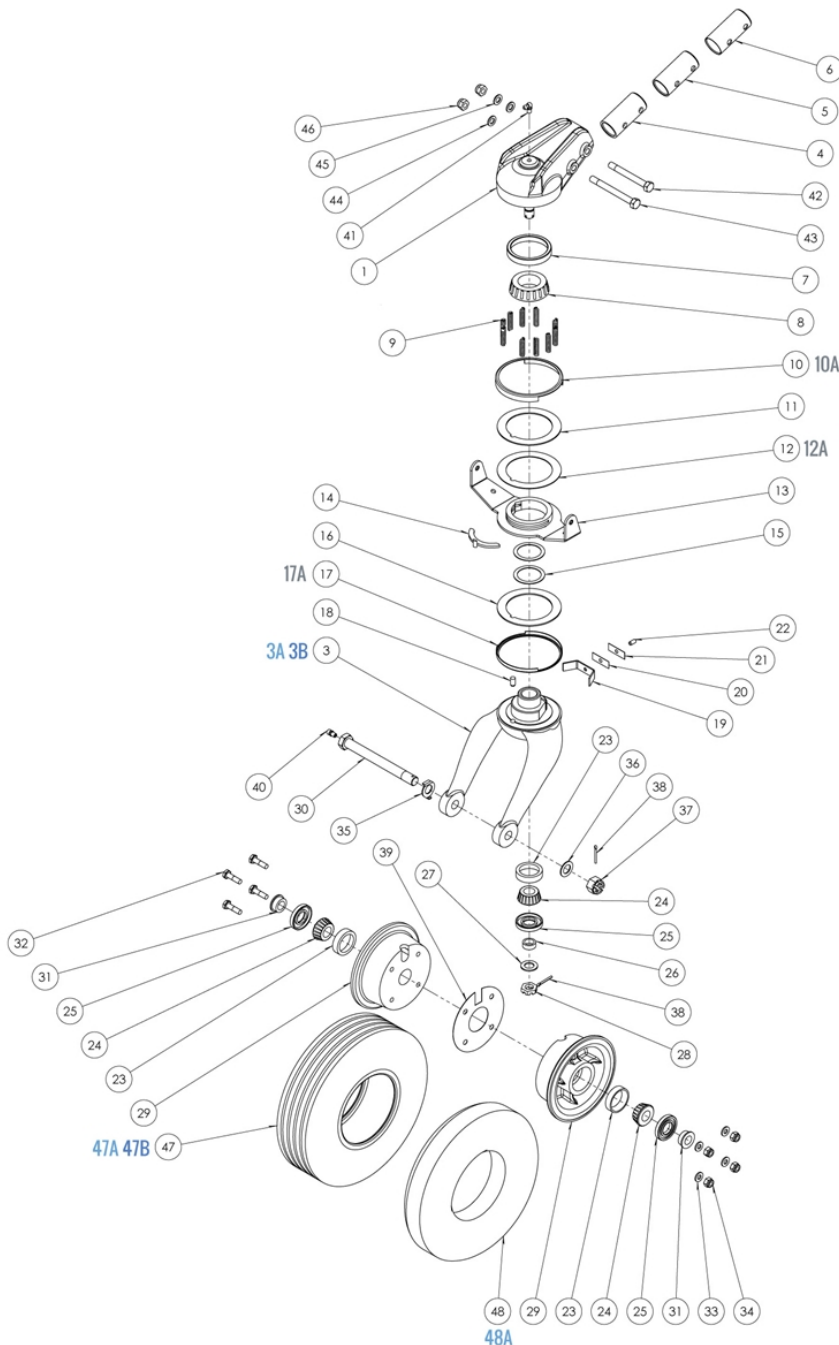
A post-accident examination revealed that the tailwheel rotated freely to the right but was very stiff and difficult to rotate to the left. Disassembly of the tailwheel revealed that the steering arm - bent inside radius (item #13 in photo 4 below) was heavily scored and worn. The compression spring (item #19 in photo 4 below), had sharp edges on the ends of the spring and the spacer (item #20 or #21 in photo 4 below) was not present allowing for excessive movement of the spring in its assembly.

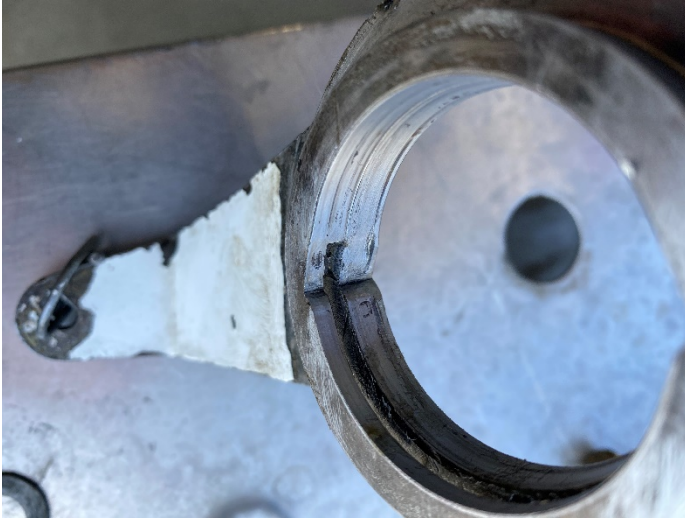
Photo 5 - Tailwheel steering arm's scored and damaged inside radius.

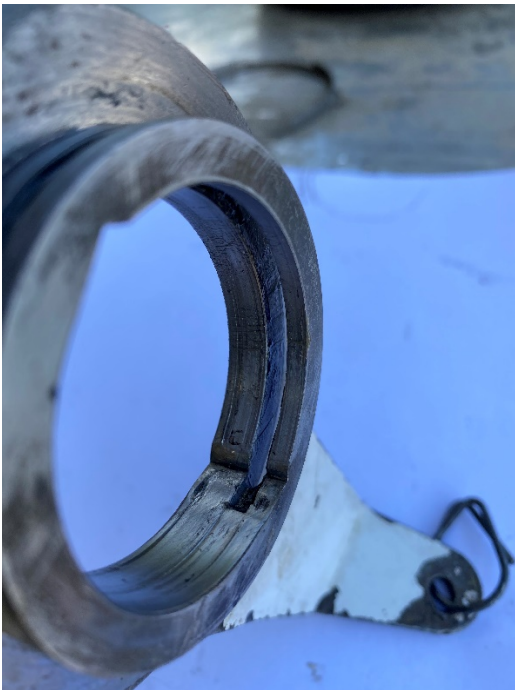
Photo 6 - Tailwheel steering arm's scored and damaged inside radius.

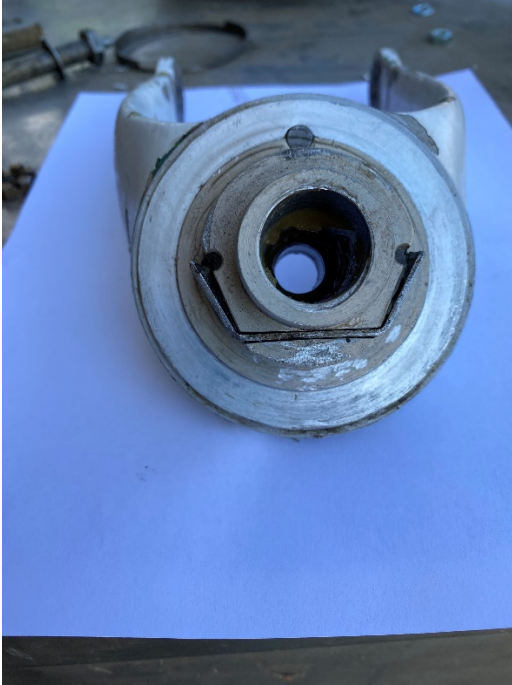
Photo 7 - Compression spring in its respective attach point. Note, no spacer present.
