## **NATIONAL TRANSPORTATION SAFETY BOARD**

### **Specialist's Factual Report**

# **METEOROLOGY**

ANC21FA065

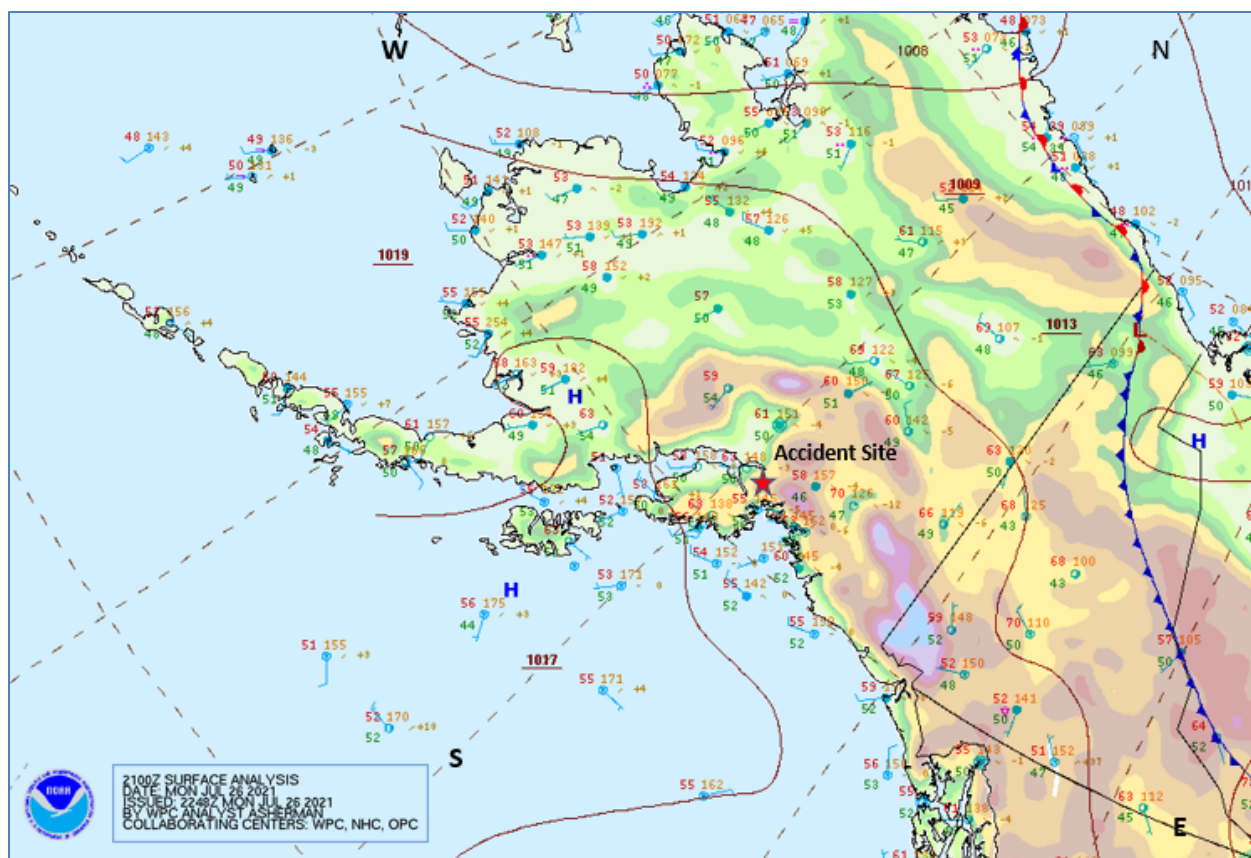
The NWS Surface Analysis Chart centered over southcentral Alaska for 1300 AKDT is included as figure 1 with the approximate accident site marked by a red star. The chart depicted high-pressure systems to the west and southwest of the accident site over southwest Alaska and in the northern Gulf of Alaska at 1019- and 1017-hectopascals (hPa)<sup>1</sup> respectively, which prevailed over southcentral Alaska. The chart depicted a weak pressure gradient<sup>2</sup> based on the spacing of the isobars with generally light winds over the region. The station models surrounding the accident site depicted southwest to westerly winds of 10 knots or less, with temperatures in the range of 58° to 63° Fahrenheit (F).

Figure 1 - NWS Surface Analysis Chart for 1300 AKDT with the accident site marked by the red star.

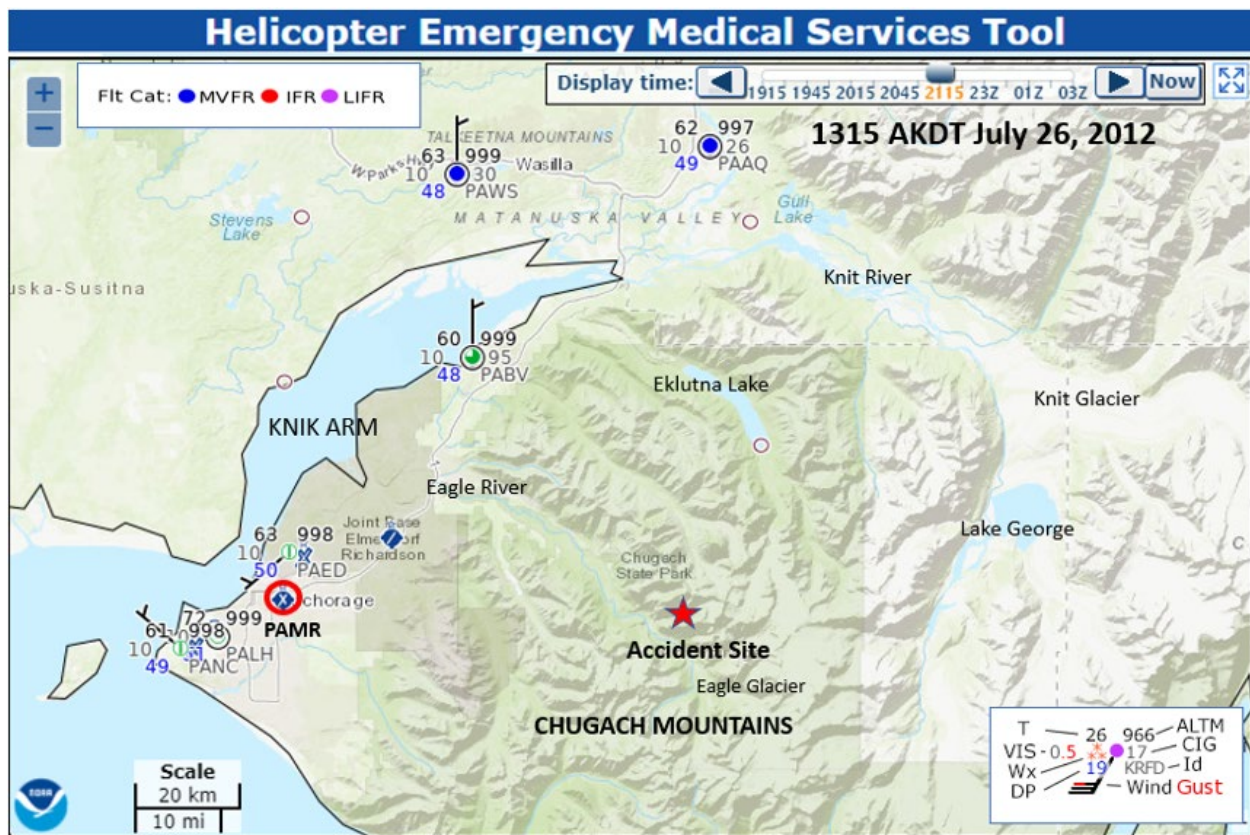
The NWS Aviation Weather Center's Helicopter Emergency Medical Services Tool<sup>4</sup> display of METARs was documented near the time of the accident and provided a graphical display of the weather conditions and general flight categories<sup>5</sup> with the local terrain. Figure 2 is the 1315 AKDT display of the METARs over the area with the approximate accident site marked by the red star.

Figure 2 - NWS AWC HEMS Weather Tool display of METARs at 1315 AKDT and accident site.

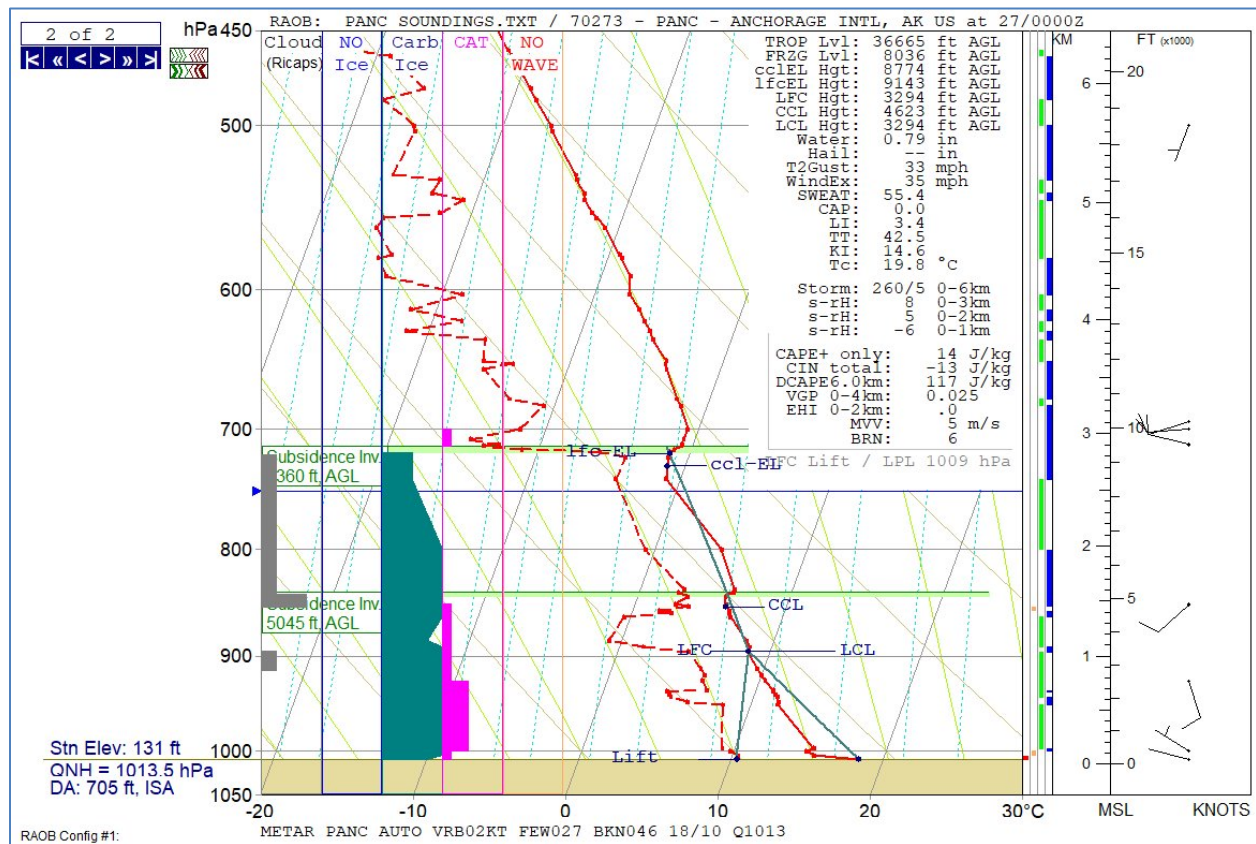
Figure 3 – NWS PANC 1600 AKDT sounding.

The NWS PANC 1600 AKDT sounding depicted a lifted condensation level (LCL)<sup>10</sup> and level of free convection (LFC)<sup>11</sup> at 3,294 ft agl, with a convective condensation level (CCL)<sup>12</sup> at 4,623 ft agl, which support a few to scattered clouds at the LCL at approximately 2,700 ft agl and a broken layer at approximately 4,600 ft agl as depicted on the left of the diagram in gray as determined by the RAOB analysis program. The freezing level was identified above 8,000 ft. The sounding indicated several temperature inversions below 10,000 ft, with the atmosphere

characterized as stable with a lifted index<sup>13</sup> of 3.4, and the precipitable water content of 0.79 inches. The sounding supported a moderate to severe risk<sup>14</sup> of carburetor type icing from the surface through 7,000 ft, based on the temperature and relative humidity profiles which is depicted in dark green on the left side of the profile (see section 10.0). The wind profile indicated light variable near-surface winds generally from the west at 10 knots between 5,000 and 10,000 ft. The mean 0 to 6 km (or 18,000 ft) wind was from 230° at 7 knots.

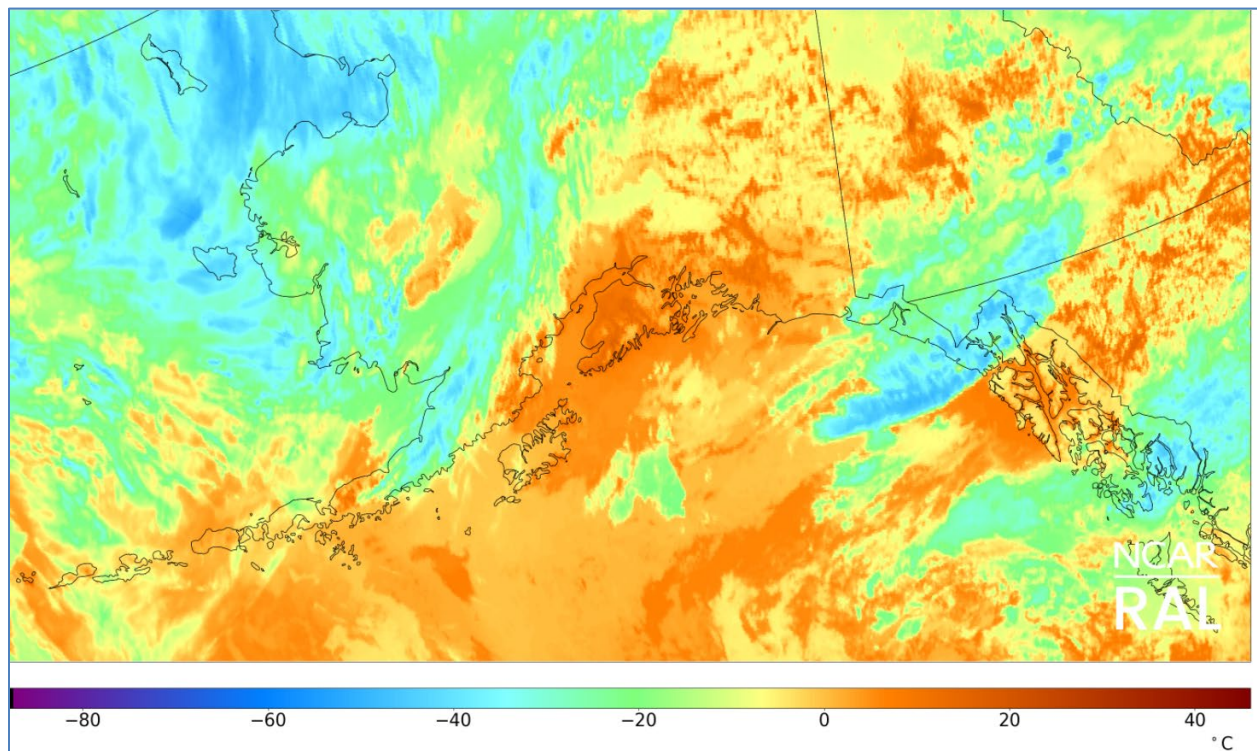
accident time were documented. The infrared long wave imagery (band 14) at a wavelength of 11.2 microns ( $\mu\text{m}$ ) provided radiative cloud top temperatures, and the low-level water vapor (band 10) at a wavelength of 7.3  $\mu\text{m}$ , both provided a nominal spatial resolution of 2 km, while the visible (bands 1,2 and 3) GeoColor<sup>16</sup> image provided a resolution of 0.5 km. Figure 5-7 are the GOES-17 infrared, low-level water vapor, and visible images for 1305 AKDT, respectively. The infrared imagery depicted clear conditions and warm low-level clouds as bright red to orange colors with the colder clouds in blue shades. While the moisture channel depicted dark colors as dry air and moisture as white to purple layers. The visible image depicted clouds and snow cover as different shades of white, with the clear conditions the true ground cover. The images depicted relatively clear skies over the Anchorage and Knik Arm areas with scattered to broken low-stratocumulus type clouds over the interior sections of southcentral Alaska.

**Figure 5 - GOES-17 infrared satellite image for 1305 AKDT.**

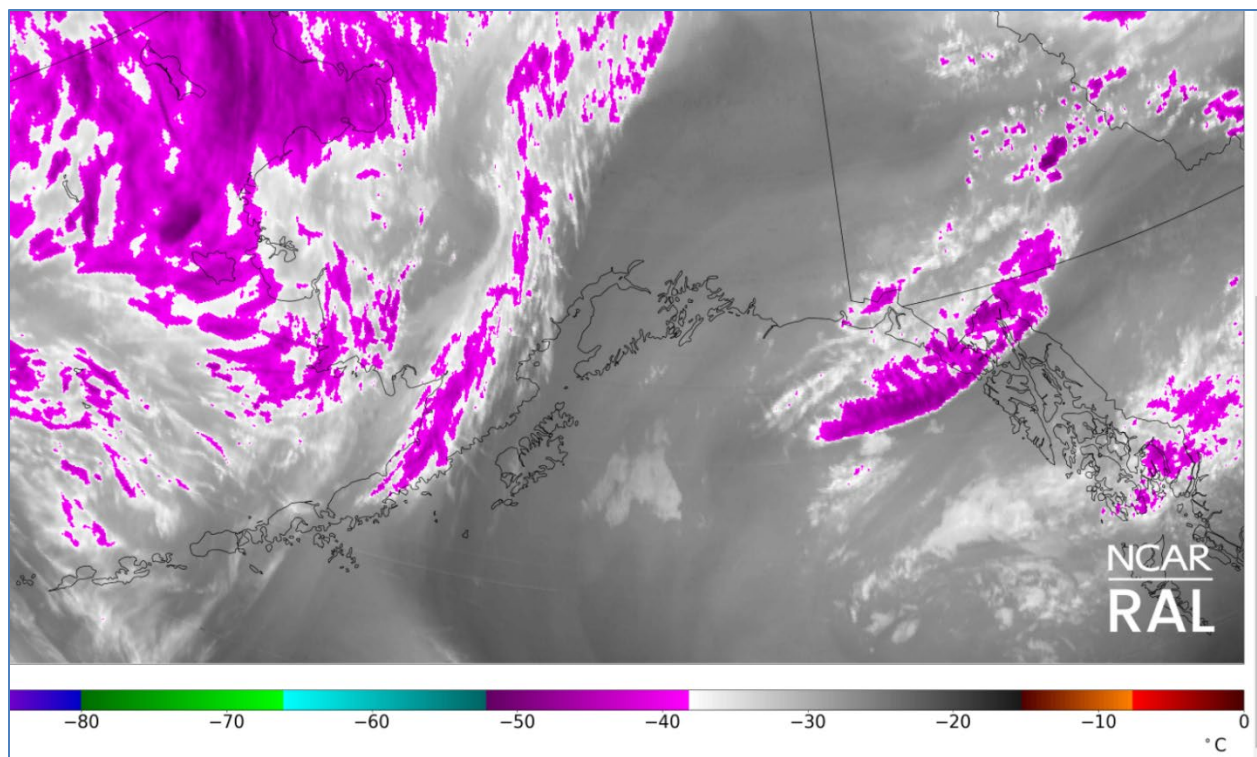
**Figure 6 - GOES-17 low-level water vapor image for 1305 AKDT.**

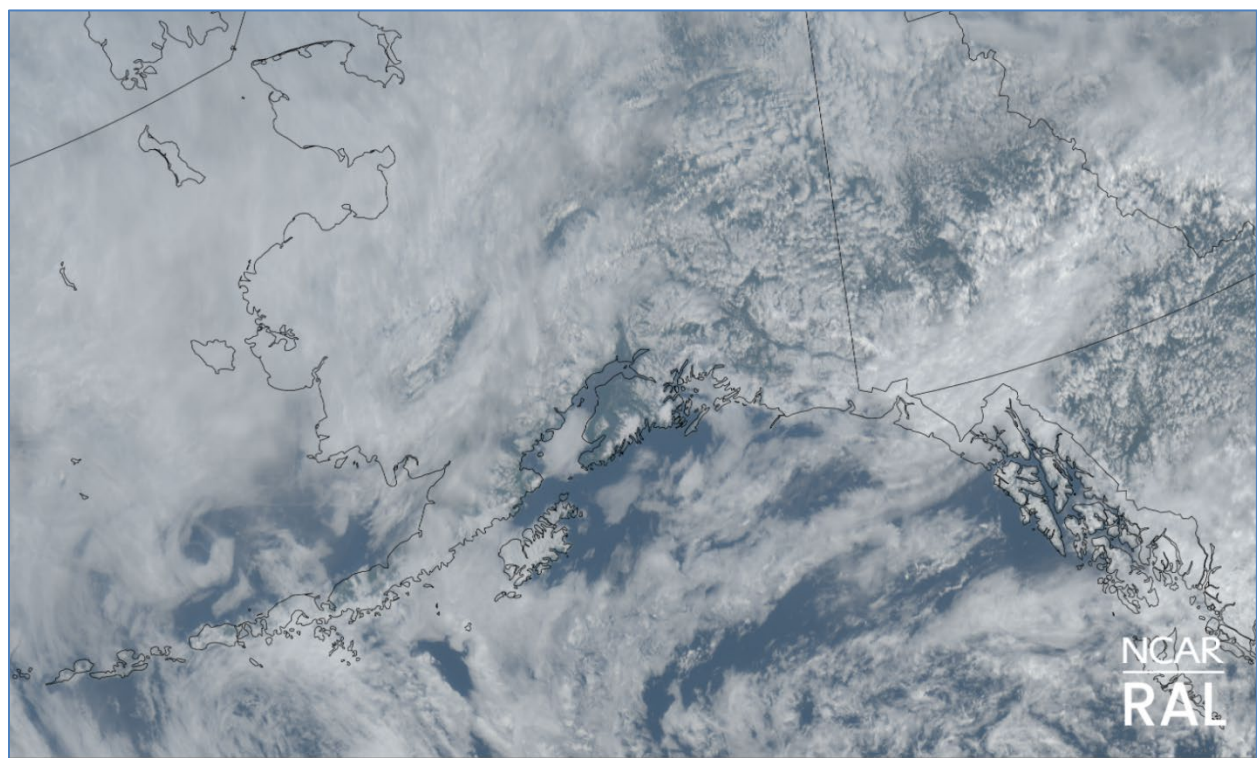
**Figure 7 - GOES-17 GeoColor visible image for 1305 AKDT.**

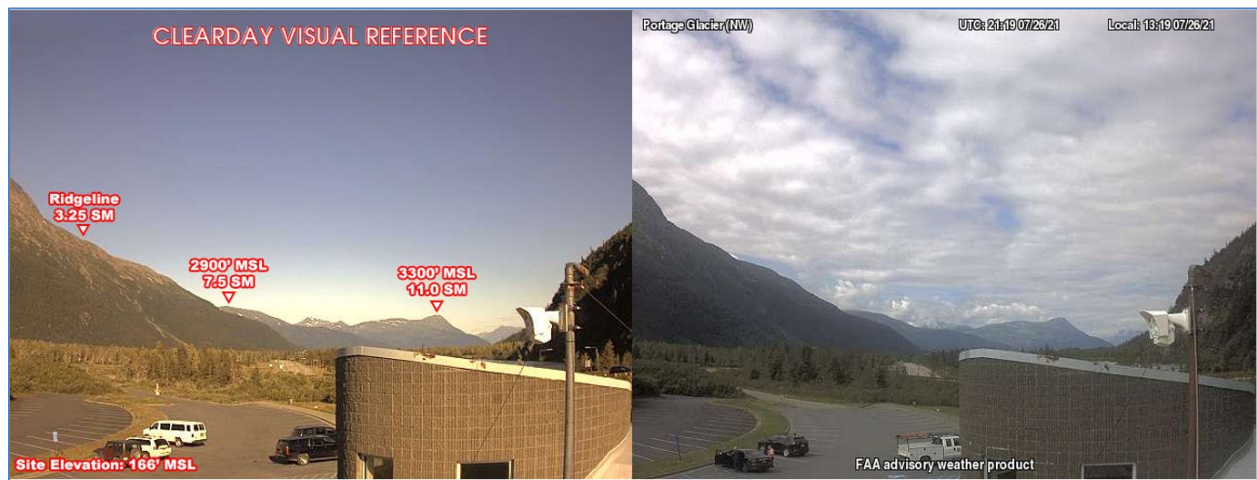
The FAA weather camera<sup>17</sup> images from Palmer (PAAQ), Portage Glacier (PATO), and Whittier (IEM) were reviewed and depicted a broken layer of stratocumulus clouds over the region with no significant visibility restrictions. Most of the mountains were still partially covered in snow and with only the tallest mountains south of Portage Glacier and from Whittier were obscured by clouds during the period. Figures 8-10 are the FAA weather camera images from Portage Glacier viewing northwest at 1319 AKDT, Whittier viewing north at 1320 AKDT, and Palmer viewing southeast at 1318 AKDT respectively. None of the camera's views extended over the accident site.

Figure 8 - FAA Portage Glacier northwest camera view on a clear day and at 1319 AKDT.

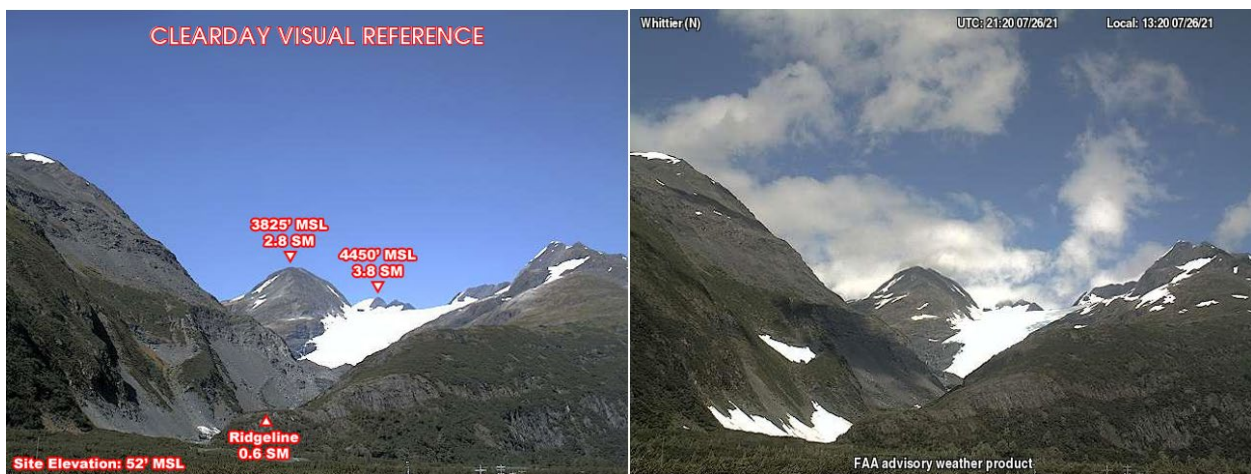
Figure 9 - FAA Whittier north camera view on a clear day and at 1320 AKDT with mountain obscured above 4,450 ft at 3.8 miles.

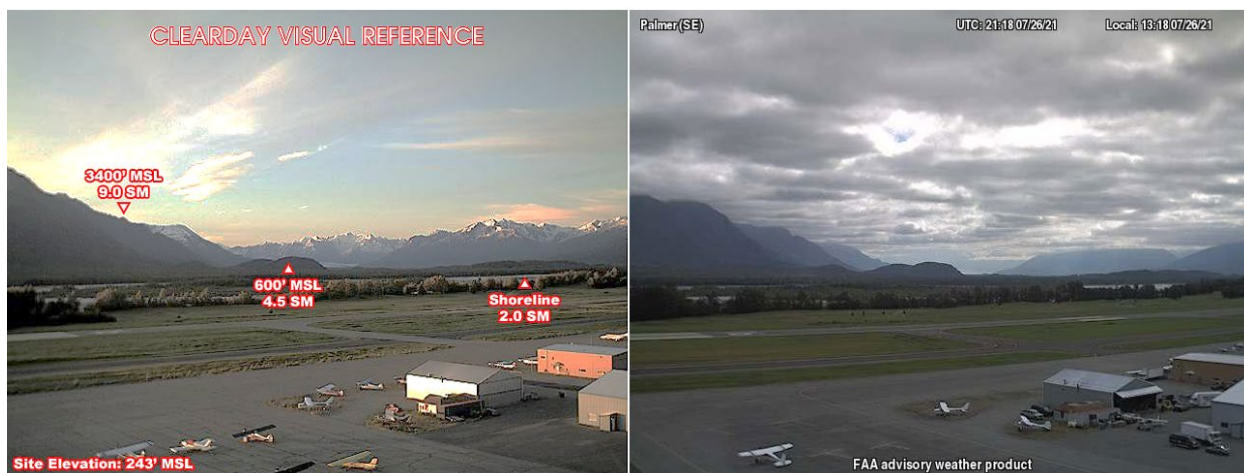
Figure 10 - FAA Palmer southeast weather camera view on clear day and at 1318 AKDT.

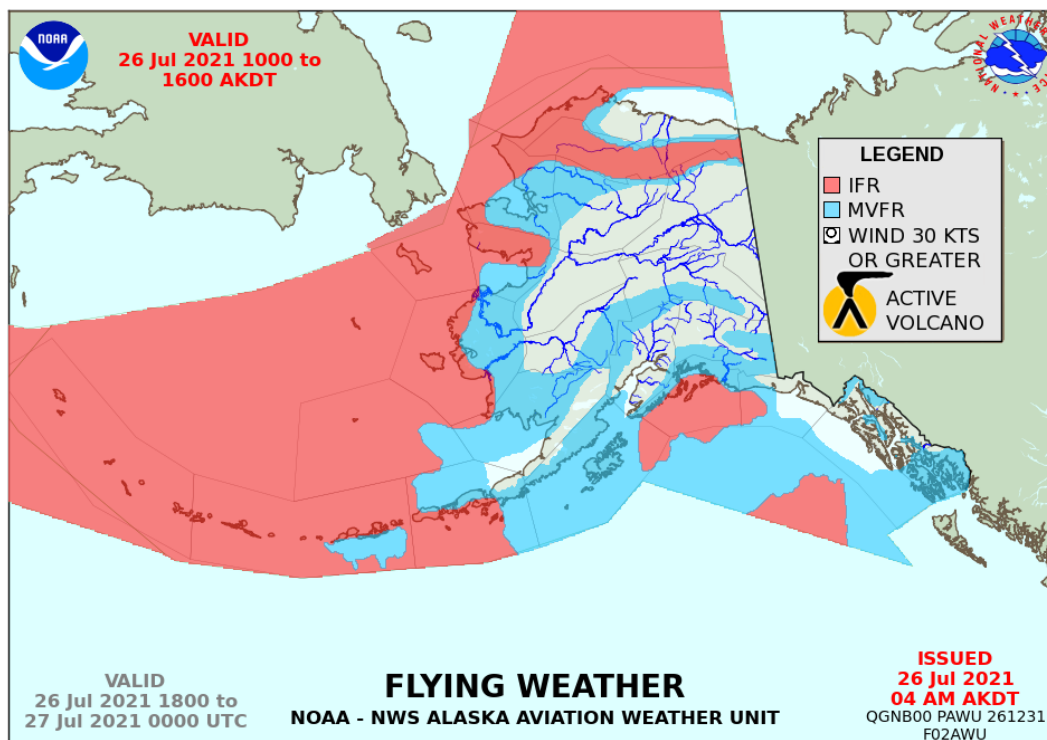
The NWS Anchorage AAWU issued the following aviation weather graphics during the period; the Flying Weather (figure 11) or depiction of the general flight categories, the Convective Outlook (figure 12), Low-Level Turbulence (figure 13), and Icing Forecast Summary (figure 14). The charts depicted generally VFR conditions expected to prevail over the region, with no thunderstorms or towering cumulus clouds expected, and no significant low-level turbulence or structural icing over the region during the period.

Figure 11 - NWS AAWU Flying Weather general flight categories valid for the period.

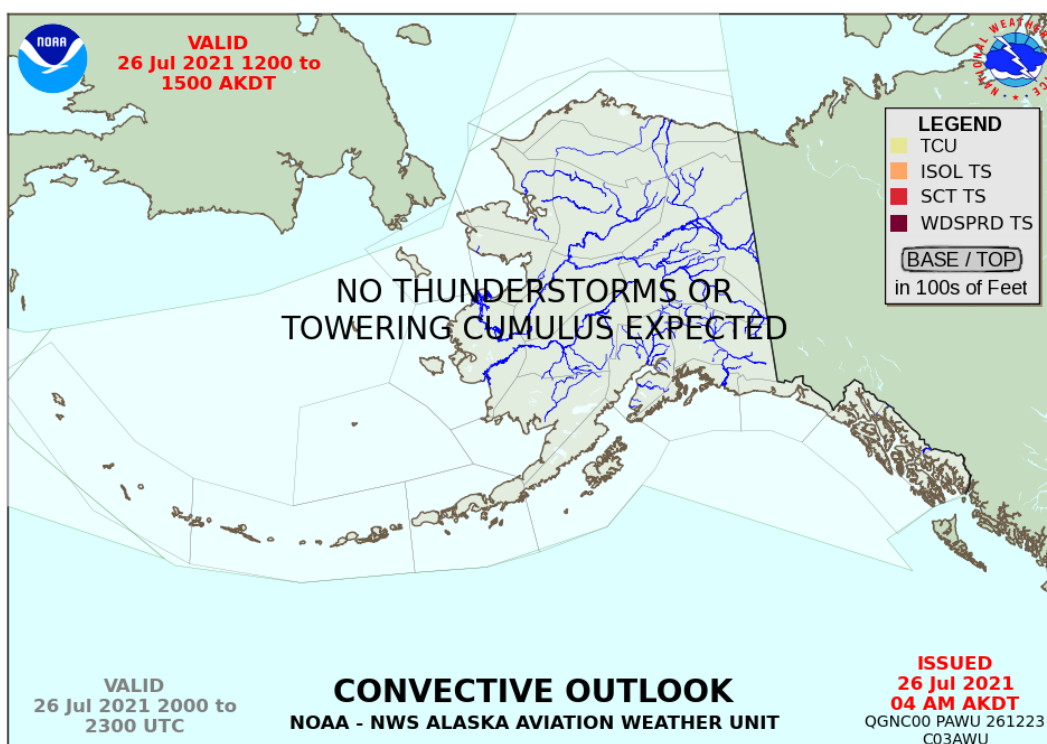
Figure 12 - NWS AAWU Convective Outlook for the period.

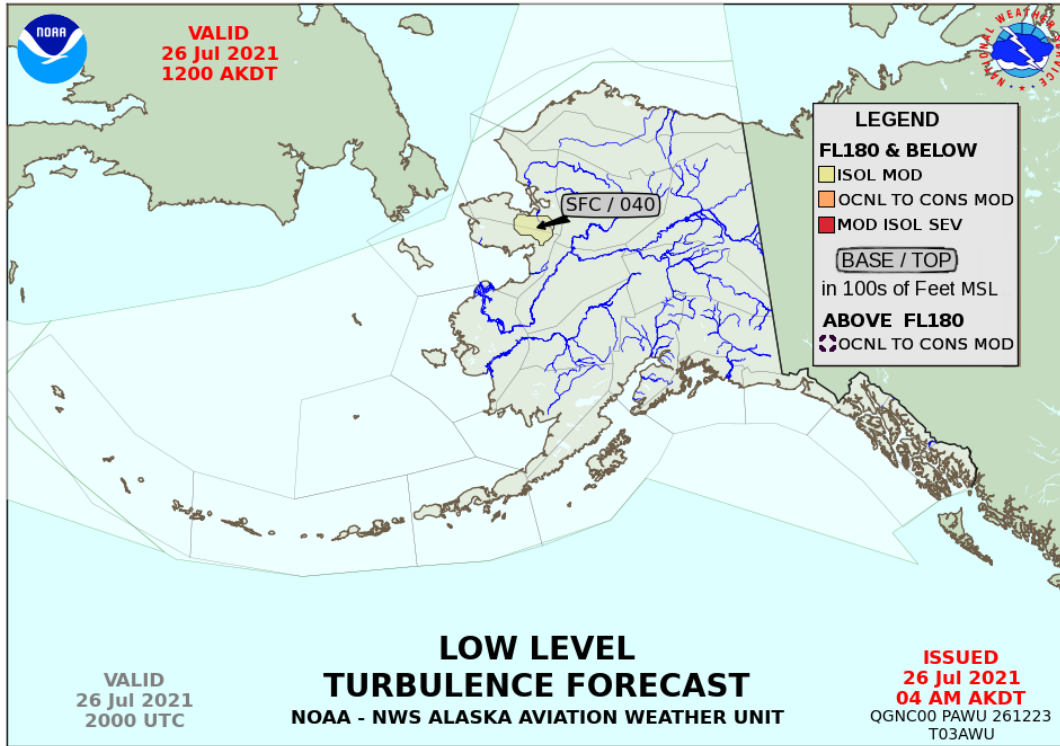
Figure 13 - NWS AAWU Low-Level Turbulence Forecast.

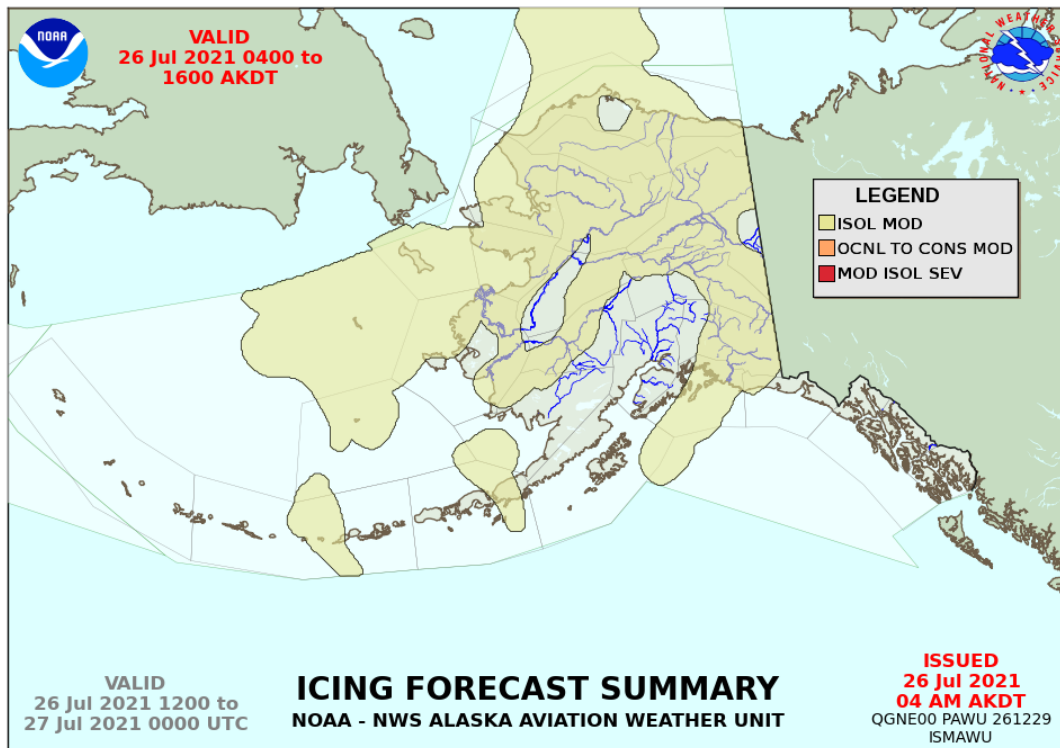
Figure 14 - NWS AAWU Icing Forecast Summary.

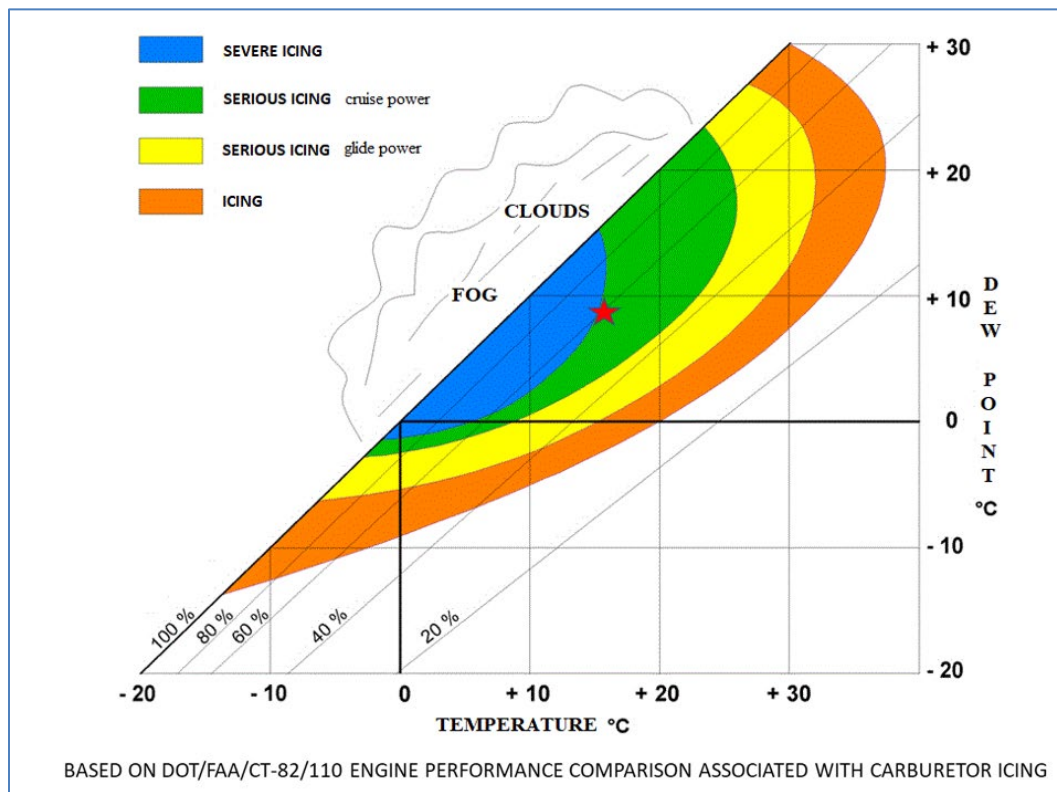
Figure 15 is an icing probability chart based on the Department of Transportation (DOT) and FAA research on engine performance at various temperature and relative humidity ranges, and the potential for carburetor icing<sup>19</sup>. A red star represents the conditions reported at PABV at the time of the accident, which were also similar to the conditions reported at PANC, PAED, and PAAQ. The chart indicated a moderate risk of serious carburetor icing (green) conditions at cruise power and severe at glide power and bordered the severe category (blue) for serious icing at any power setting.

**Figure 15 – Carburetor Icing Potential given temperature, dew point, and relative humidity.**
