## Air Safety Investigations Aircraft Incident/Accident Technical Report

| Aircraft Incident/<br>Accident Information | Year: 1983 | Make: Cessna | Model: 172P |
| Air Safety Investigator: Jennifer D. Barclay | | Report #: ASI-21-CB-T | Report date: 01-31-22 |

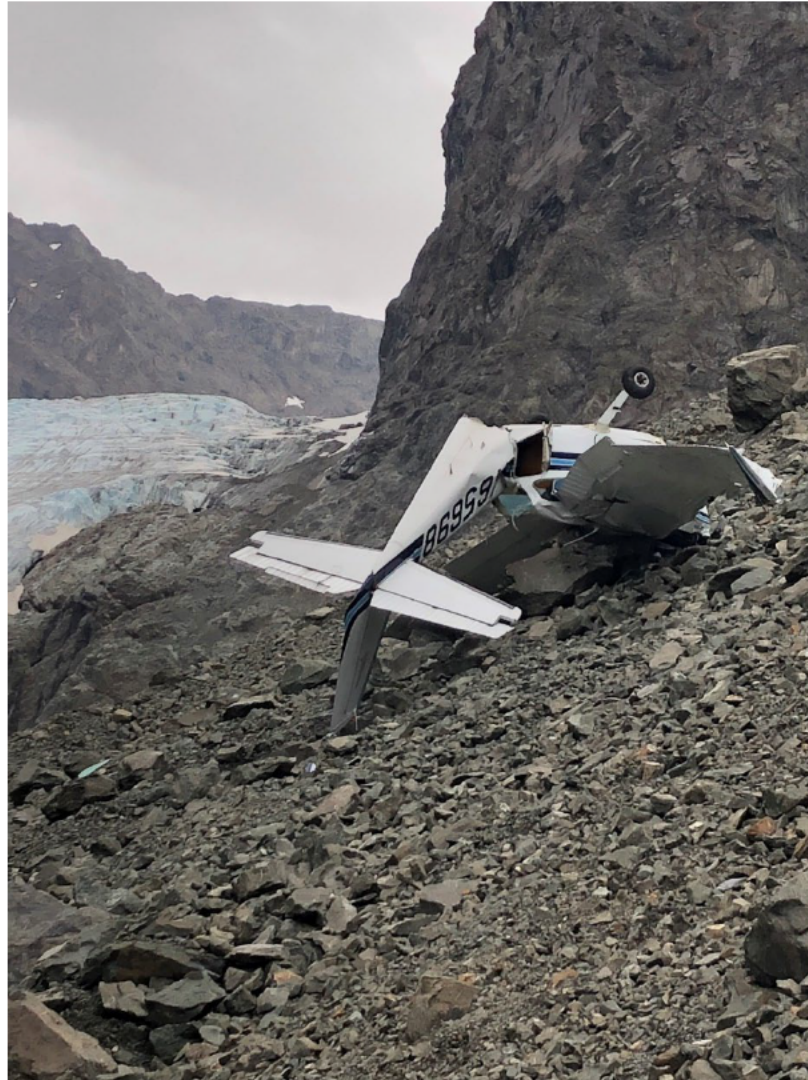
NTSB Photograph

The aircraft impacted terrain in a left-wing and nose-low flight attitude and came to rest inverted. The empennage separated from the fuselage at approximately Fuselage Station (FS) 108. The nose landing gear was forced aft and the lower fuselage exhibited fore-aft crush damage from the firewall to approximately FS 30. The left wing sustained leading edge impact compression damage approximately one foot inboard of the strut. The outboard left wing tip area was bent upwards with slight aft twisting.

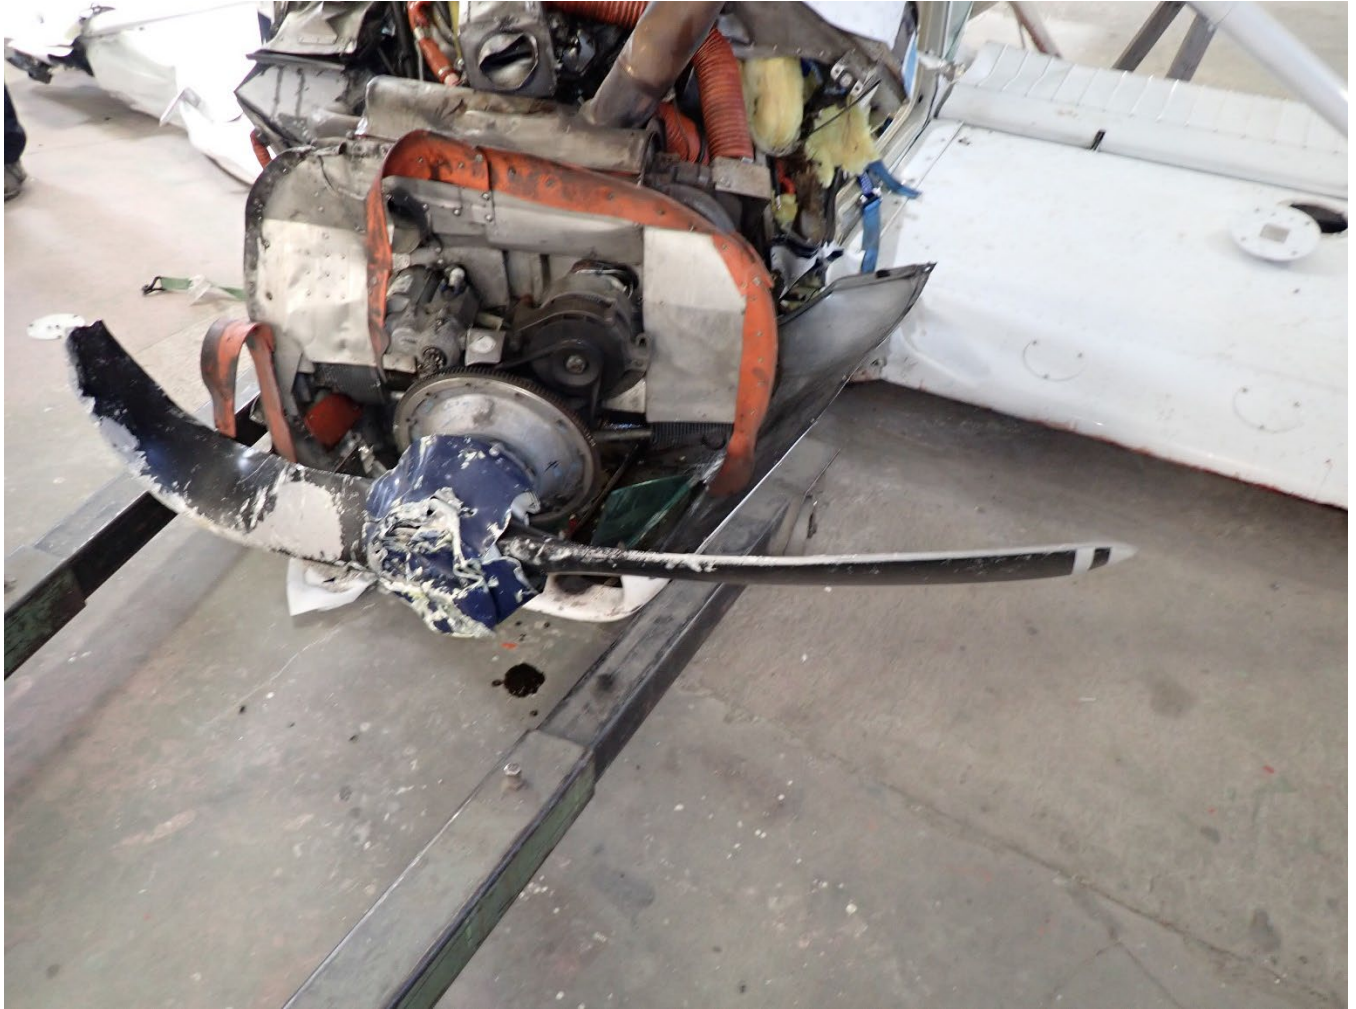
Propeller, ASI-21-CB-058

The propeller remained attached to the engine. Both blades exhibited significant gouges along the length of the leading edge. One blade was relatively straight with a 1" tip separation. The other blade was bent forward at midspan and the outer 1/3 of the blade was fracture separated. The spinner was crushed aft over the hub.
