# **NATIONAL TRANSPORTATION SAFETY BOARD**

## **Airworthiness Group Chairman's Factual Report**

#### **ANC21FA069**

Location: Ketchikan, Alaska  
Date: August 5, 2021  
Time: 1050 Local Time (ADT)  
Aircraft: Southeast Aviation de Havilland DHC-2 MK.1, registration N1249K

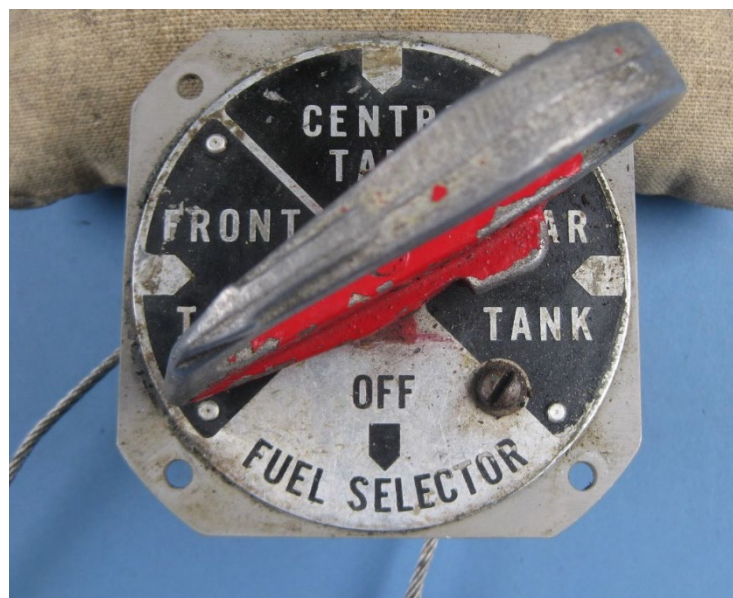
**Figure 1 - Airplane's Fuel Selector**

The flight compartment Fuel Selector was noted in the "OFF" position in photographs taken on scene and after the airplane was recovered.

During the on-scene examination, the fuel selector's red handle was rotated to the other selection positions (Front, Centre, and Rear fuel tanks) and the fuel selector valve, located in the fuselage belly, aft of the fuel tanks, was noted to move. The fuel selector could be moved to each of the positions, with the valve moving with each selection. The fuel selector was then removed for further examination for witness marks. See Figure 1.

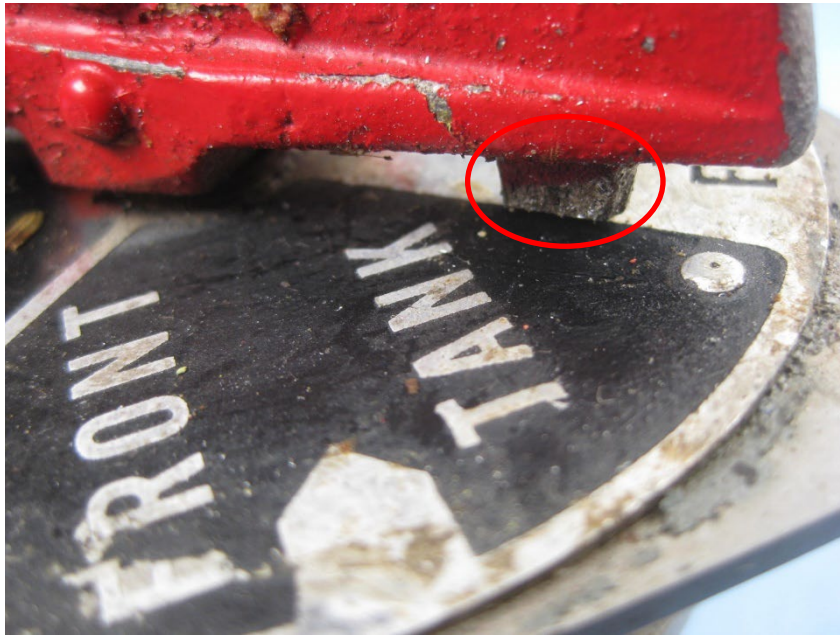
**Figure 2 - Fuel Selector Panel, FRONT TANK Selection Area. Note the selector handle tab circled in red.**

For the FRONT TANK area, see Figure 2.

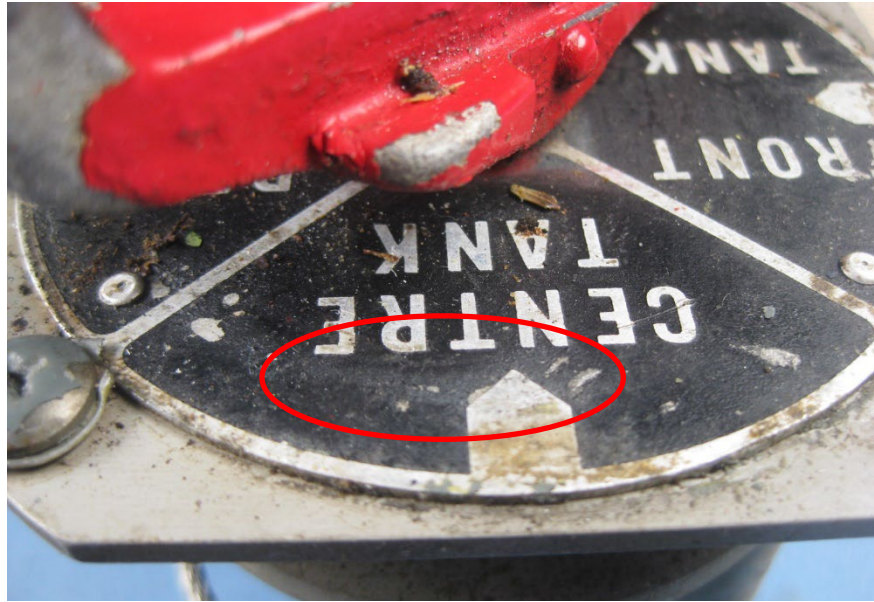
**Figure 3 - CENTRE TANK sector of Fuel Selector. Note marking in area of red circle.**

The CENTRE TANK area was also examined. There was an area of marks noted in the sector. See Figure 3.

No definitive impact witness marks were noted on the selector. The markings on the CENTRE TANK sector were the only marks noted during the examination.

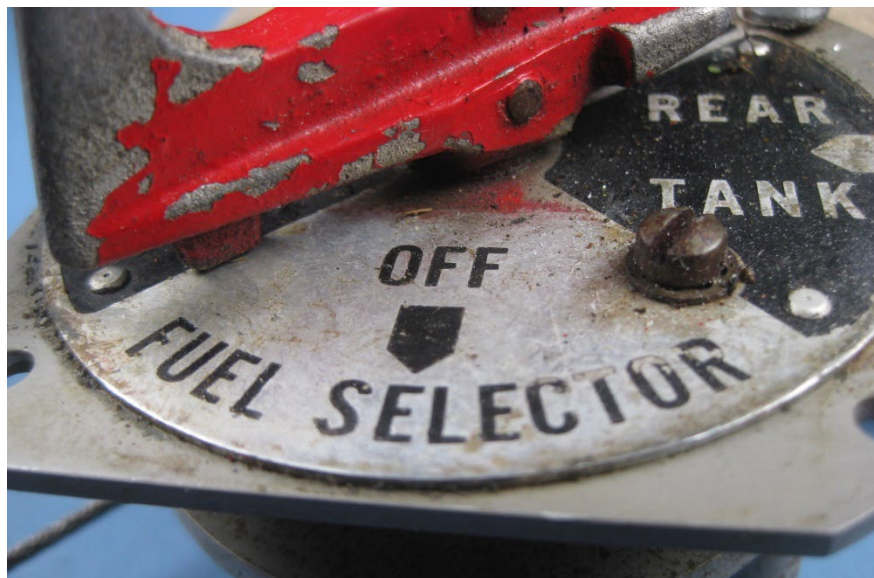
**Figure 4 - The Fuel Selector OFF area.**

The OFF sector was also examined. See Figure 4.

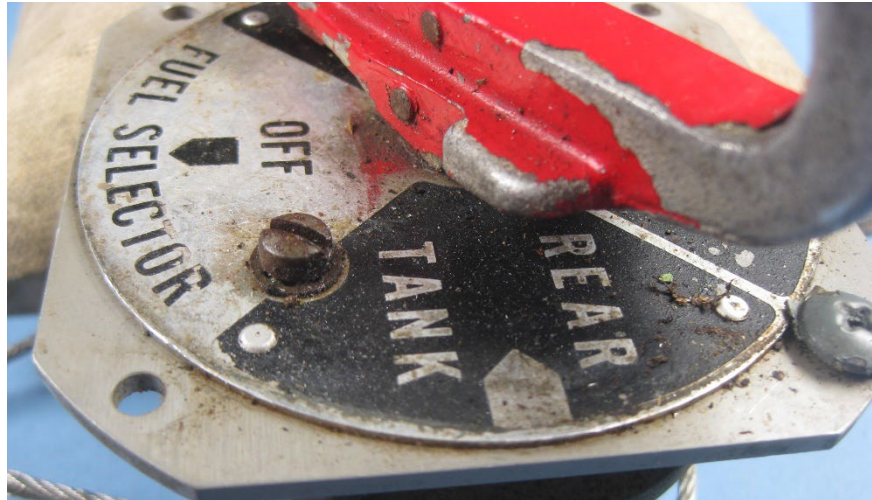
**Figure 5 - The REAR TANK sector of the fuel selector.**

Finally, the REAR TANK sector was also examined. See Figure 5.

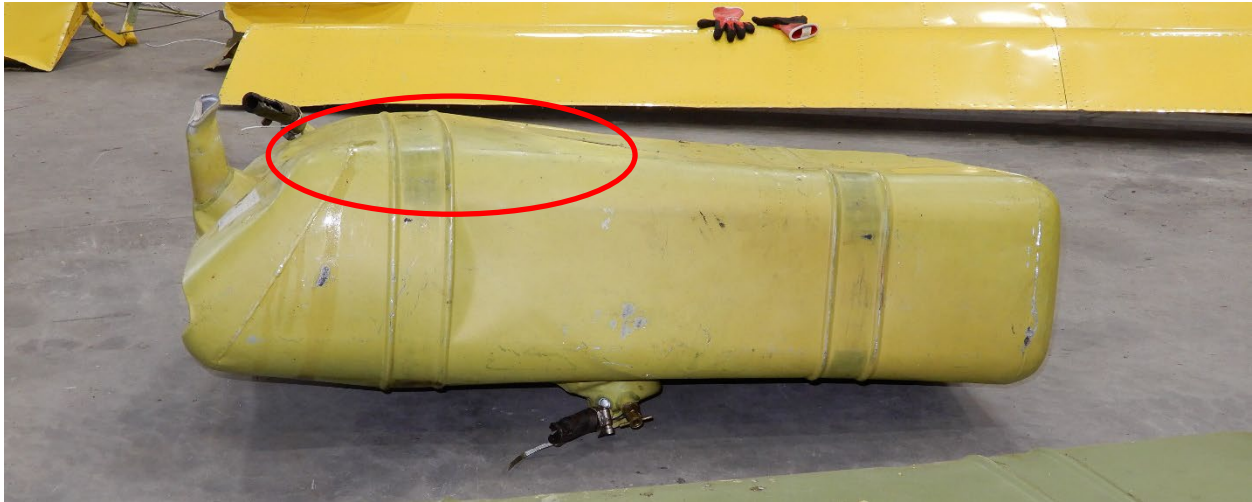
- Front Tank: The tank-retaining straps were intact. When the access panel on the top of the tank was removed, and the tank opened, a trace amount of fluid was noted at the bottom. The fluid (and tank) and had an odor like aviation fuel. The trace amount of fluid was noted in the tank around the tank sump/intake area and around the left (pilot's side) of the tank. The fluid did not cover the entire bottom of the tank, just around the lower areas.

The tank also exhibited visual indications of hydraulic deformation around the left (pilot) side of the top and bottom sides. The tank was pushed out such that it interfered with hose fitting for the Front Tank's ventilation tube.

The filler neck was crushed, but the neck remained open. See Figure 6.

**Figure 6 - Front Fuel Tank (Area of hydraulic deformation in red circle)**

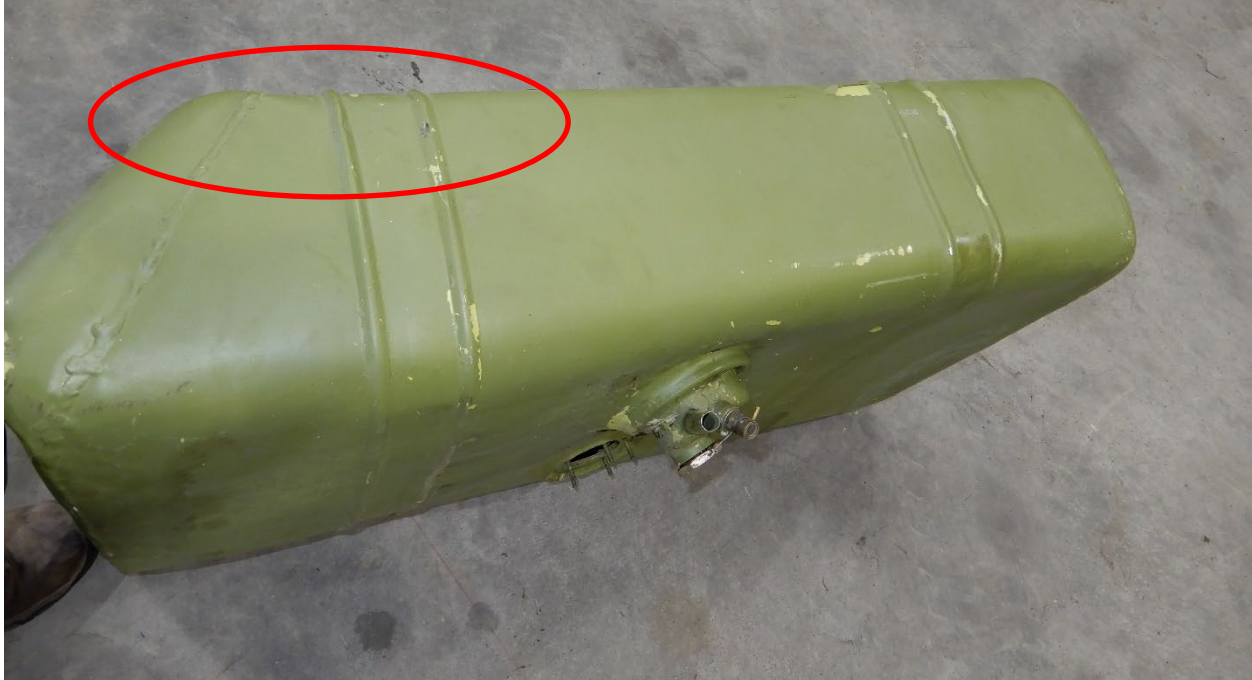
- Center Tank: When exposed, both Center Tank restraining straps were found broken. The straps were broken on the aft side of the Center Tank. When the access panel on the top was removed and the tank opened, a small amount of fluid was noted in the tank around the tank sump/intake area of the tank. The fluid did not cover the entire bottom of the tank, just around the lower areas.

The Center Tank also exhibited hydraulic deformation around the left side of the tank. The tank was pushed out on the bottom, left side of the tank, and appeared to be compressed on the right side of the tank. The filler neck remained intact. See Figure 7.

**Figure 7 - Center Fuel Tank (Area of hydraulic deformation in red circle)**

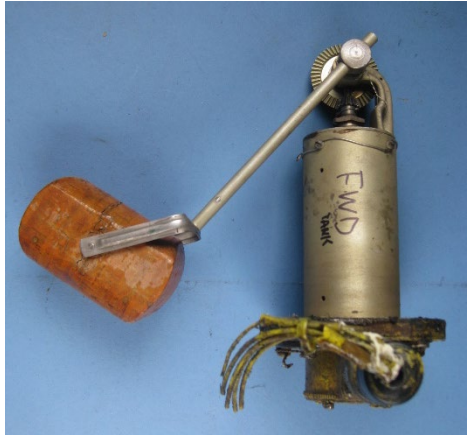
The sensors were visually examined and photographed. The sensor removed from the Front Tank was examined. No visual anomalies were noted. See Figure 8.

**Figure 8 - Fuel Quantity Sensor removed from the Front Fuel Tank.**

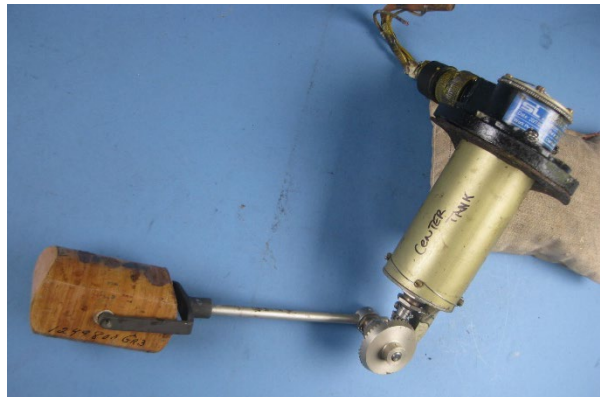
The sensor removed from the Center Tank was also examined. No visual anomalies were noted. See Figure 9.

**Figure 9 - Fuel Quantity Sensor removed from the Center Fuel Tank.**

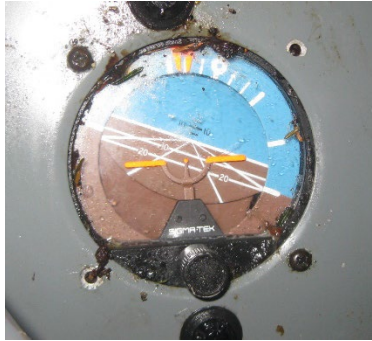
Attitude Indicator: Indicated Left Wing approximately 25 degrees down and nose down attitude of approximately 18 degrees. A photograph

taken at the accident location showed the indicator in a different attitude than after the airplane was moved to the hangar. See Figure 10.

**Figure 10 - Attitude Indicator, as noted after airplane recovery.**

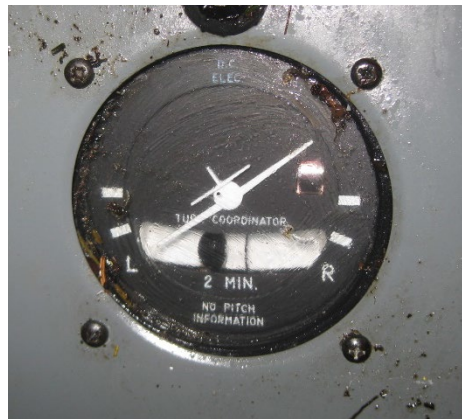
Turn coordinator: a left wing down past standard rate turn. The ball is to the left because of how the wreckage was resting on hangar floor. See Figure 11.

**Figure 11 - Airplane Turn Coordinator, left wing down indication.**

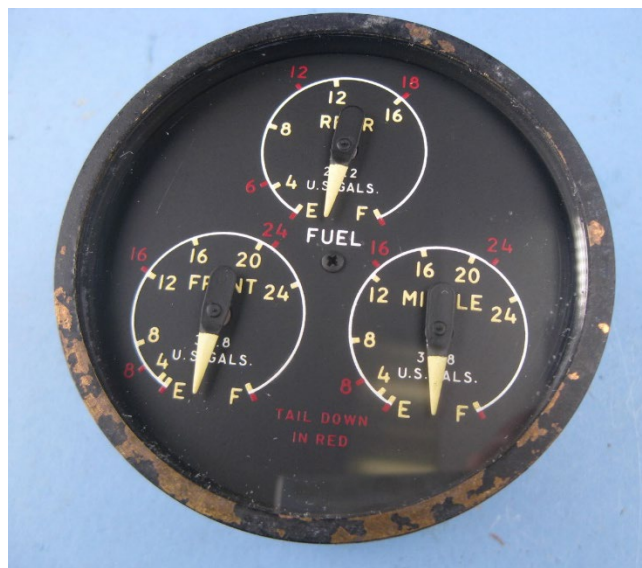
**Figure 12 - The Fuel Quantity Indicator, as recovered.**

The Fuel Quantity Indicator (See Figure 12) was further examined for witness marks, from the indicator needles onto the instrument face, that indicated the needle's position at impact. The needle position at impact would indicate the amount of fuel in the fuel tanks at impact.

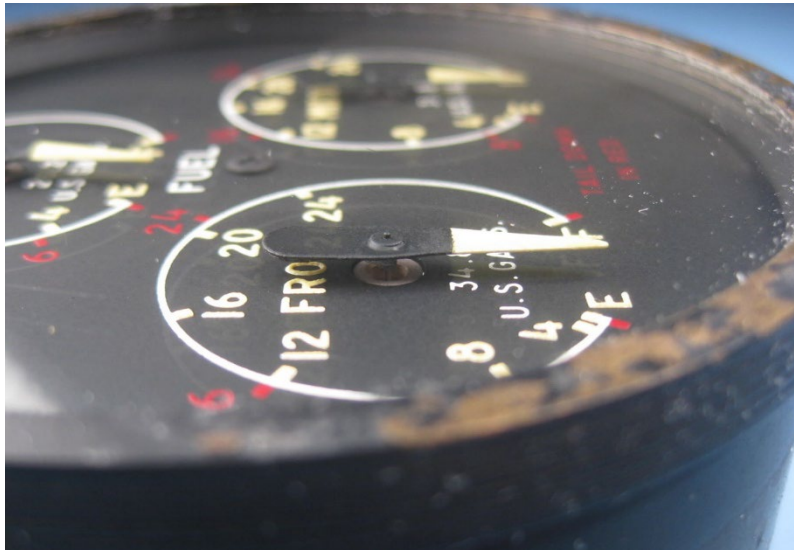
The area of the FRONT Tank was examined. No needle impact marks were noted, and the needle did not appear bent or damaged. See Figure 13.

**Figure 13 - The indication area of the FRONT fuel tank, with no impact marks noted.**

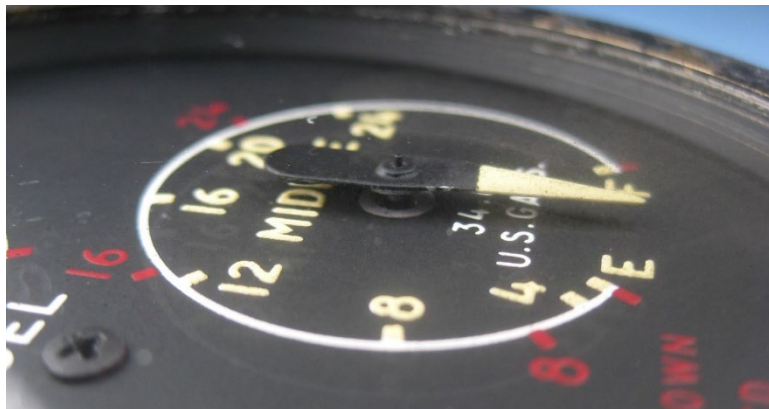
The area of the MIDDLE Tank was also examined. No needle impact marks were noted, and the needle did not appear bent or damaged. See Figure 14.

**Figure 14 -The indication area of the MIDDLE fuel tank, with no impact marks noted.**

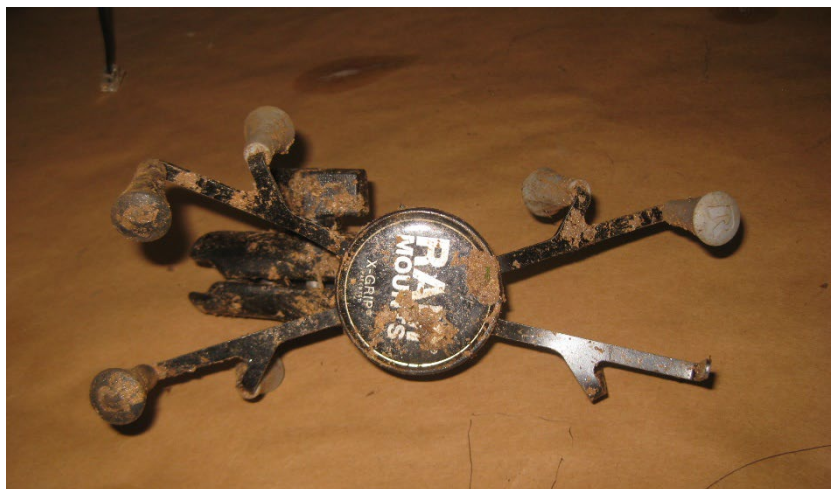
**Figure 15 - iPad Flight Deck Mount**

A flight deck iPad mount was recovered from the wreckage. See Figure 15. The mount was found disconnected from the airplane flight deck instrument panels.

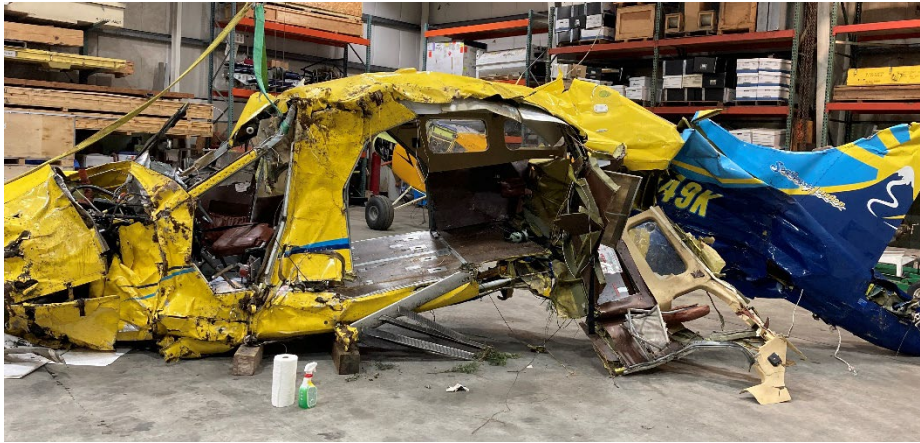
The fuselage remained intact but exhibited impact damage on the left side of the airplane. The left side of the fuselage, aft of the passenger cabin back to the area

of the vertical stabilizer fairing, was crushed inwards. As part of the airplane recovery, the tail section of the fuselage was folded forward towards the forward section of the airplane. See Figure 16.

**Figure 16 - Left Side of Fuselage, during examination. (Photograph courtesy of the FAA)**

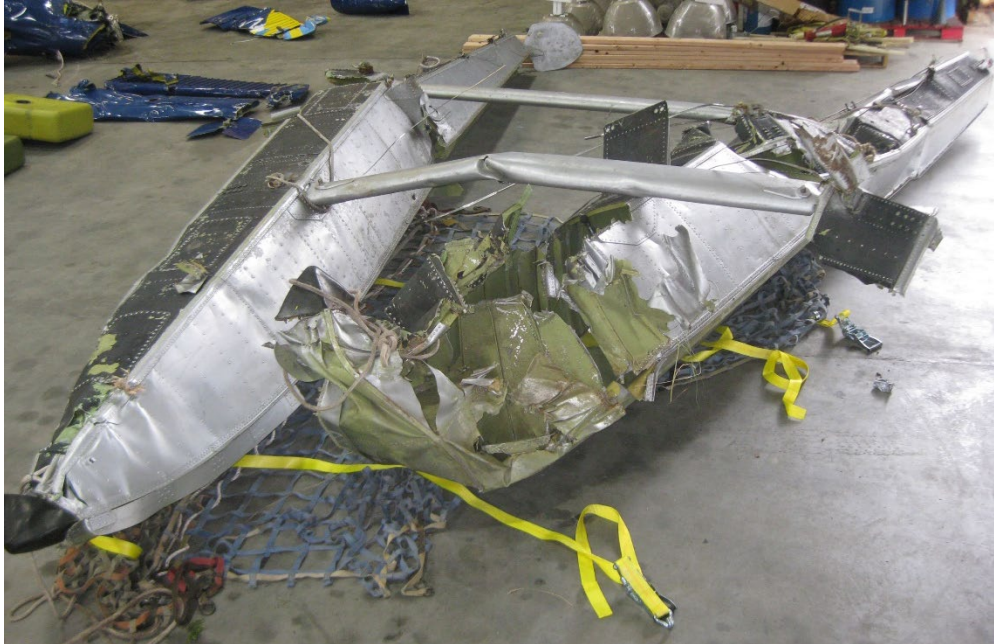
**Figure 17 - Approximate configuration of airplane floats.**

The forward section of the left float was crushed and breached, from the nose to approximately the area of the forward spreader bar. The forward and rear segments of the left float were twisted relative to each other, at the area of the connection of the rear spreader bar. The left water rudder was separated from the float.

The floats were arranged in their approximate configuration. See Figure 17.

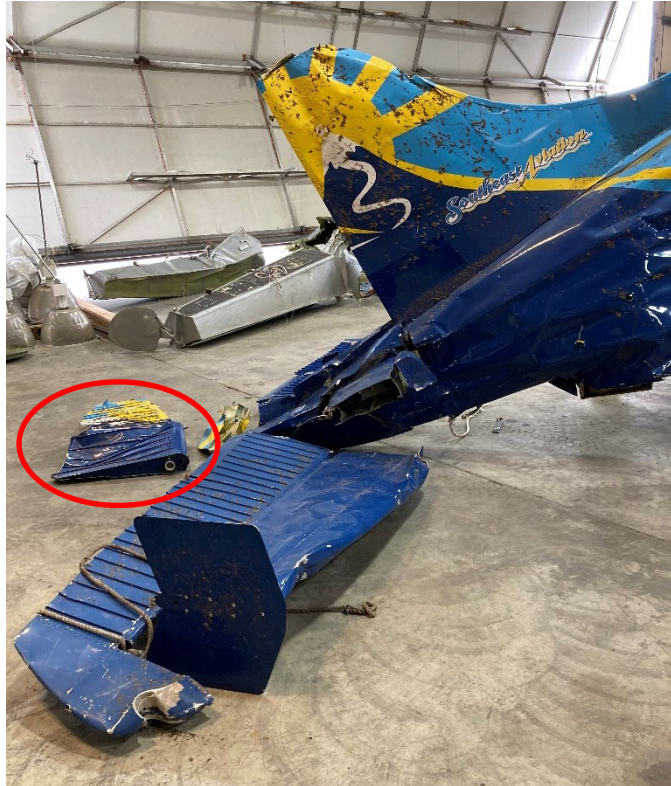
The vertical stabilizer remained connected to the airplane but was crushed aft. The forward fairing was partially detached from the fuselage. The middle rudder connection (trim) and top (pivot) were fractured. The rudder cap was separated from the rudder surface and the forward area of the cap was crushed aft. See Figure 18.

**Figure 18 - Tail Section of Airplane, showing right horizontal stabilizer, vertical stabilizer, and rudder (separated, circled in red). (Photo courtesy of the FAA)**

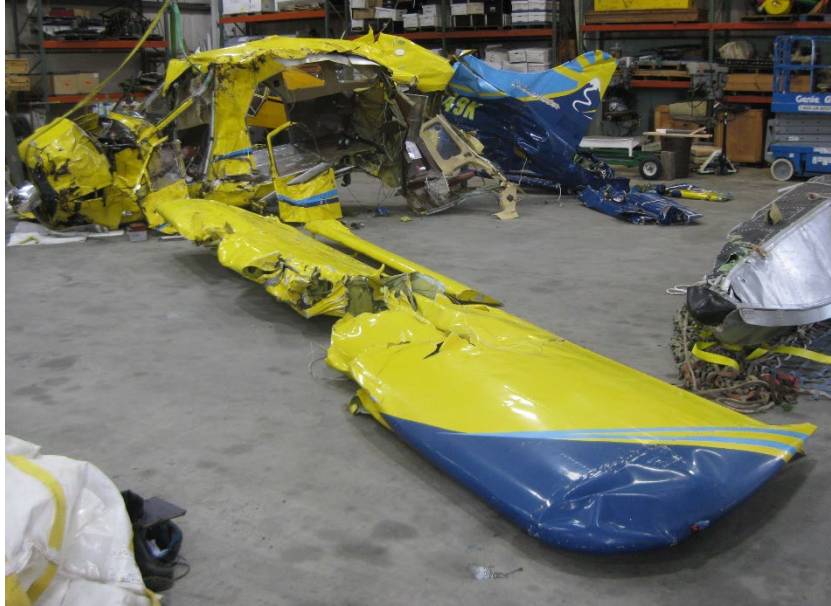
**Figure 19 - The Airplane's Left Wing, during examination.**

For the left wing, the outer segment of wing was measured at 112 inches in length. The left-wing cap and red light were noted on the piece. The entire aileron was connected to the segment. At the area of the fracture, the leading edge and wing were crushed aft. See Figure 19.

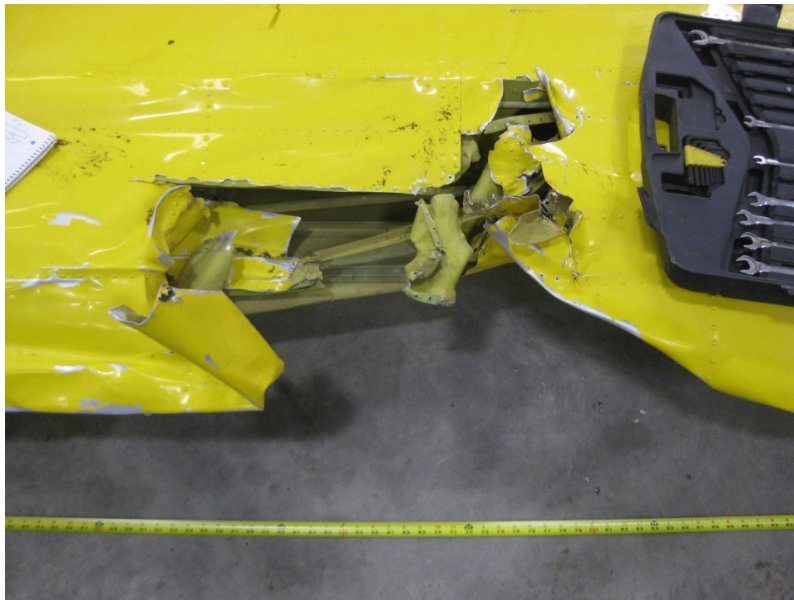
The larger segment of left wing was complete to the wing root, approximately 146" in length. The area of fracture was crushed at the leading edge, with pieces of tree noted in the piece. In this segment of wing wreckage, impact marks were noted that were angled from a wings level perspective. See Figure 20.

**Figure 20 - Left wing. Note the angled impact marks.**

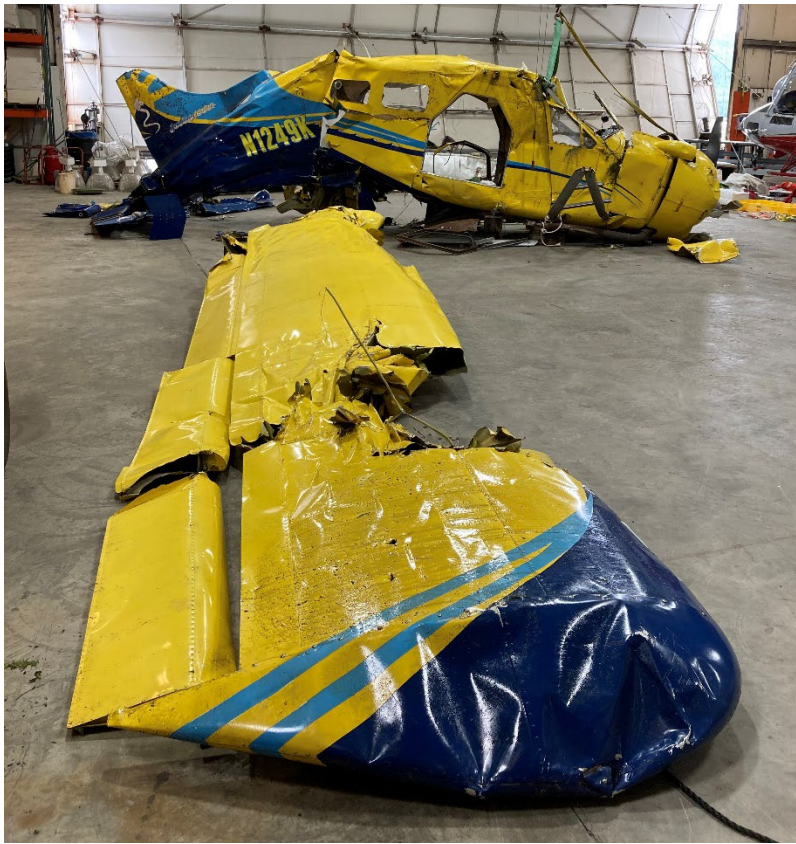
The entire right wing was recovered, but it was separated into two pieces. The outer piece was approximately 5 feet in length and included the wing cap. The fracture point was the area of the trailing edge flap and aileron junction. The area of the fracture was crushed from the leading edge aft. See Figure 21.

**Figure 21 - Right Wing and right side of fuselage, during the airplane examination.  
(Photograph courtesy of the FAA)**

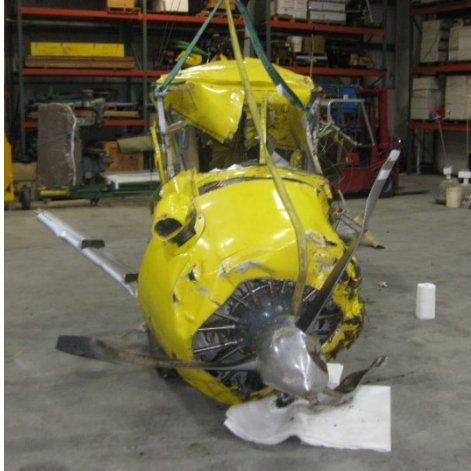
**Figure 22 - Airplane Engine and Forward Fuselage, during examination.**

The airplane was fitted with one engine. The engine was mounted on the front of the fuselage. See Figure 22.

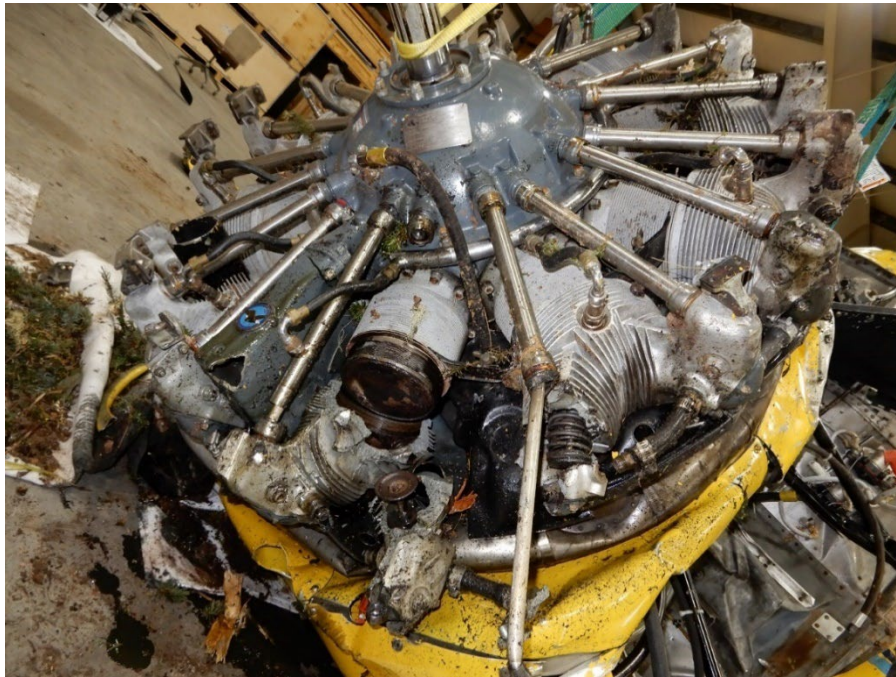
**Figure 23 - Airplane Engine**

The engine was found attached to the airframe even though several of the engine mounts were separated. The propeller could not be rotated by hand. The oil sump was damaged and had a hole in it.

The engine's nine cylinders were examined. The engine's Number 6-cylinder head was separated from the engine. The cylinder barrel remained attached to the engine case. The piston remained in the cylinder and no anomalies were noted. The No. 7 cylinder exhaust valve cover was impact separated and the spring was visible. All other cylinders remained attached to the case and appeared undamaged.

The engine was removed and retained for further examination. See Figure 23.

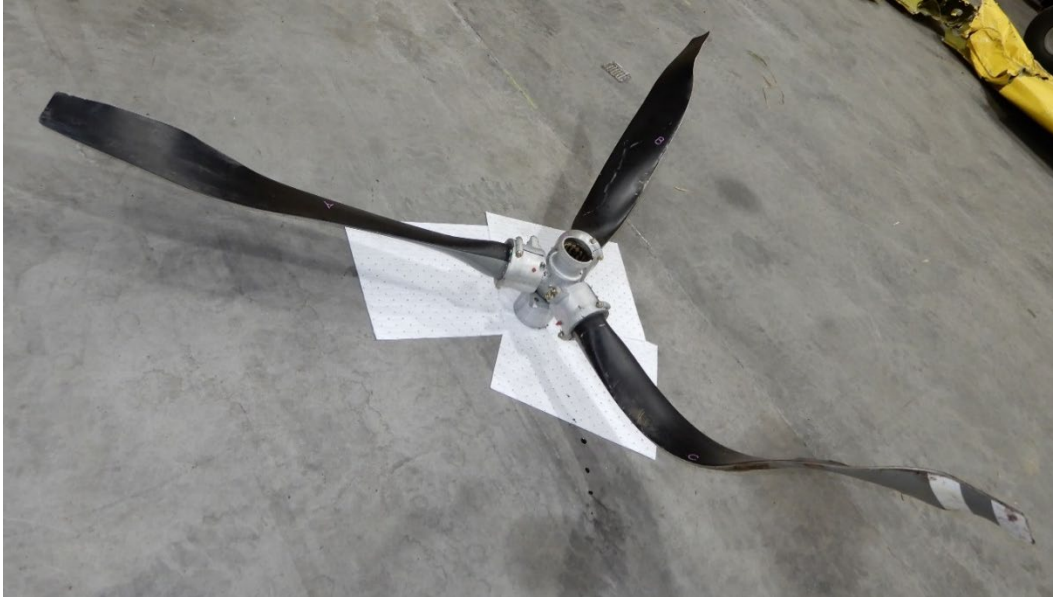
**Figure 24 - Propeller and hub, after removal from the airplane engine.**

The airplane was equipped with a 3-bladed, controllable pitch propeller. All three blades remained attached to the hub. The spinner was removed, and a visual examination noted some visible impact damage. The propeller was then removed from the engine for further examination. See Figure 24.

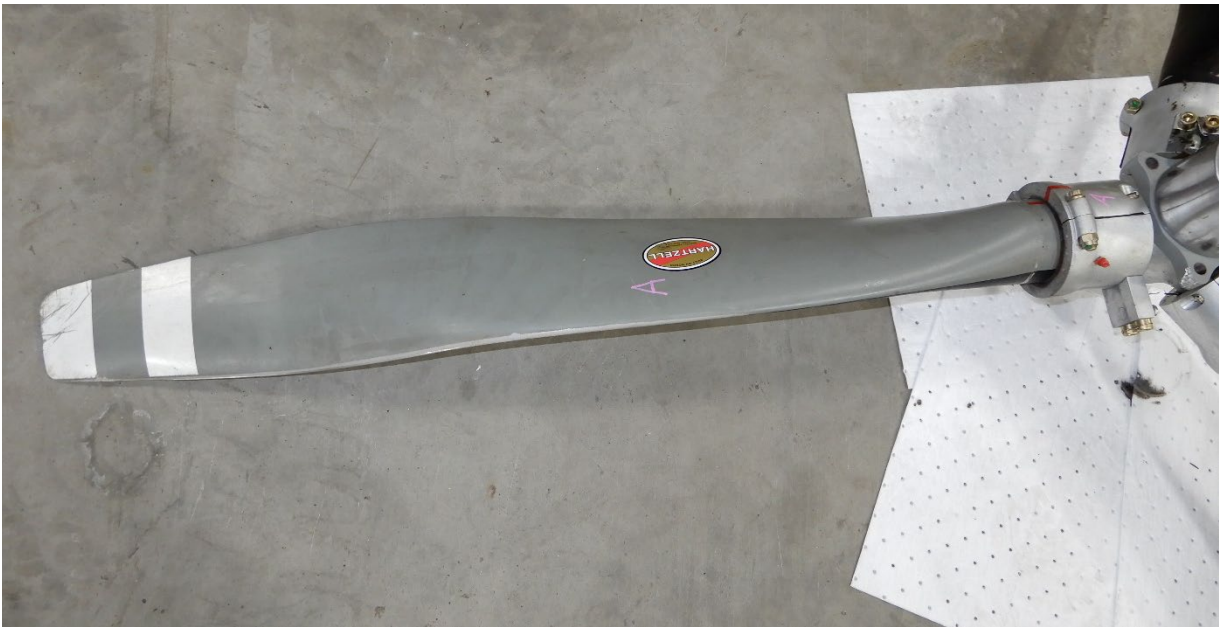
**Figure 25 - Propeller Blade A**

Blade A remained secured in the propeller hub grip. The red stripe remained aligned from the blade to the grip. The blade exhibited bending about midspan. The blade A link pin unit was separated from the hub. See Figure 25.

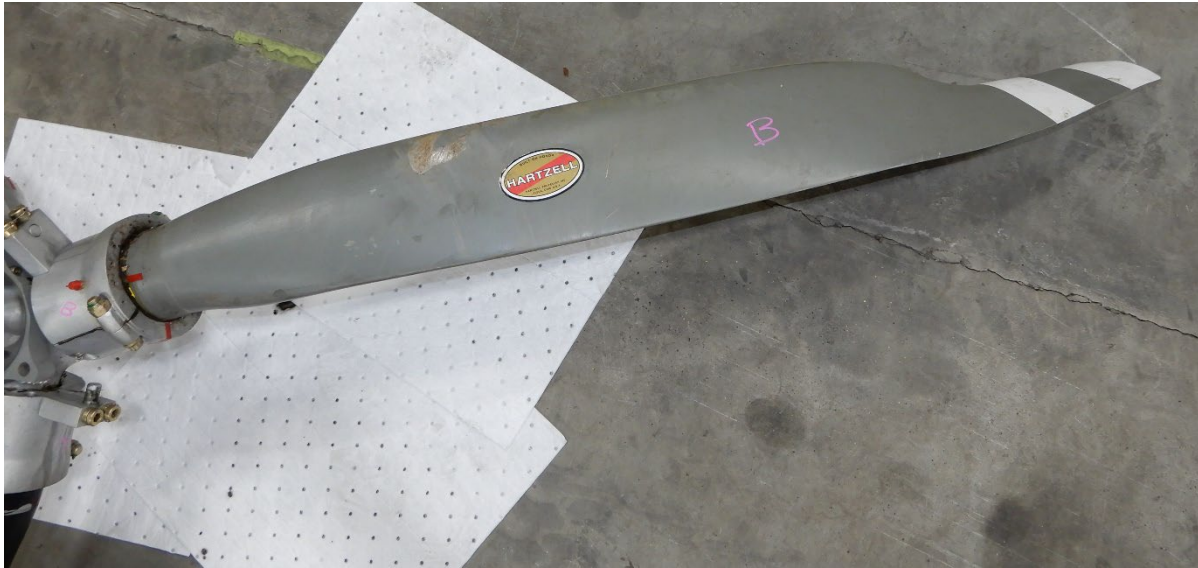
**Figure 26 - Propeller Blade B**

Blade B remained secured in the propeller hub grip. The red stripe was not aligned from the blade grip to the blade, but the blade did not turn in the grip. Blade B exhibited bending about 8 inches from the tip of the blade. Chordwise scratching was noted on the back of Blade B. The Blade B link pin unit remained intact and attached to the hub. See Figure 26.

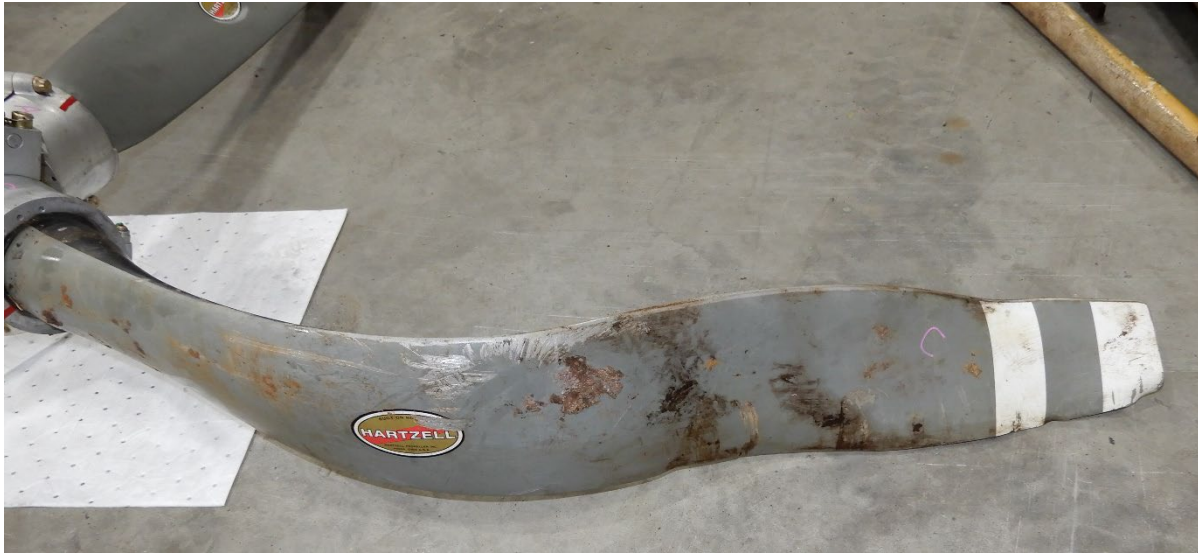
**Figure 27 - Propeller Blade C**

Propeller Blade C remained secured in the propeller hub grip. The red stripe was aligned from the blade grip to the blade. The blade exhibited bending about midspan to the tip of the blade. In addition, the face and back of Blade C exhibited chordwise scratching. The link pin unit was separated from the hub. See Figure 27.
