## **NATIONAL TRANSPORTATION SAFETY BOARD**

### **AIRFRAME / ENGINE EXAMINATION SUMMARY**

**ANC21LA061**

Location: Skwentna, Alaska  
Date: July 16, 2021  
Aircraft: Cessna 172, N7137T  
NTSB Investigator-in-Charge: Eric Swenson

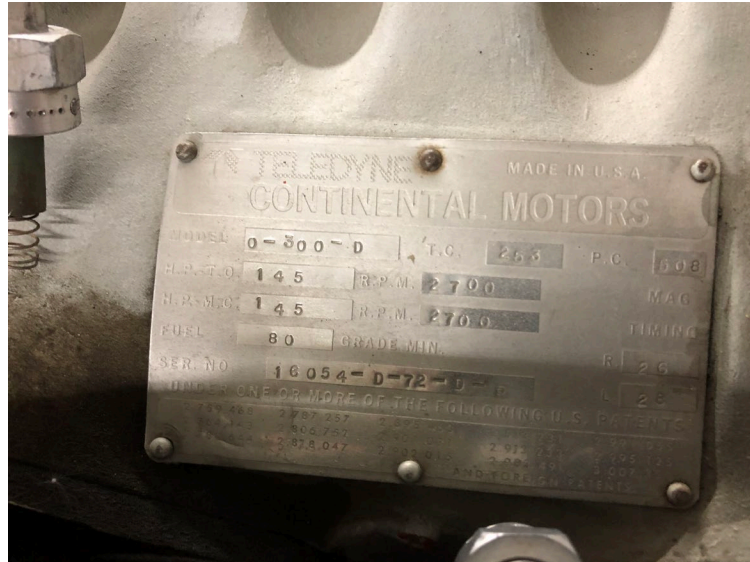
Figure 1: View of the engine data

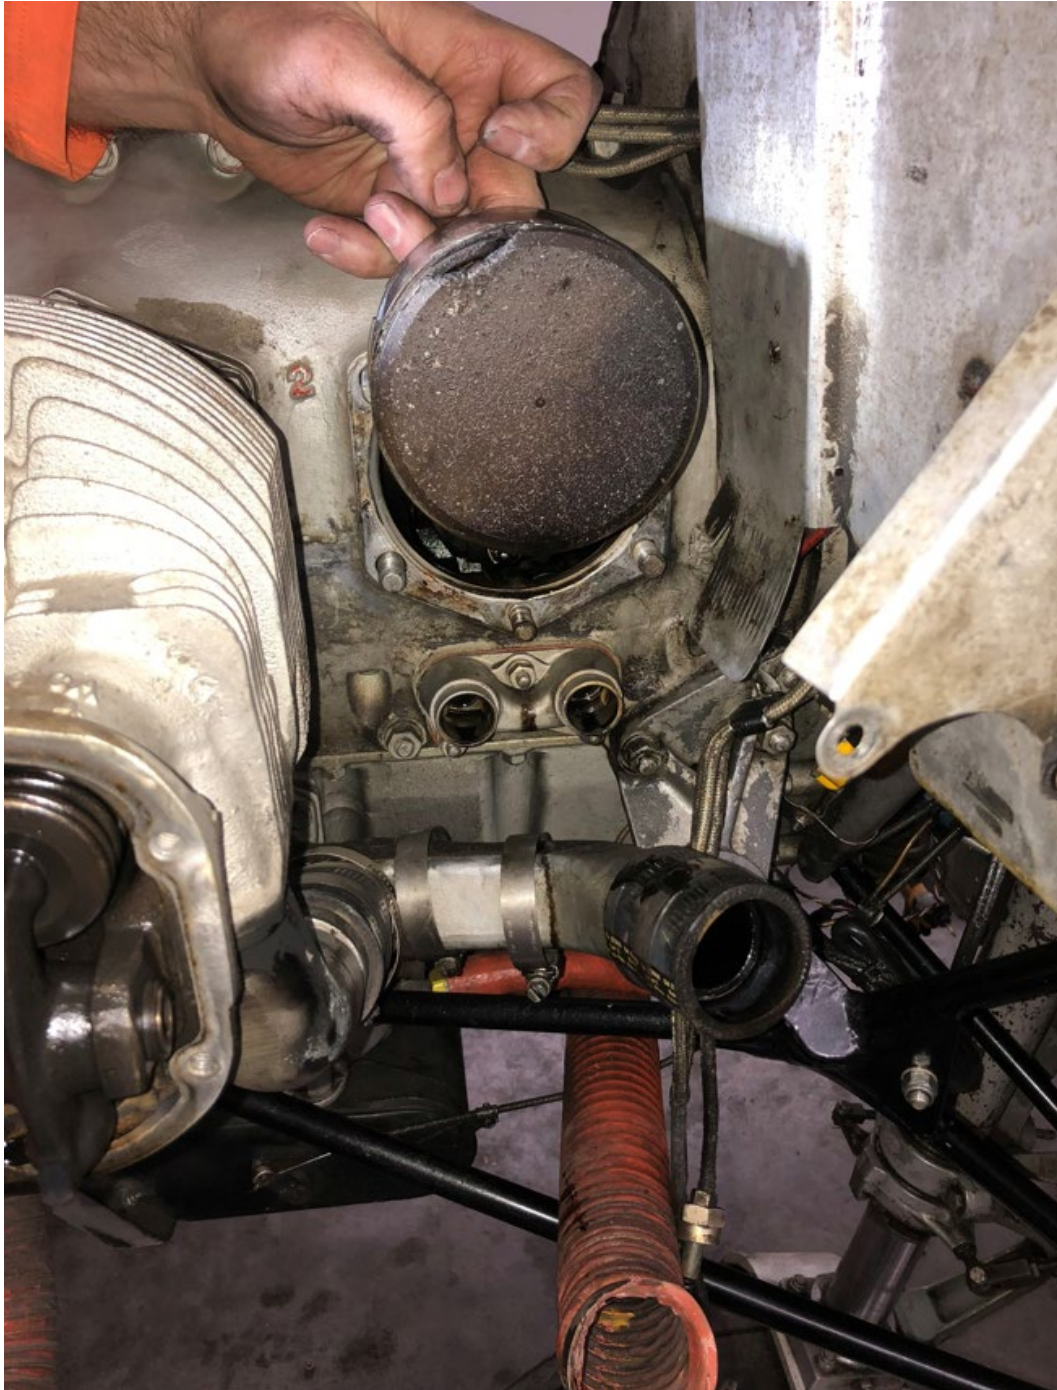
A local A&P mechanic (Dan Ellis) was retained from Ellis Aviation to help with the examination. The upper spark plugs were removed, and the crankshaft was rotated by hand utilizing the propeller. Rotational continuity was established. Compression was obtained on all cylinders utilizing a compression tester with the exception of cylinder number (No.) 2. The No. 4 cylinder also had lower compression. The No. 2 and No. 4 cylinders were removed. The upper (top) portion of the No. 2 piston face and all three upper compression rings were damaged. Scuffing was observed throughout the sides of the piston.

**Figure 2: Cylinder No. 2 Piston**

The signatures found in the removal of the No. 2 cylinder were consistent with detonation and/or preignition.

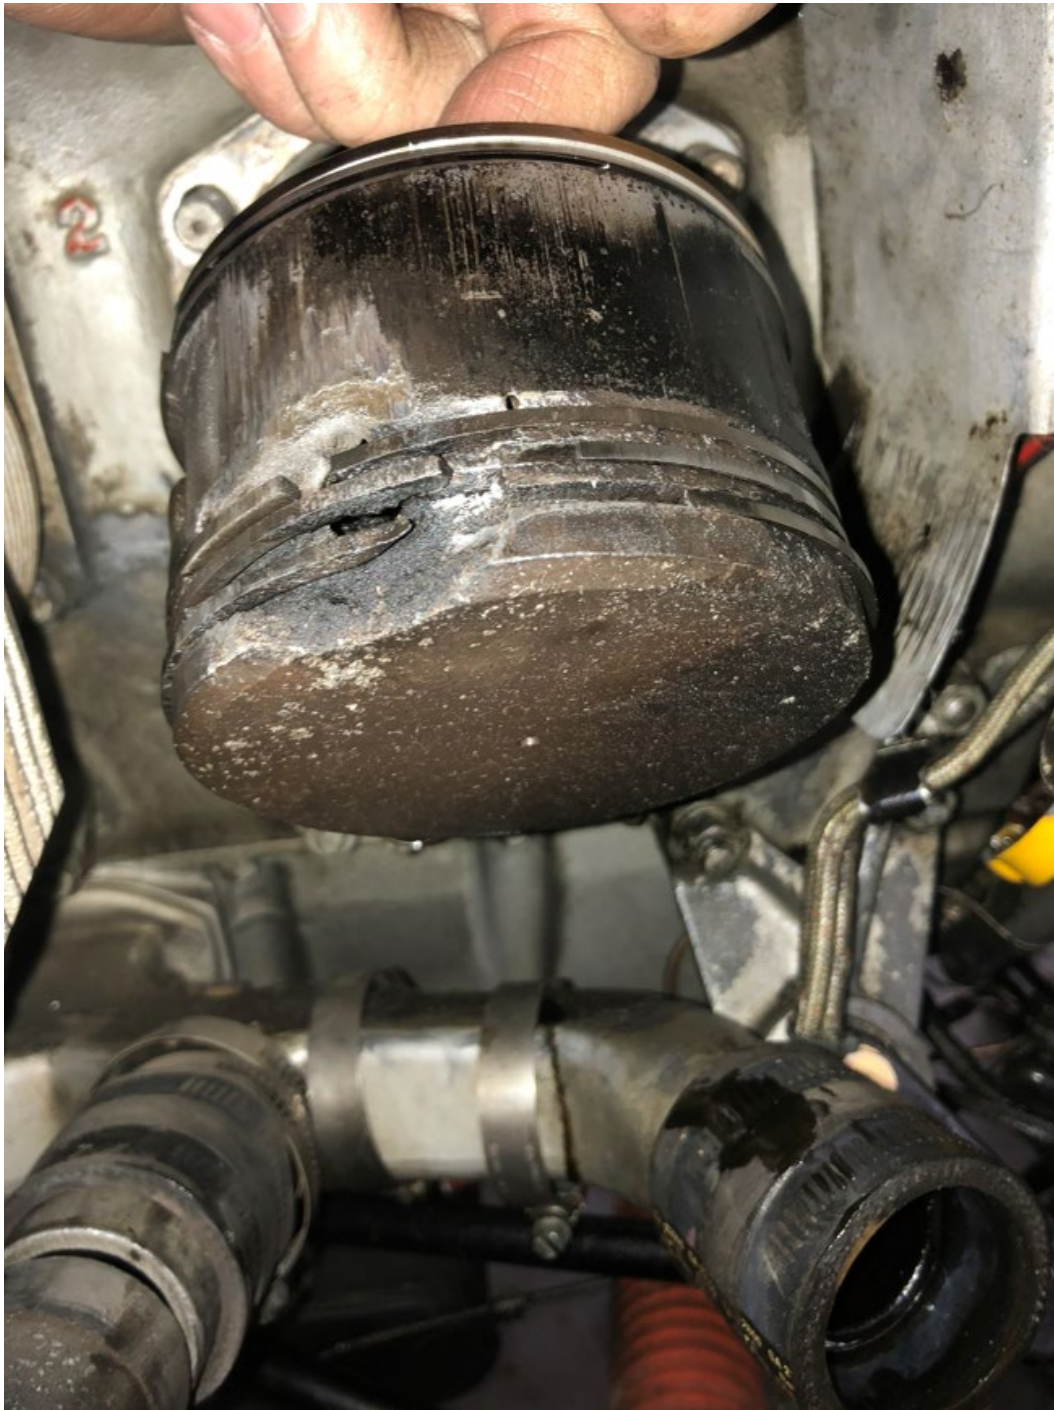
**Figure 3: Cylinder No. 2 Piston**

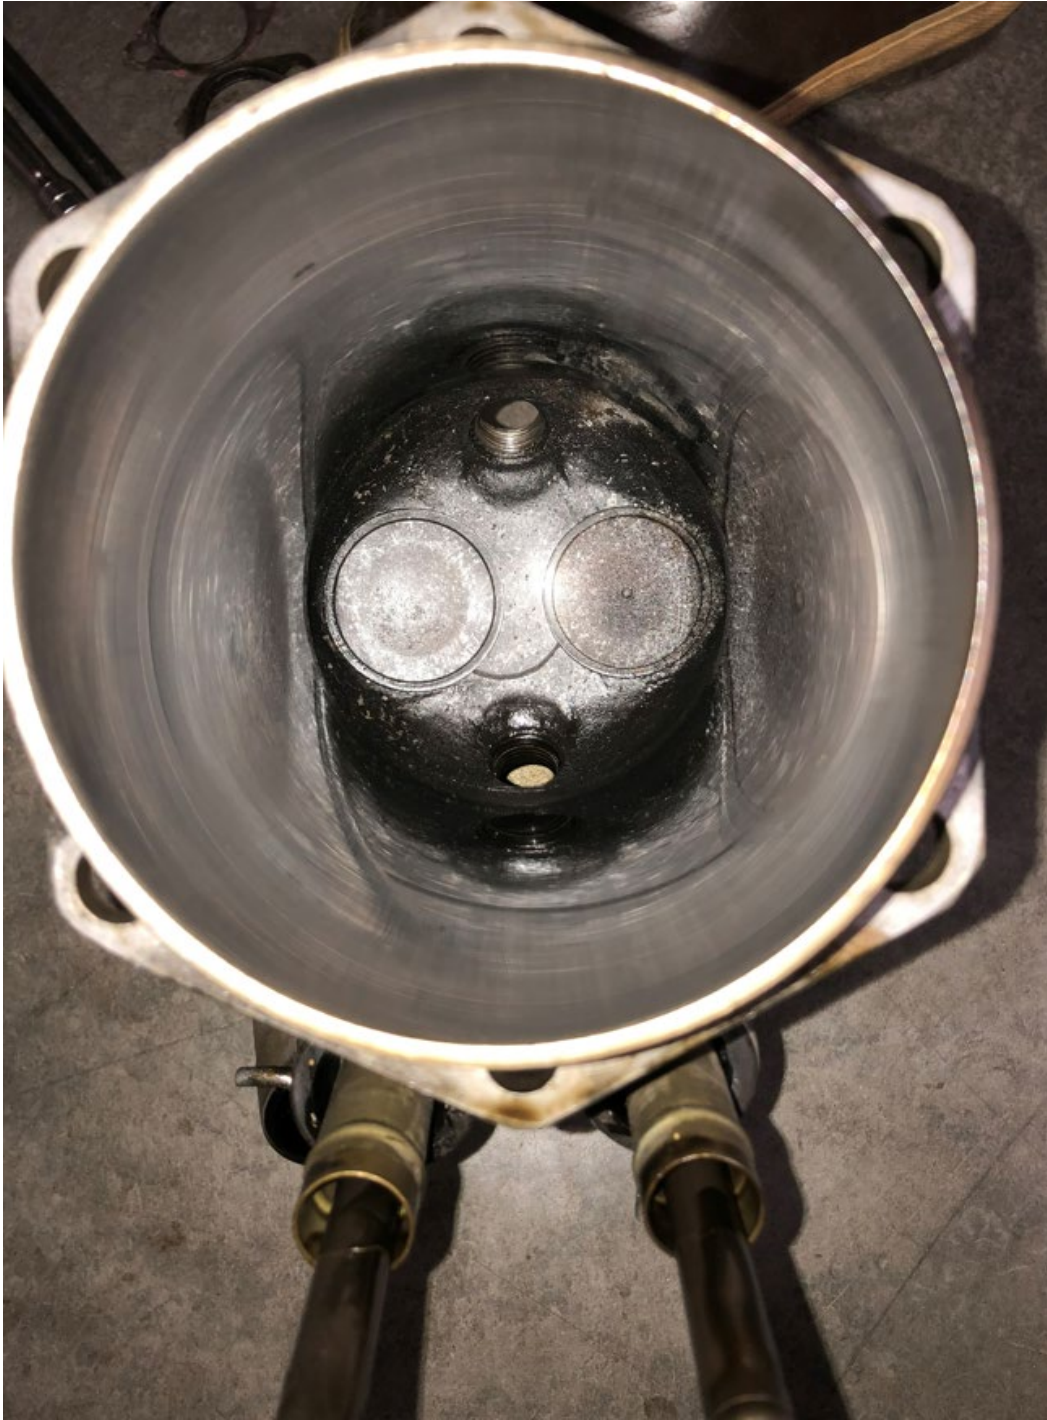
**Figure 4: Cylinder No. 2**

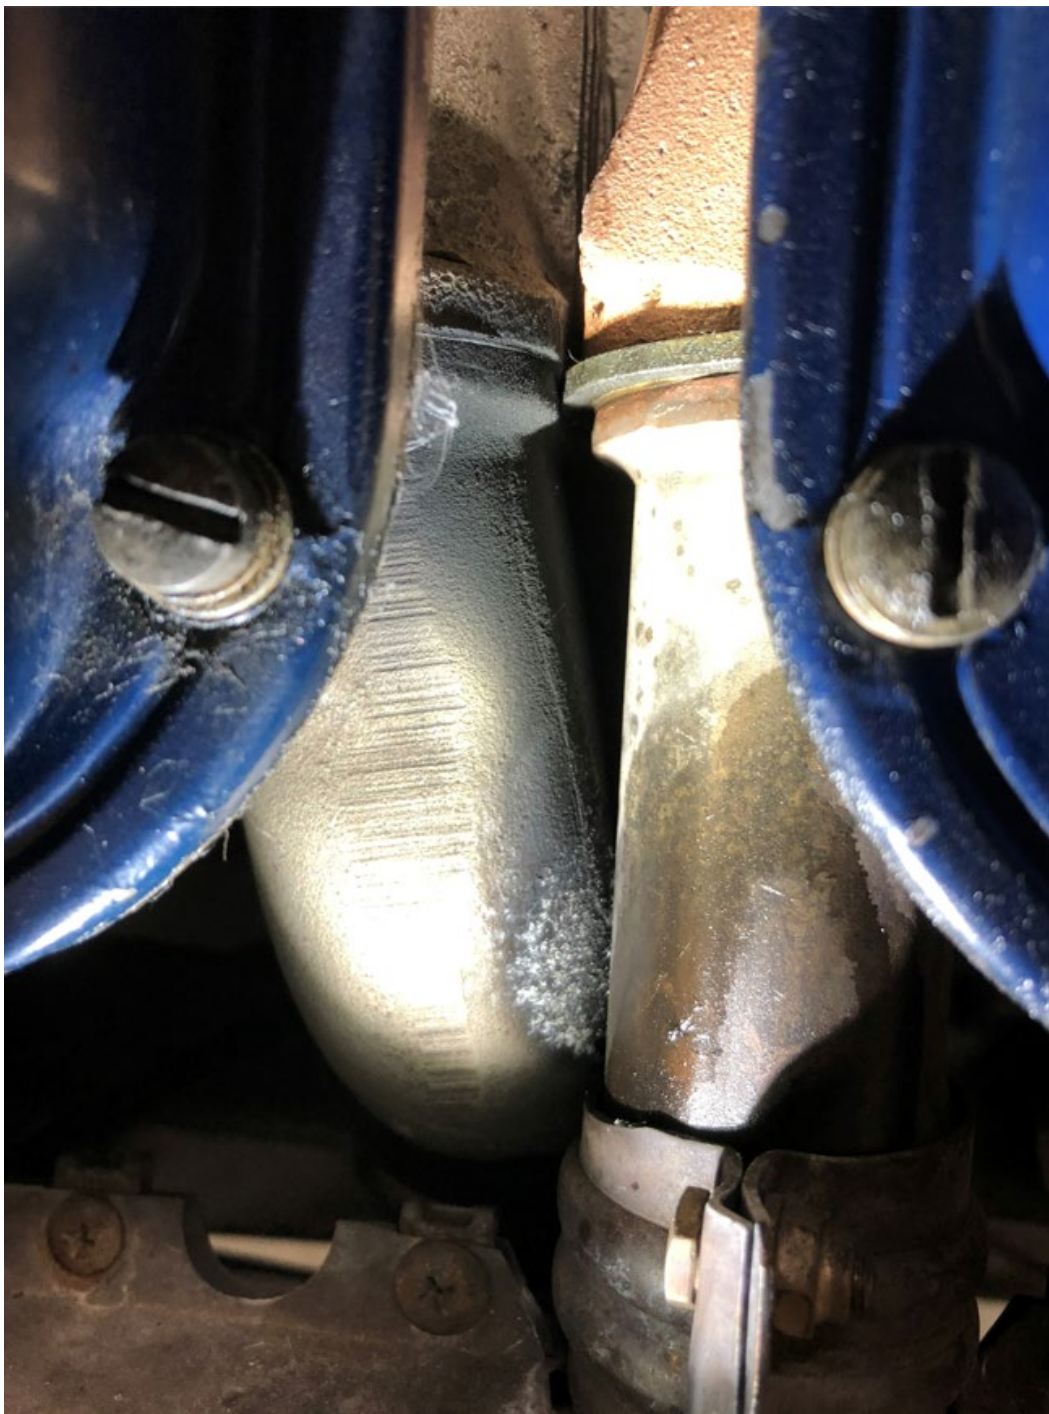
The exhaust on the left side of the engine had improper bolts installed on the muffler with one nut missing (only the left side was removed). Cylinder No. 2 had an improper gasket installed on the exhaust flange. Cylinder No. 2 exhaust was in contact with Cylinder No. 4 intake tube with indications of heat transfer.

**Figure 5: Exhaust from Cylinder No.2 (Right) in contact with intake tube from Cylinder No. 4 (Left)**

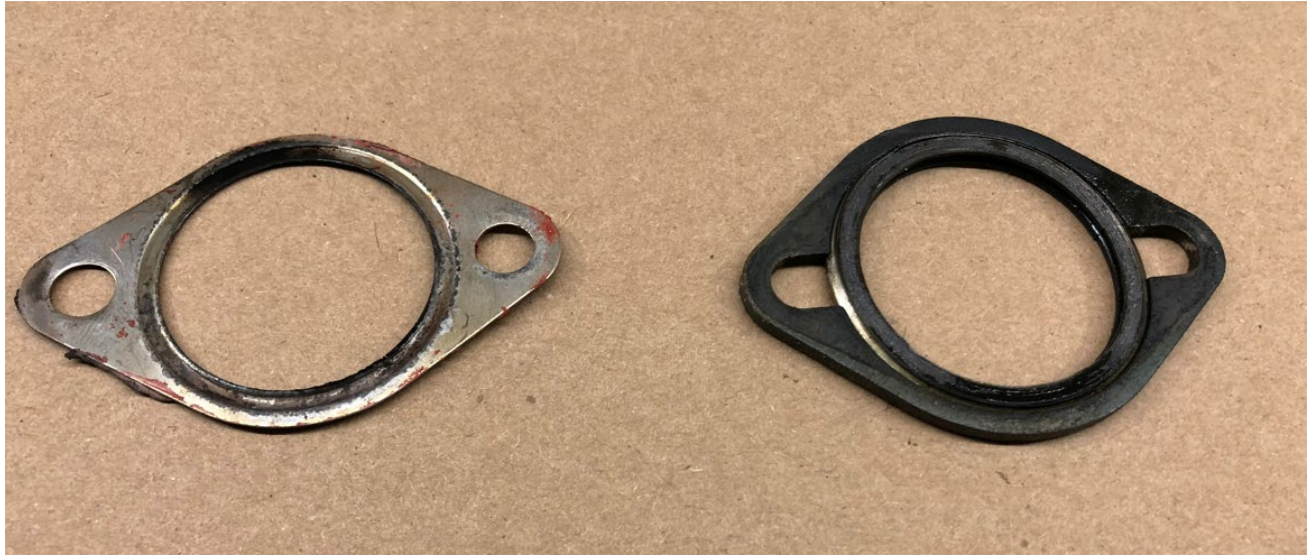
**Figure 6: Stock exhaust gasket found on Cylinder No. 4 (Left): Larger exhaust gasket found on Cylinder No. 2 (Right)**
