## **Examination Summary**

NTSB ACCIDENT NUMBER: ANC21LA068

AIRCRAFT REGISTRATION/AIRCRAFT TYPE: N8656K, Stinson 108

### **Post-Accident Engine Examination Summary**

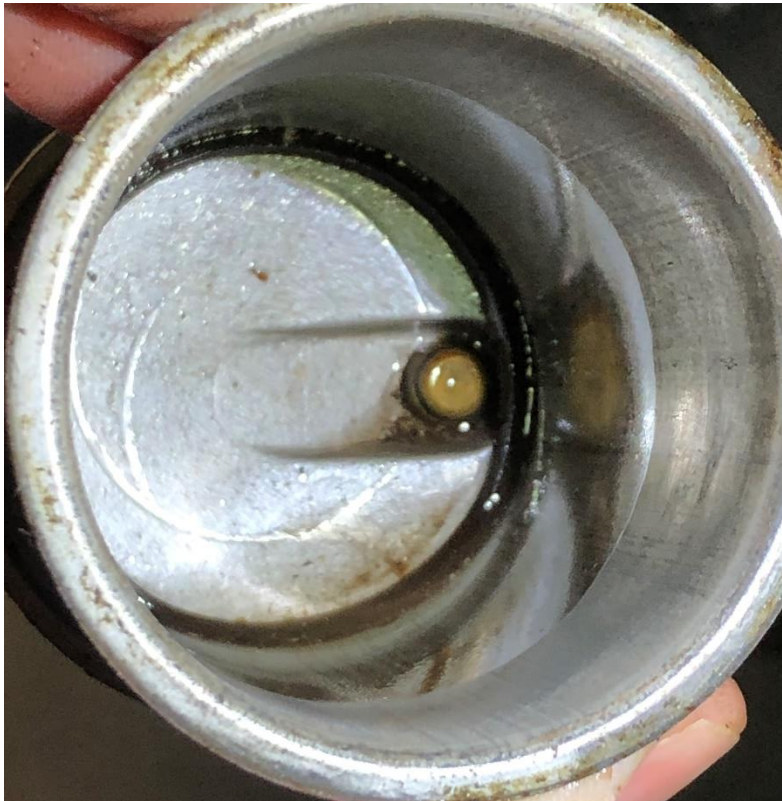
- Fuel was sumped from the fuel strainer and tested negative for ethanol
- Fuel strainer contained debris consistent with an organic material both in the screen and on the bottom of the bowl.

*Photo 1: Fuel Strainer Bowl*

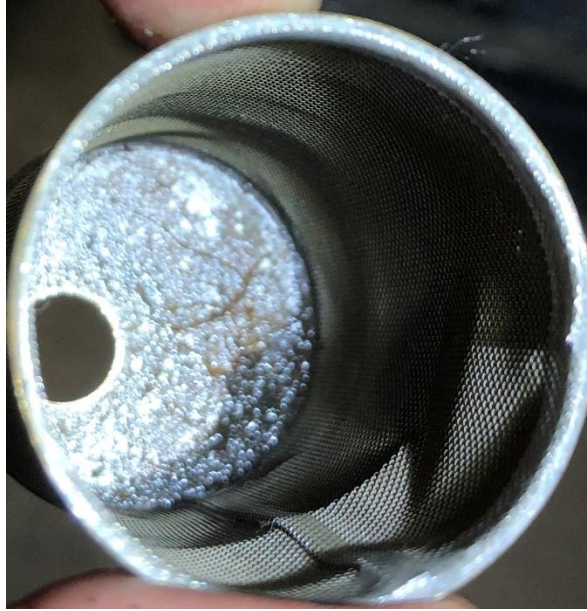
*Photo 2: Fuel Strainer Screen*

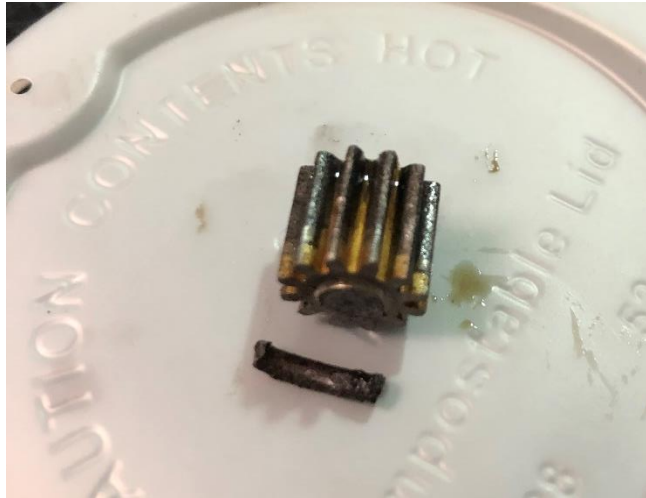
- Internal engine continuity was established and verified by removal of the top engine plate, which allowed an unobstructed view into the engine
- The cam shaft was examined and found to display impact marks, consistent with pieces of a cotter pin that were later found in the oil sump.
- Oil sump contained metallic debris and also a 1cm x 1cm gear that was later determined to be from the original mechanical tachometer that fell into the oil sump when the tachometer was being switched to a digital tachometer

*Photo 4: Tachometer Gear and Cotter Pin*

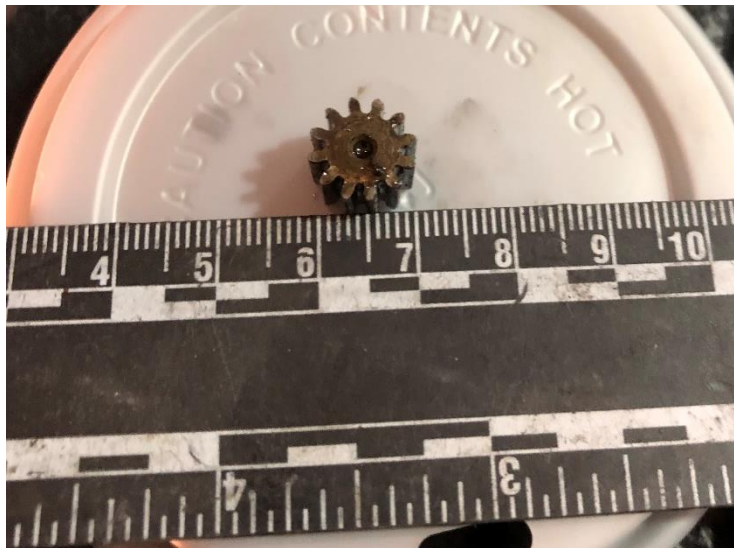
*Photo 5: Tachometer Gear*
