**NATIONAL TRANSPORTATION SAFETY BOARD**

**SYSTEMS GROUP CHAIRMAN'S FACTUAL REPORT**

ANC21LA073

| Aircraft: | Cessna 208B |

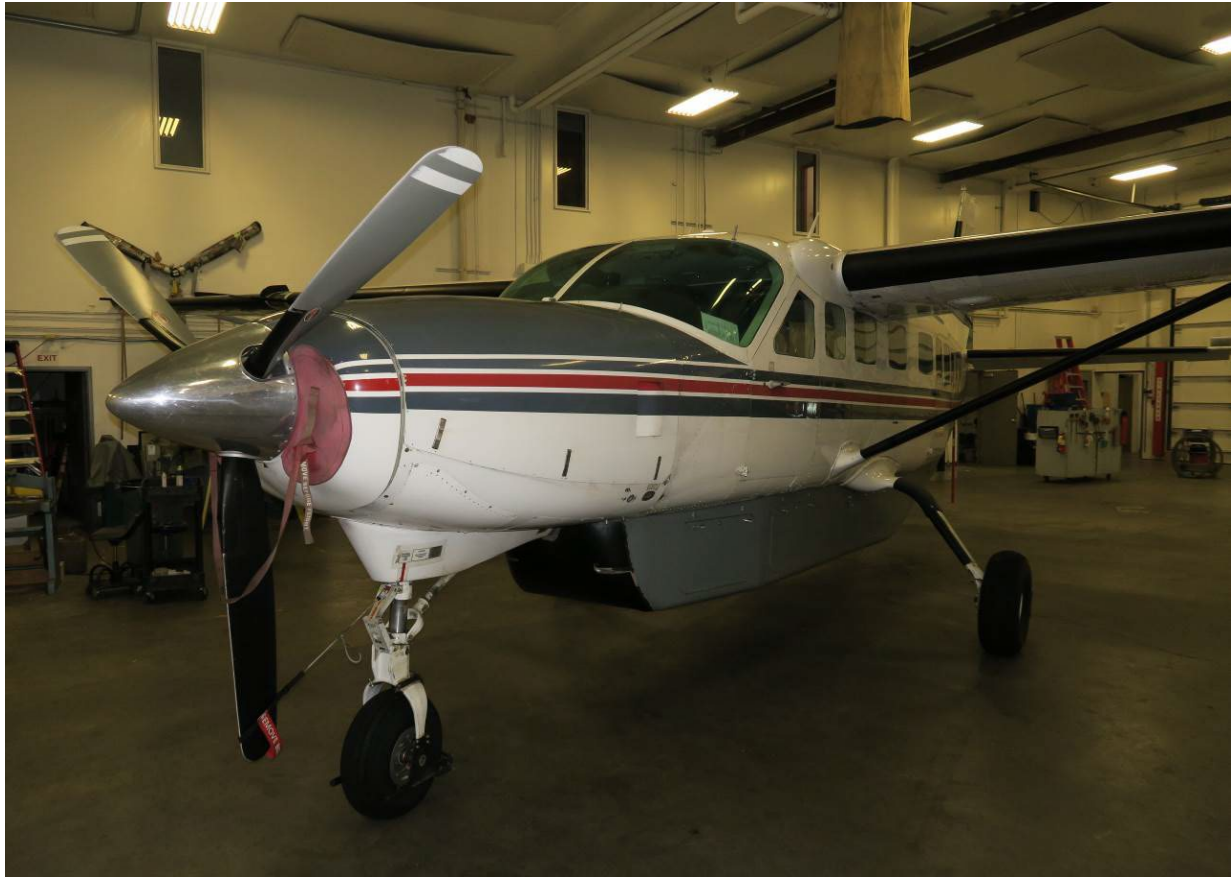
**Figure 1: Aircraft at Time of Examination**

On Aug 20-21, 2021, FAA Inspectors from the Fairbanks FSDO, the Wright Air Service Director of Safety, and the Textron Air Safety Investigator performed an examination of the accident aircraft. The NTSB participated in the investigation virtually. The aircraft was located in a Wright Air Service maintenance hangar at Fairbanks International Airport (see Figure 1).

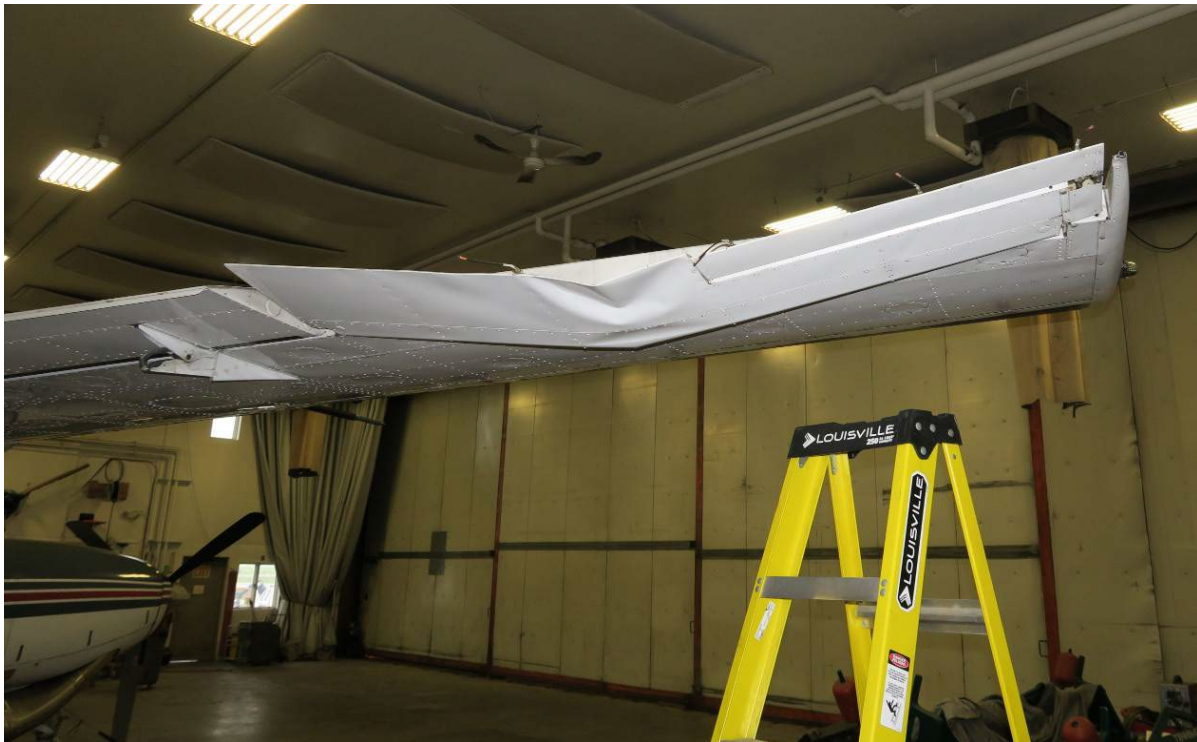
**Figure 2: Damage to Right Aileron**

A visual examination for obvious signs of deformation and impact was conducted on the aircraft exterior. No detailed inspection of the aircraft major structure was performed during this systems examination. The airframe remained intact. There was no evidence of impact or fire. Two slight wrinkles existed in the leading edge of the right wing. The inboard wrinkle was 6 feet outboard of the wing root. The outboard wrinkle was 5 feet inboard of the wing tip. A ¼ inch crack in the upper cabin skin radiated from a rivet common to the right wing forward attach fitting. The right aileron was bent downward 6 inches at the midspan (see Figure 2). The inboard and outboard aileron attach fittings were bent toward the center of the aileron and twisted slightly downward. The left wing leading edge was slightly wrinkled 6 feet outboard of the wing root. A visual inspection of the horizontal stabilizer attach bolts was performed with no anomalies noted. A visual inspection of the elevator torque tube fasteners also did not reveal any anomalies. All flight control surfaces were examined for secure structural attachment with no anomalies identified.

The damaged right aileron initially prevented full operation of the aileron system by coming in contact with the trailing edge closeout panel of the wing when traveling downward. The position in which the aileron system tended to return to, or remain in, when placing the control wheel in the wings level position will be referred to as the compromised zero position. From the compromised zero, an inclinometer was placed on the left aileron and zeroed. The left aileron travel from that position measured 6.5 degrees up and 11.3 degrees down. The right aileron travel was measured in the same manner. It traveled 18.3 degrees up and 3.9 degrees down. The left aileron was then forced upward into a position where it was faired with the wing tip and measured to be 4.7 degrees up from the compromised position. Wing and floorboard panels were removed to facilitate inspection of the aileron control cable

The aileron trim system was immobile until the right aileron was removed. The aileron trim indicator in the cockpit was observed in the neutral position before attempted operation. As a result of damage to the right aileron, trim tab travels could not be directly measured. After the right aileron was removed, the trim tab push/pull rod ends were braced together by inserting one bolt that extended through both of them to prevent independent rotation, and the trim system operated smoothly. The aileron trim cable tension was measured at zero. The aileron trim actuator attach position common to the displaced right aileron outboard attach point was displaced inboard approximately 0.10 inch. Forcing the trim tab actuators outboard toward their original position increased the tension on the cables. The trim tab stops remained secured to the cable with no indications of slippage. With the aileron trim indicator in the cockpit set to neutral the aileron push/pull rods measured 1.98 inches which is consistent with a neutral trim tab position.
