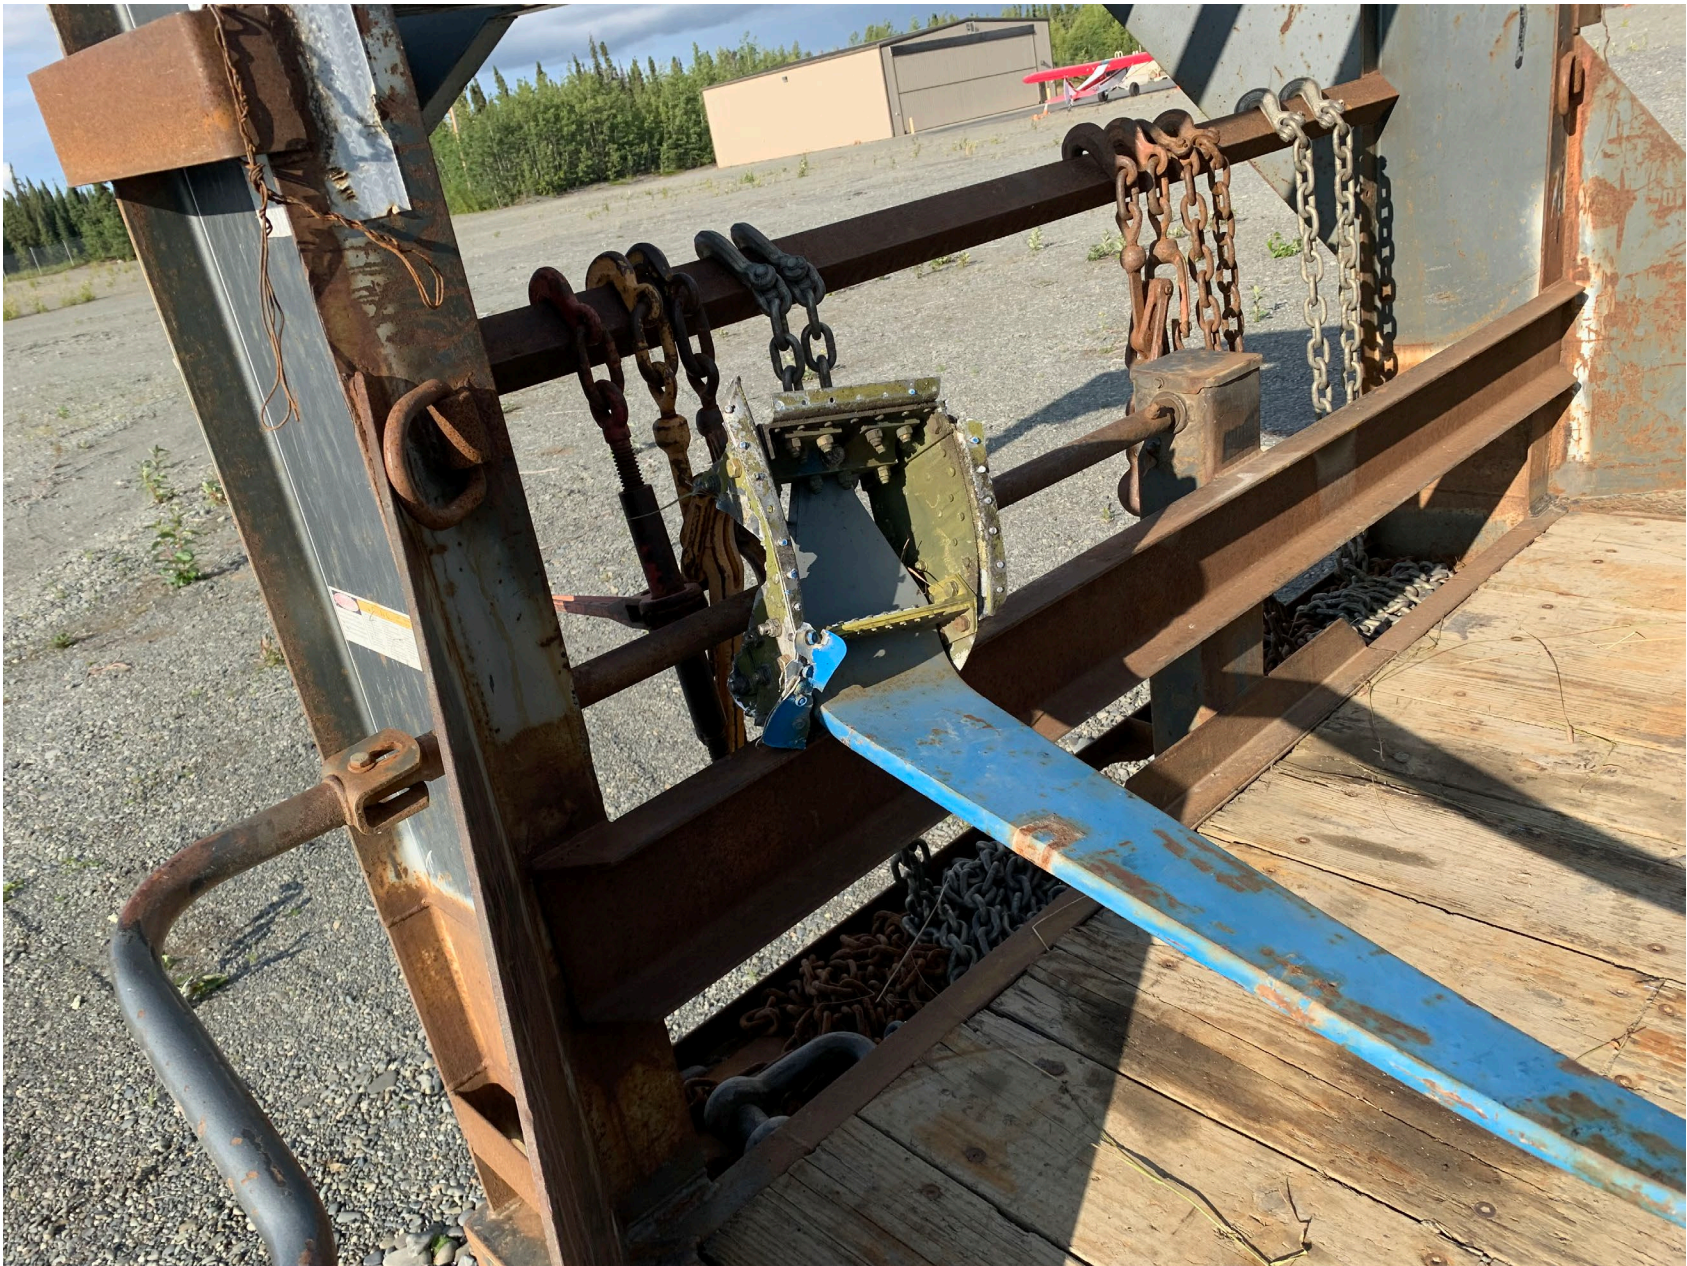
**Photo 1 – Photo of left main landing gear “gearbox” assembly and landing gear leg. (Photo provided by FAA)**

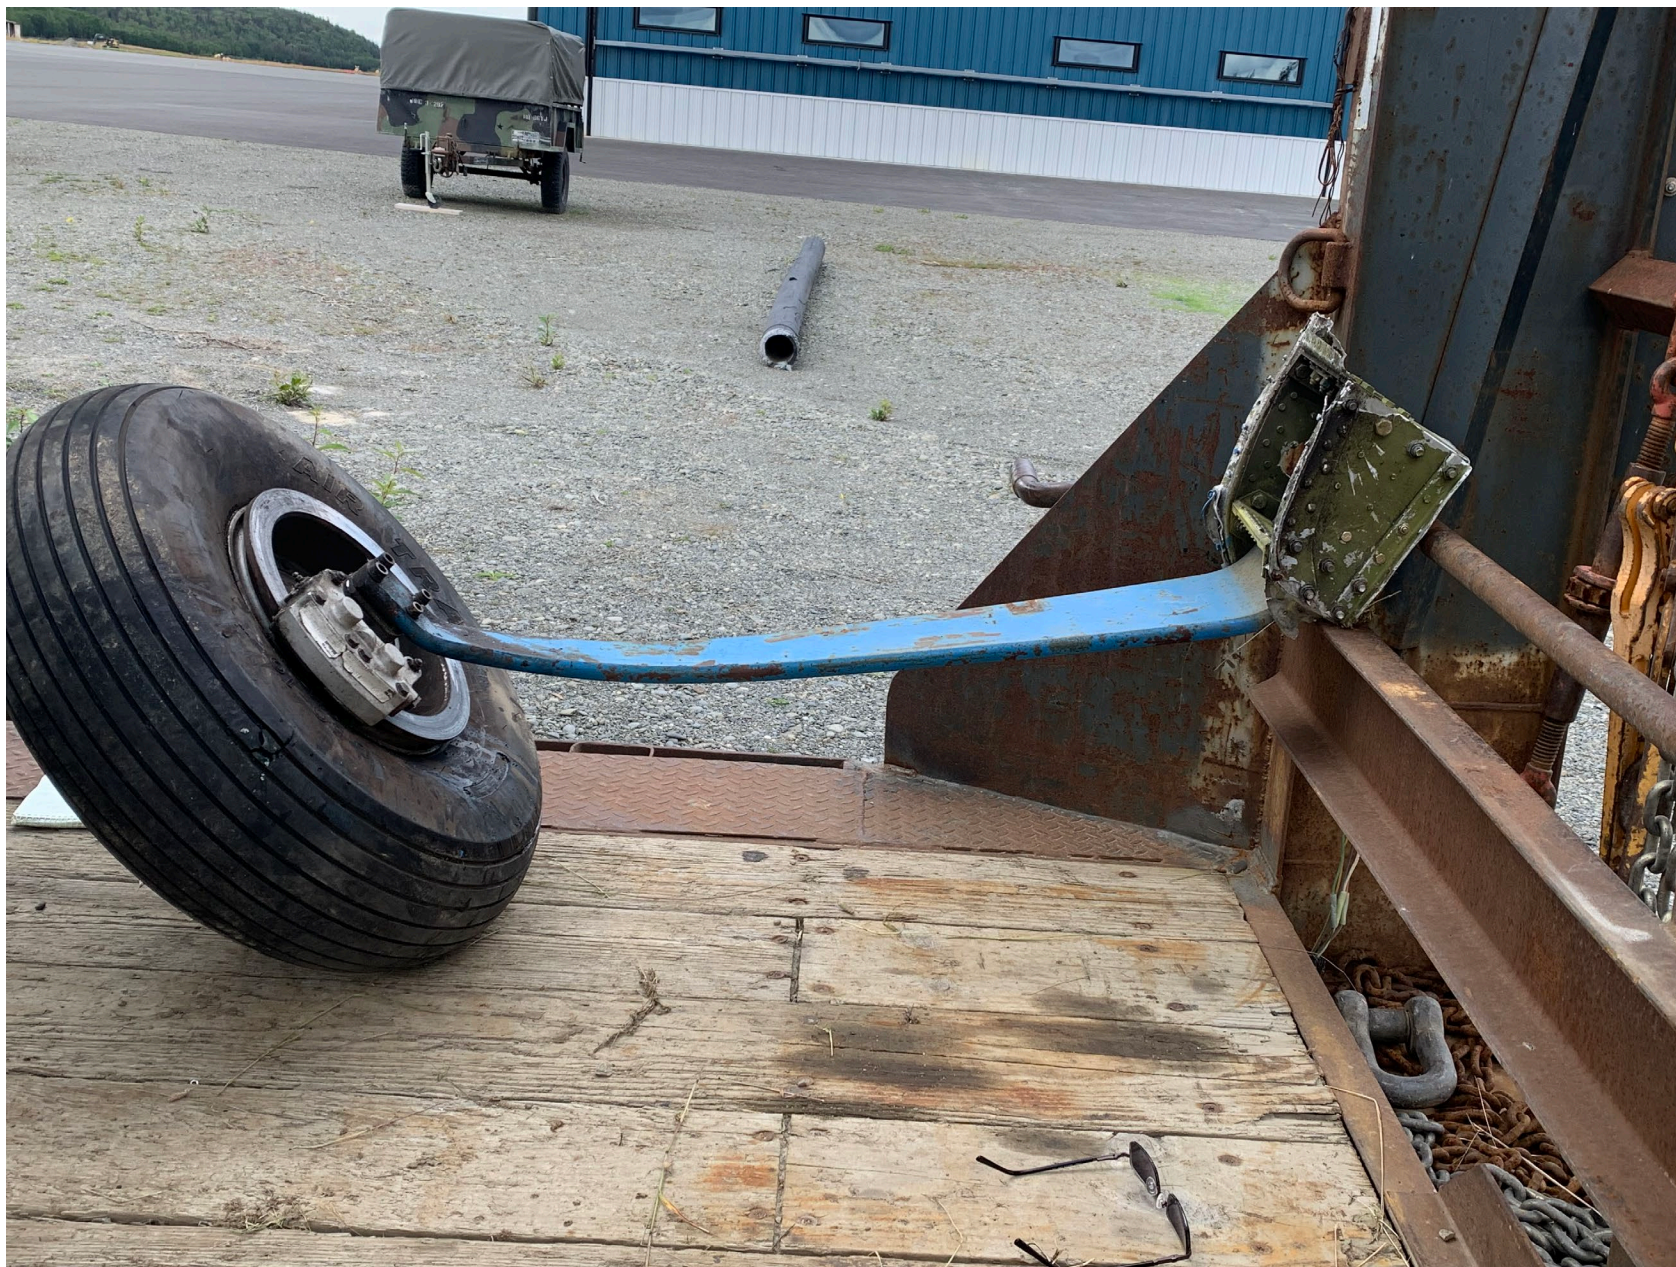
**Photo 2 – Side view photo of left main landing gear “gearbox” and landing gear leg. (Photo provided by FAA)**

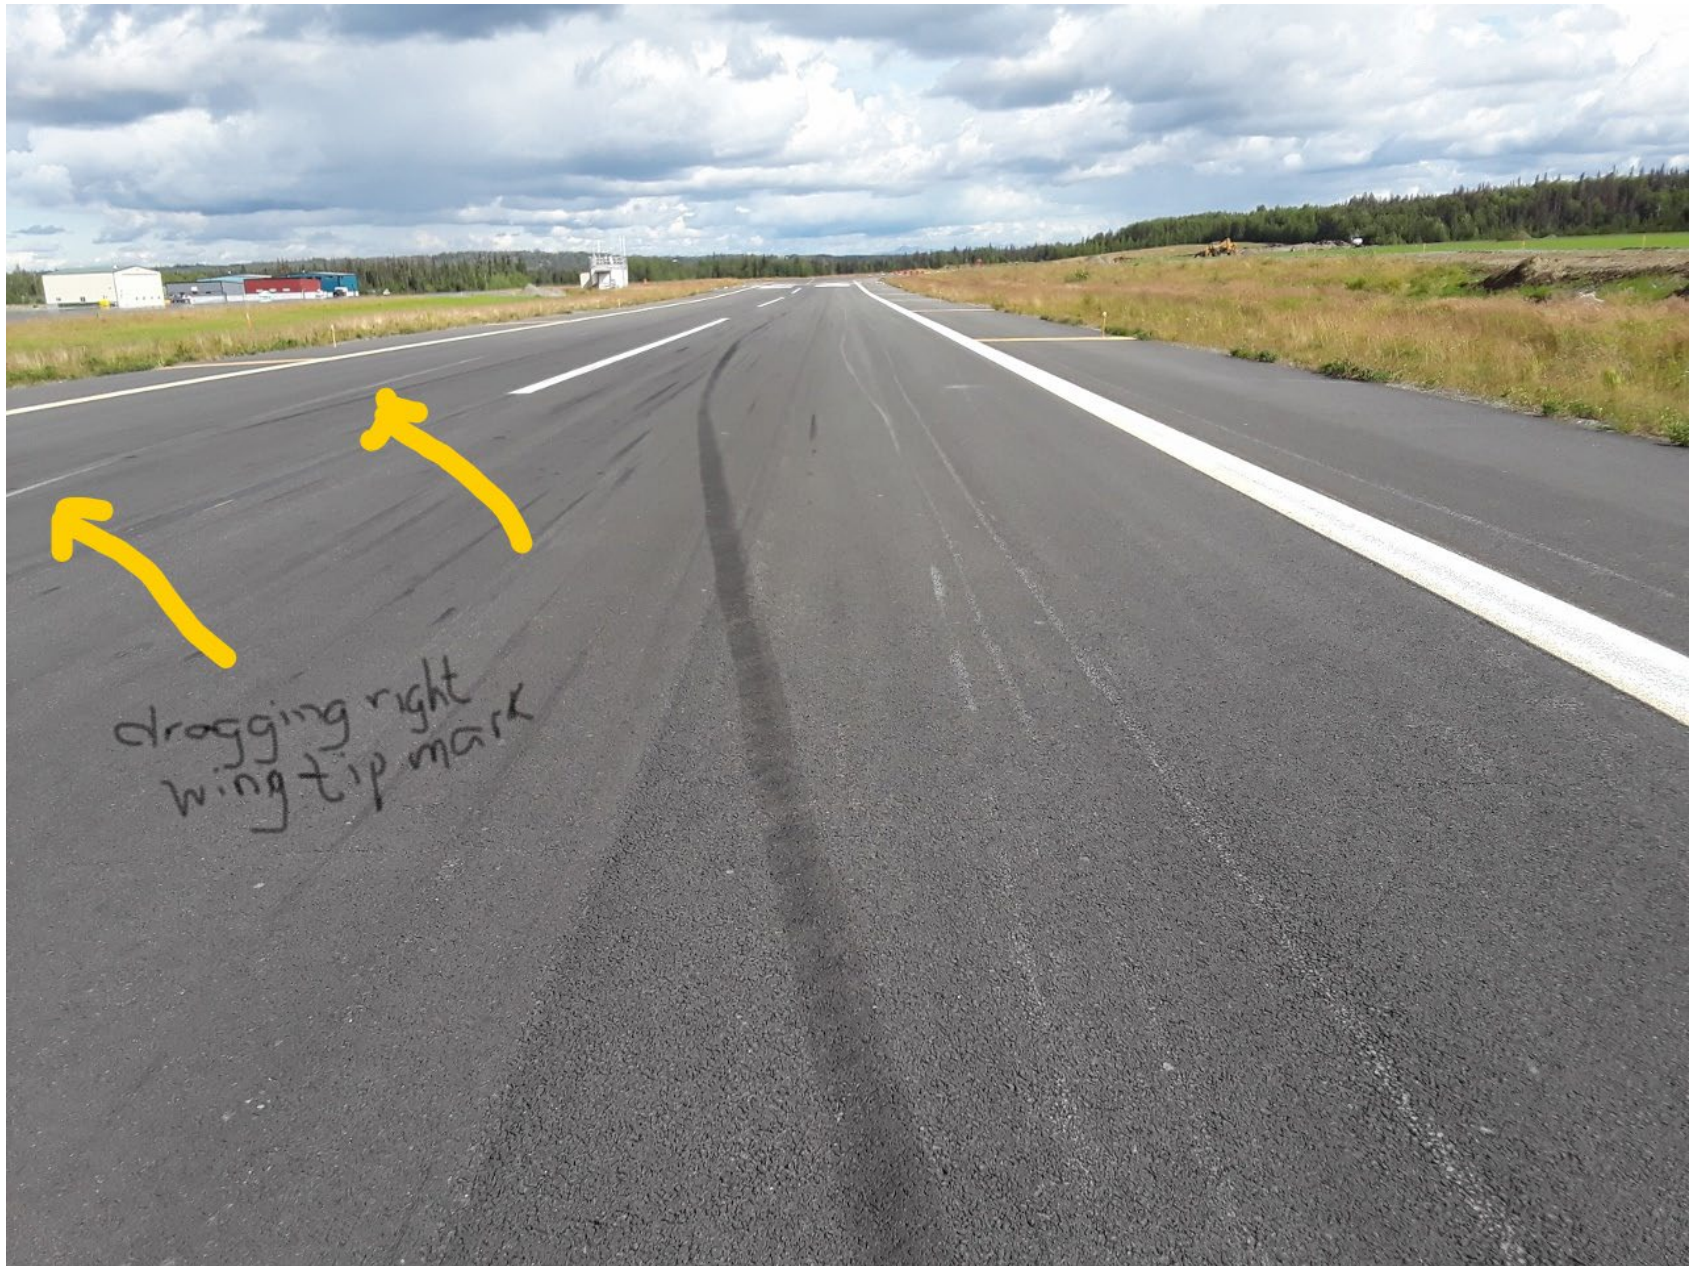
**Photo 3 – Photo of skid marks on runway, looking east. (Photo provided by FAA)**

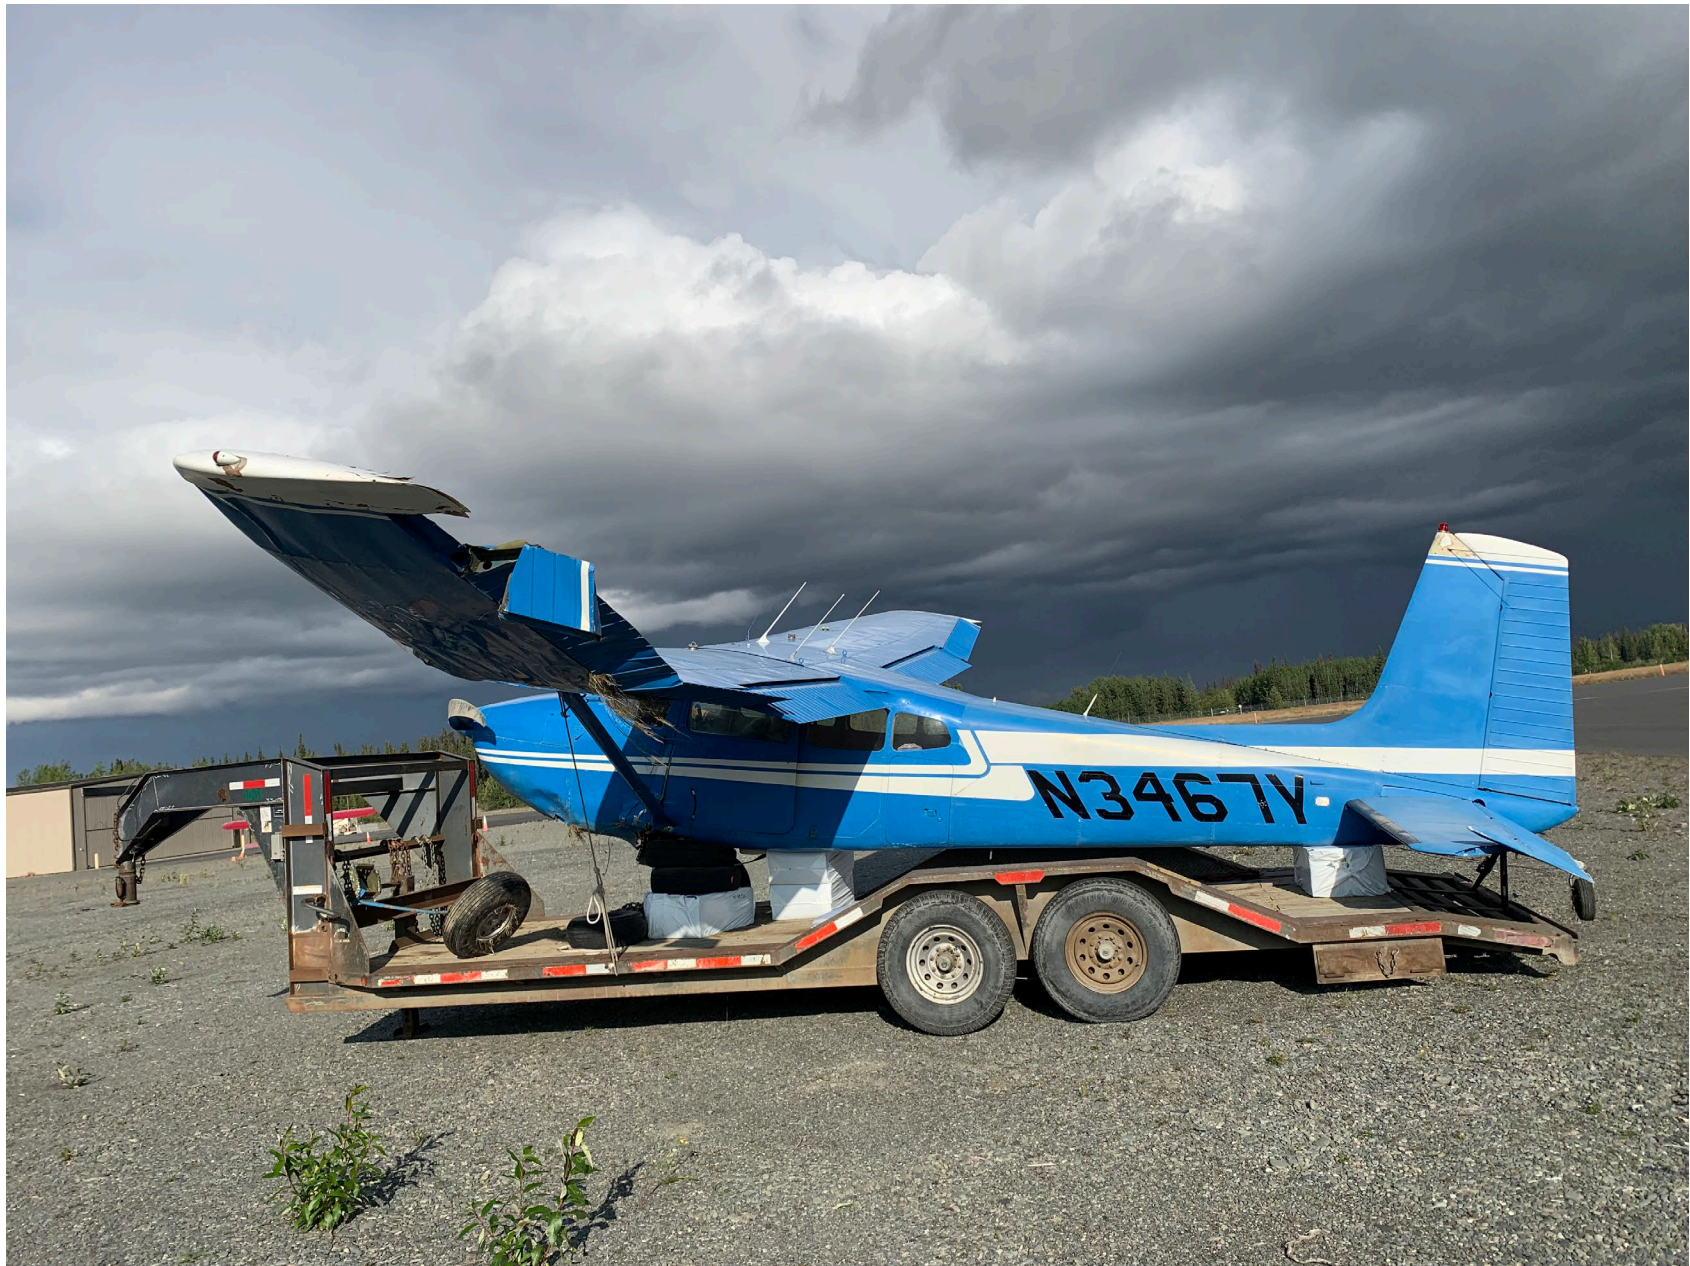
**Photo 4 – Photo of accident airplane, left side, after recovery. (Photo provided by FAA)**

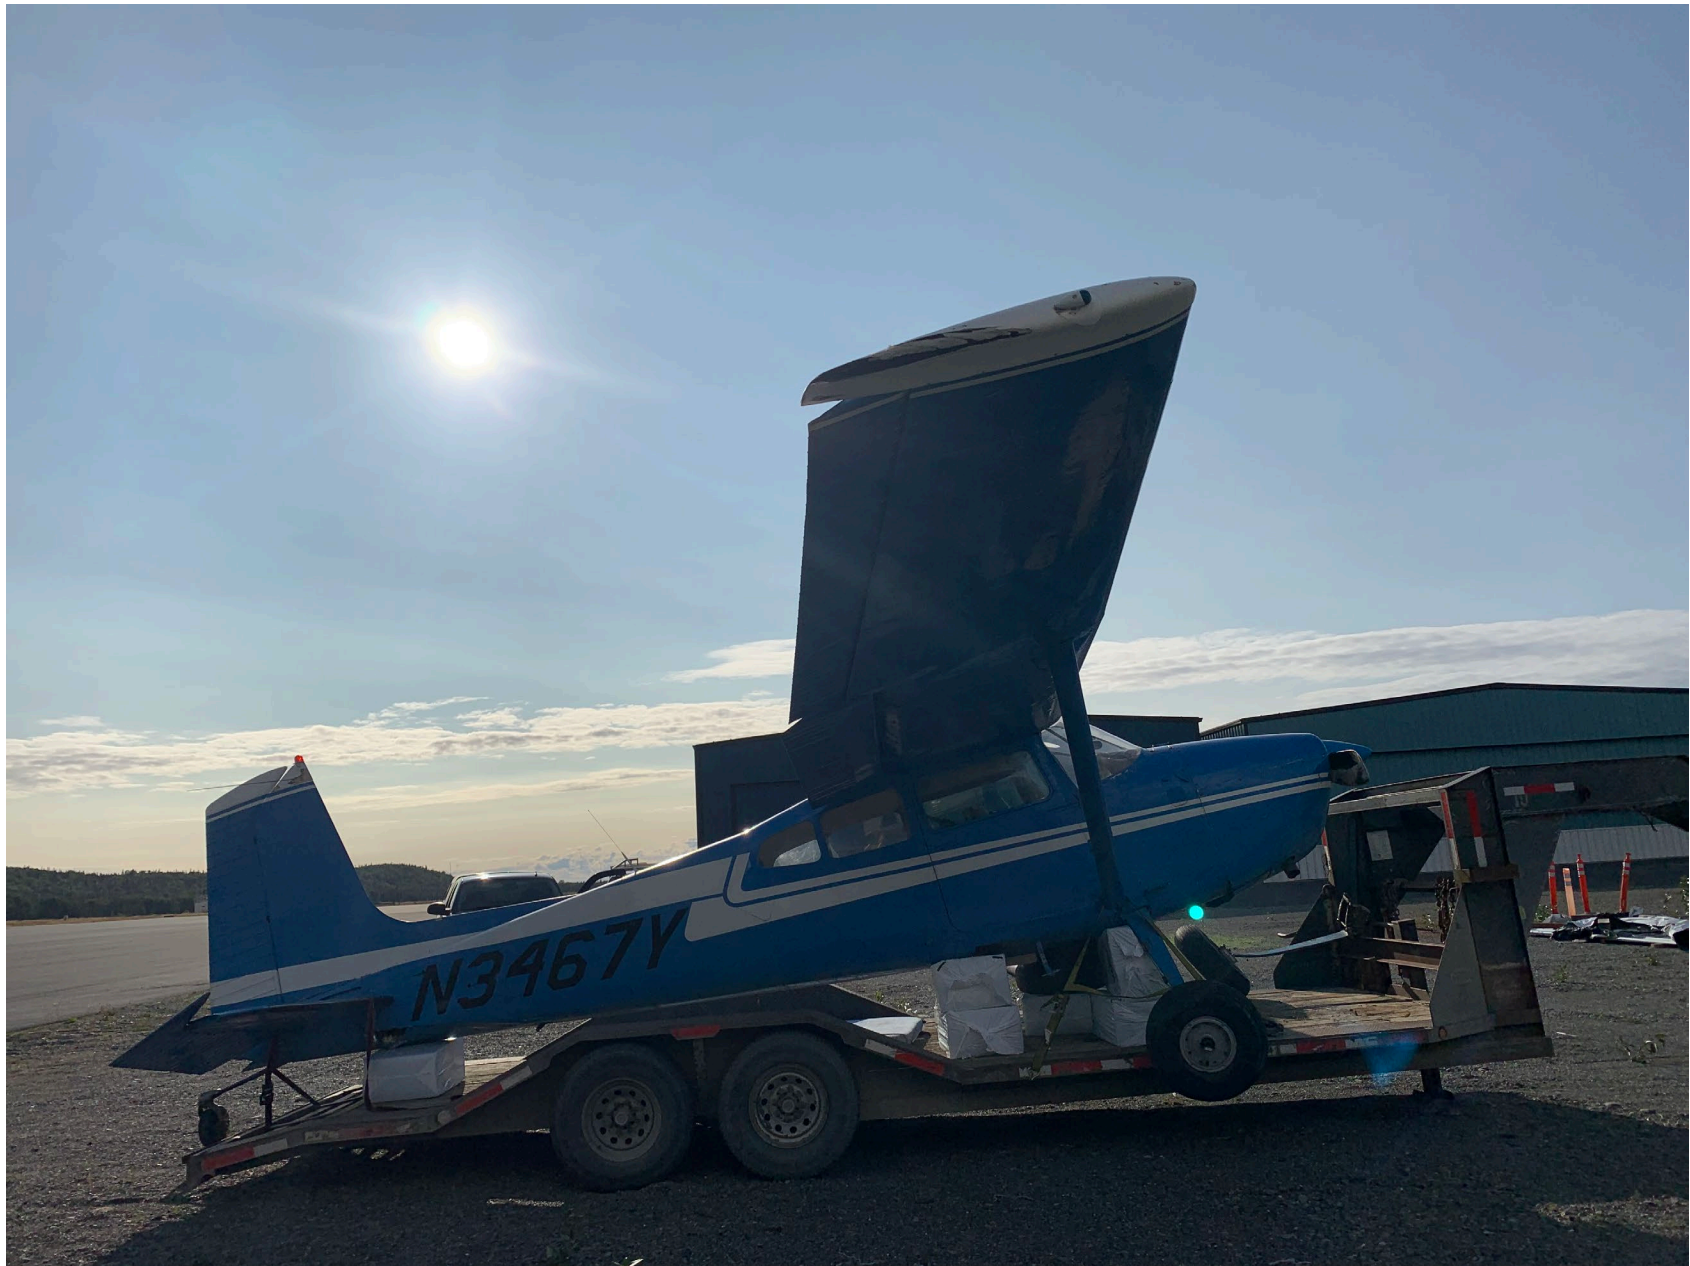
**Photo 5 – Photo of right wing, which depicts runway abrasion damage to outboard portion of wing tip fairing. (Photo provided by FAA)**
