N3467Y

RWY 25 – temporary due to construction – NOTAMED

Date/Time: 08/13/2021 Approx. 1550 Local

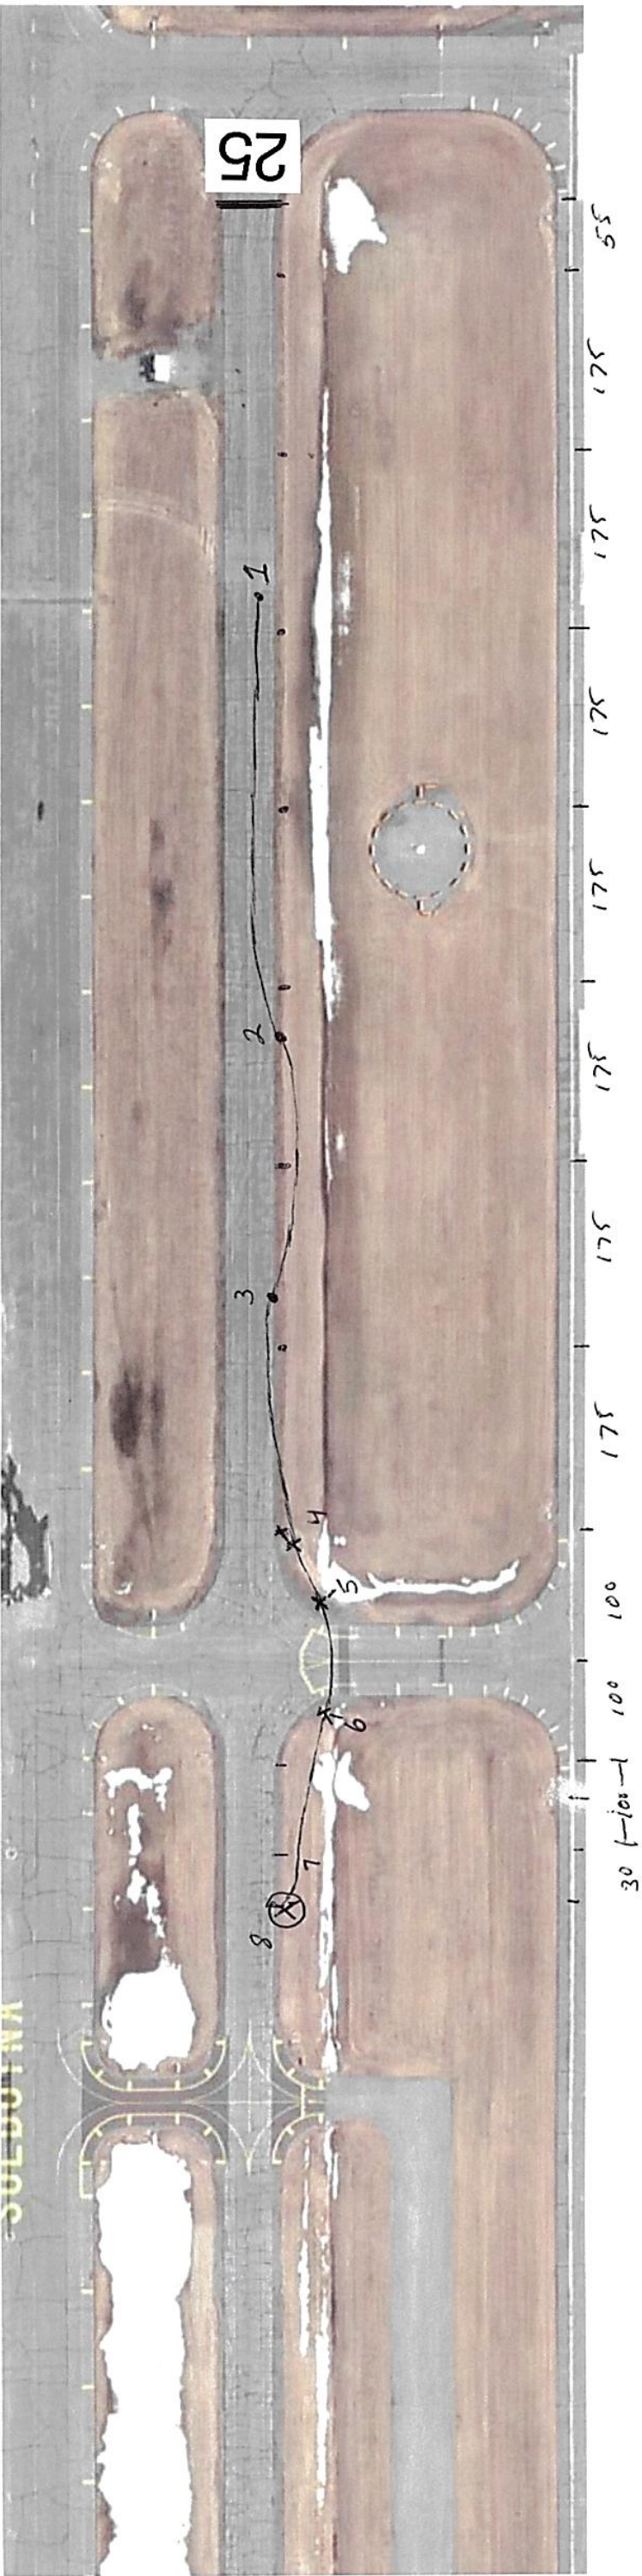
1. First indication of impact – simultaneous contact with right wing and right main gear 361 feet from runway 25 threshold, fuselage was on left side of rwy centerline. Continuous wing contact and tire skid marks until departure from runway

2. Aircraft departed south side of runway 434 feet from initial contact area (795 from rwy threshold)
3. Aircraft re-entered runway 267 feet from original departure point (1062 ft. from rwy threshold)

4. Aircraft departed south side of runway again 218 feet later (1280 ft. from threshold). Destroyed nearby taxiway light and directional sign
5. Aircraft continued and destroyed “Wig Wag” flasher before becoming airborne at closed taxiway

6. Aircraft touch down on other side of closed taxiway. Fuselage, just in front of and below horizontal stabilizer, impacted and destroyed runway directional sign.

7. Aircraft left gear collapsed
8. Aircraft came to rest, at runway edge 1249 ft. from first indication of impact, point #1 (1610 ft. from runway threshold)
