# NATIONAL TRANSPORTATION SAFETY BOARD

## MATERIALS LABORATORY FACTUAL REPORT

Report No. 21-080

Place : Port Alsworth, Alaska  
Date : August 21, 2021  
Vehicle : Stinson 108-3, N6476M  
NTSB No. : ANC21LA086  
Investigator : David Banning, AS-ANC

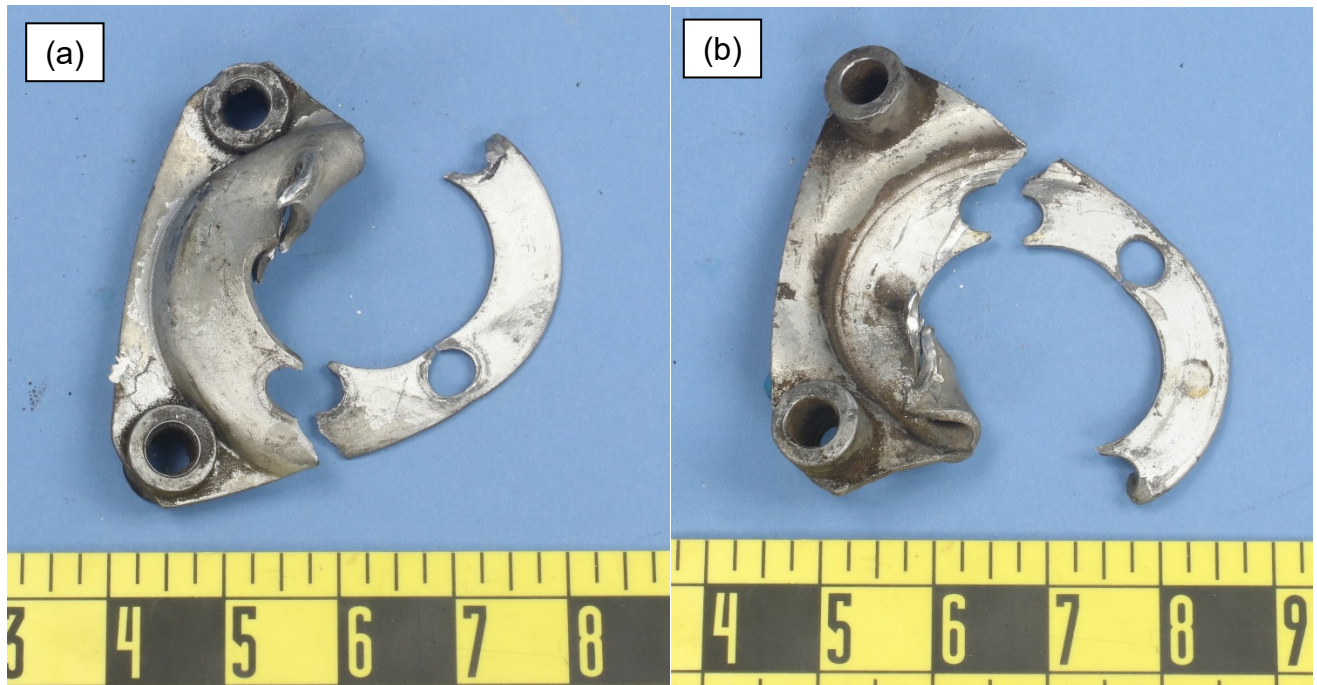
The two pieces of the brake torque plate are shown as received in Figure 1, viewed from opposite sides. The remnants consisted of the main body of the part, along with a flange segment that had fractured. Both pieces exhibited areas of post fracture batter and scrape marks. In addition, the fractures about the lower bolt hole in Figure 1b showed material that was bent and deformed out of plane from the rest of the flange fractures. These out-of-plane features were typical of subsequent fractures.

Figure 1 – View of the pieces of the torque plate from (a) the outboard and (b) inboard sides.

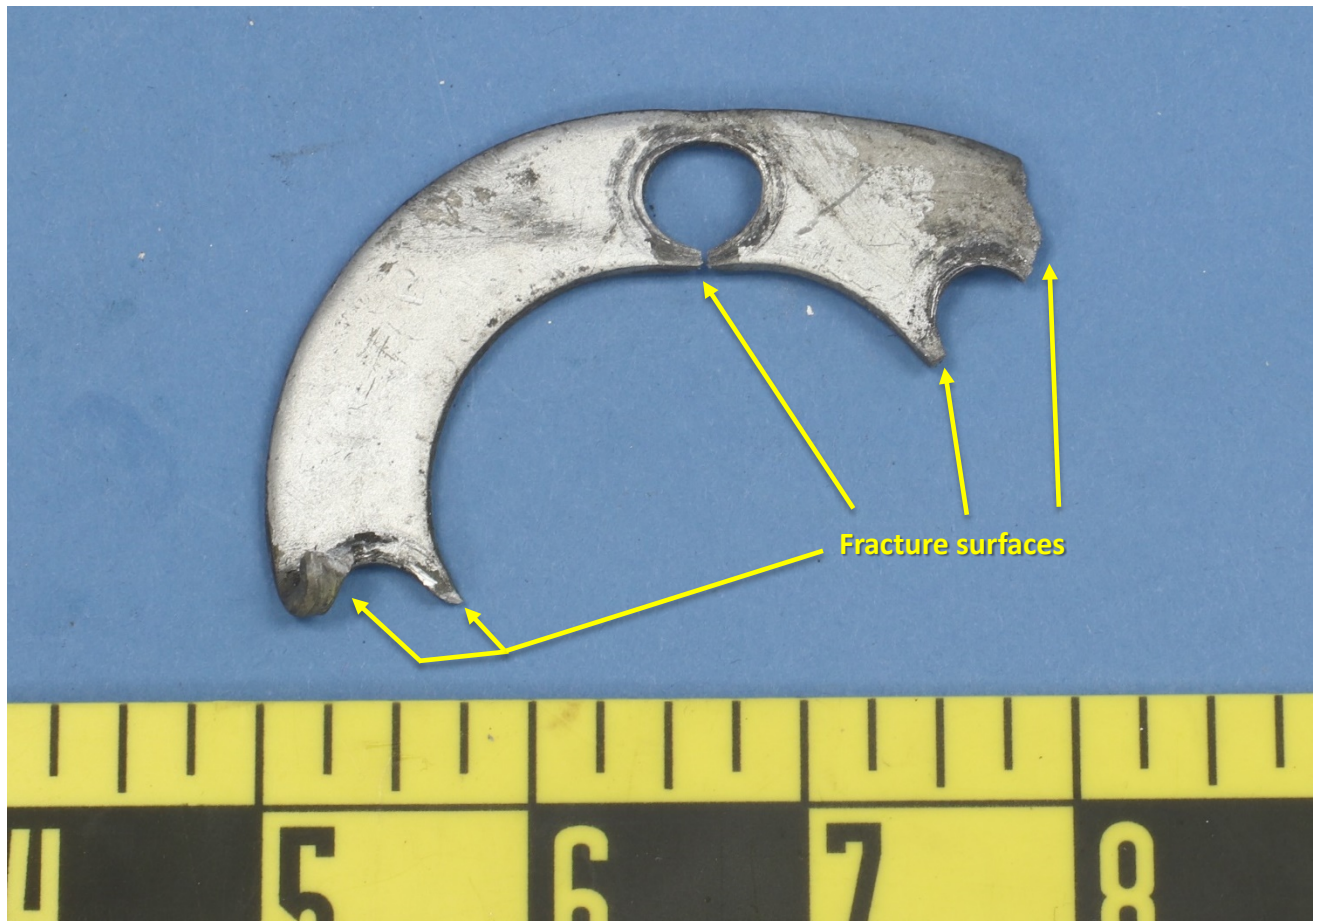
As it exhibited multiple fractures and was still generally planar in shape, the flange fragment was examined more extensively. As shown in Figure 2, the flange had fractured at five locations, each around an attachment bolt or fastener hole, consistent with the locations of least cross-sectional area, or higher stress concentration. Each end of the flange fragment exhibited two fractured filaments about a hole, with another fracture at the center bolt hole on one of the filaments, while the one opposite was intact.

Figure 2 – View of the fractured flange remnant, showing the five fractured surfaces.

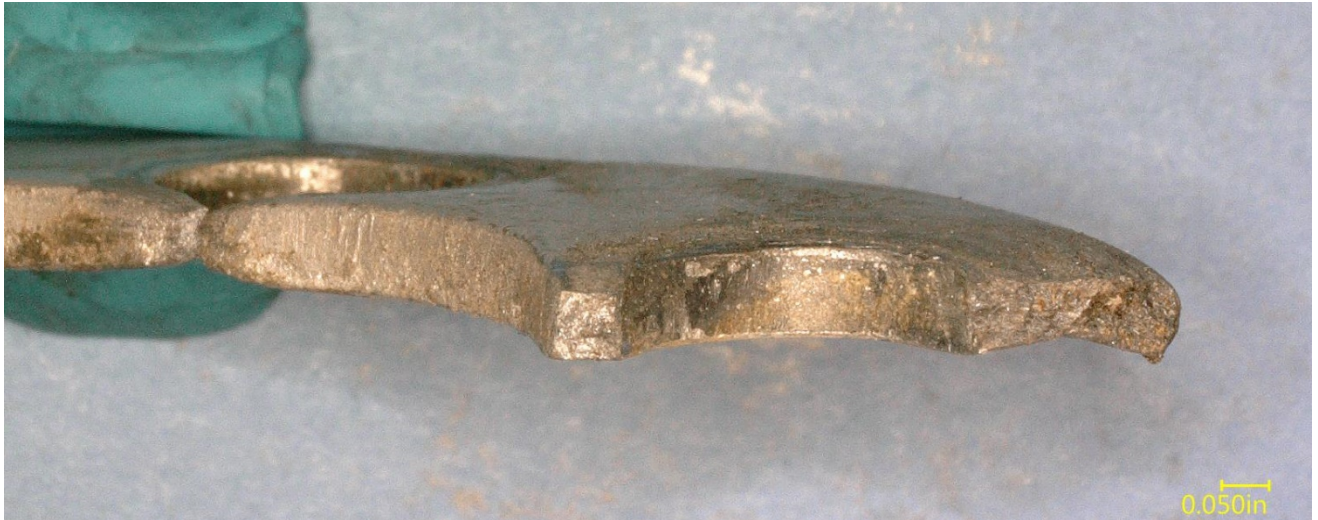
The fractures on the right side of the flange fragment in Figure 2 are shown in Figure 3 from a planar view, showing the surfaces. Each surface exhibited a generally dull fibrous luster, with a rough surface texture. In addition, the area of the flange fragment adjacent to the bolt hole exhibited a depression, consistent with wear from the adjacent bolt head or nut, similar to a countersunk machining process.

The fracture in Figure 3 exhibited localized thinning along the centerline (creating a bowtie shape) with some downward deformation (as oriented in Figure 3) adjacent to the fracture. The left filament exhibited localized thinning or necking in both directions, as demonstrated in Figures 3 and 4.

Figure 3 – View of the fracture surfaces around the bolt hole on the right side of Figure 2.

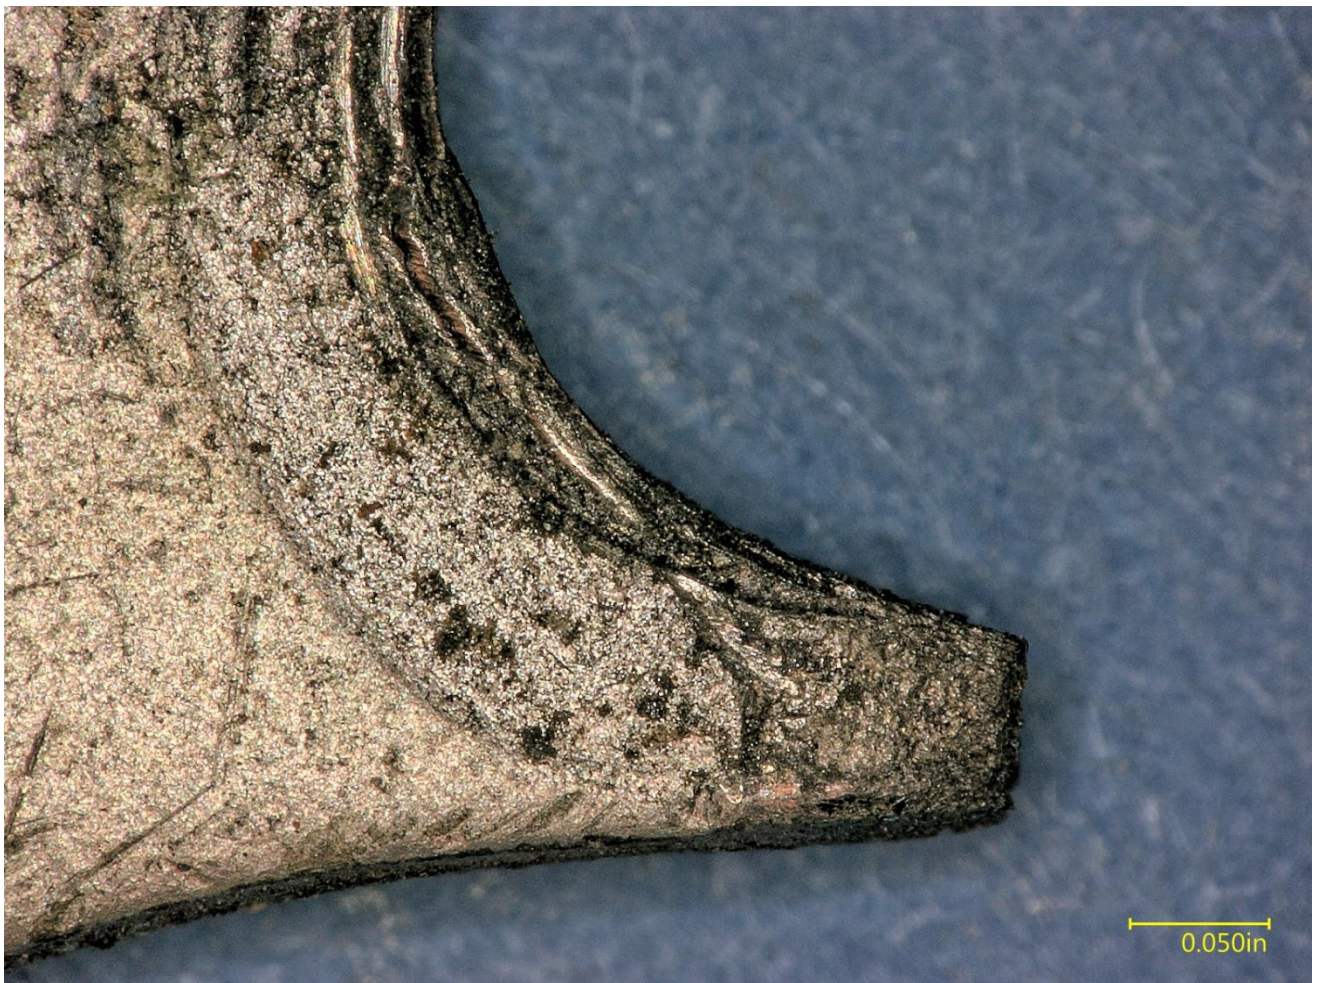
Figure 4 – Oblique view of the left fractured filament in Figure 3 near the bolt hole, showing localized thinning.

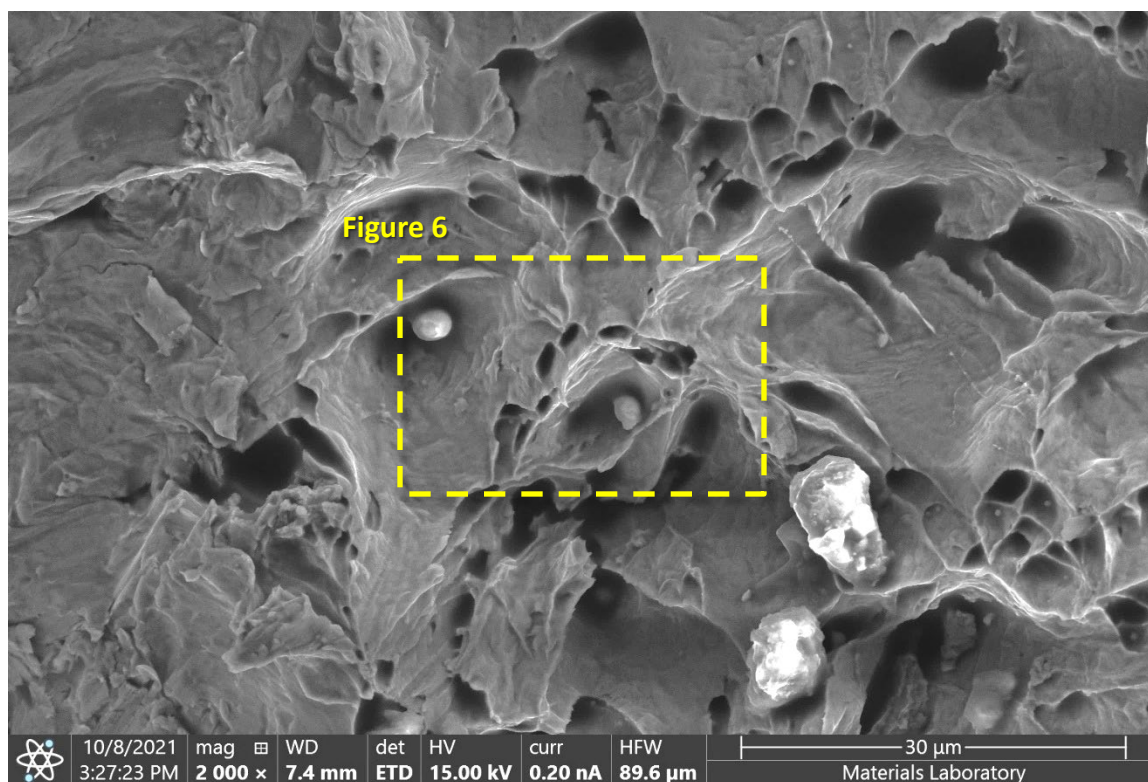
These fracture surfaces were examined using a scanning electron microscope (SEM). Figure 5 shows a typical area of the fracture surface, examined as received without cleaning. As illustrated in Figure 6, the fracture surface exhibited dimpled rupture, consistent with overstress fracture in tension. No other fracture features consistent with other failure modes were observed on these fracture surfaces.

Figure 5 – Secondary electron (SE) micrograph of a typical area of the fracture surface in Figure 3 and Figure 4.

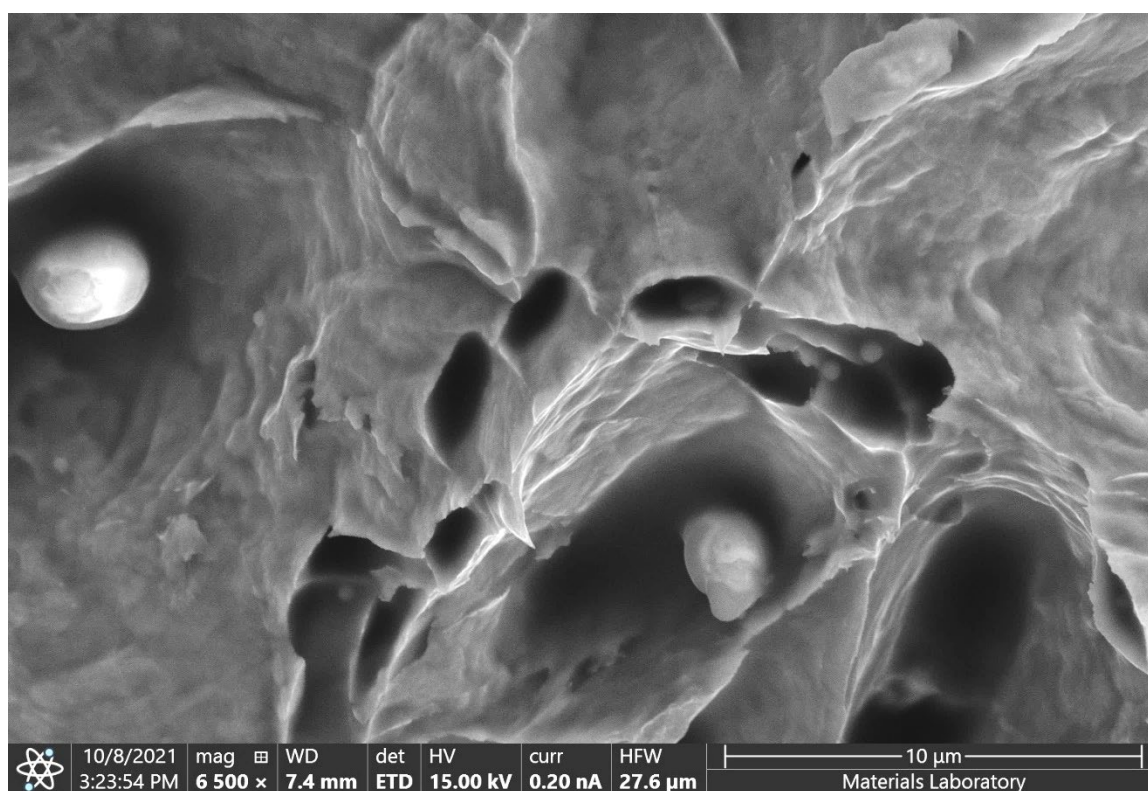
Figure 6 – SE micrograph of a dimpled rupture in the boxed area in Figure 5.

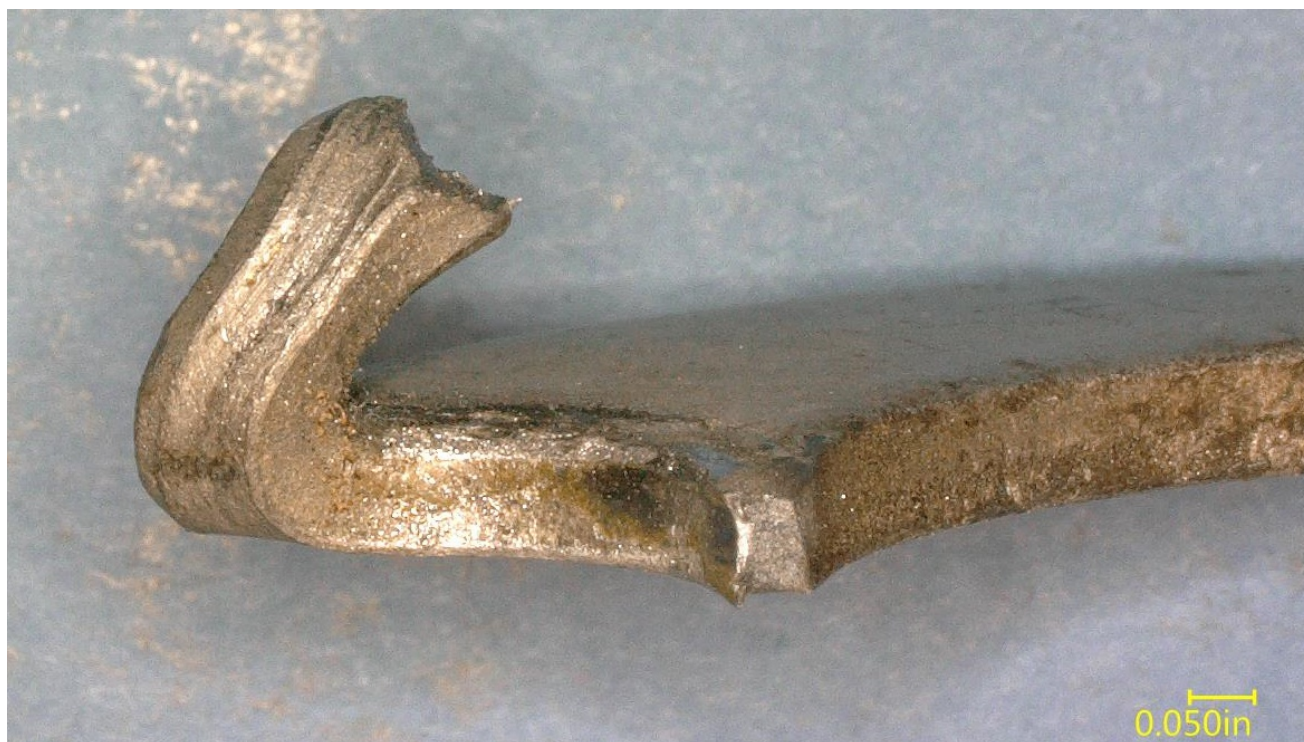
Figure 7 shows the fracture surfaces of the opposite side of the flange fragment (left side in Figure 2). These fractures exhibited similar features to those of the right side of Figure 2, except for the left filament which had been bent upward, as positioned in Figure 7. Both fracture surfaces exhibited a dull, fibrous luster, with a rough surface texture. The right filament in Figure 7 exhibited a general cup shape, with outward deformation (towards the right in Figure 7) and wear on the inside bolt surface. Examination of the fracture surfaces using a SEM found dimpled rupture features analogous to those illustrated in Figures 5 and 6. These features were consistent with overstress fracture, interacting with the fastener that pushed outward and upward when the flange failed.

Figure 7 – View of the fracture surfaces around the bolt hole on the left side in Figure 2.

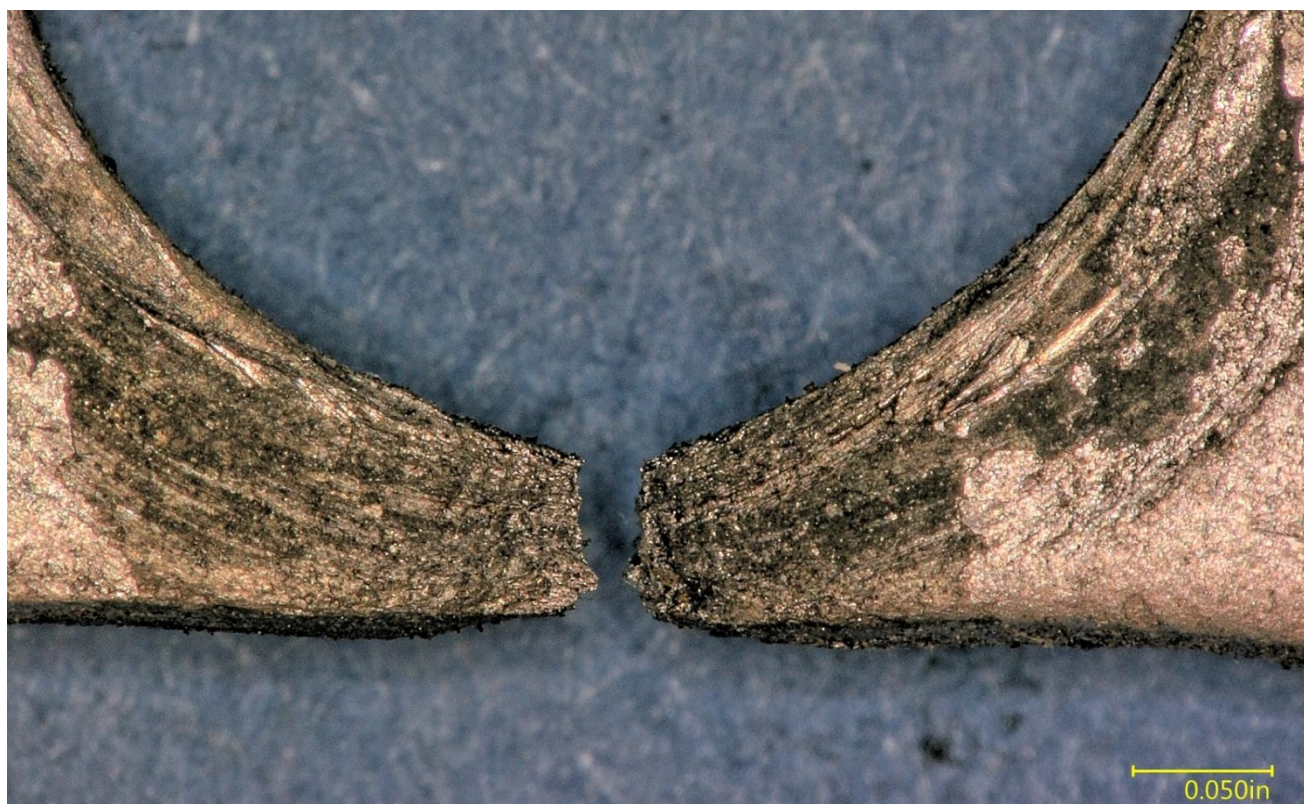
Figures 8 and 9 illustrate the planar and side views of the fractured filament at the central bolt hole in the flange fragment. The fracture surfaces faced and mated to each other, with one side exhibiting a cup shape, and the opposite having a cone shape. Particularly shown in Figure 9, the fractured filament exhibited localized thinning in the form of necking at the fracture location. These features were consistent with classical features of tensile overstress.

Figure 8 – View of the lower fracture around the bolt hole in the middle of Figure 2.

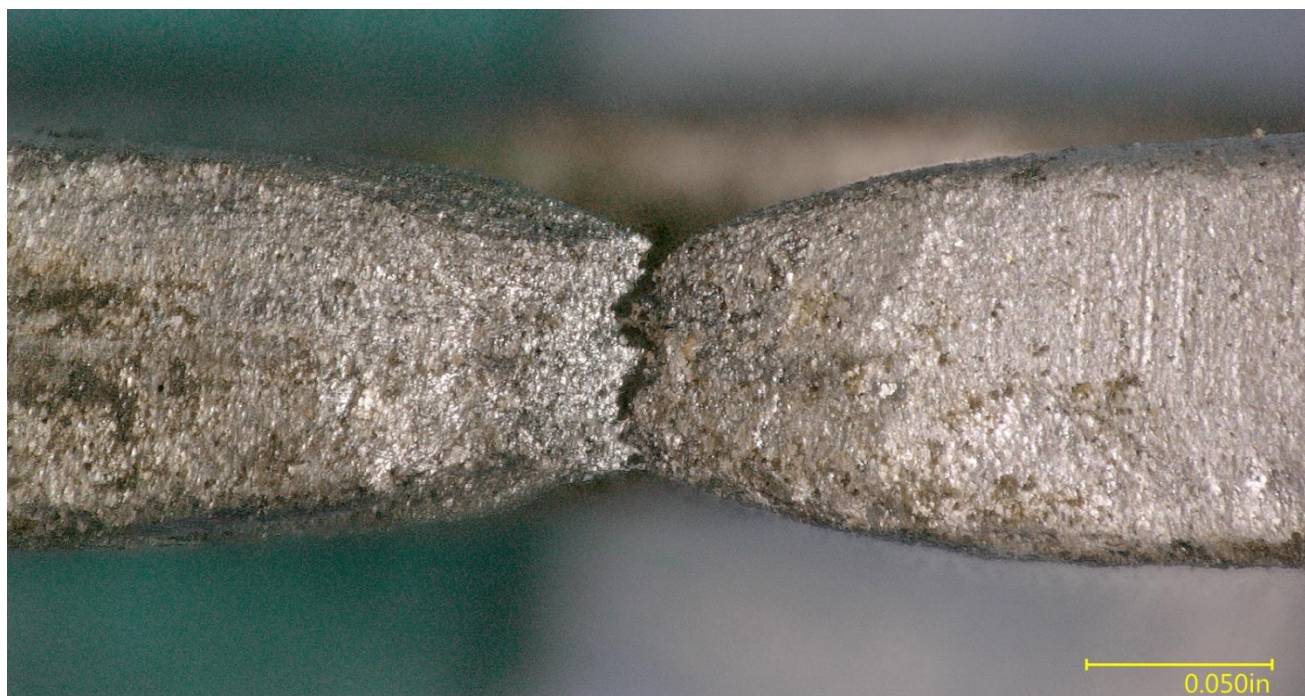
Figure 9 – Side view of the fracture in Figure 8, showing necking at the fracture.

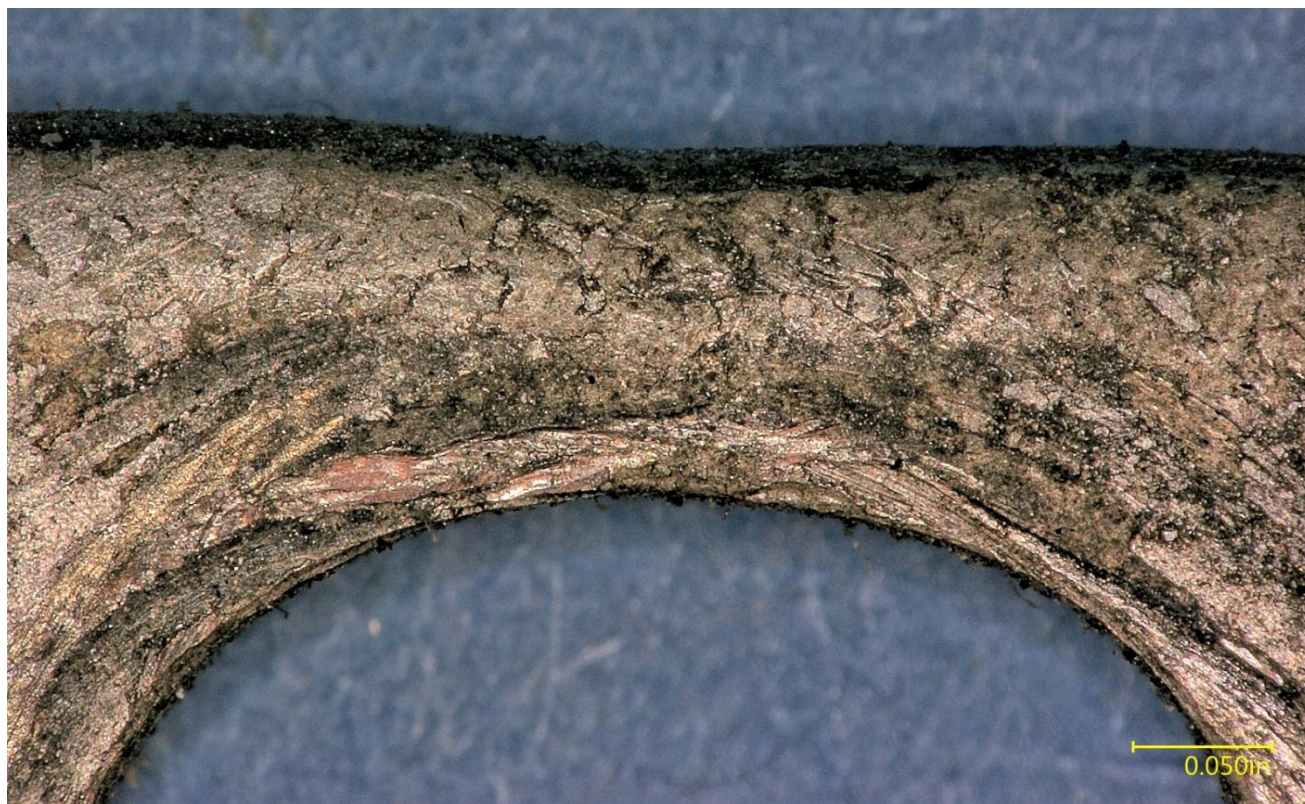
The opposite filament is illustrated in Figure 10. This area exhibited localized necking, consistent with unstable plastic deformation prior to fracture in tension. This area, however, did not exhibit any fractures or cracks, consistent with the applied stresses decreasing prior to fracture.

Figure 10 – The intact filament opposite the fractured one in Figure 8 and Figure 9, showing necking.
