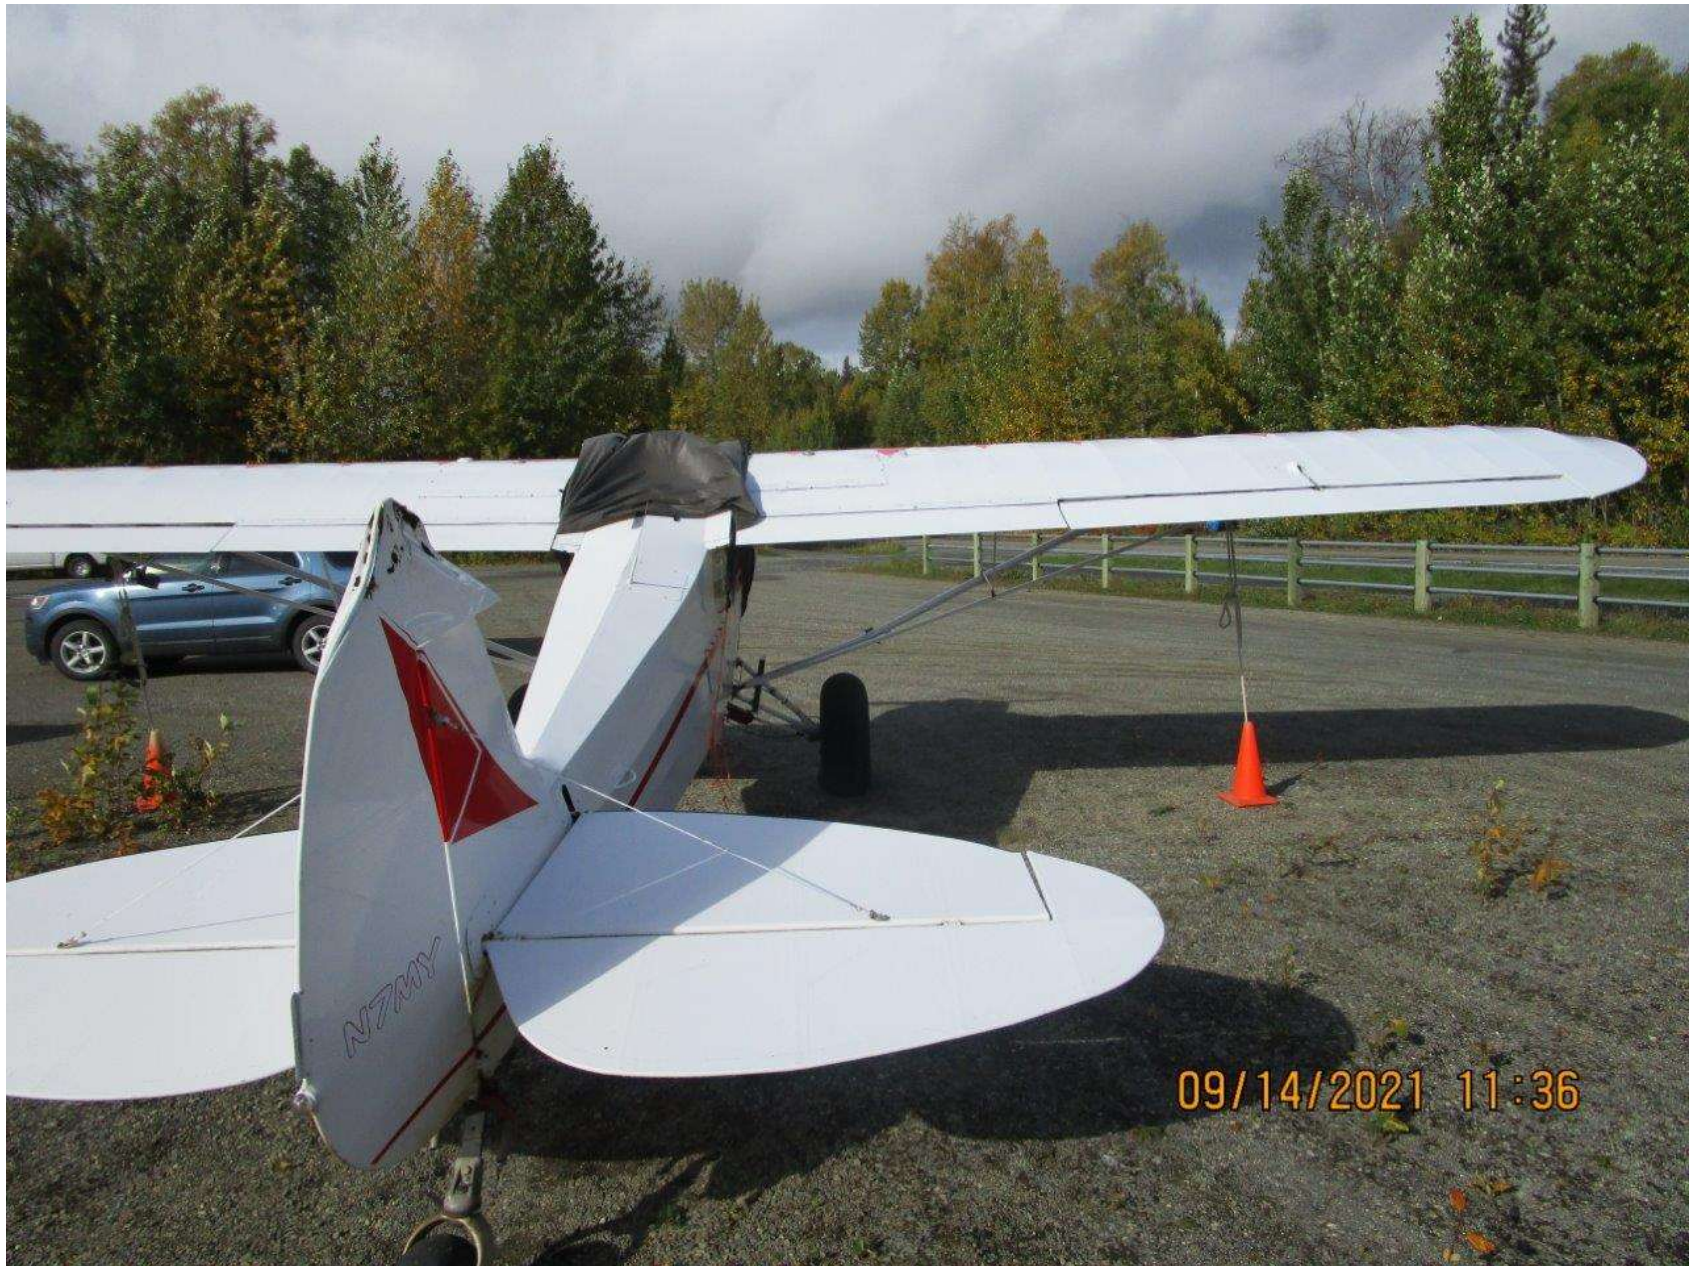
**Photo 1 – Rear view of damaged empennage and right wing (Photo courtesy of the FAA)**

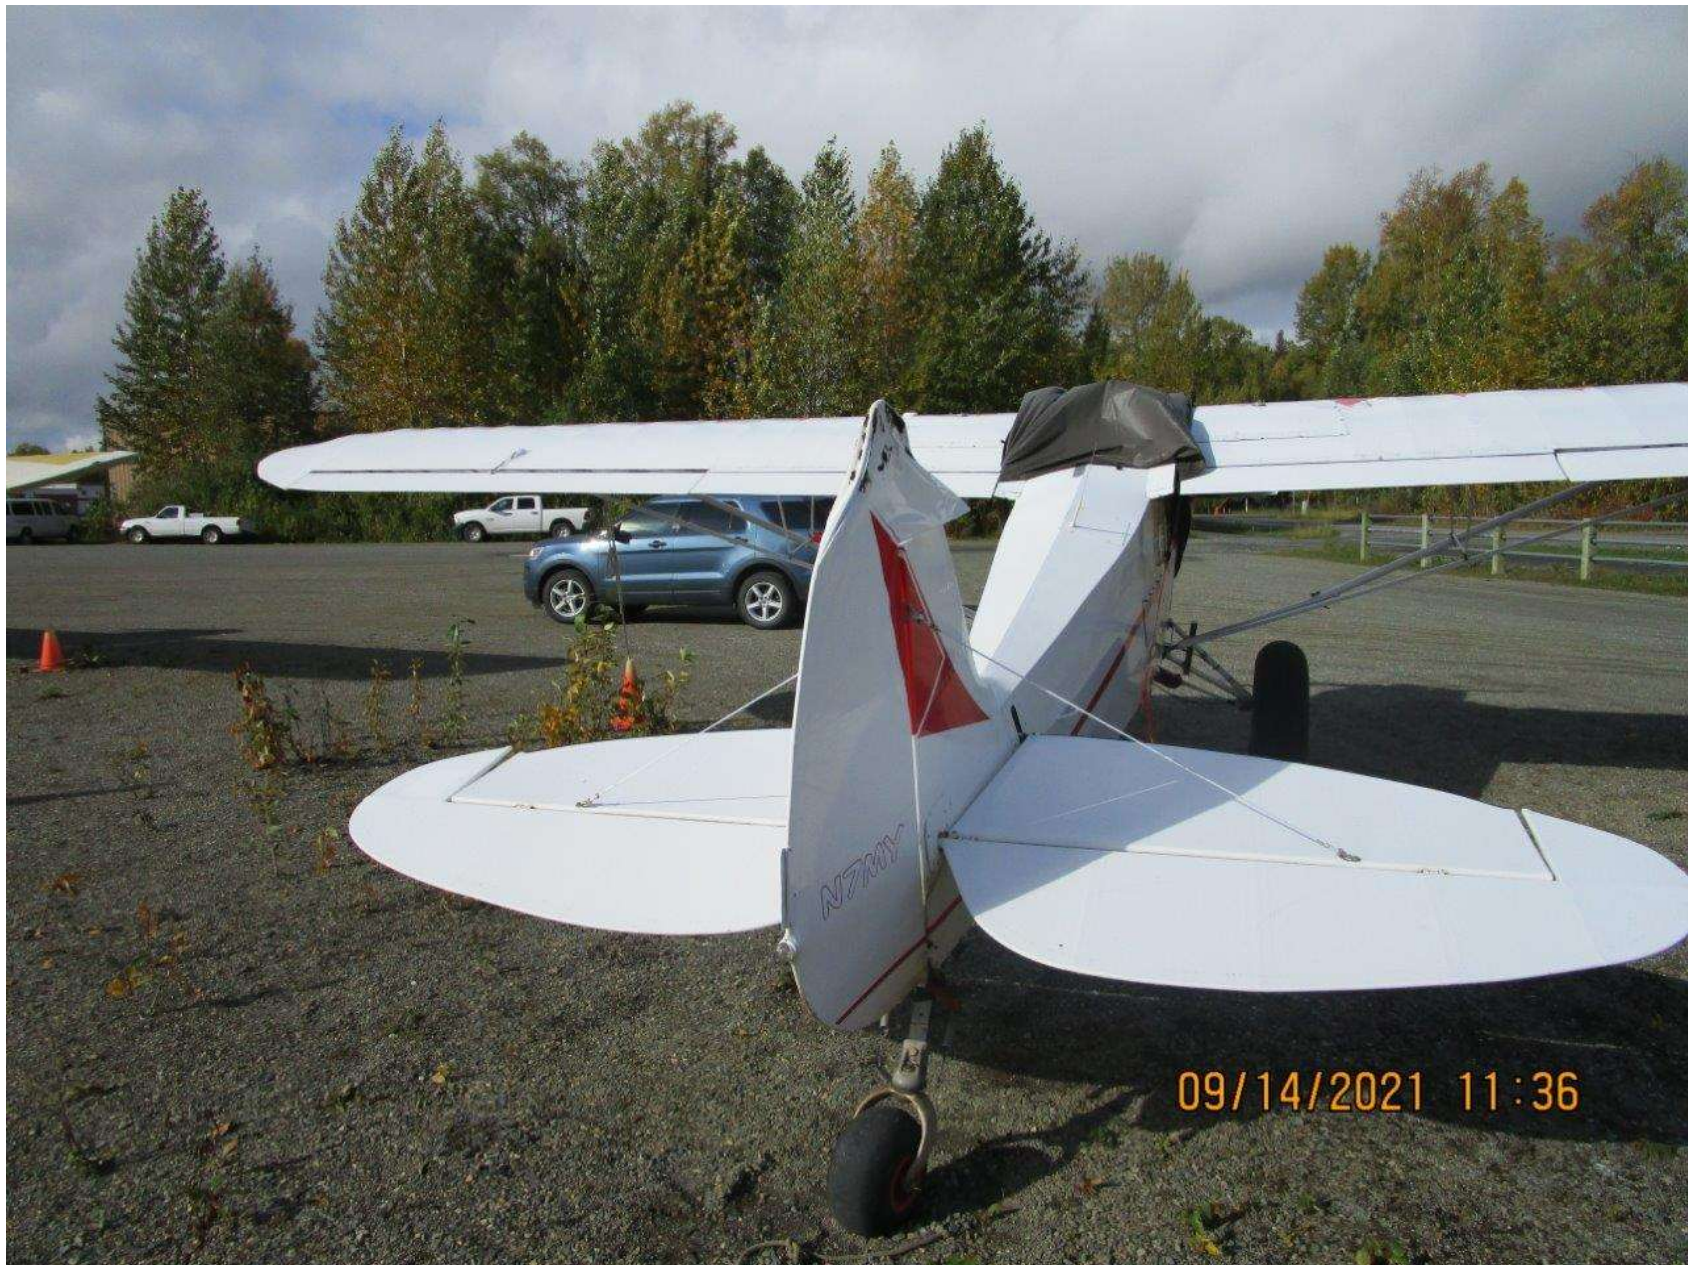
**Photo 2 – Rear view of damaged empennage and left wing (Photo courtesy of the FAA)**
