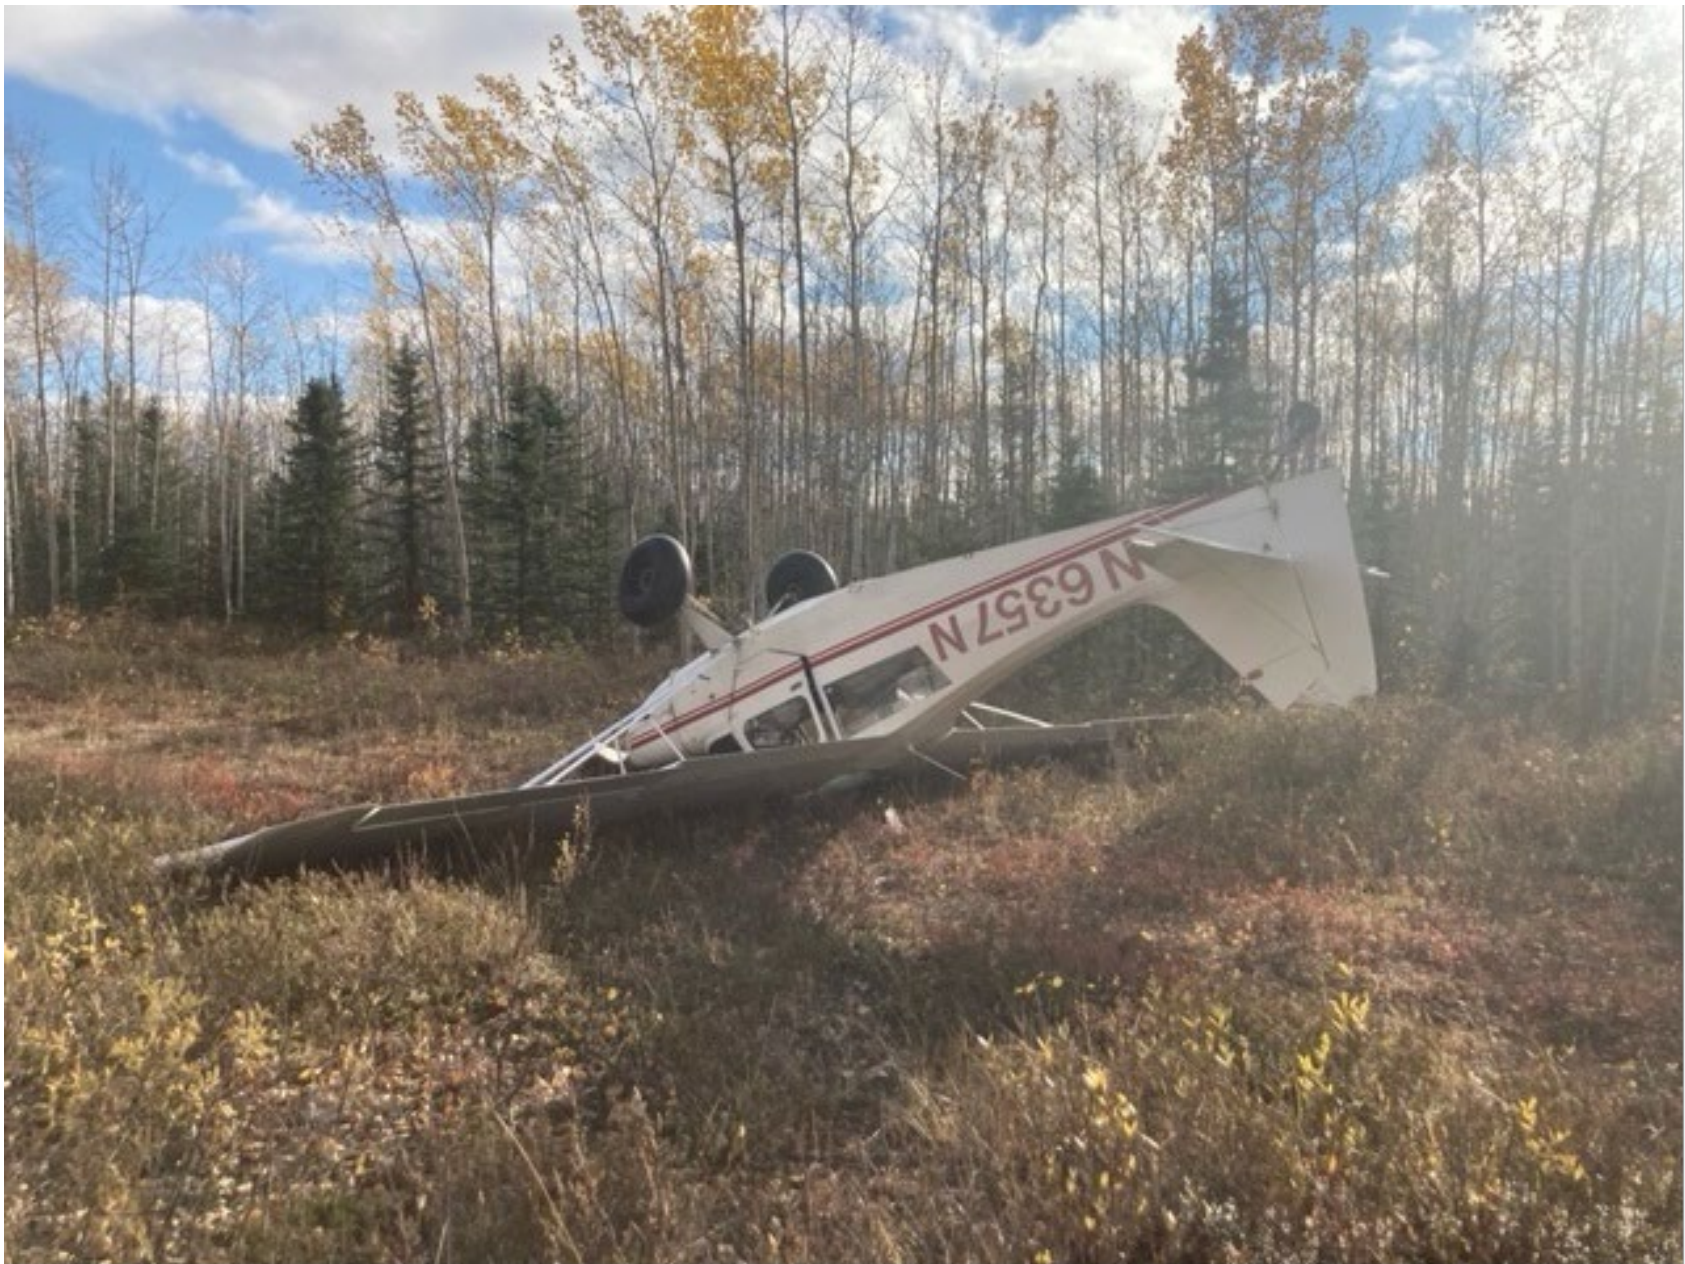
**Photo 1 – View of damaged empennage (Photo courtesy of the pilot)**

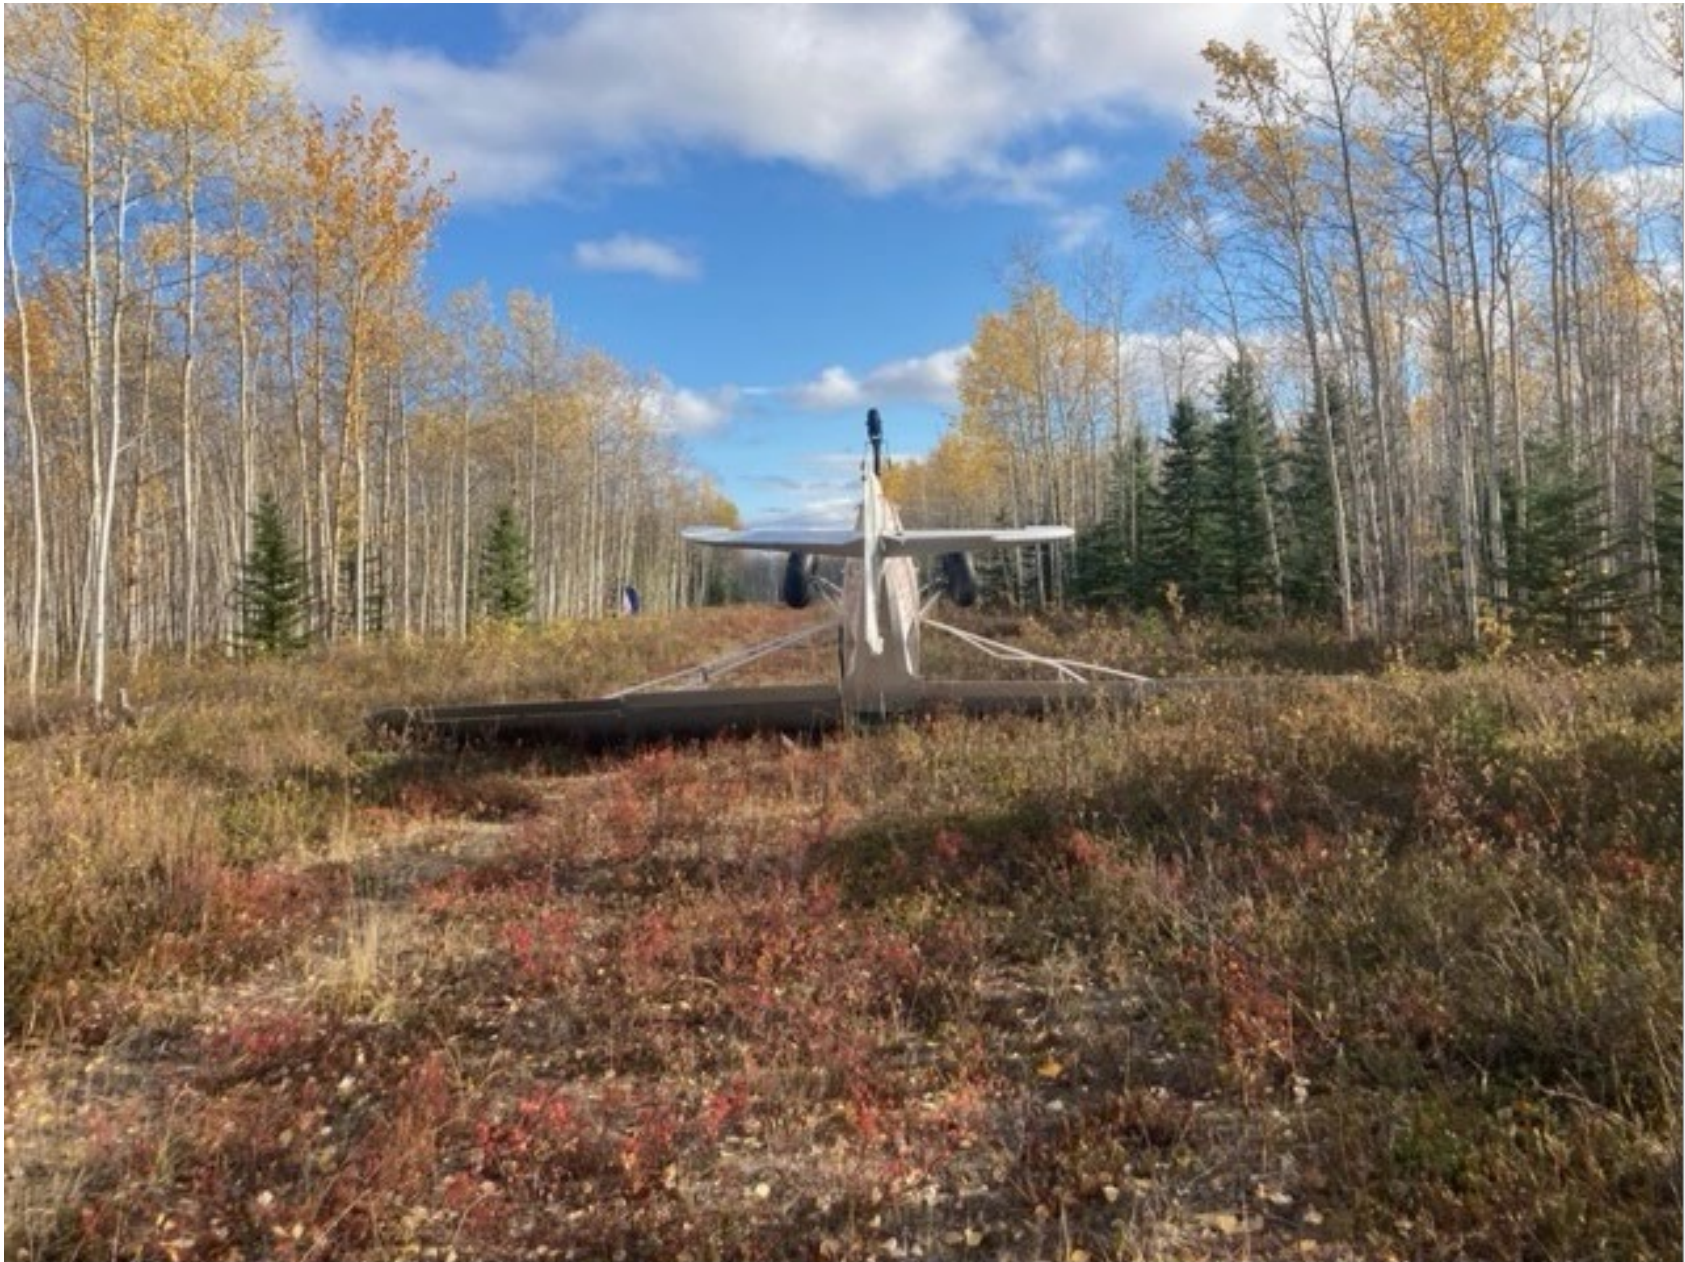
**Photo 2 – View of damaged lift strut (Photo courtesy of the pilot)**
