## **Wreckage Examination Summary**

NTSB ACCIDENT NUMBER: ANC22FA005

AIRCRAFT REGISTRATION/AIRCRAFT TYPE: N540AK, Gerald Jones 2+2

ACCIDENT LOCATION: Kodiak, AK

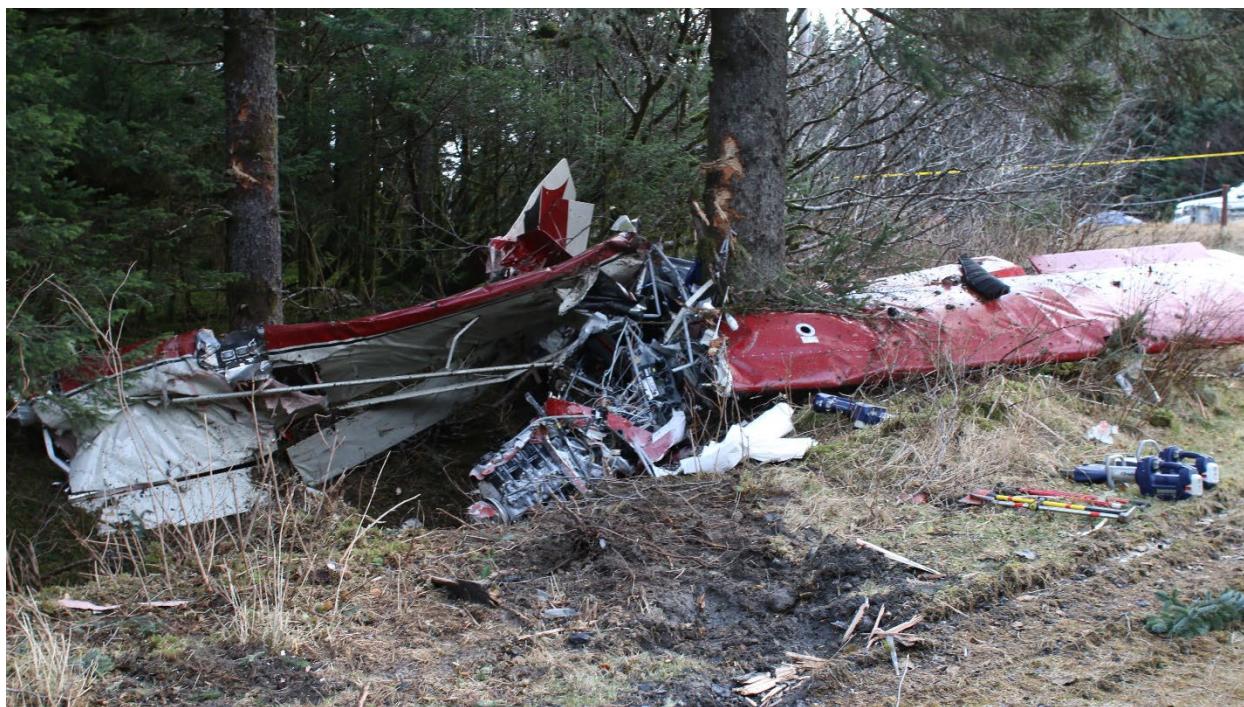
The airplane impacted a hard gravel road at an elevation of about 92 ft. A video surveillance camera captured the impact sequence and showed the airplane impacted in a right wing low near vertical attitude. The airplane came to rest about 25 feet from the initial impact site in a heavily forested area and sustained substantial damage to the fuselage, wings, and empennage.

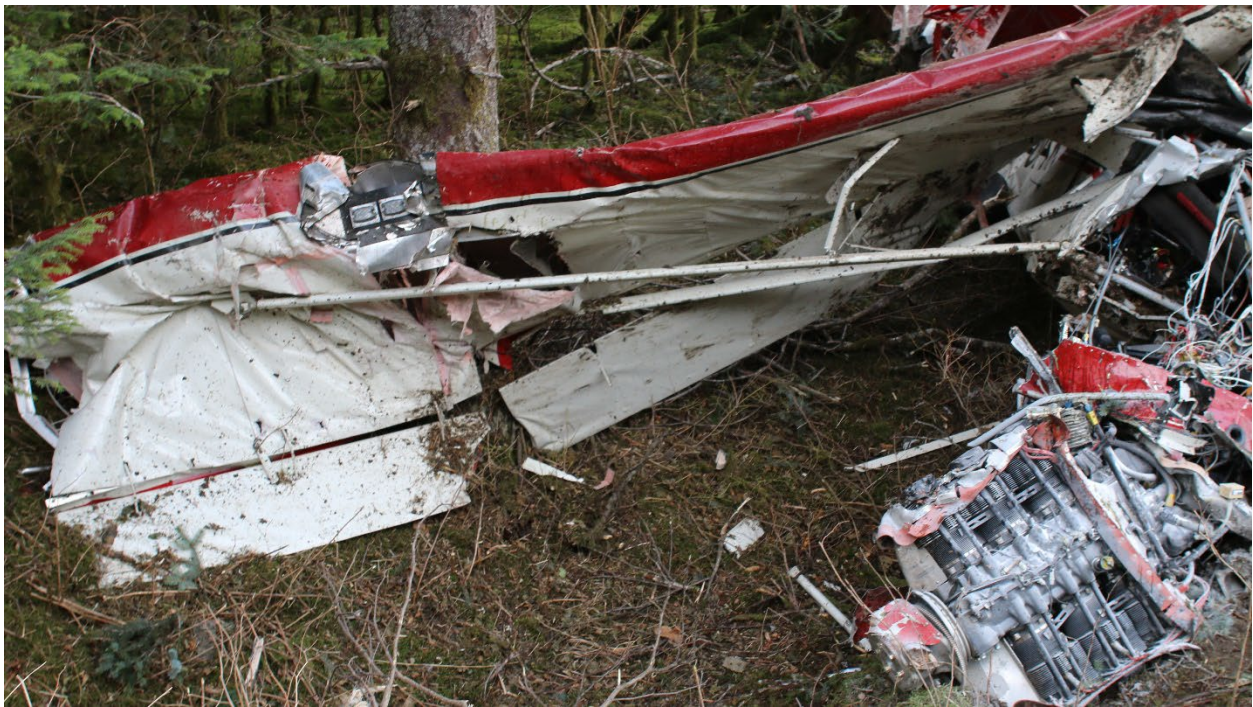
- The right wing exhibited extensive leading edge impact damage about 10 feet from root outboard to the tip.
- The right aileron remained attached to its respective attach points and sustained impact damage.
- The right flap separated from all its attach hinge points but remained attached by its push-pull tube.
- The right flap exhibited impact damage.
- The right wing tip separated at impact and was found in front of the direction of travel .
- The right wing remained attached at its rear attach point but separated near the spar by the forward attach point.

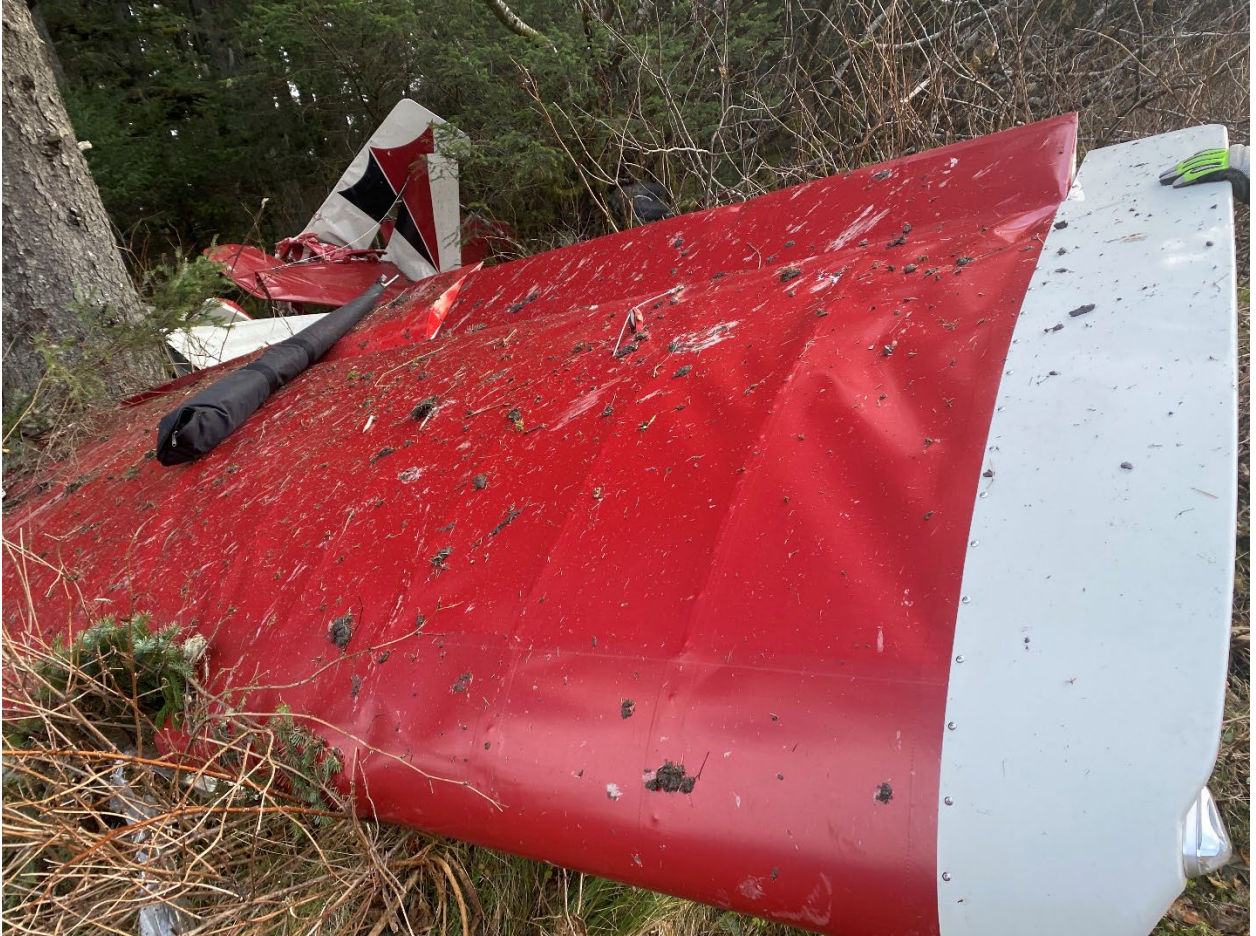
- The left wing separated from both its front and rear attach points.
- The leading edge of the left wing exhibited minor impact damage
- The left flap separated from all its hinge attach points, the trailing edge near the root had a large elliptical impact area consistent with impact damage from a large tree.
- About 20 gallons of fuel was drained from the left wing's fuel tank.

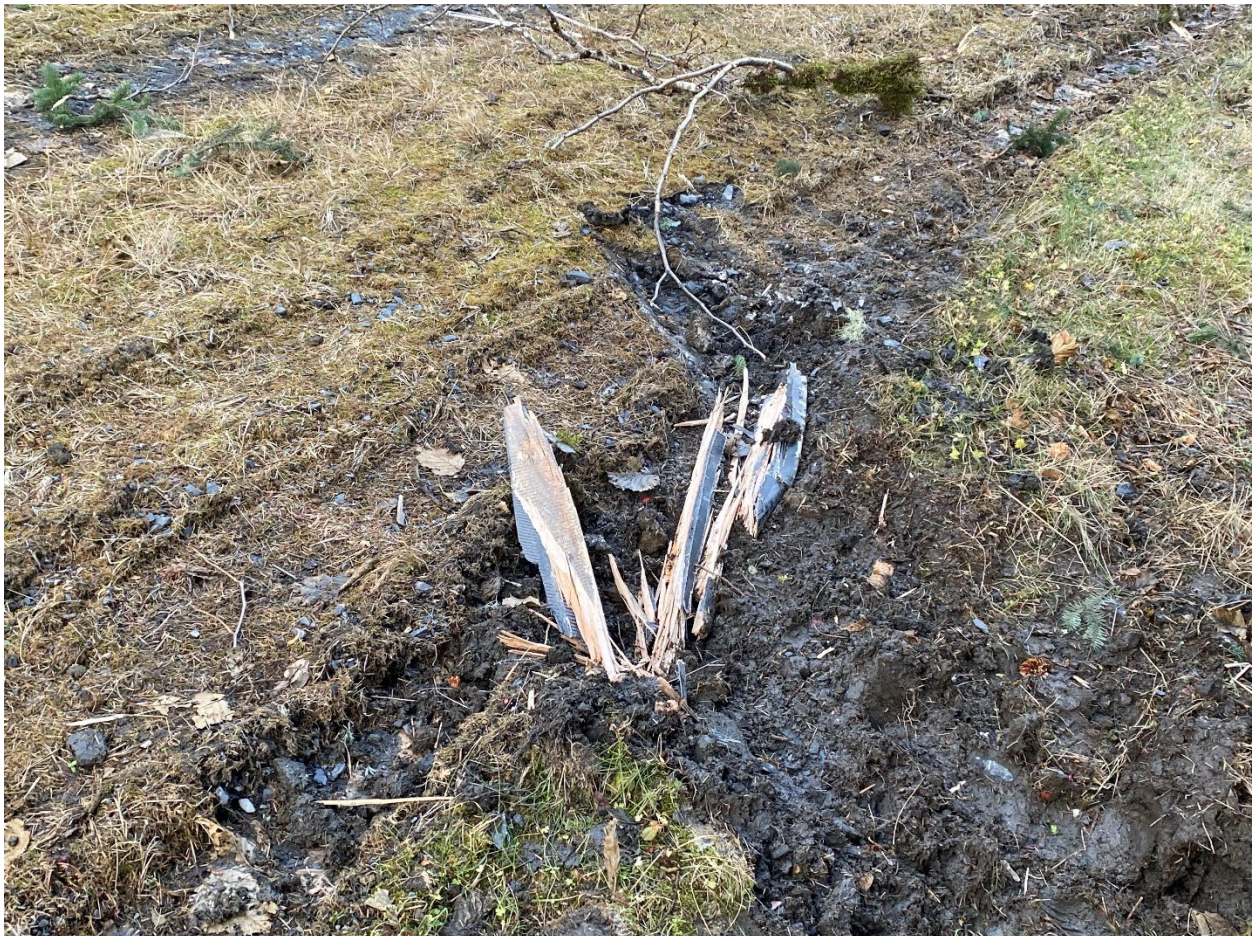
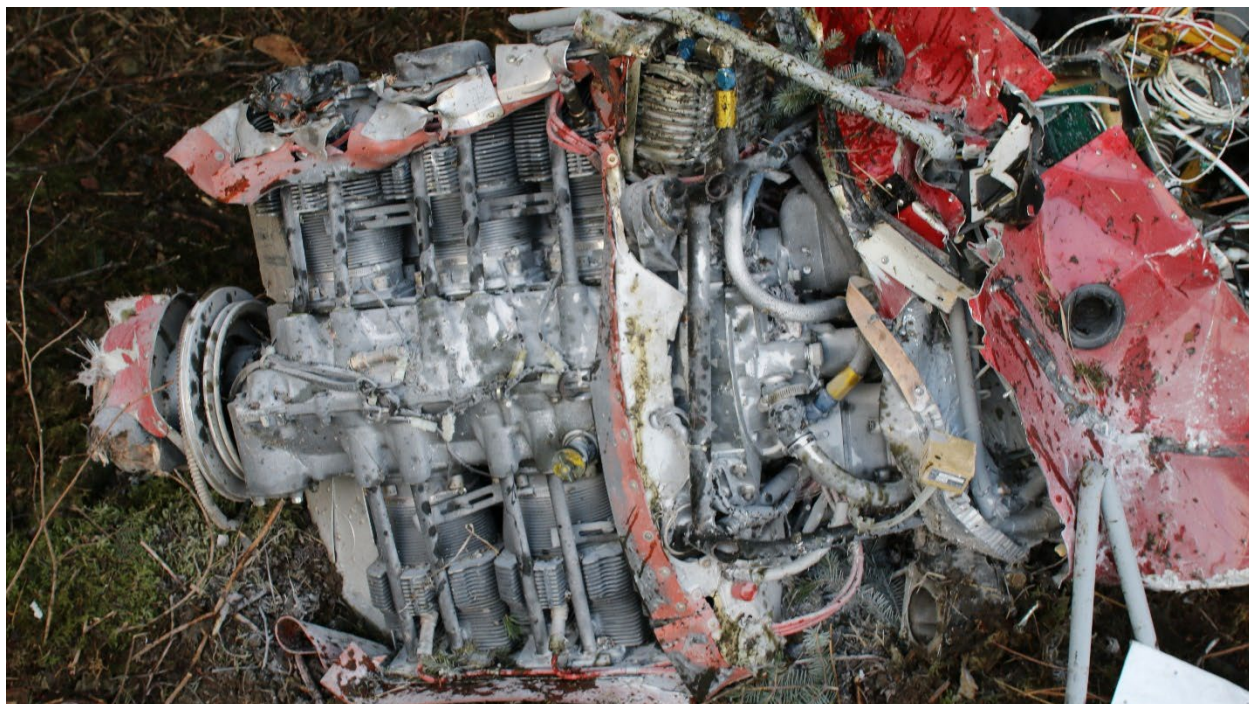
The powerplant is a six-cylinder, air cooled, direct drive, horizontally opposed, normally aspirated (carburetor), internal combustion engine. The engine was removed from the airframe during recovery. The engine had sustained extensive impact damage to the underside and right side. The exhaust system had been displaced aft. Visual examination of the engine revealed no evidence of pre-impact mechanical malfunctions or fire.

The propeller hub remained attached to the crankshaft; however, the propeller blades were shattered and splintered due to impact damage. The spark plugs were removed from each cylinder and the crankshaft was rotated by hand at the crankshaft flange. The crankshaft was free and easy to rotate in both directions and exhibited rotational scoring. "Thumb compression" was observed on all six cylinders. The complete valve train was observed to operate and appeared to be free of any pre-mishap mechanical malfunction. Normal "lift action" was observed at each rocker assembly except for the number six cylinder that had weak compression that was attributed to a significantly bent exhaust push rod. Mechanical continuity was observed throughout the rotating group, valve train and accessory section during hand rotation of the crankshaft. The combustion signatures observed at the spark plugs displayed coloration consistent with normal operation. There was significant ductile bending of the exhaust system components.

There was no evidence of pre-impact mechanical malfunctions observed during the engine examination.
