## NATIONAL TRANSPORTATION SAFETY BOARD

### COMPONENT EXAMINATION FACTAL REPORT

Place : Gila Bend, AZ  
Date : April 15, 2022  
Vehicle : Robinson R-22  
NTSB No. : ANC22FA030  
Investigator: E. Swenson

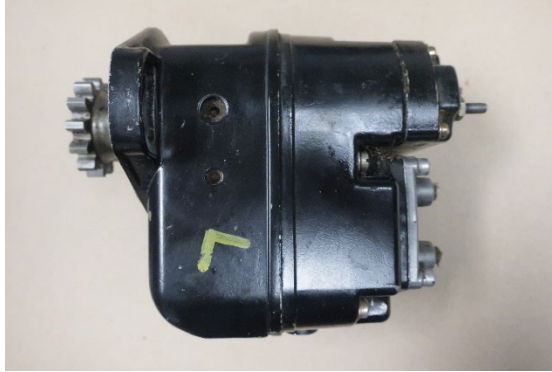
Photo 1. Left Magneto

The left magneto appeared undamaged (Photo 1). The ignition leads had been clipped off at the ignition wire cap. The drive gear rotated freely by hand. The tach signal lead pins are straight with no damage or corrosion observed. The nylon distributor gear visually examined, all teeth were present, no damage noted. Overhaul date was stamped 5.16 (May 2016).

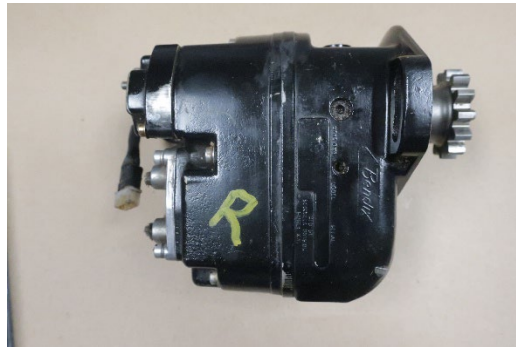
Photo 2. Right Magneto

The right magneto appeared undamaged (Photo 2). The ignition leads had been clipped off at the ignition wire cap. The drive gear rotated freely by hand. The tach point electrical connector was attached. The nylon distributor gear visually examined, all teeth were present, no damage noted. Overhaul date was stamped 5.16 (May 2016).

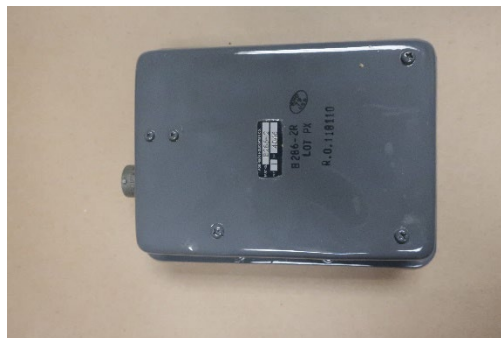
Photo 3. Governor Control Box

Governor control box was intact and the interface between cover plate and box appears to be completely sealed (Photo 3). Slight indentation of the upper surface of the box was observed

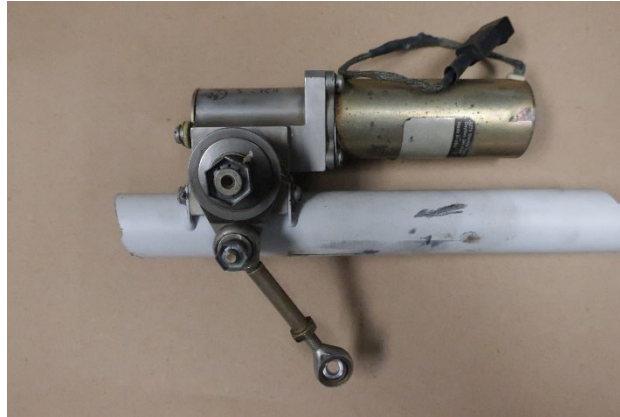
Photo 4. Governor motor assembly

The governor motor assembly was attached to the collective control tube (Photo 4). The control tube had been cut on both sides of the governor assembly. The throttle link and

friction disk were attached and undamaged. Motor and gear housing was attached, safety wired, and no damage noted.

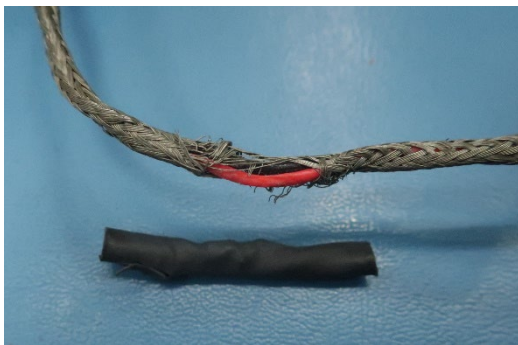
The power cable had a portion covered by a 1.5-inch section of heat shrink from a previous repair (Photo 5). When the heat shrink was removed it revealed a "repair" covering an area where some of outer braided shielding was frayed & the insulation had been worn exposing a small amount of inner conductor (Photo 6). Electrical continuity testing showed that the red (pin 1) could short to ground if the wire was worked back and forth when the power was routed by the controller thru pin 1. Power applied to pin 1 (red) drives the friction disk in the clockwise direction (when facing the friction disk) which equates to reducing the throttle. This would ground out the power to the motor throttle reduction. The effect would be that the governor would not reduce throttle, or it would reduce it at a slower than normal rate. Depending on the duration of the applied power pulse, a shorted wire could potentially trip the governor circuit breaker.

Photo 5. Power lead repair with heat shrink removed.

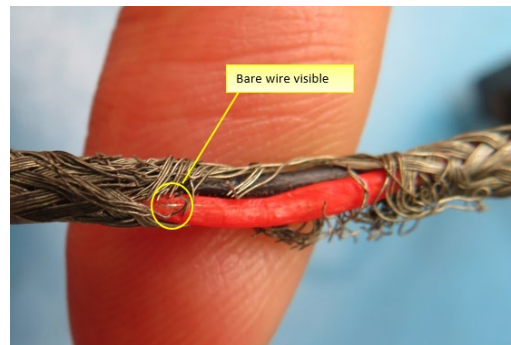
Photo 6. Bare conductor wire visible through worn red insulation and braided shielding.
