## **NATIONAL TRANSPORTATION SAFETY BOARD**

### **Wreckage Examination**

**ANC22FA030**

**Wreckage  
Examination  
N7516G**

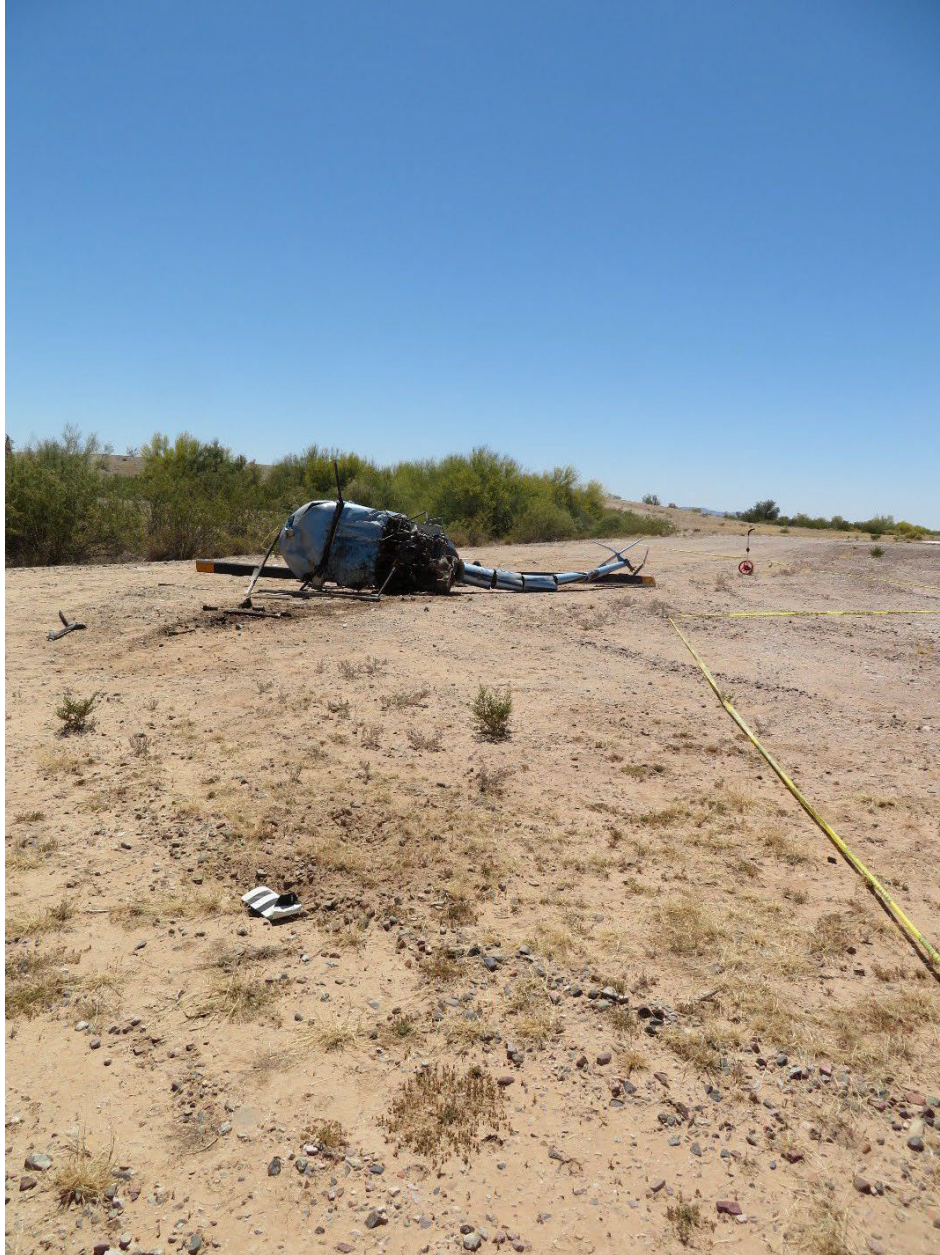
Photo of accident helicopter at accident site looking west (NTSB photo)

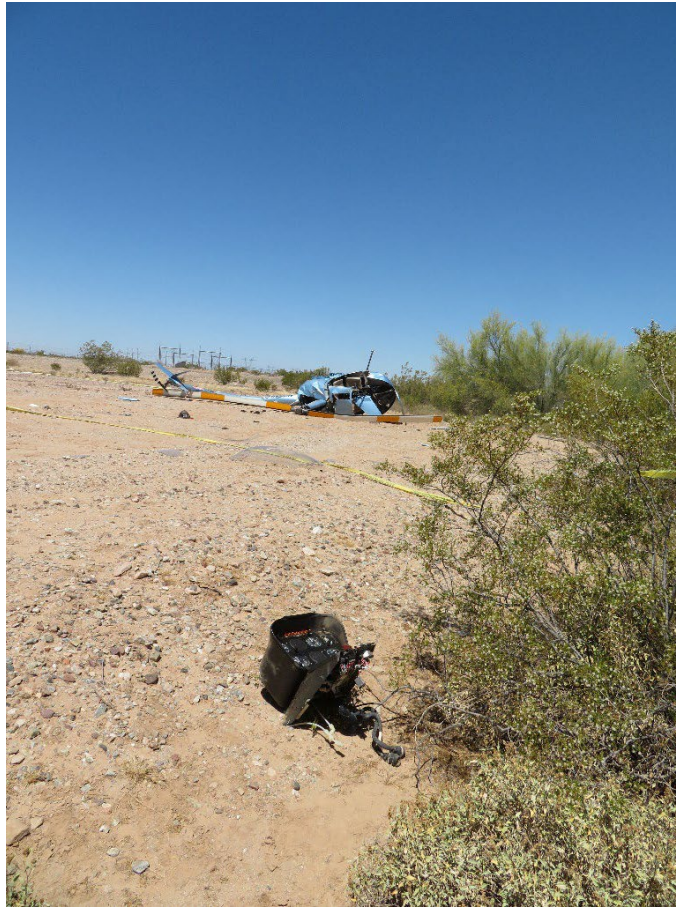
Photo of accident helicopter looking east (NTSB Photo)

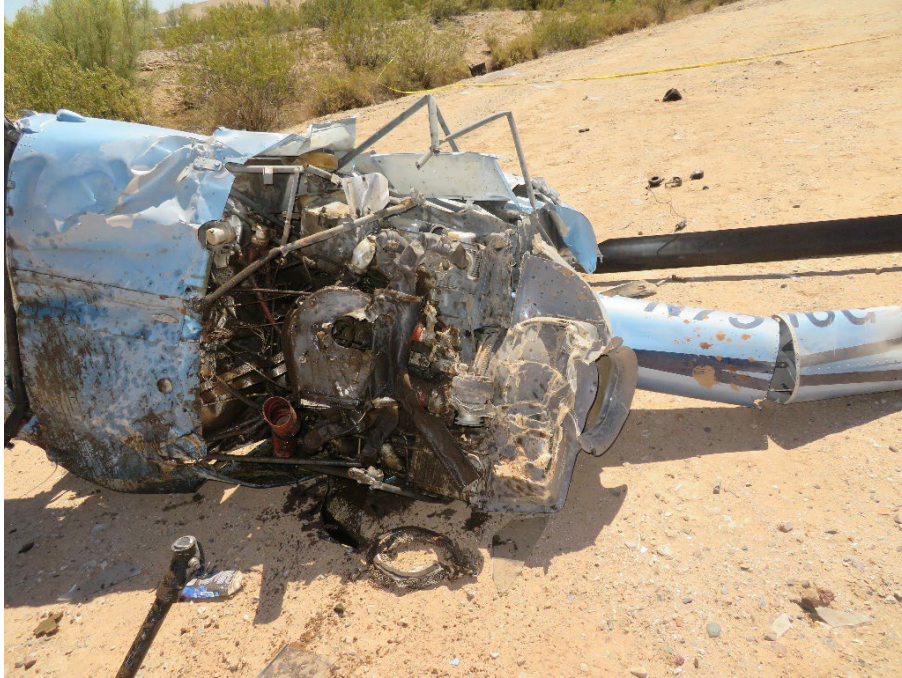
- Severe crushing on underside of fuselage and engine
- Right skid (pilot)
  - Toe attached in place
  - Heal displaced and separated
- Left skid (copilot)

Photo of underside and engine of accident helicopter (NTSB Photo)

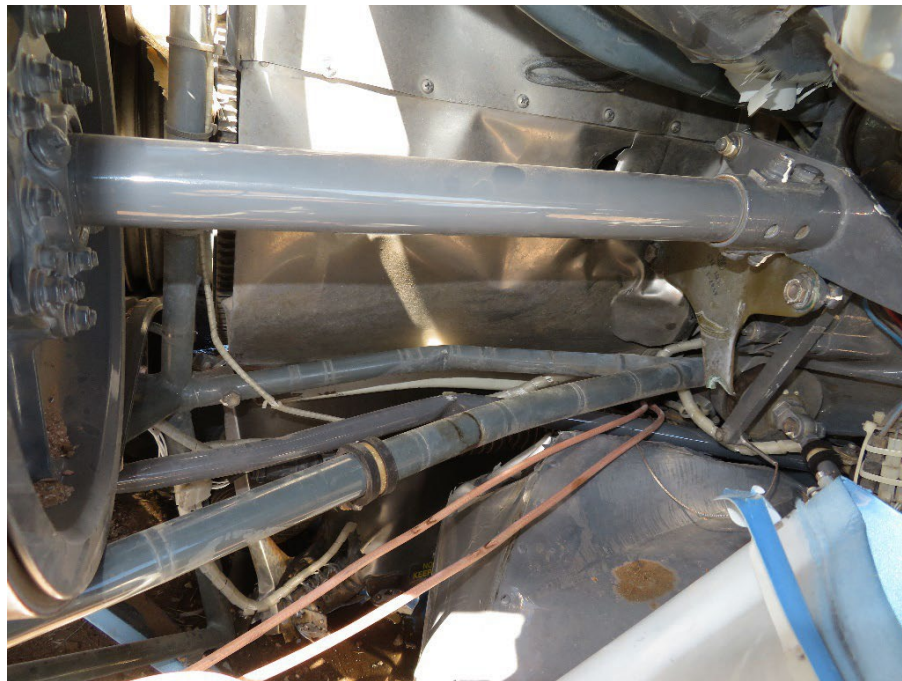
Photo of main rotor drive shaft (NTSB Photo)

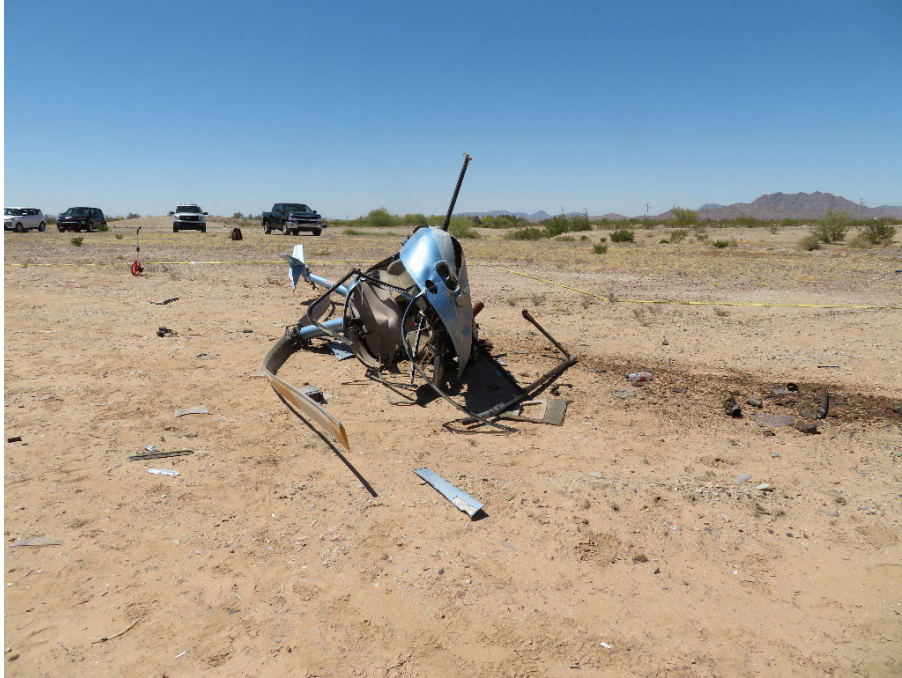
Photo of main wreckage looking north (NTSB Photo)

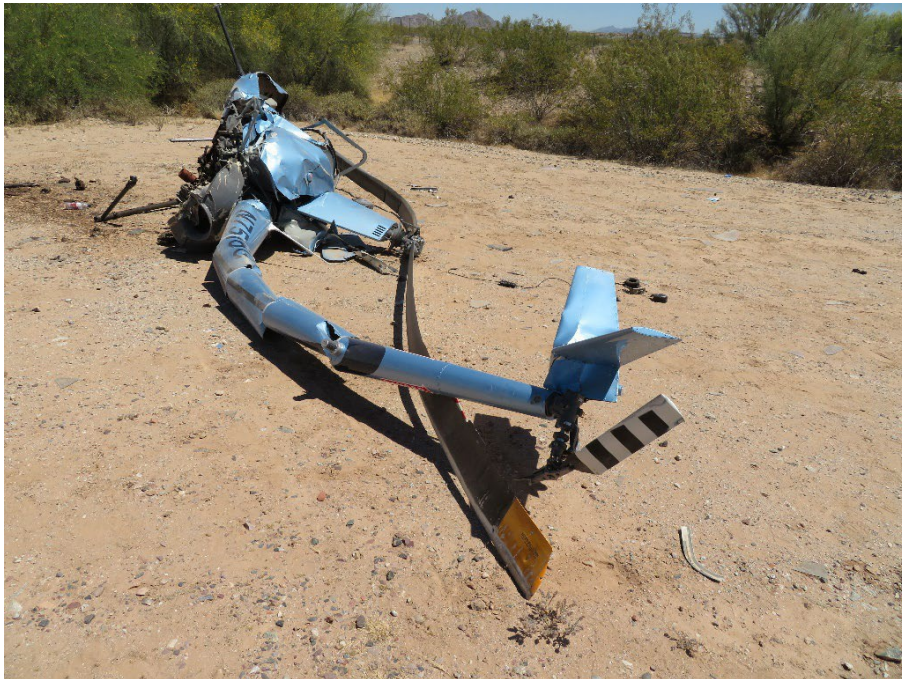
- Horizontal stabilizer: bent down
- Lower vertical stabilizer: bent to the left
- Tail skid: fractured at the empennage
- Tail boom has white transfer marks laterally across the top of the tail cone

Photo of main wreckage with tail boom in foreground, looking south (NTSB Photo)

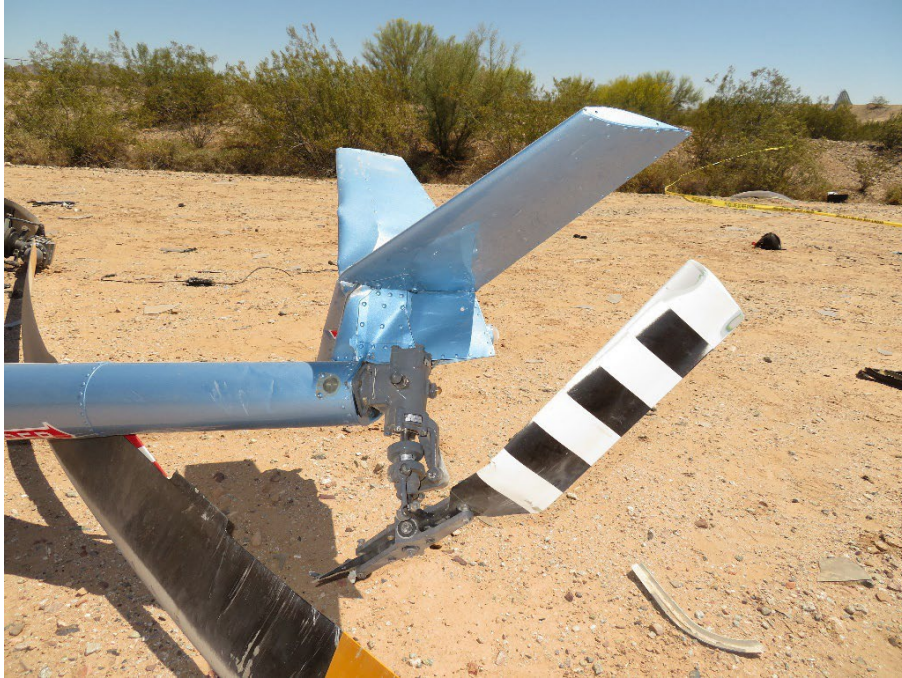
- Rear tail rotor blades:
  - Broken rear blade
    - Part # A029-2
    - Rev S
    - S/N: 8270
  - Non-Broken
    - Part # A029-2
    - Rev S
    - S/N: 8275
- Upper vertical stabilizer: not damaged

Photo of tail rotor gearbox, tail rotor hub, and blades (NTSB Photo)

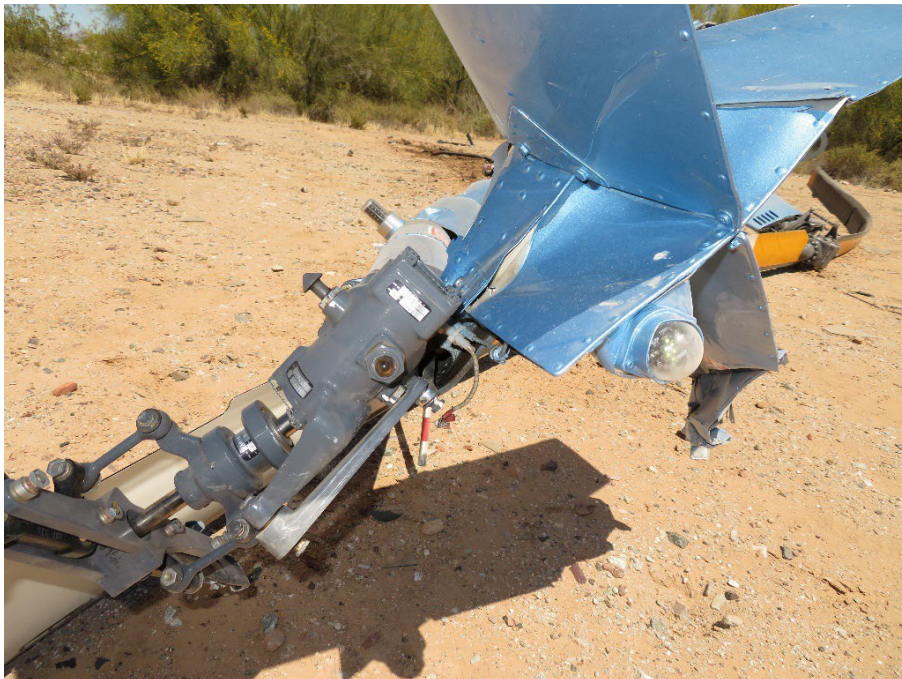
- Rear rotor: no oil visible in sight glass
- Tail rotor flight controls: still connected: pitch change separated and damaged: Pitch change assembly rotates freely, but will not slide due to bend in TRGB output shaft

Photo of tail rotor gearbox, tail rotor hub linkages, looking south (NTSB Photo)

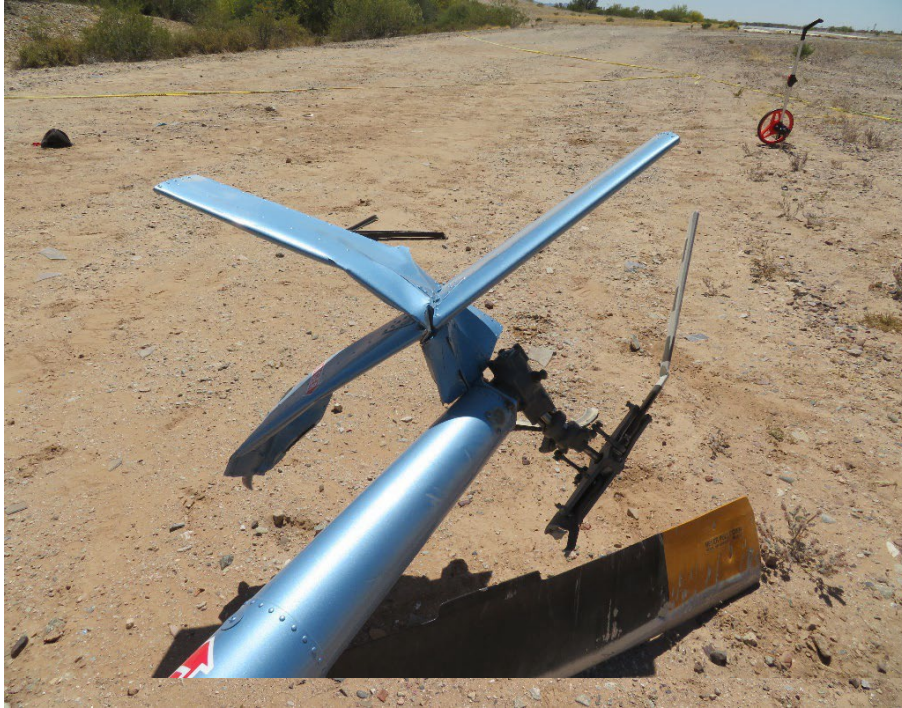
Photo of tail rotor gearbox and aft portion of tail boom, looking west (NTSB Photo)

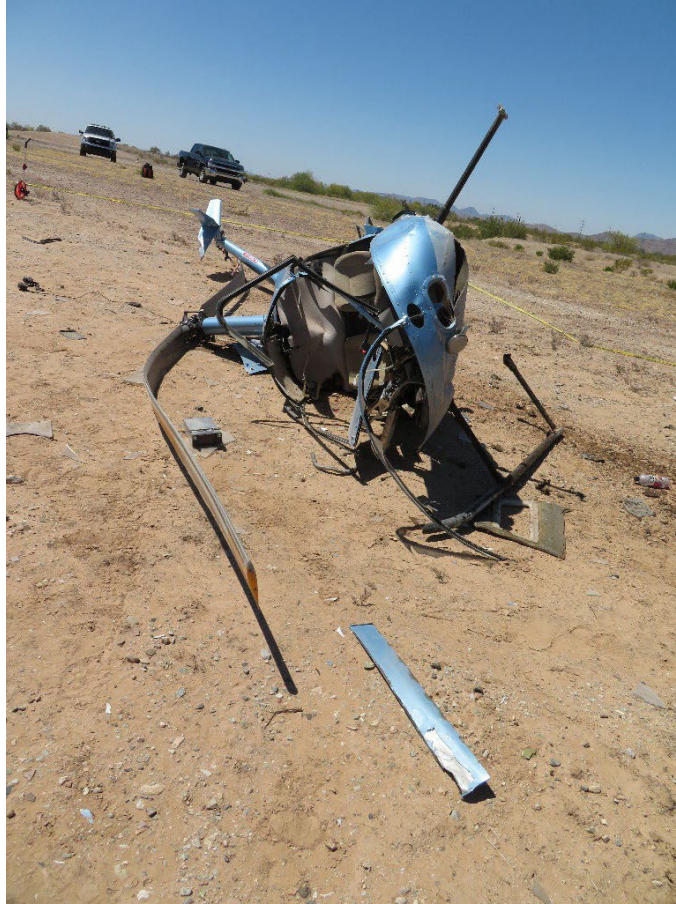
Photo of cockpit and cabin area looking west (NTSB Photo)
