# National Transportation Safety Board

ANC22FA047

## **MATERIALS LABORATORY**

Factual Report 23-043

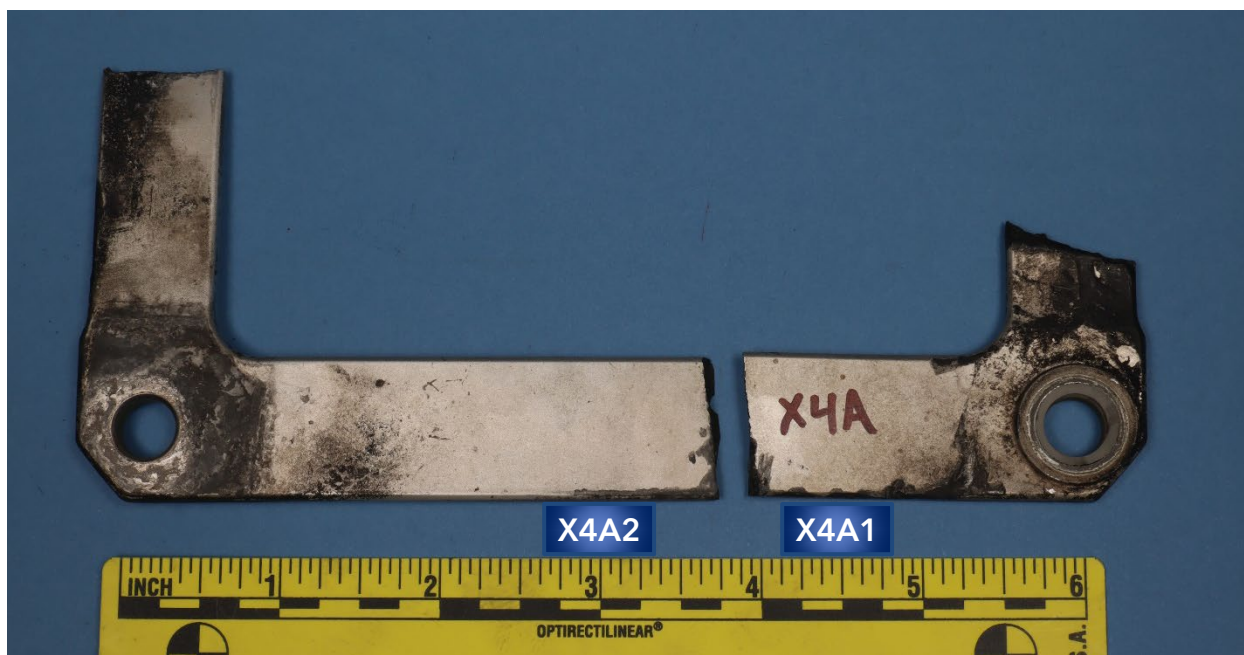
An overall view of the submitted KAflex coupling pieces are shown in figure 1. The pieces were from the flex frame attached to the transmission end of the interconnect (drive shaft) between the engine and the main transmission. The fracture submitted for detailed examination was labeled X4A. For reference in this report, the mating sides of the fracture are labeled X4A1 and X4A2 as shown in figure 1.

**Figure 1.** Overall view of the submitted KAflex coupling pieces as received.

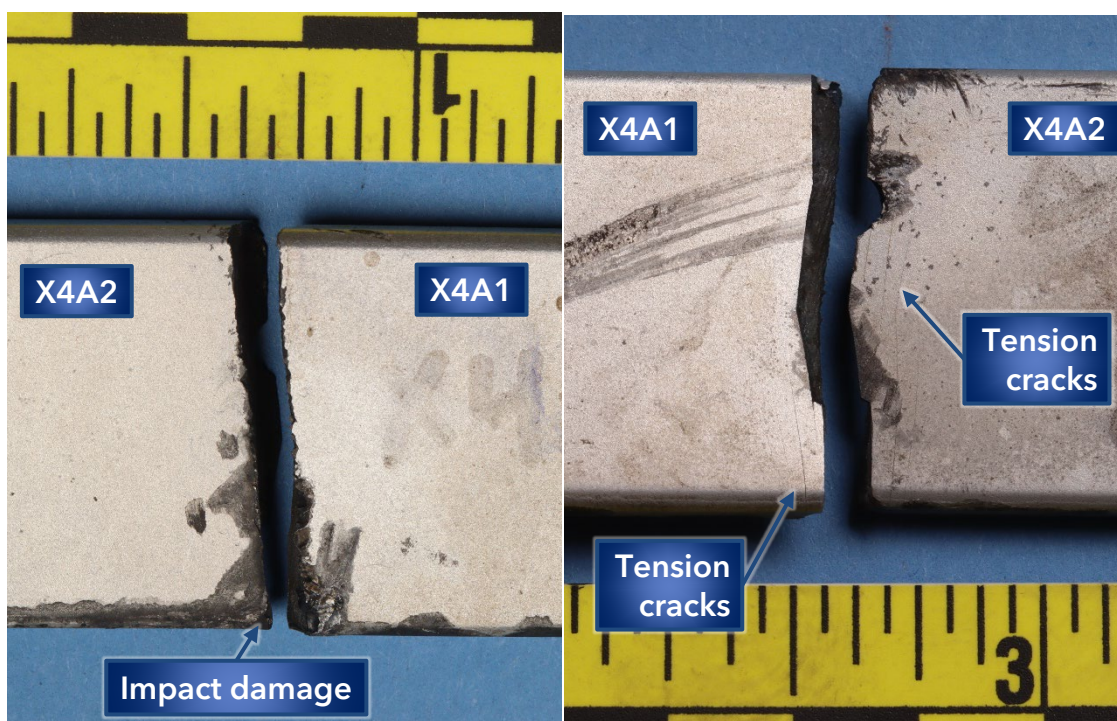
The submitted pieces were partially covered with sooty deposits. To facilitate a closer examination of the fracture surfaces, the surfaces were cleaned with a soft-bristle brush dipped in a solution of Alconox detergent and water. The surfaces were then rinsed with water followed by ethanol. Closer views of the cleaned fracture area on opposite sides of the frame are shown in figure 2. Impact damage was observed at the fracture location on one side as indicated in the left image in figure 2, and the damage extended across the fracture plane. On the opposite side of the frame, tension cracks parallel to the fracture surface were observed adjacent to the fracture as indicated in the right image in figure 2.

**Figure 2.** Closer views of the X4A fracture location after cleaning. Impact damage was noted on both sides of the fracture on one side of the frame (left image), and tension cracks were observed adjacent to the fracture on the opposite side (right image).

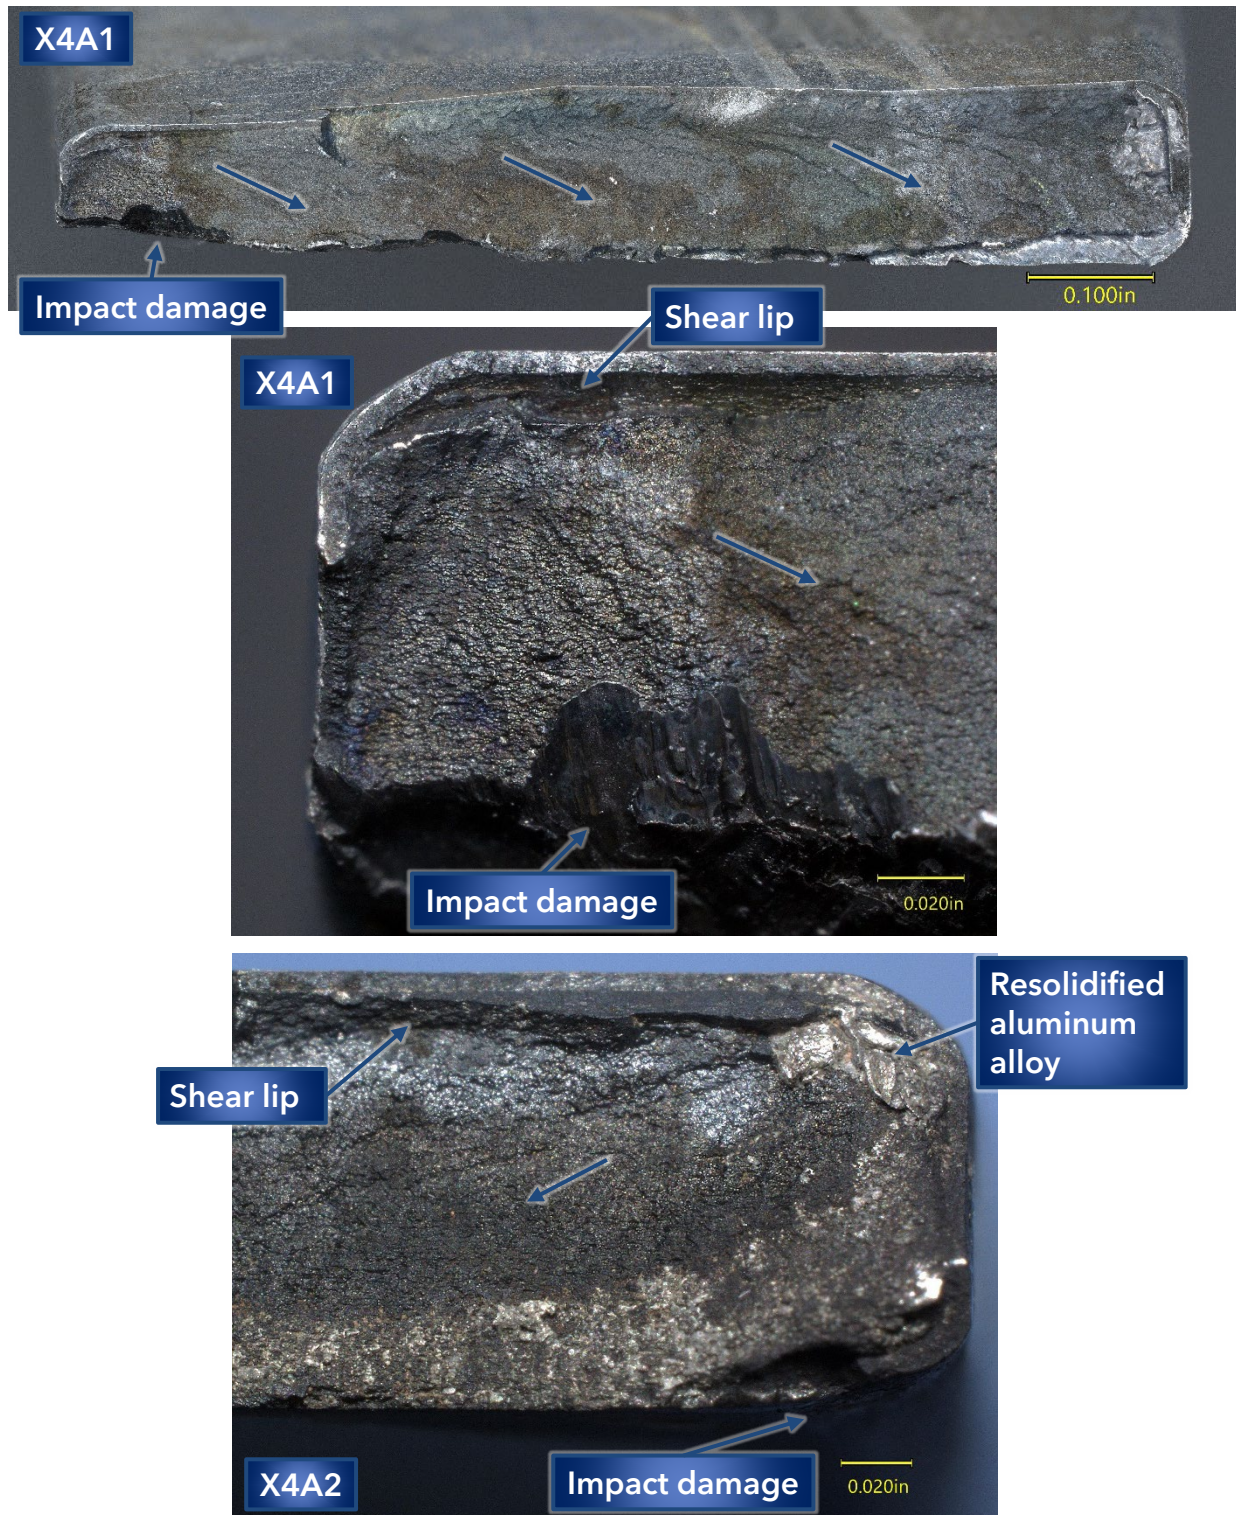
An overall view of fracture surface X4A1 is shown in the upper image in figure 3. The fracture surface generally had rough features with radial marks and curving chevron marks consistent with overstress fracture. Unlabeled arrows in figure 3 indicate the general direction of fracture propagation from the upper left corner as viewed in the upper image. Closer views of the initiation area on fracture X4A1 and the mating surface on X4A2 are shown in figure 3 in the middle and lower images, respectively. The area of impact damage was observed on the lower side as viewed in figure 3, and a shear lip was observed at the opposite side of the fracture

surface. Tinting from oxidation and surface deposits was observed, but the patterns were different on the mating surfaces, consistent with post-fracture oxidation and deposition.

The frame piece with fracture surface X4A2 was sectioned near the fracture surface to facilitate examination using a scanning electron microscope (SEM). Fracture features were generally obscured by oxidation. The silvery smooth area near the upper right corner (as viewed in figure 3) had a dendritic appearance consistent with resolidified material. Analysis of the material using energy-dispersive x-ray spectroscopy (EDS) revealed a spectrum consistent with an aluminum alloy as noted in figure 3.

**Figure 3.** Overall image of fracture surface X4A1 (upper image) with a closer view of the fracture initiation on X4A1 (middle image) and the mating side (lower image). Unlabeled arrows indicate the general fracture propagation direction. The fracture initiation area on X4A1 showed tinting consistent with post-fracture oxidation. Similar oxidation patterns were not observed on the mating side of the fracture.
