# National Transportation Safety Board

ANC22FA047

## **MATERIALS LABORATORY**

Factual Report 23-038

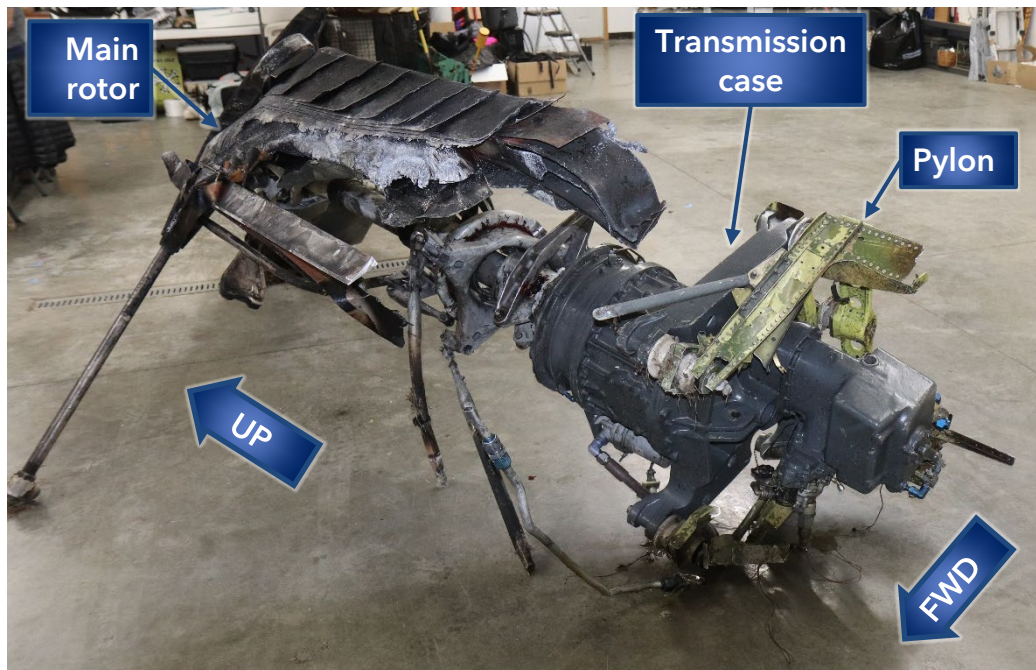
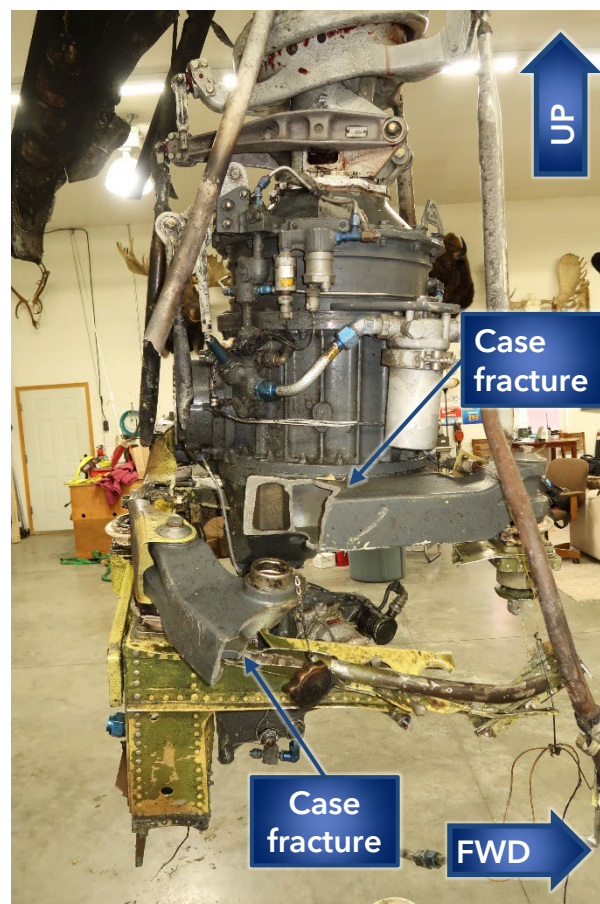
A group examination of the main transmission case, pylon structure, and associated components was conducted on February 8, 2023, at a storage facility in Wasilla, Alaska. Views of the main transmission case and pylon structure are shown in figures 1 through 4. The transmission case was fractured on the right side near the aft support as shown in the lower image in figure 1. The forward pylon support legs were fractured through the rivets attaching the isolation mount pad to the vertical faces of the legs as shown in figure 2. The pylon aft support legs are shown in figures 3 and 4. The aft left support leg was fractured at the lower attachment bracket for the friction damper, and the aft right support leg was fractured at its lower end. The lift link and attached fuselage beam structure pieces had been previously disassembled from the main transmission case and were previously examined (see Materials Laboratory Factual Report 22-093).

**Figure 1.** Overall view of the forward left side of the main transmission and pylon assemblies (upper image) and a view of the right side of the assemblies (lower image) showing the location of the case fracture.

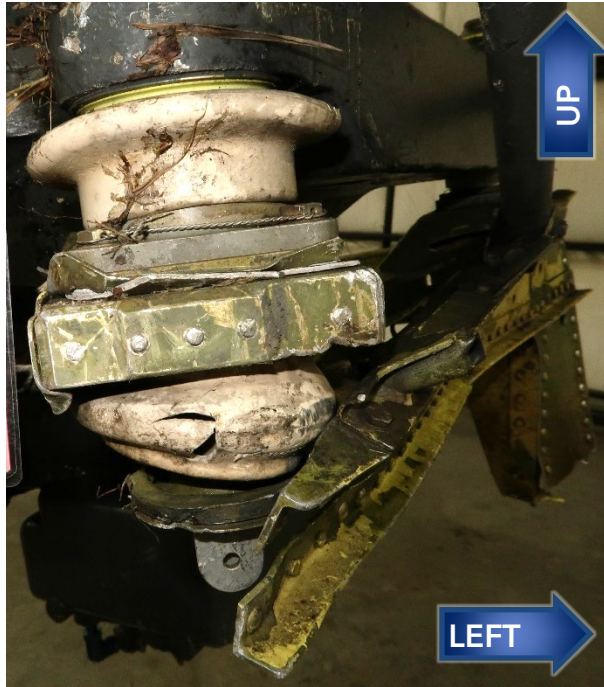
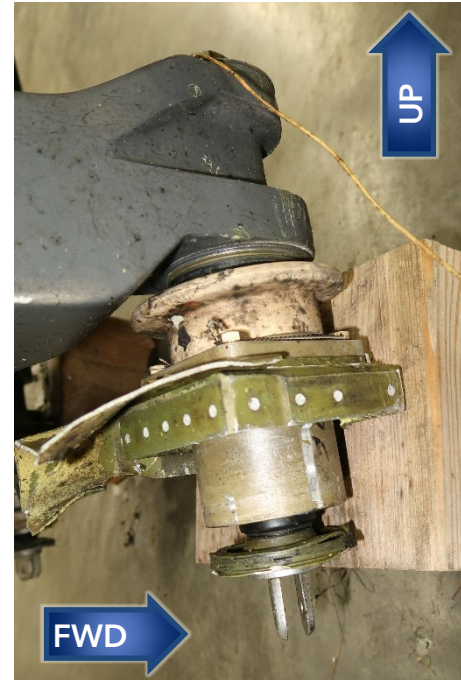
**Figure 2.** Close views of the fractured pylon support legs at the forward left (left image) and forward right (right image) main transmission attachment locations.

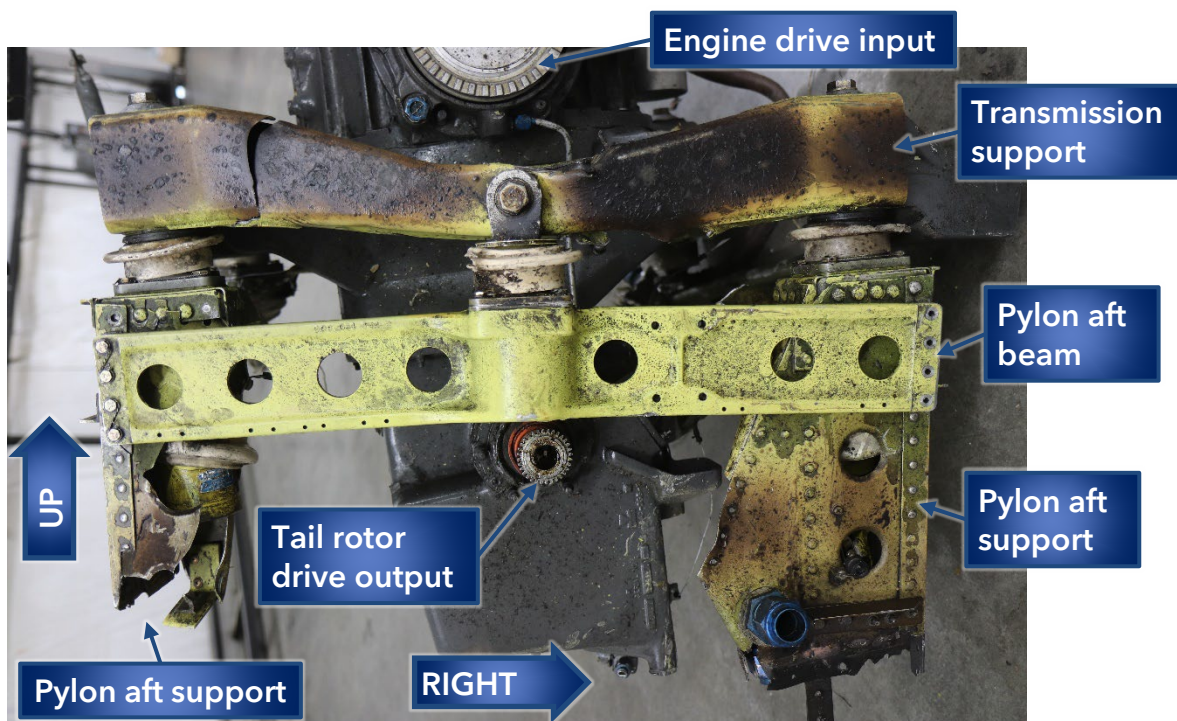
**Figure 3.** View of the aft side of the pylon assembly.

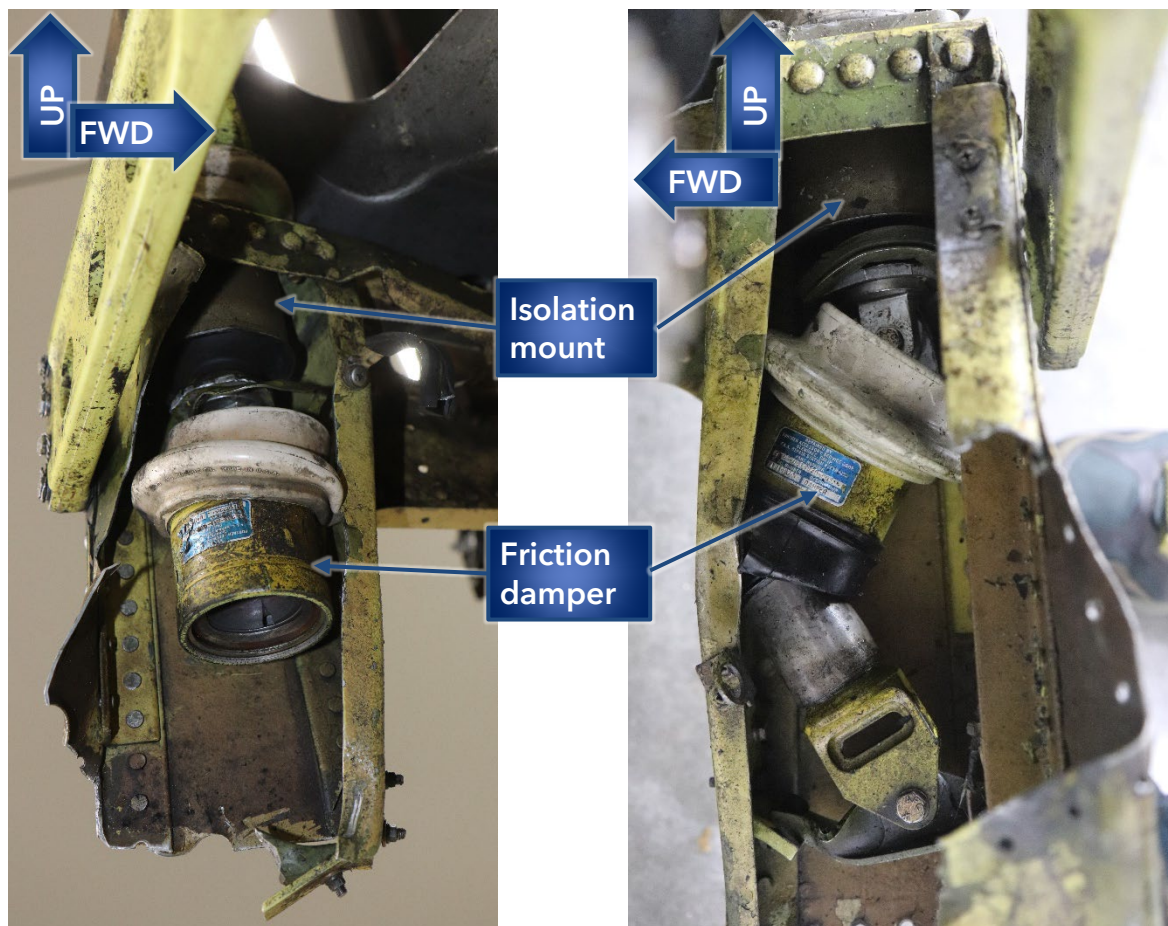
**Figure 4.** Views of the inboard sides of the left (left image) and right (right image) aft pylon support legs showing friction dampers and isolation mounts.

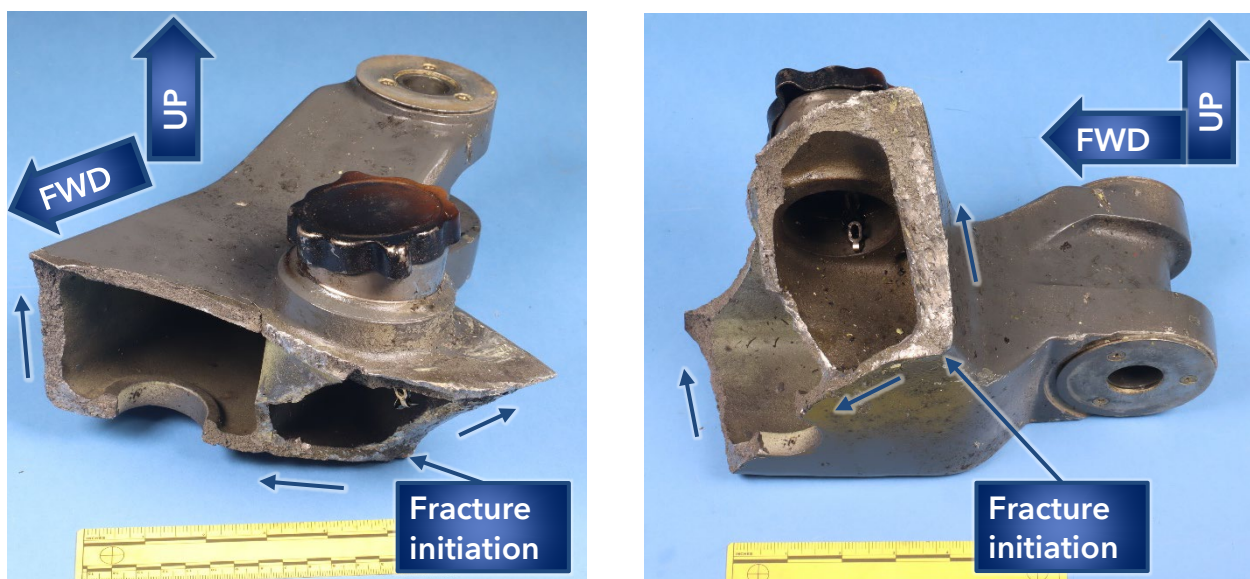
Views of the fractured main transmission case piece are shown in figure 5. The fracture was located near the right aft attachment lug where the lug portion transitioned to the main body of the case. The fracture surface had relatively uniform rough fracture features consistent with overstress fracture. Radial features were consistent with fracture propagation emanating from an initiation site located at the lower aft corner of the fracture as indicated in figure 5. The initiation site was examined closely using an optical stereomicroscope, and no evidence of any preexisting damage or progressive fracture mechanism was observed. Vertical portions of the fracture surface were rubbed consistent with post-fracture contact as the main body of the case moved upward relative to the aft right attachment lug piece.

**Figure 5.** Views of the fracture surface on the main transmission case piece disassembled from the aft right pylon support. Unlabeled arrows indicate overstress fracture propagation directions.

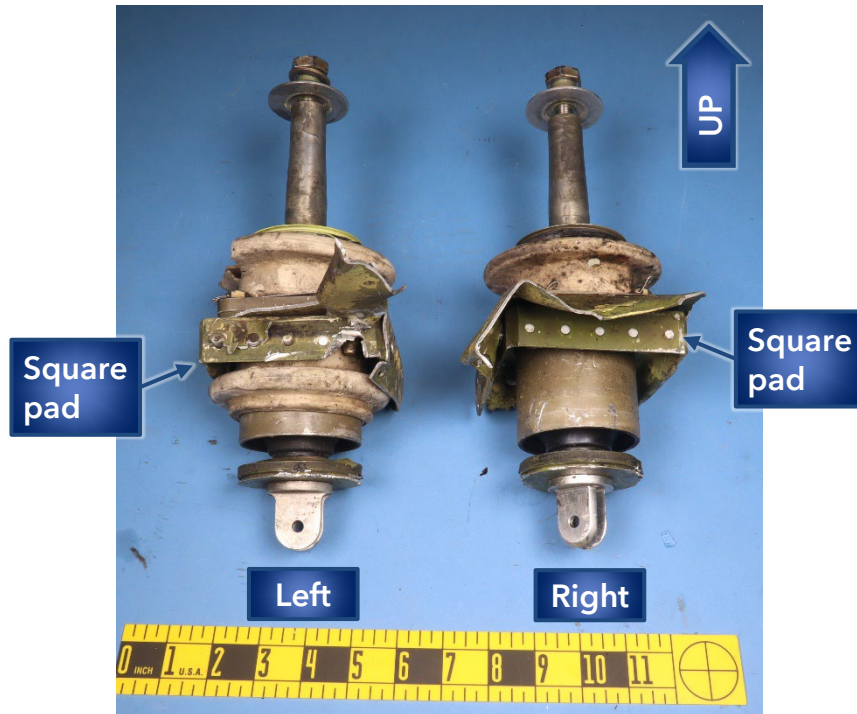
Isolation mounts and attached pylon structure at the main transmission case forward left and right attachments are shown in figure 6. The isolation mounts were attached to square pads at the upper ends of the pylon legs, and pieces of the longitudinal channels remained attached to the pads. The channel fractures showed deformation and were on slant angles consistent with ductile overstress fracture. Separation between the square pads and the vertical leg structures occurred mostly by fracture of the rivets, which were deformed consistent with ductile shear fracture. The rivets pieces remaining in the square pads were deformed upward, consistent with the isolation mounts and square pads moving downward relative to the pylon structure.

**Figure 6.** Aft sides of the forward isolation mounts and attached pylon support structure after disassembly from the main transmission case.

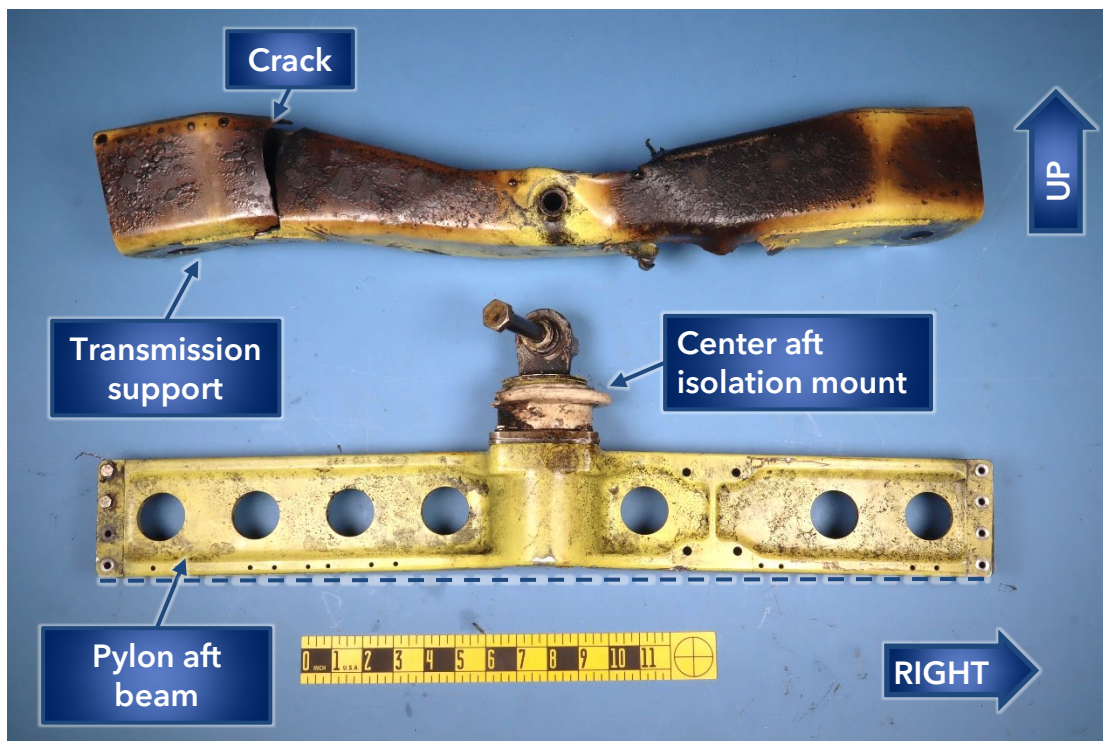
The pylon aft beam was bent slightly upward in the middle relative to the ends. The extent of the bend is illustrated in figure 7, where a straight dashed line touching the lower surface at the outboard ends shows a gap at the middle of the beam. Sliding contact marks were observed on the lower surface in the middle of the beam as shown in figure 13, consistent with contact with the tail rotor drive components extending from the aft side of the main transmission.

**Figure 7.** Aft transmission support after disassembly from the isolation mounts and the pylon aft beam with attached center isolation mount after disassembly from the pylon supports.

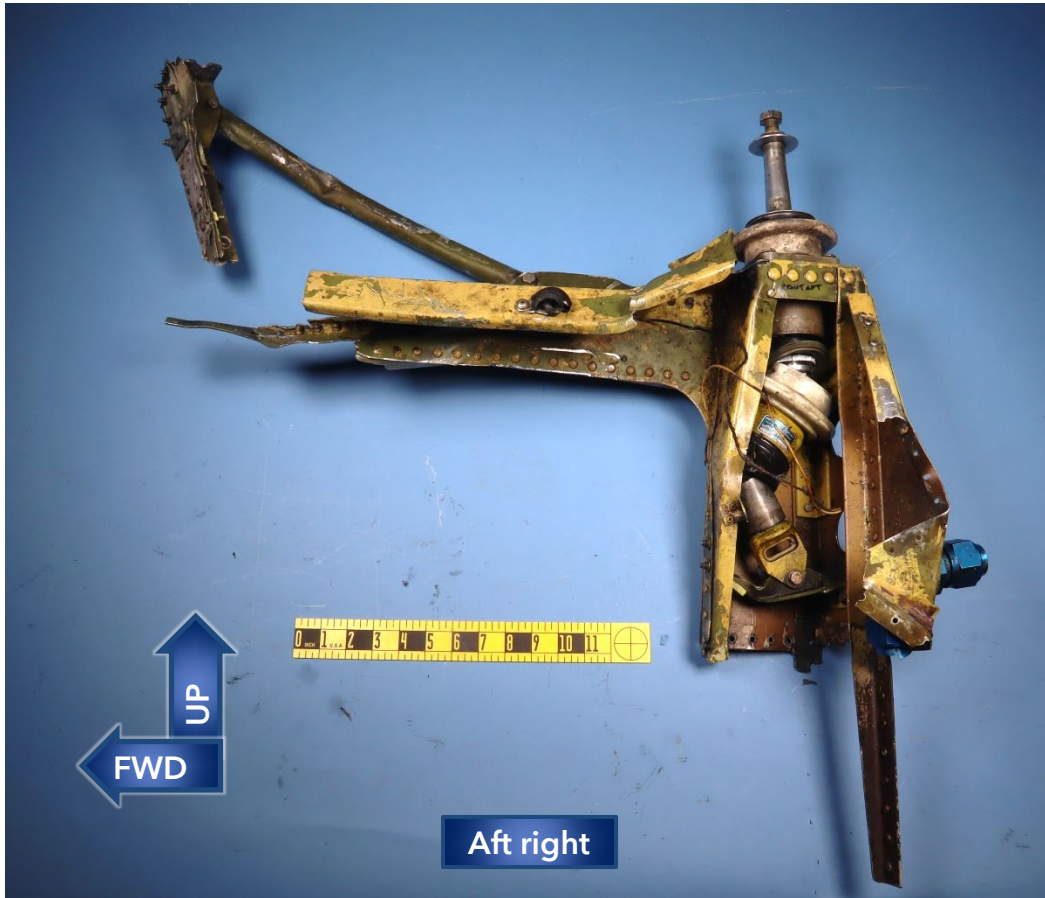
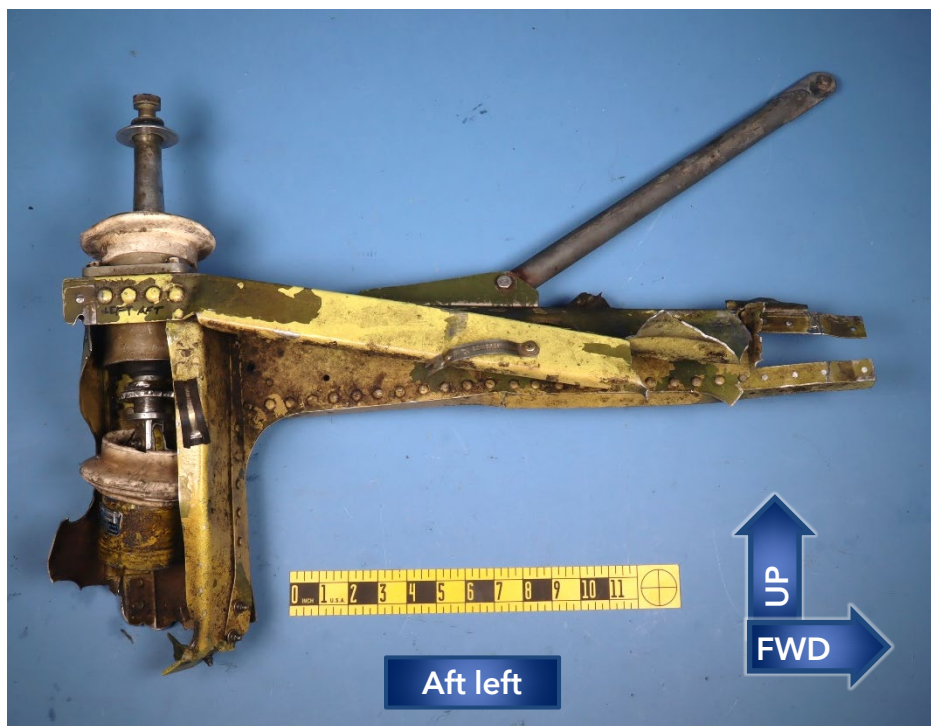
The inboard sides of the aft right and aft left isolation mounts, friction dampers, and attached pylon pieces are shown in figure 8. The upper portion of the friction dampers were separated from the lower portions consistent with overextension of the dampers. To facilitate closer examination of the damage, the isolation mounts were disassembled from the square pads on the pylon legs.

**Figure 8.** Aft pylon pieces after disassembling the main transmission case from the aft isolation dampers.

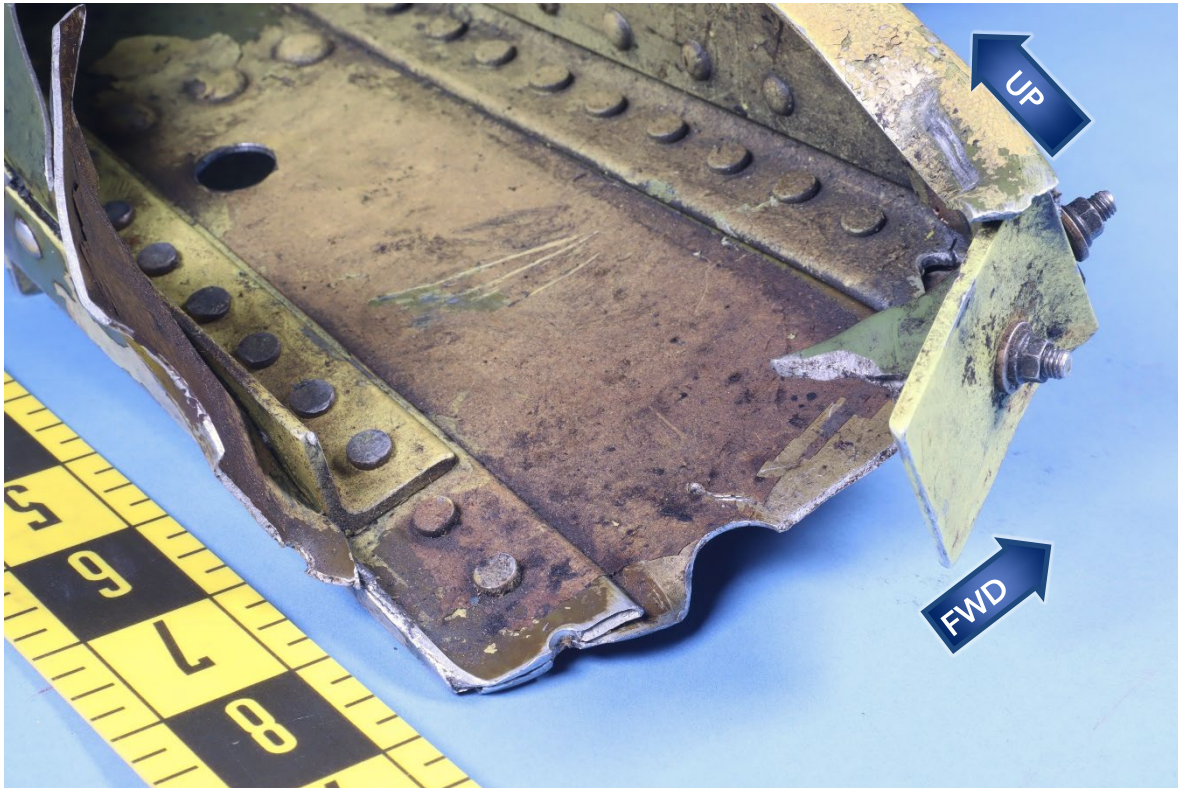
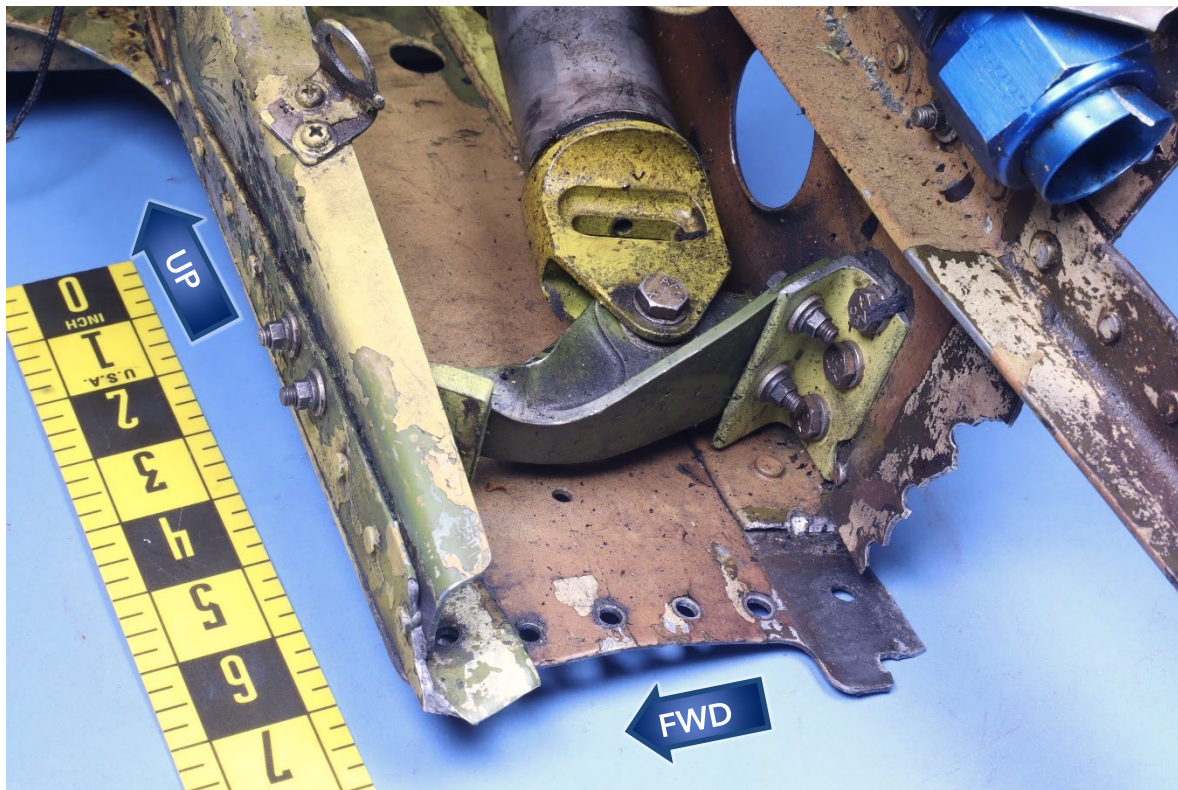
The lower ends of the pylon's aft legs after disassembly are shown in figure 9. At the aft left leg fracture shown in the upper image in figure 9, the fracture was located near the lower attachment bracket for the friction damper, and the forward end of the bracket remained attached to the pylon leg. The forward attachment flange for the friction damper bracket was deformed downward, consistent with the friction damper moving downward relative to the separated upper portion of the pylon leg. The fracture surface at the aft end of the fracture through the outboard surface of the leg was obliterated by post-fracture contact, but remaining portions of the fracture in the adjacent stiffener were on slant angles consistent with ductile overstress fracture. The remaining lower fractures on the aft left pylon leg also had deformation and slant angles consistent with ductile overstress fracture.

A view of the lower end of the aft right pylon leg after disassembly of the isolation mount from the pylon is shown in the lower image in figure 9. The friction damper lower bracket was deformed consistent with the damper being pushed downward relative to the pylon leg. The leg was separated mostly through sheared rivets and through sheared-out rivet holes at the lower end of the leg.

**Figure 9.** Lower ends of the aft left (upper image) and aft right (lower image) pylon support pieces after disassembling the isolation mounts and upper portions of the friction dampers.

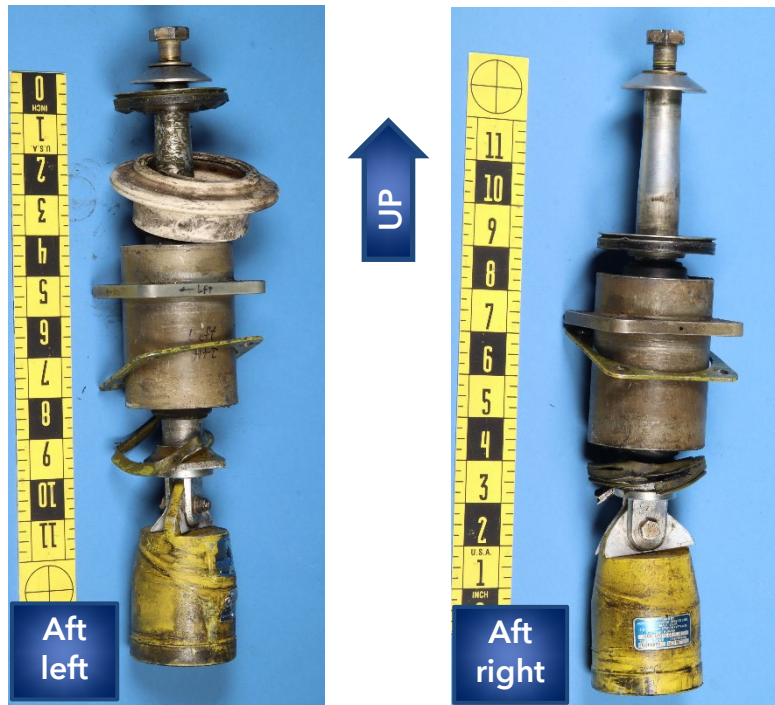
Overall views of the aft left and aft right isolation mounts and upper ends of the friction dampers after disassembly from the pylon are shown in figure 10. The isolation mounts were further disassembled from the friction dampers and bushings by sliding the isolation mounts off the upper ends of the mounting bolts. Views of the aft left and aft right isolation mounts and associated bushings after disassembly are shown in figure 11. The elastomer on the upper and lower bushings were deformed consistent with heavy contact with the outer cylinder for the isolation mounts. The lower bushings were also fractured and had features consistent with ductile overstress fracture from contact with the lower end of the isolation mount outer cylinder.

**Figure 10.** Aft left and aft right isolation mounts and upper portions of the friction dampers after disassembly from the pylon supports.

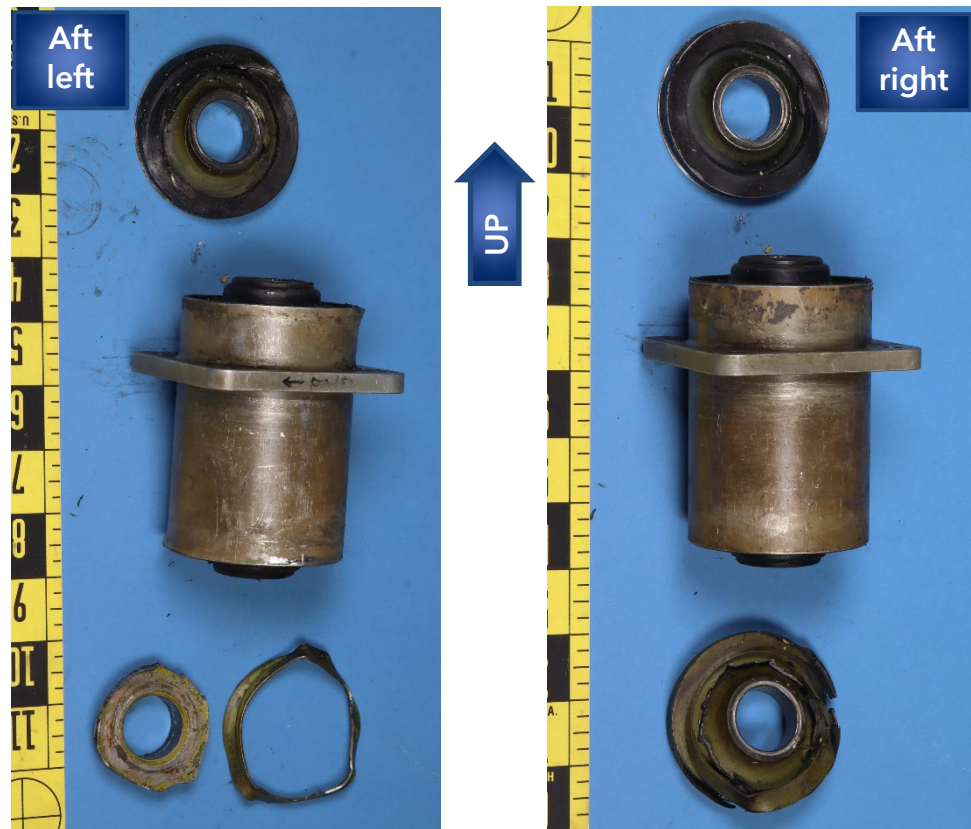
**Figure 11.** Aft left and aft right isolation mounts and bushings after disassembly from the isolation mount bolts.

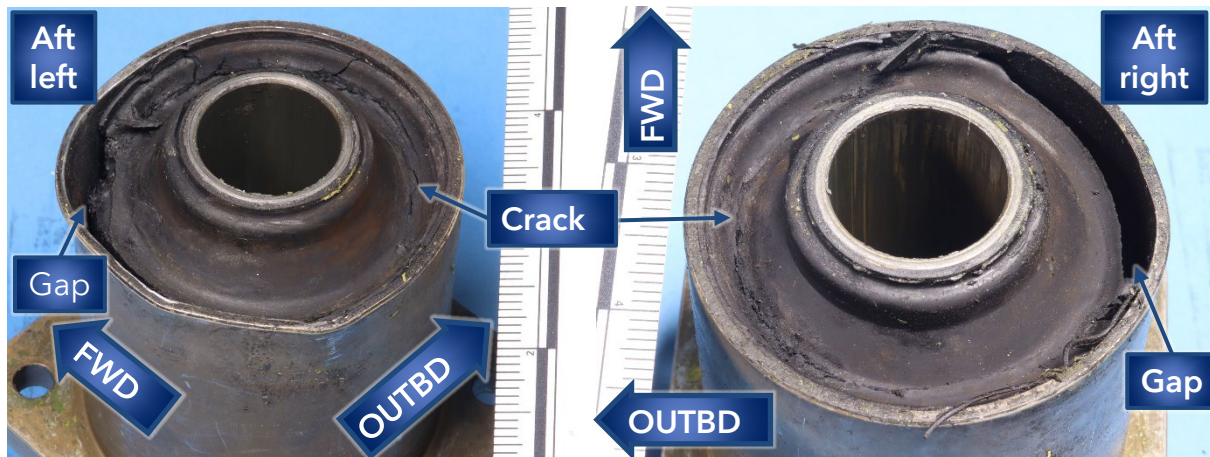
The lower ends of the aft left and aft right isolation mounts are shown in figure 12. The elastomer was cracked around approximately  $\frac{1}{2}$  the circumference on the inboard side of each isolation mount, and the elastomer was separated from the outer cylinder at the outboard side of each mount, leaving a gap between the cylinder and the elastomer. The outboard sides of the outer cylinders were deformed at the lower end consistent with contact with the fractured edges of the lower bushings, particularly on the aft left isolation mount.

**Figure 12.** Lower ends of the aft left and aft right isolation mounts.

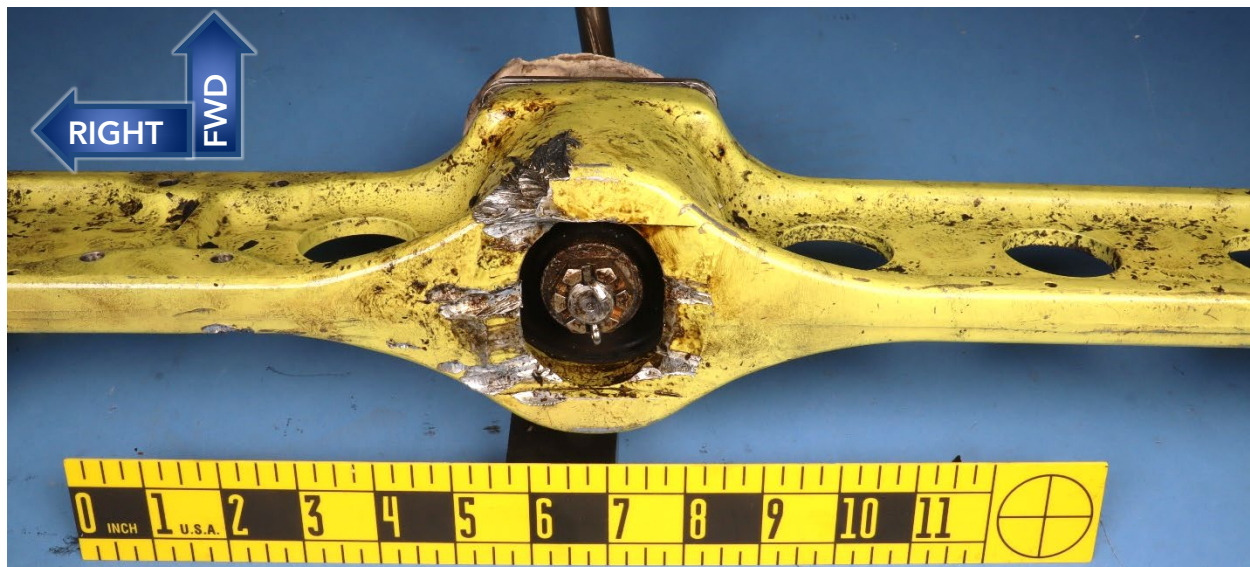
**Figure 13.** Sliding contact damage on the underside of the pylon aft beam.

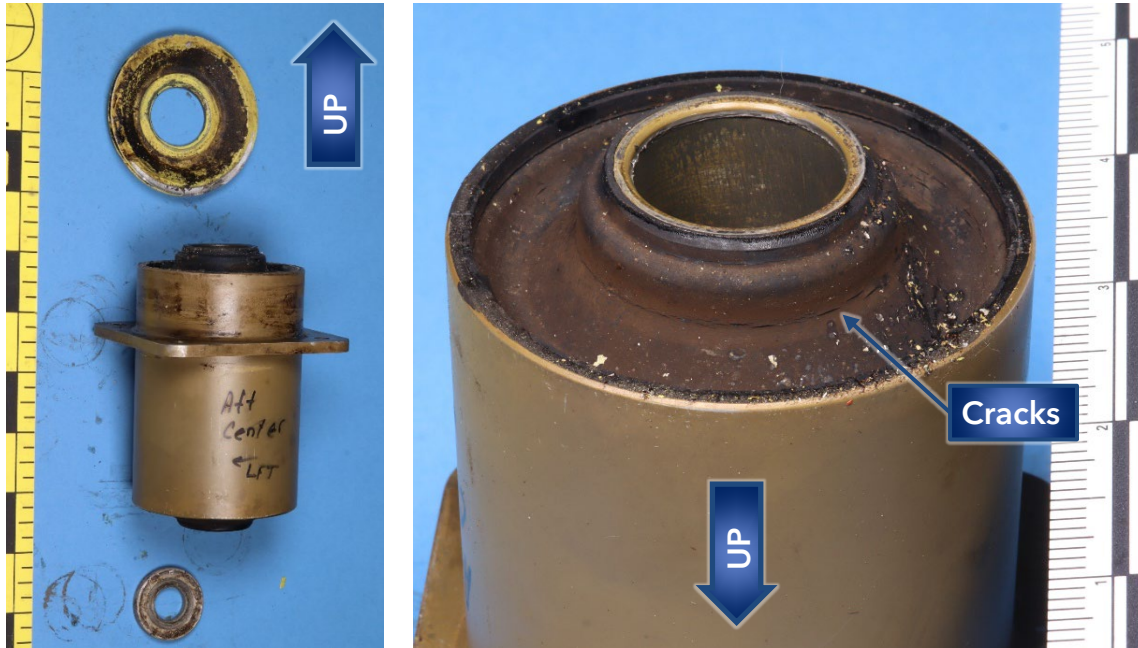
The aft center isolation mount was disassembled from the pylon aft beam, and the center bolt was removed to separate the upper bushing and lower washer from the mount. A view of the disassembled isolation mount, upper bushing, and lower washer are shown in the left image in figure 14, and a view of the lower end of the isolation mount is shown in the right image in figure 14. The elastomer in the isolation mount did not show any separations from the outer cylinder. Small cracks were observed in the elastomer near the inner cylinder.

**Figure 14.** Aft side of the aft center isolation mount, bushing, and washer (left image) and lower end (right image) after disassembly from the pylon aft beam.

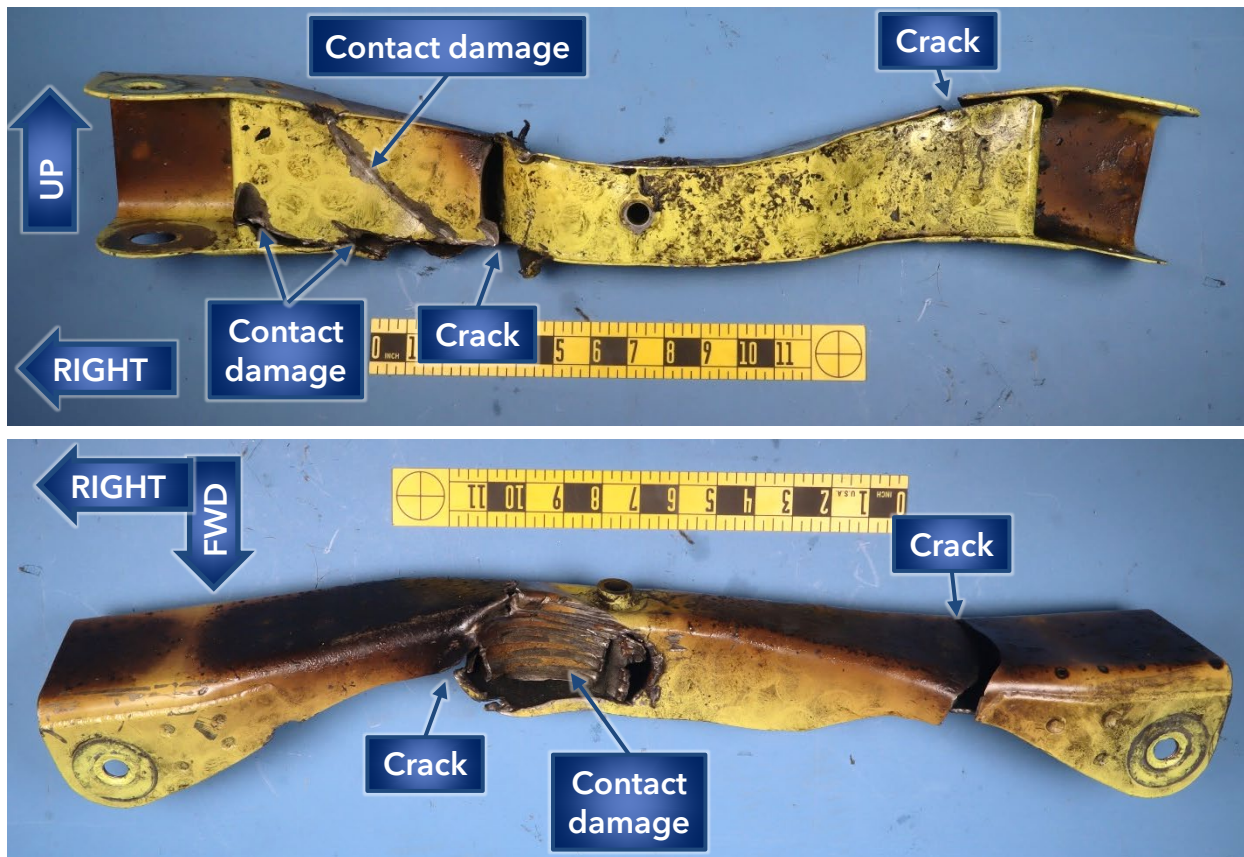
Views of the main transmission support are shown in figure 15. The upper surface was crushed with sliding contact damage to the right of center with corresponding downward deformation at the middle of the support relative to the outboard ends. The left side of the support was deformed upward relative to the right side, and the upper and aft sides of the support were cracked near the left main transmission attachment location. The forward and lower faces also were cracked to the right of center. The crack fractures on the upper and aft sides near the left attachment location had slant angles consistent with ductile overstress fracture. The surfaces adjacent to the crack at the forward and lower faces were deformed consistent with overstress fracture associated with the sliding contact damage. The aft side of the support and the area near the contact damage on the upper surface were darkened consistent with heat damage. Several areas of sliding contact damage were also observed on the forward side of the support between the centerline and the aft right main transmission attachment location.

**Figure 15.** Forward face (upper image) and upper face (lower image) of the main transmission support showing cracks and sliding contact damage.

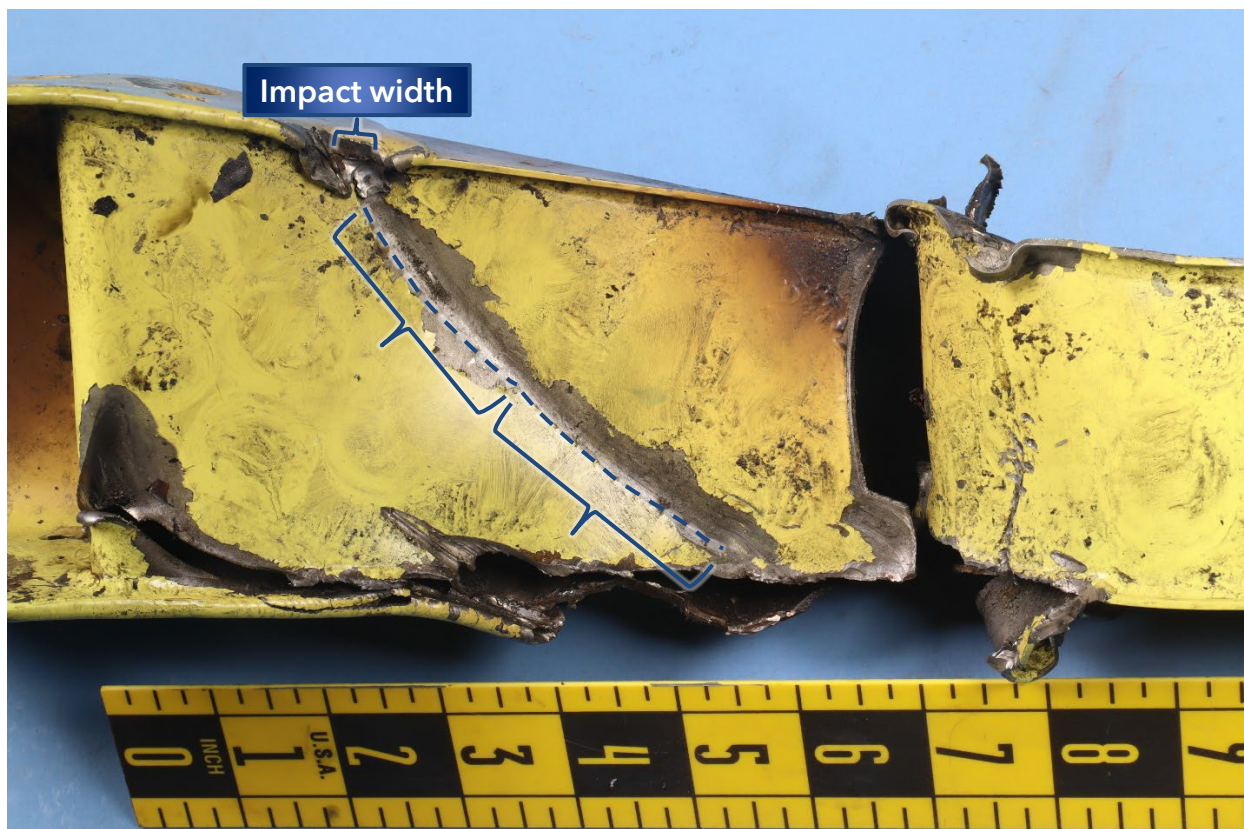
Curvature associated with sliding contact damage on the upper and forward sides of the support was measured using a Faro EDGE FaroArm coordinate measurement device fitted with a 3-millimeter hard probe acquired using Faro Cam2 Measure 10 software. The damage on the upper surface was fitted to a cylinder, and the measured cylinder had a radius of 3.75 inches. The curvature of the sliding contact damage on the forward face was measured with the aft face on the right side clamped against a flat table, and the data from the sliding contact damage was fit to a circle projected onto the flat plane defined by the table. The damage did not have a precise edge and had some variation in curvature along the entire face. The overall arc had a measured radius between 8.6 inches and 10.2 inches. However, the contact mark extending across the face appeared to be connected with two separate arcs as indicated with dashed lines and unlabeled brackets in figure 16. The upper edge of the forward face was bent downward where it was impacted by the contacting object, and the width of the impact was 0.319 inch. The sliding contact in each of the contact areas of the support indicated in figure 15 was consistent with contact with objects rotating clockwise as viewed looking toward the forward direction.

**Figure 16.** Closer view of sliding contact damage on the forward face of the transmission support. Dashed lines and unlabeled brackets indicate two separate arc segments on the sliding contact mark that extended across the face.
