# National Transportation Safety Board

ANC22FA047

## **MATERIALS LABORATORY**

Factual Report 22-093

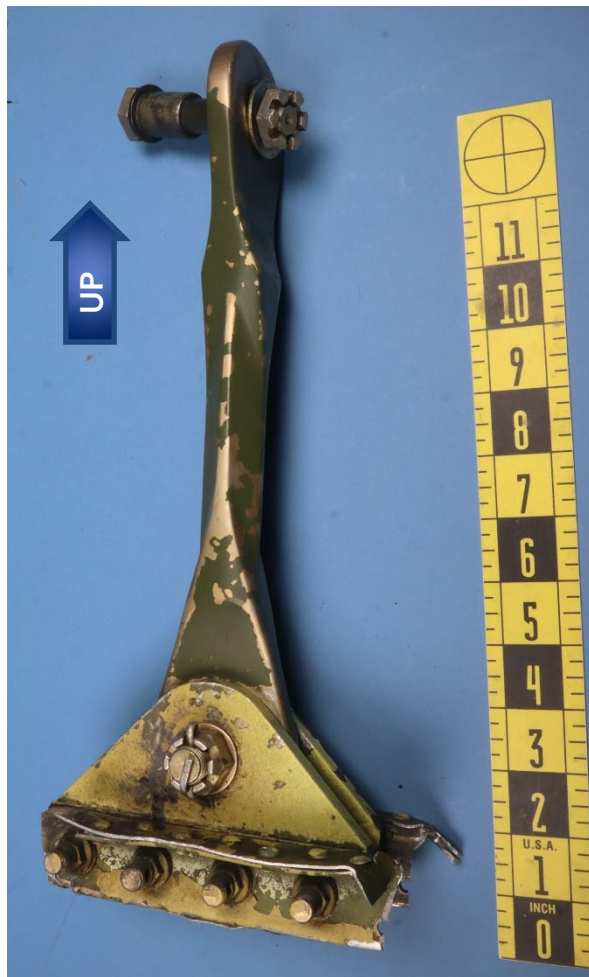
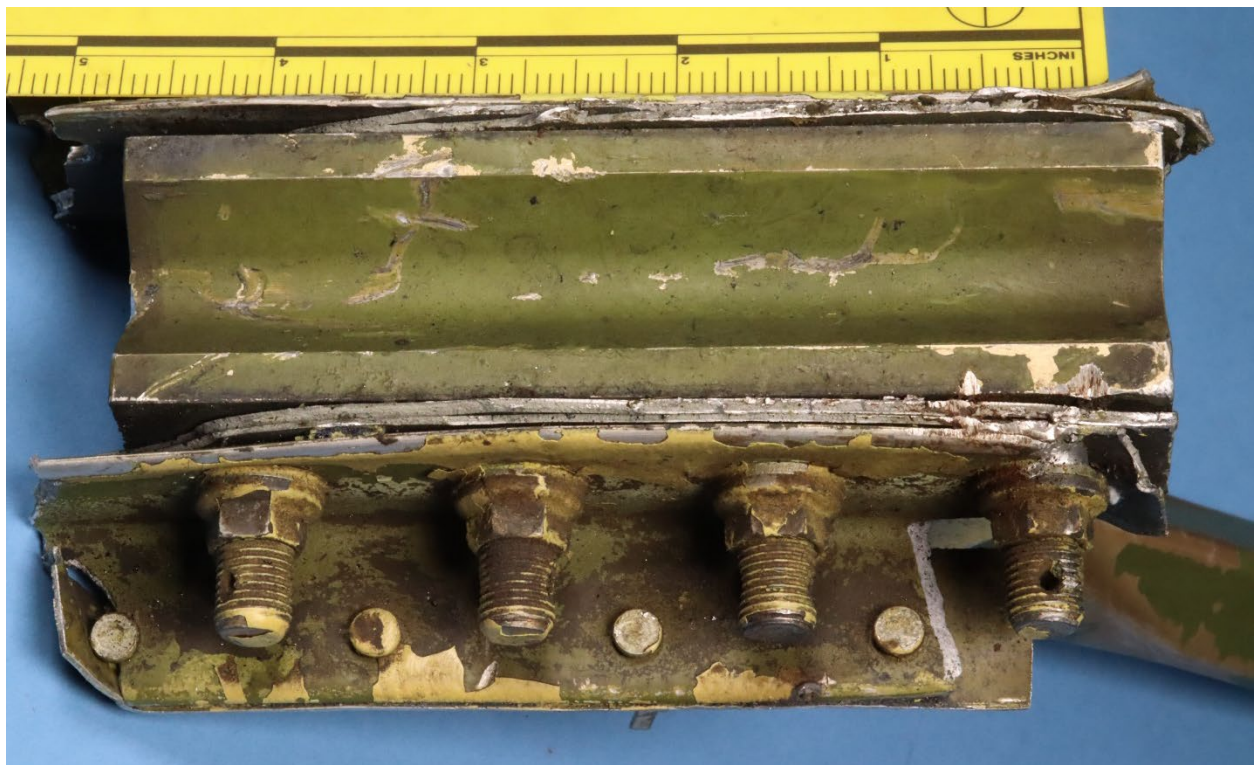
An overall view of the submitted lift link assembly and attached fuselage beam structure piece is shown in figure 1. The beam structure was fractured near the edges of the link attachment clevis fitting. Views of the fracture surfaces are shown in figures 1 and 2. Fracture features generally showed deformation and rough matte-gray features consistent with ductile overstress fracture in wrought aluminum alloys. Portions of the fracture had a more reflective appearance, particularly near the edges along the lower fracture faces and in various areas of the vertical faces consistent with smearing on a shear plane or post-fracture contact damage. No evidence of preexisting damage such as fatigue cracking was observed.

**Figure 1.** Overall view of the submitted lift link assembly with attached fuselage beam structure piece (left) and view of fractures on the lower side of the submitted beam structure piece (below).

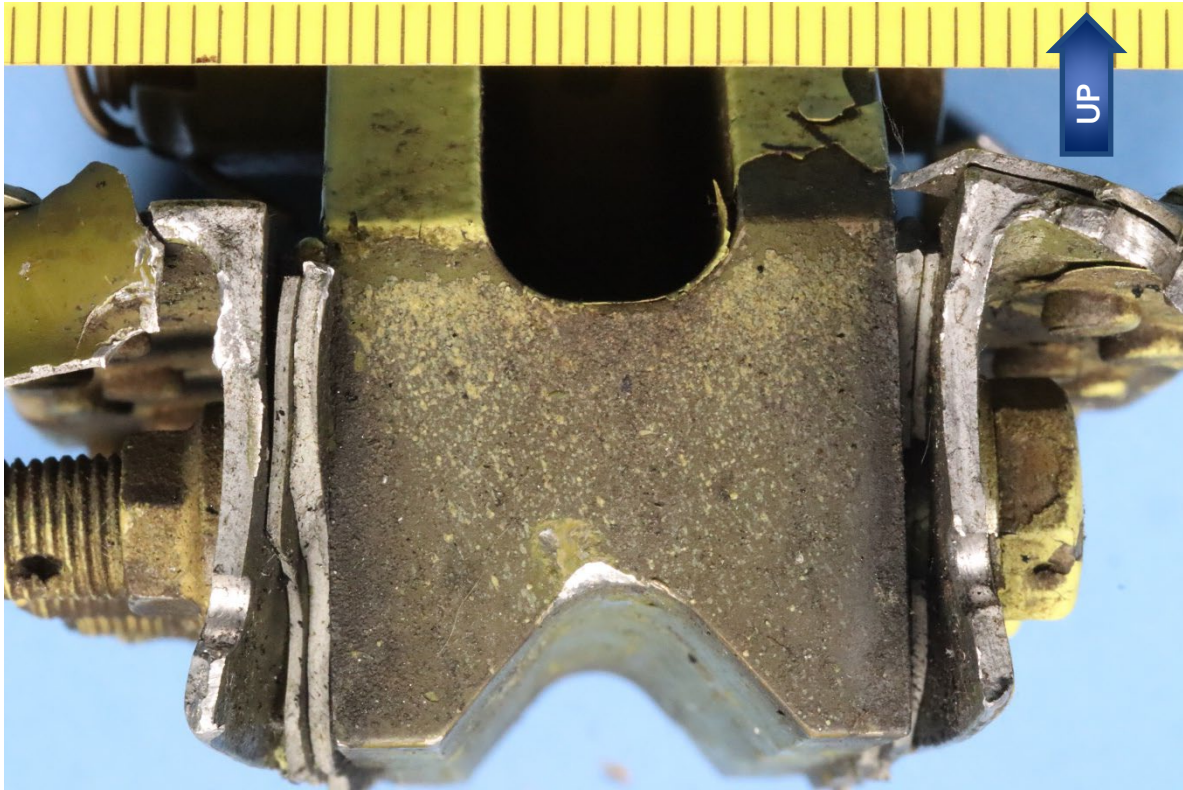
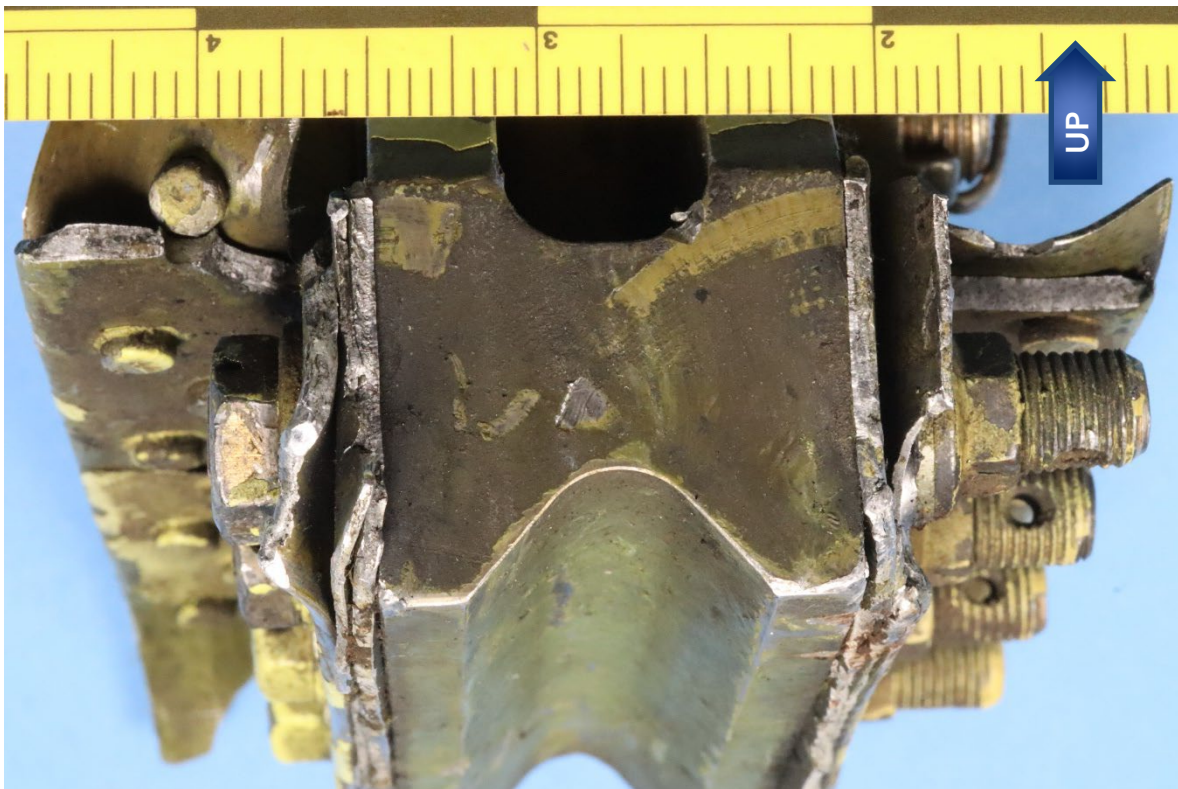
**Figure 2.** Vertical portions of the beam structure fracture surfaces at each end of the submitted piece.
